Inspection Photos  
Location Name: Bledsoe 2-26-5-45  
API Number: 125-09633

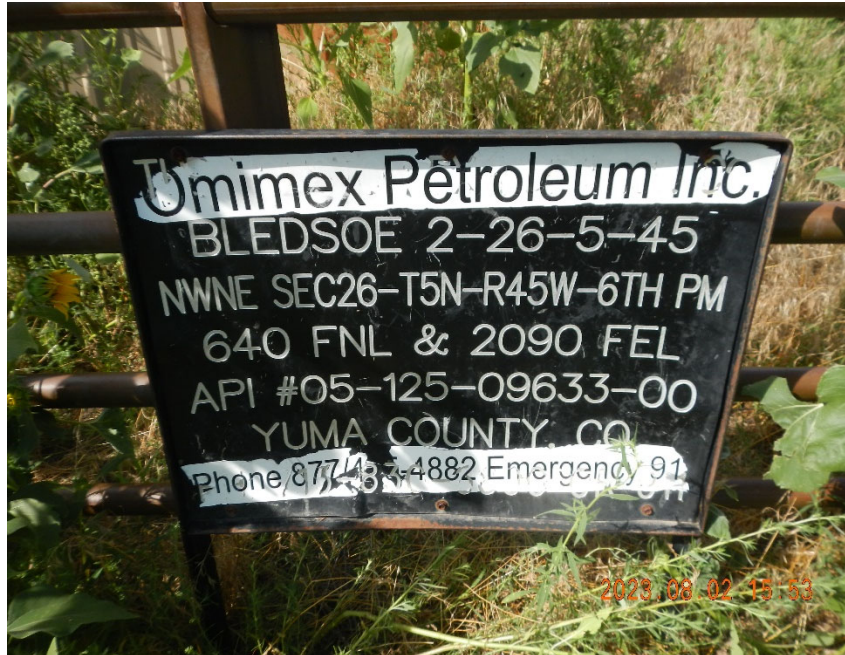
1. Well sign at remote Gas Meter Run. No Sign at well location. Note vegetation.

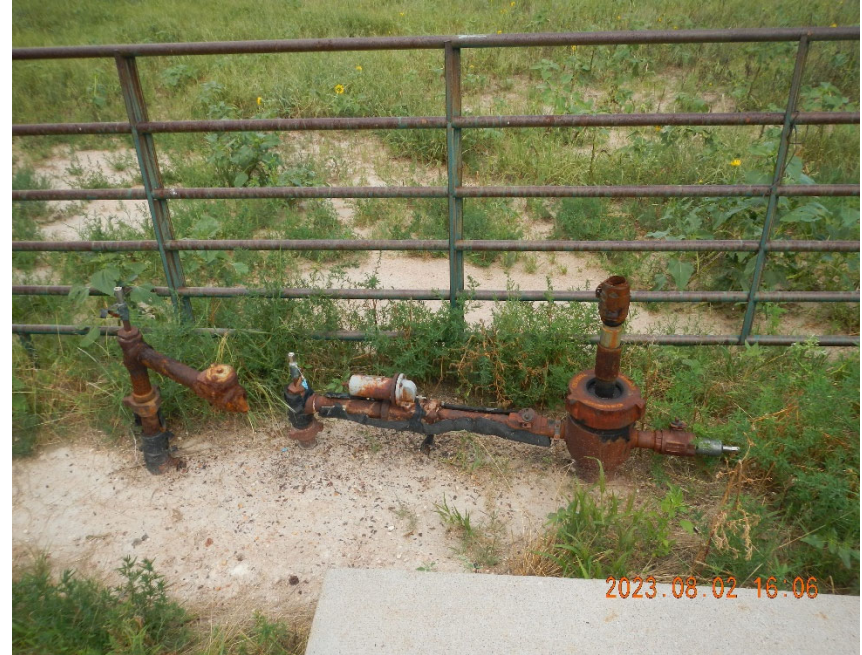
2. View of Wellhead. Note vegetation.

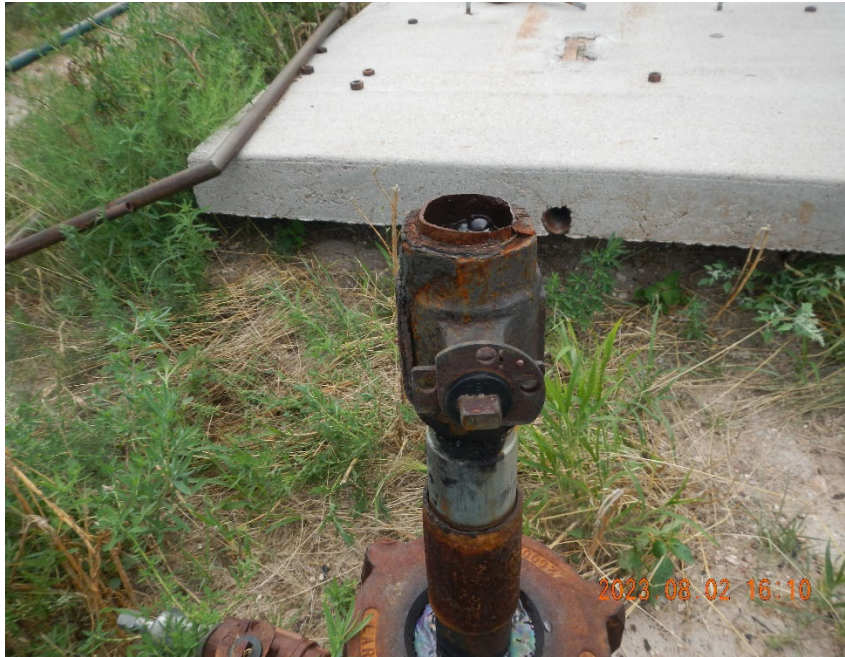
**3. Unplugged open ended valve on end of tubing joint that is leaking. Bubble is visible in trapped water.**

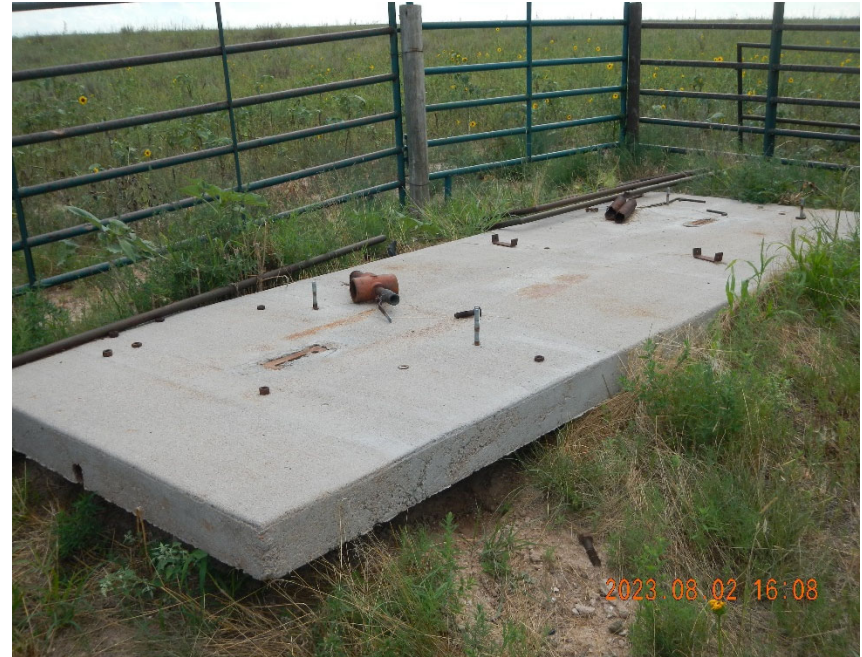
**4. Cement Pad and Production related debris inside fencing at well location.**

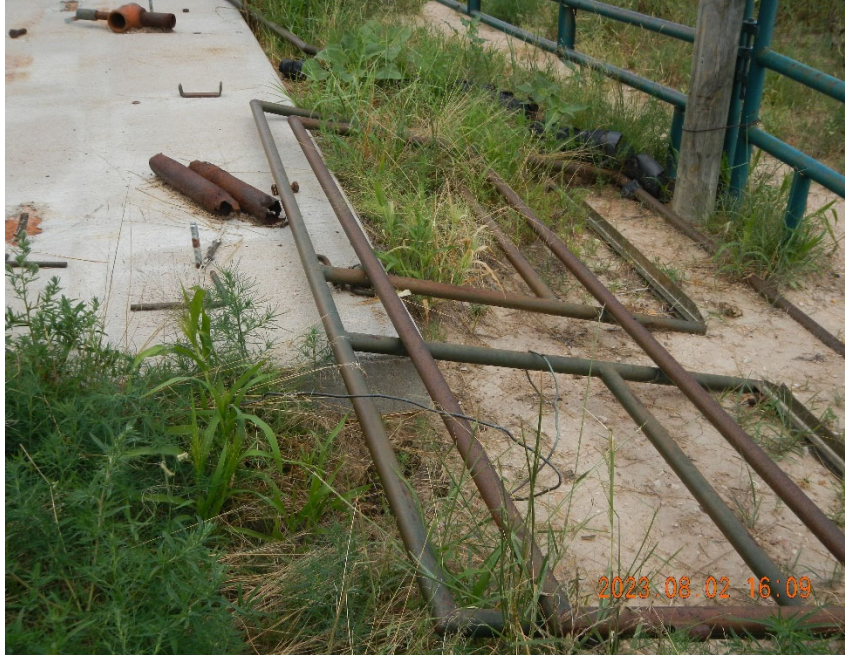
**5. Additional view of Production related equipment and debris inside fencing at well location.**

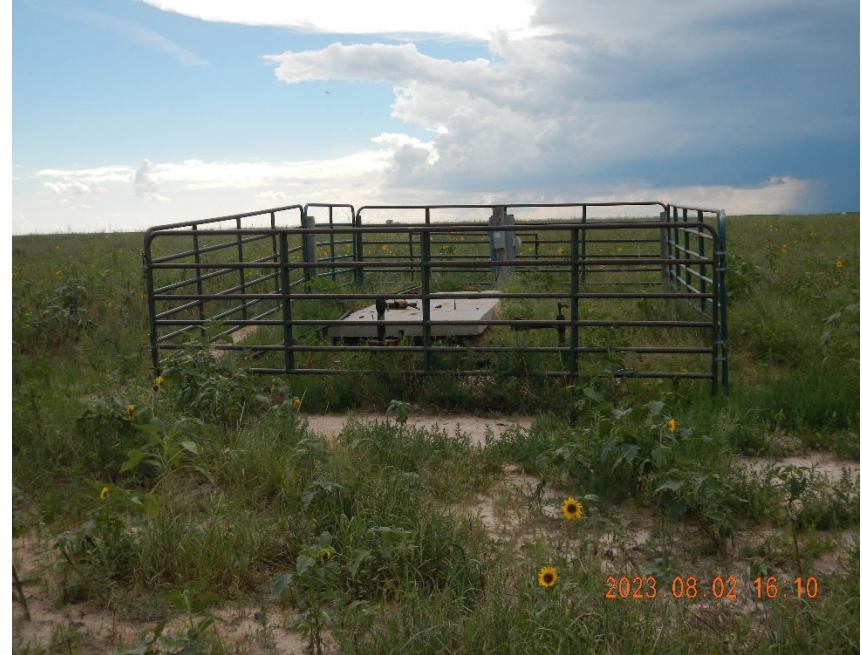
**6. Location overview.**

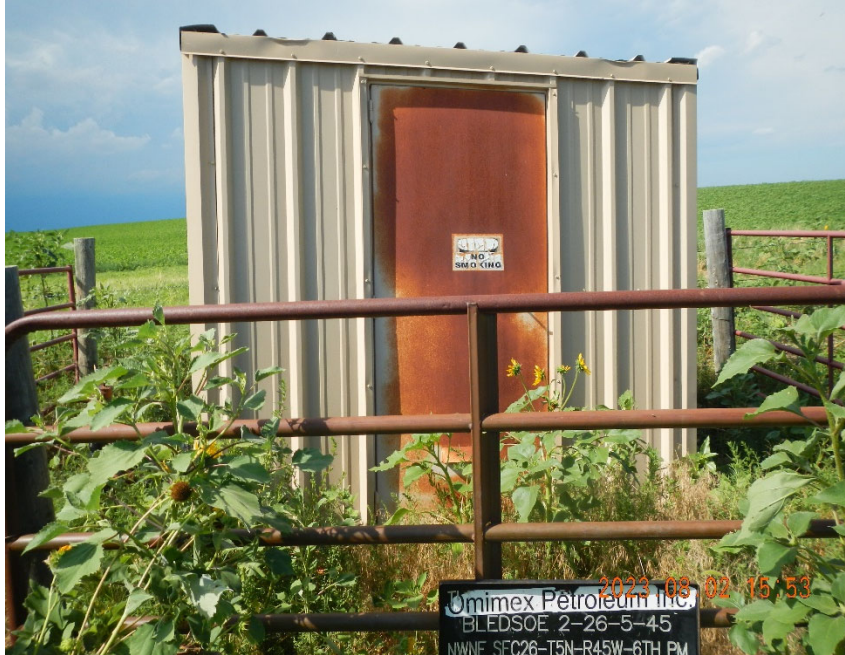
**7. Remote Gas Meter Shed. Note vegetation.**

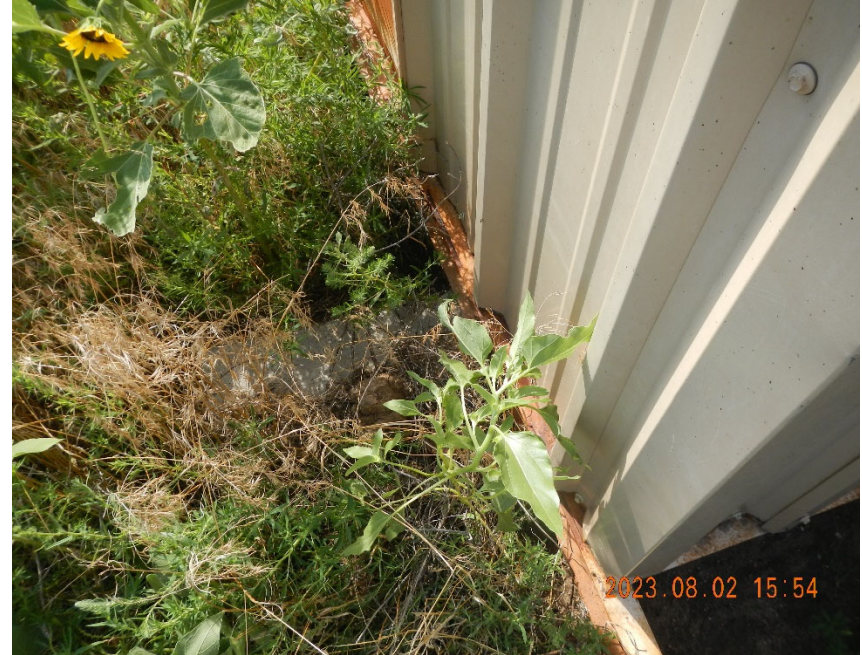
**8. View of partially visible support piling. Meter has been blown partially off support and leaning. Note vegetation.**

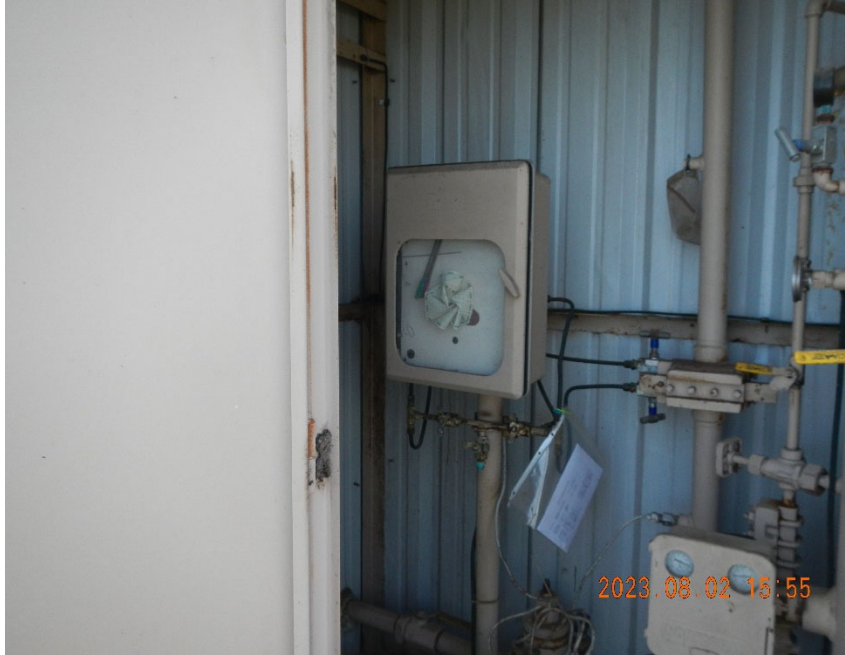
**9. Gas Meter inside Meter Shed.**

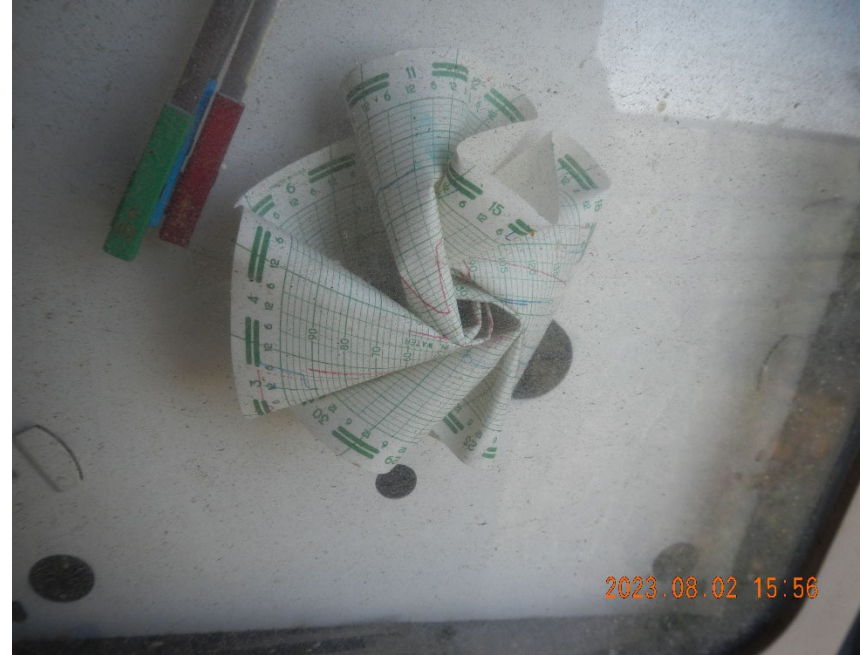
**10 Chart has twisted inside the unchecked Meter Box.**

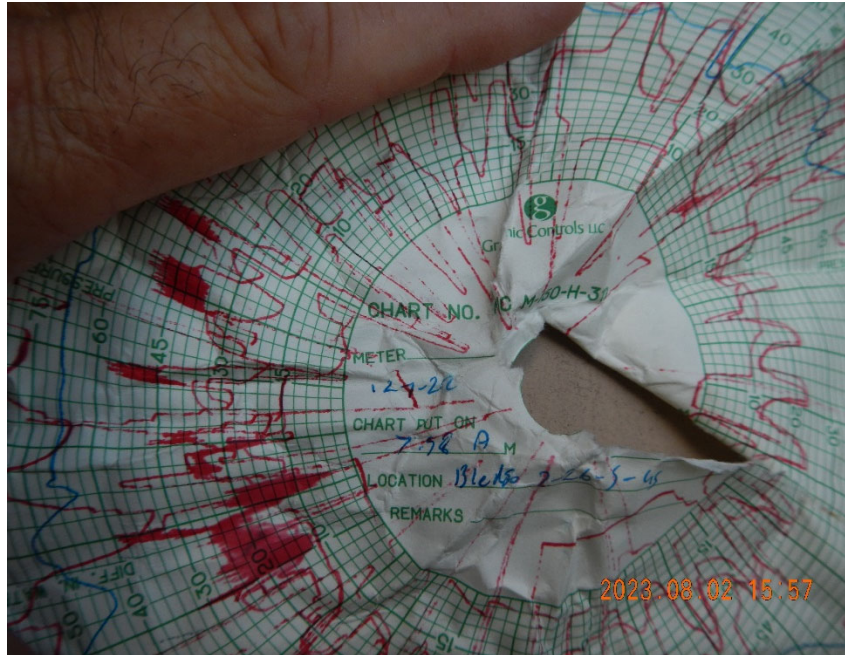
**11. View of Chart from Meter Box. Dated 12-1-22.**

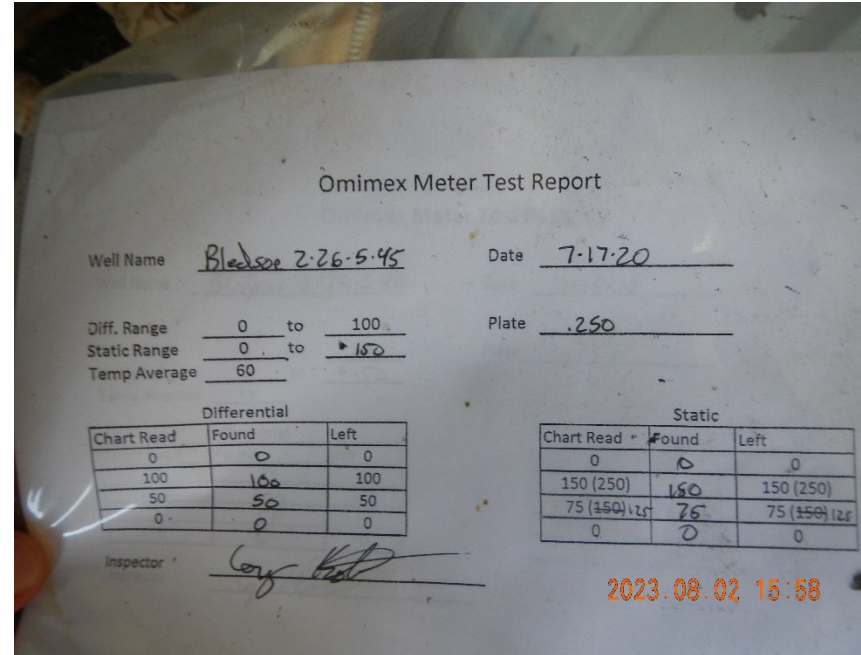
**12. View of Gas Meter Calibration/Test Log from inside Meter Shed.**
