**Storm Water Management and Erosion control**  
**Location Name: TEP ROCKY MOUNTAIN LLC CLOUGH RMV 137-27 pad**  
**Location ID: 324122**

**Location Overview: Location is within High Priority  
Habitat area & Bald Eagle Nest & Roost sites & in  
close proximity to NSO/Density Habitat areas.  
Section/Township/Range: 27 6S94W**

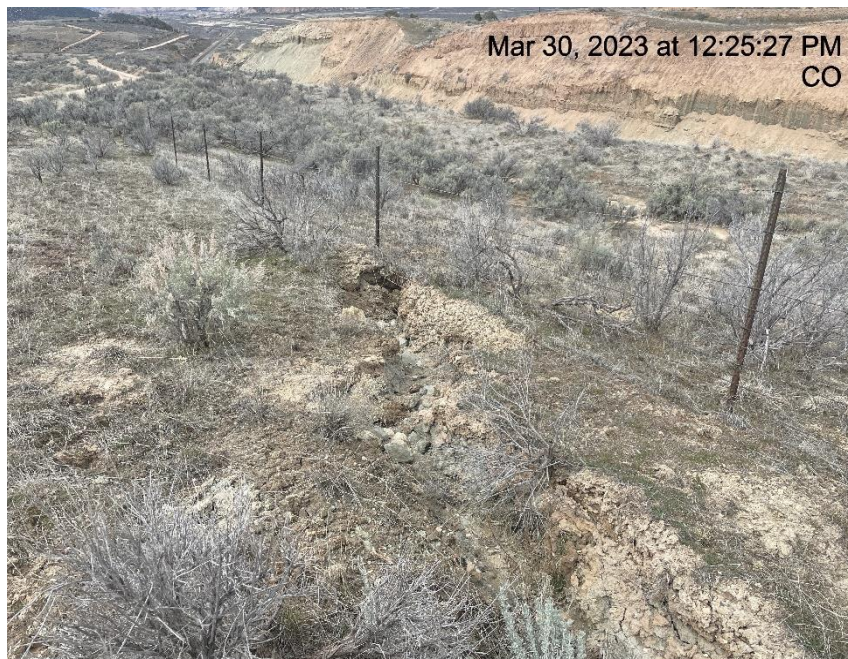
**Photo # 3788 From inspection 708900206 conducted on 03/30/2023 Ditch coming out sediment trap/insufficient run off controls/BMP's/erosion & transport of sediment**

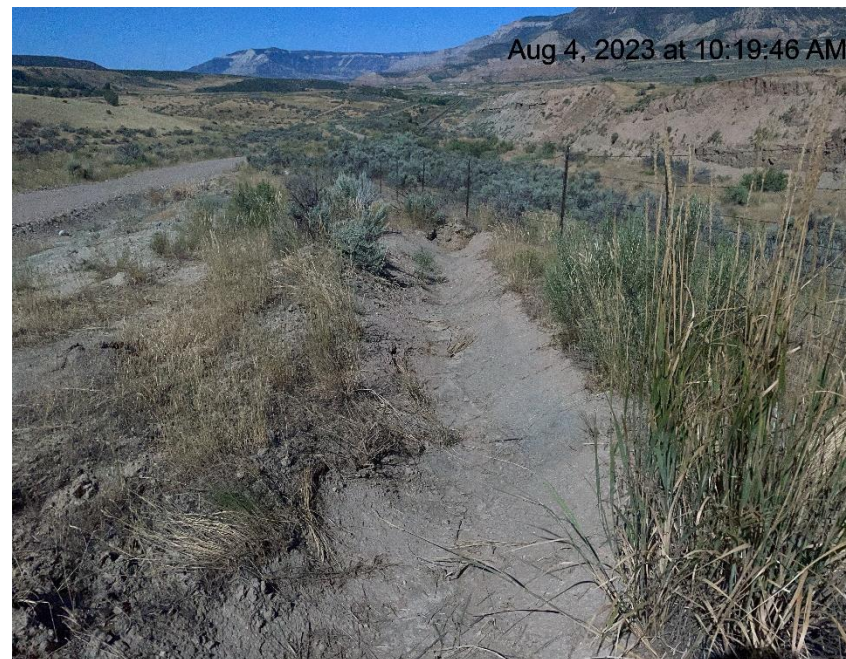
**Photo # 4676 Ditch coming out sediment trap/insufficient run off controls/BMP's**

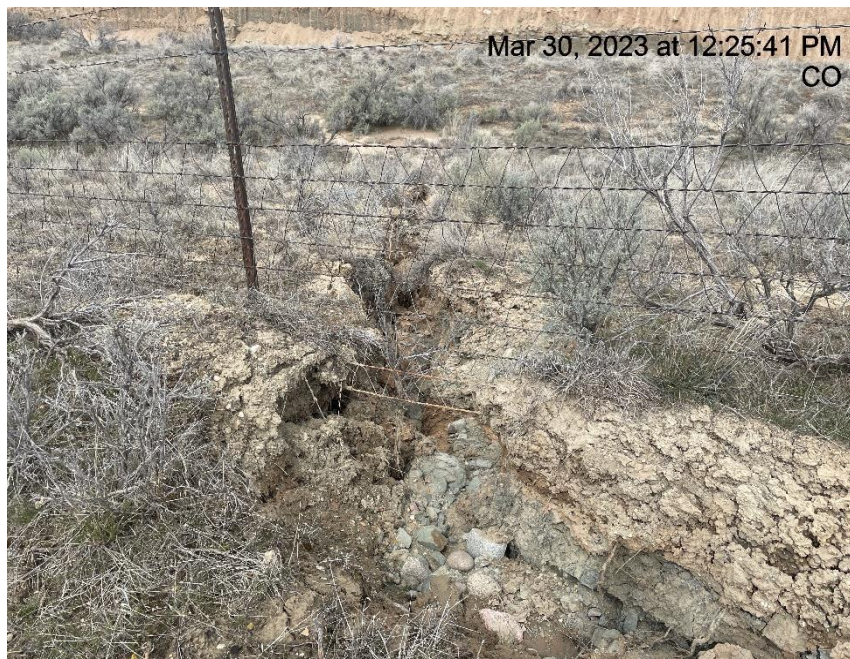
**Photo # 3789 From inspection 708900206 conducted on 03/30/2023 Ditch coming out sediment trap/insufficient run off controls/BMP's/erosion & transport of sediment**

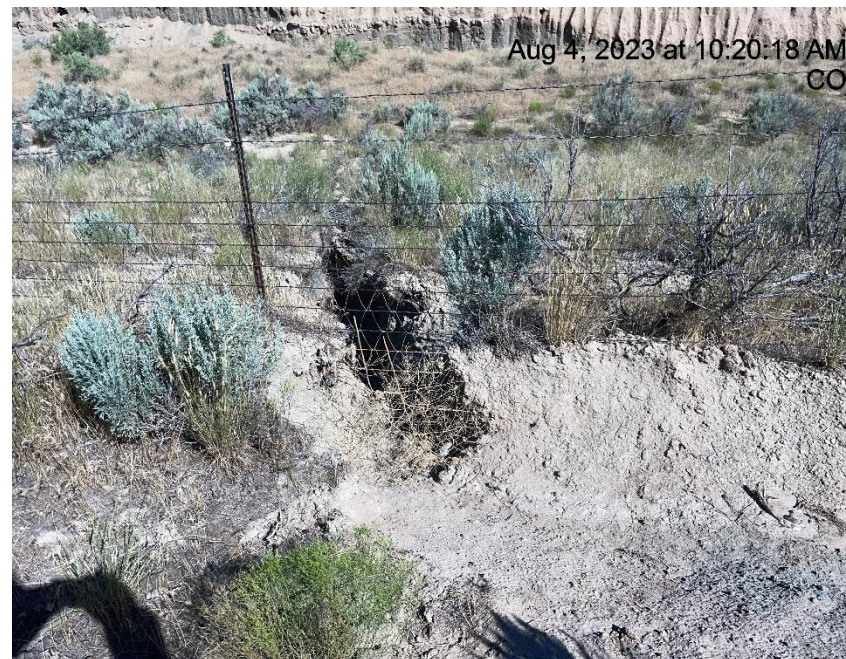
**Photo # 4680 Ditch coming out sediment trap/insufficient run off controls/BMP's/erosion & transport of sediment**

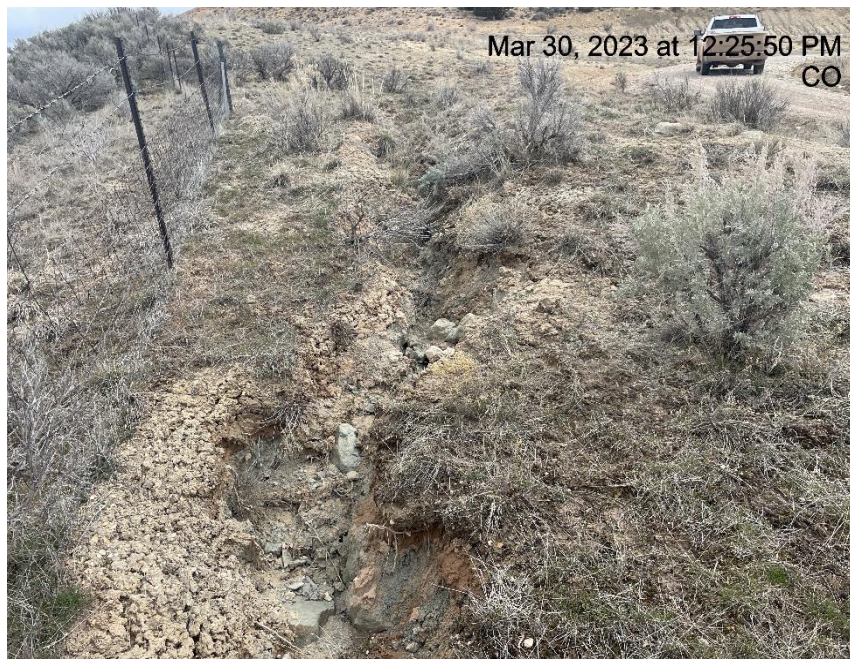
**Photo # 3790 From inspection 708900206 conducted on 03/30/2023 Ditch coming out sediment trap/insufficient run off controls/BMP's/erosion & transport of sediment**

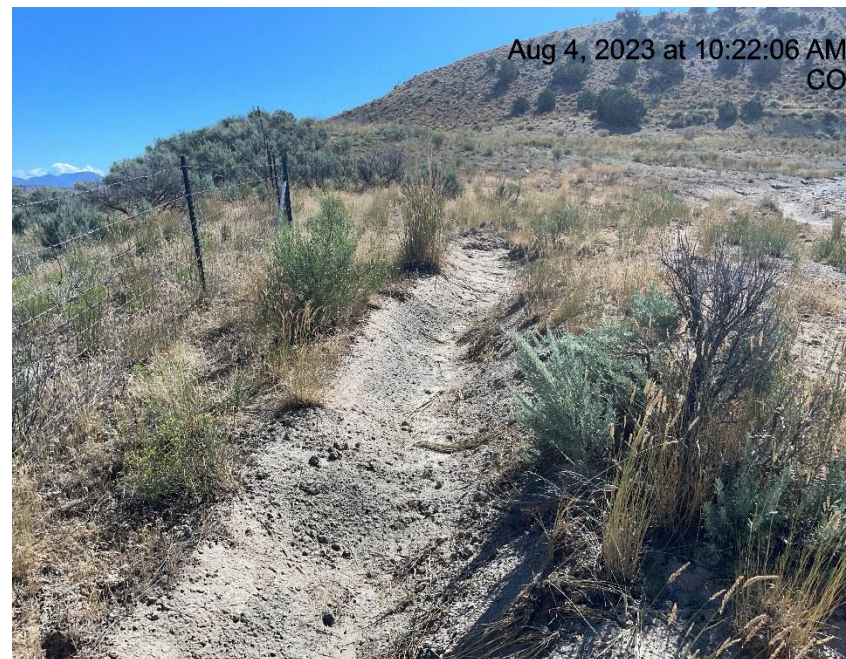
**Photo # 4688 Ditch coming out of sediment trap - Insufficient run off controls/BMP's**

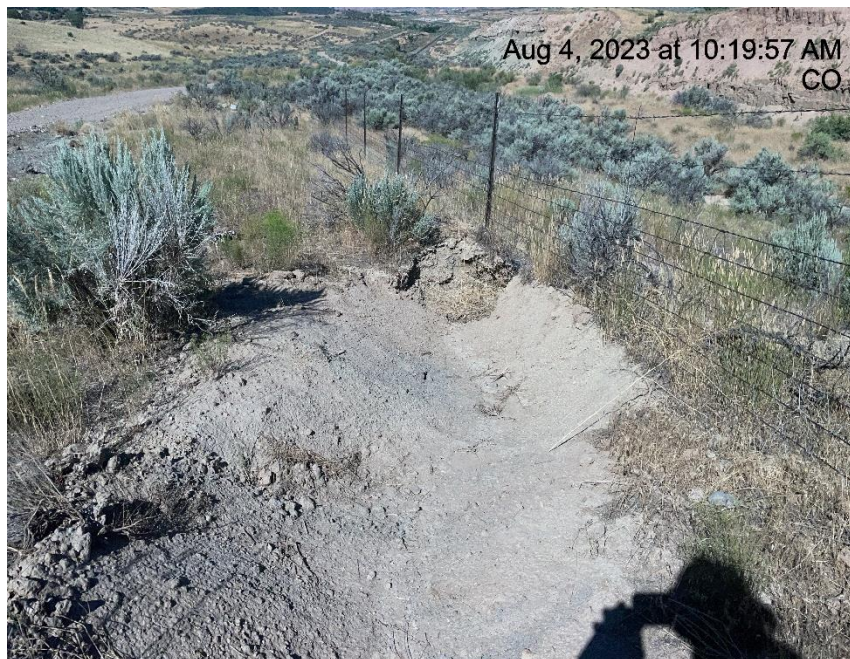
**Photo # 4677 Insufficient run off controls/BMP's**

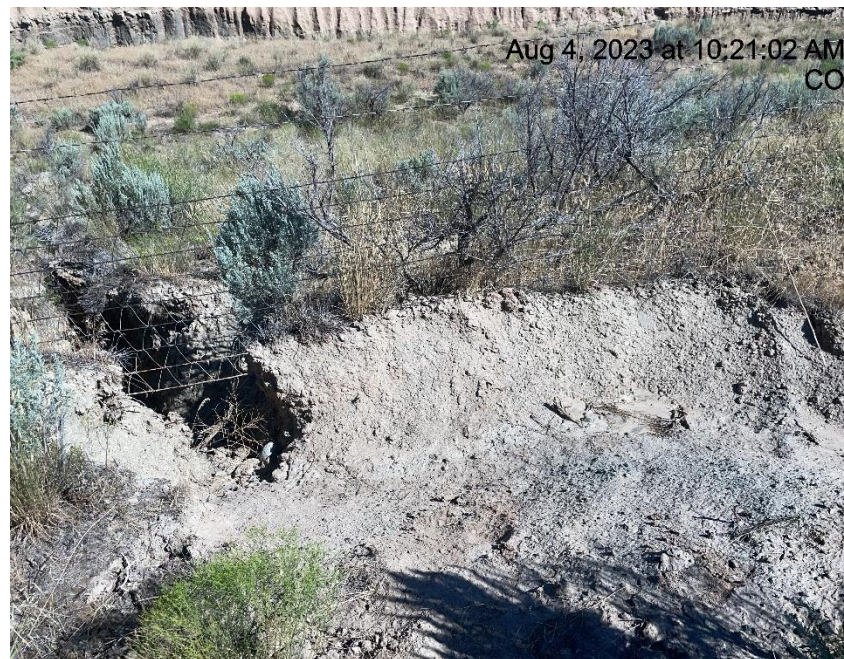
**Photo # 4683 Insufficient run off controls/BMP's/erosion & transport of sediment**

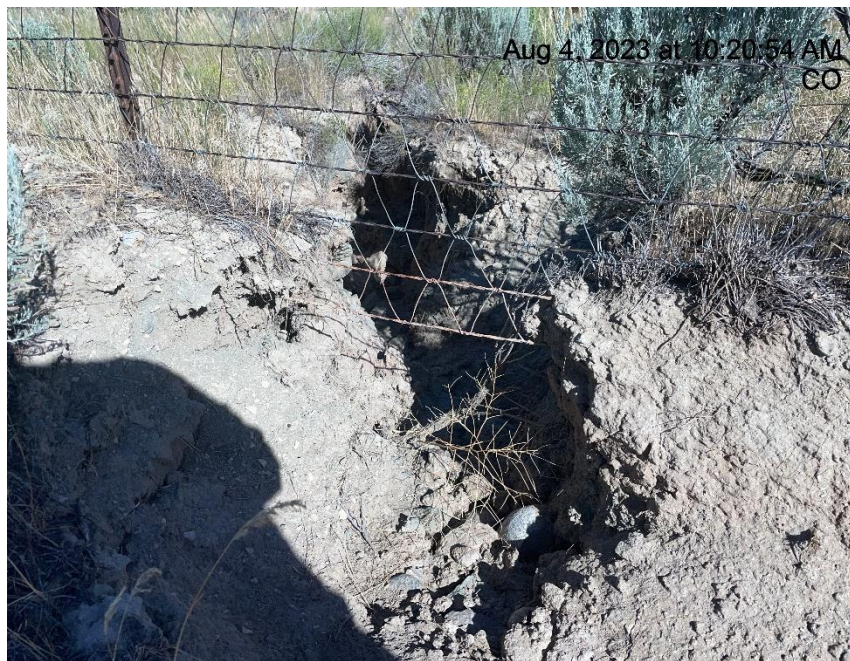
**Photo # 4681 Insufficient run off controls/BMP's/erosion & transport of sediment**

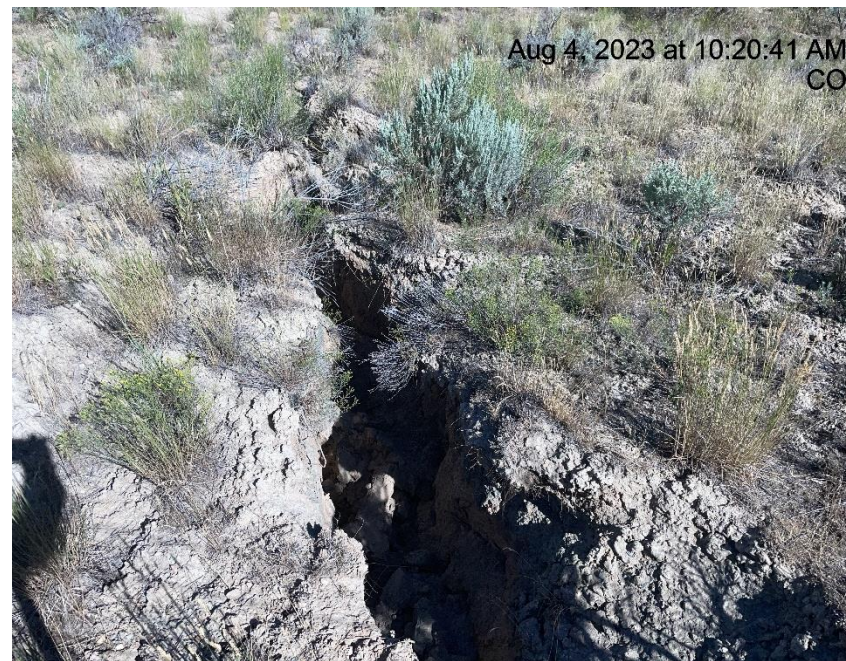
**Photo # 4682 Insufficient run off controls/BMP's/erosion & transport of sediment**

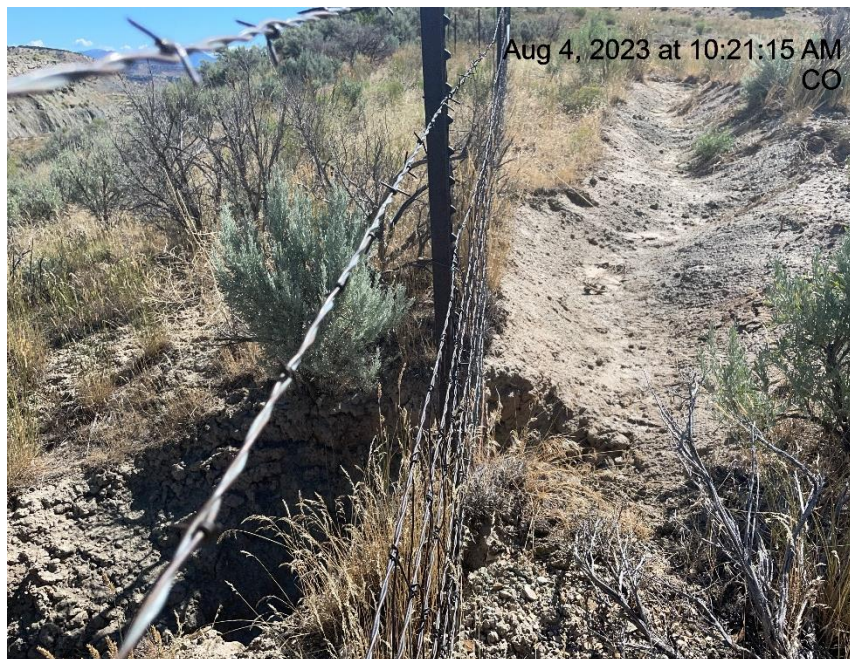
**Photo # 4684 Insufficient run off controls/BMP's/erosion & transport of sediment**

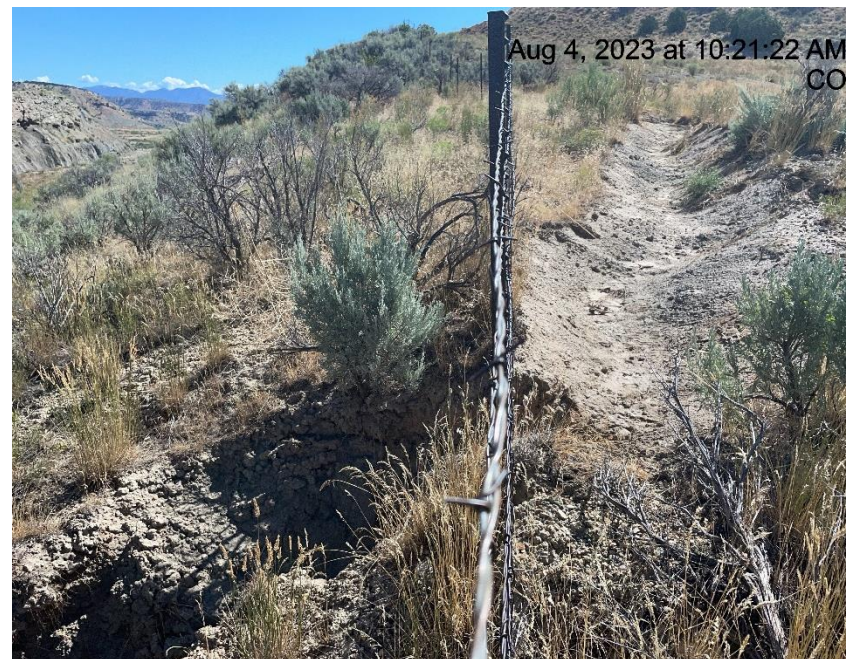
**Photo # 4685 Insufficient run off controls/BMP's/erosion & transport of sediment**

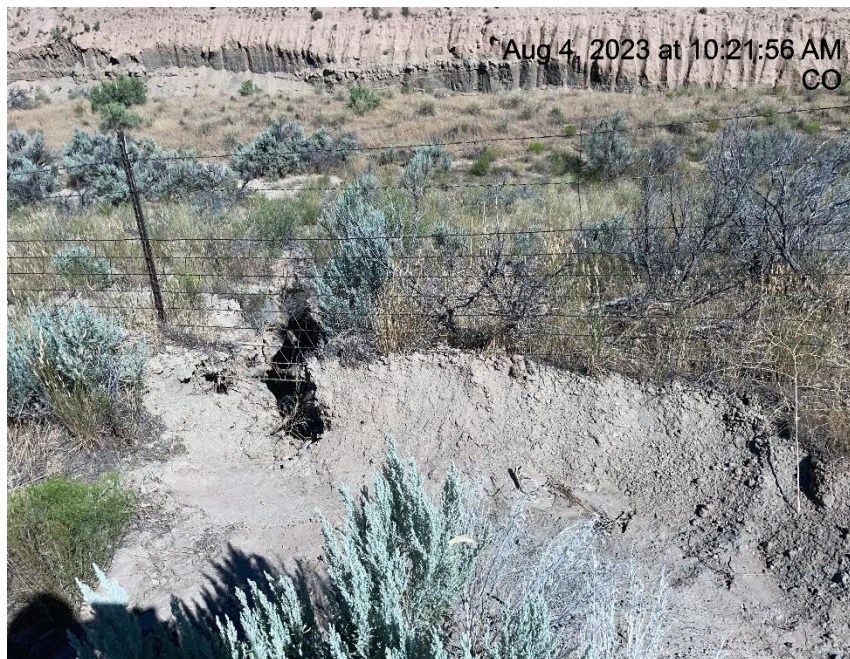
**Photo # 4686 Insufficient run off controls/BMP's/erosion & transport of sediment**

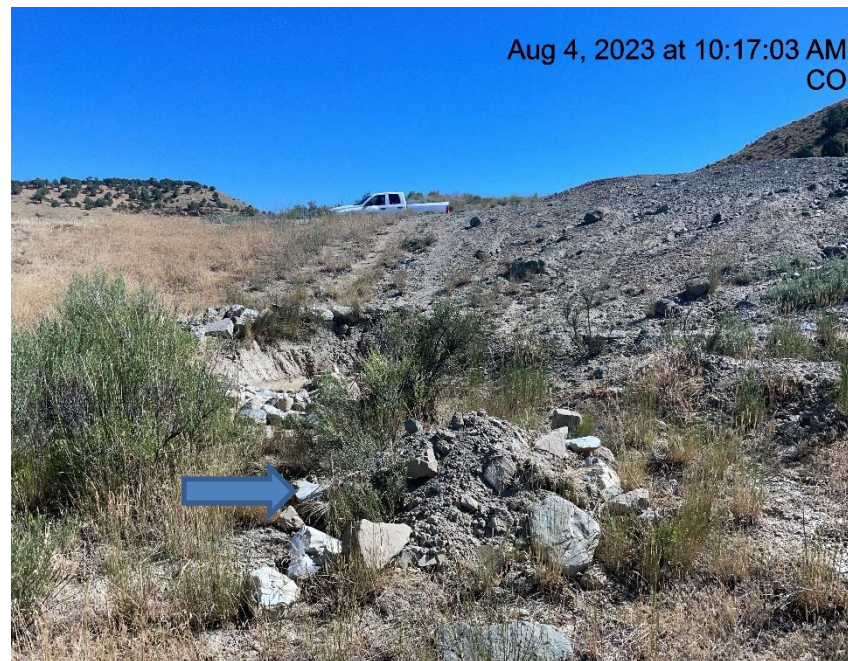
**Photo # 4673 Soils pile near sediment trap (W/NW area of location near fill slope)**

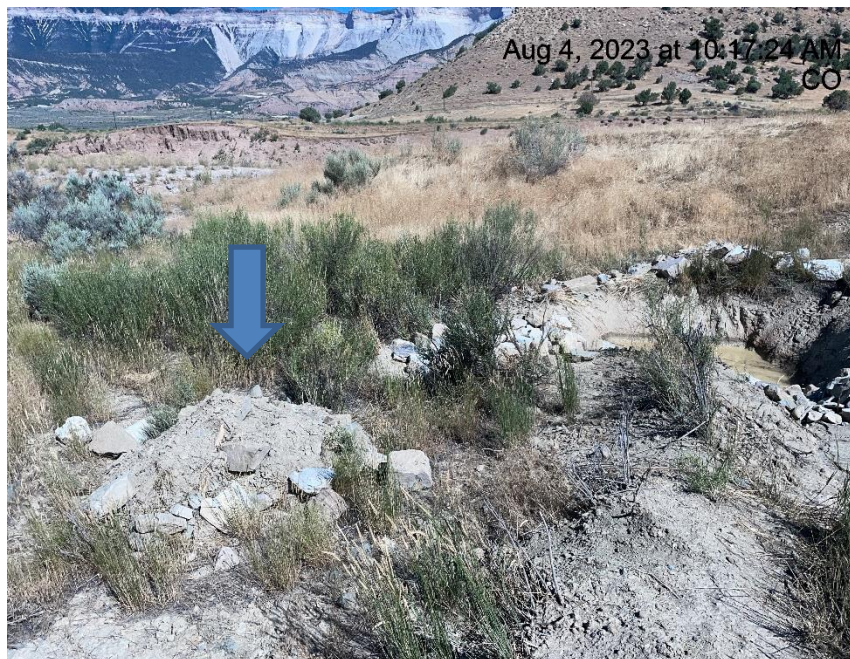
**Photo # 4674 Soils pile near sediment trap (W/NW area of location near fill slope)**
