Inspection Photos
Location Name Moyer Unit 16-29
Location ID: 317529

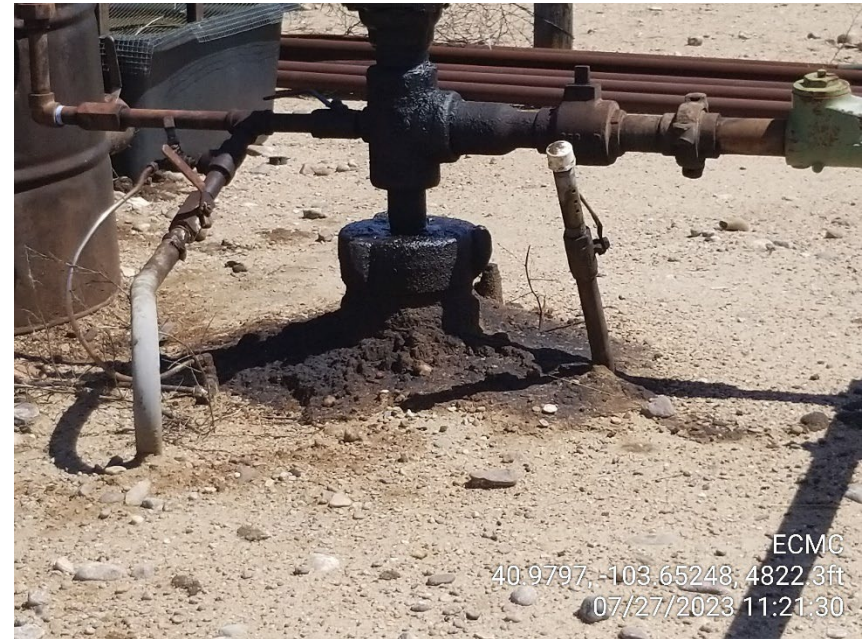
Photo 2 – Wellhead – Stained Soil
