Inspection Photos
Location Name: Schneller 9-22-5-45
API Number: 125-09609

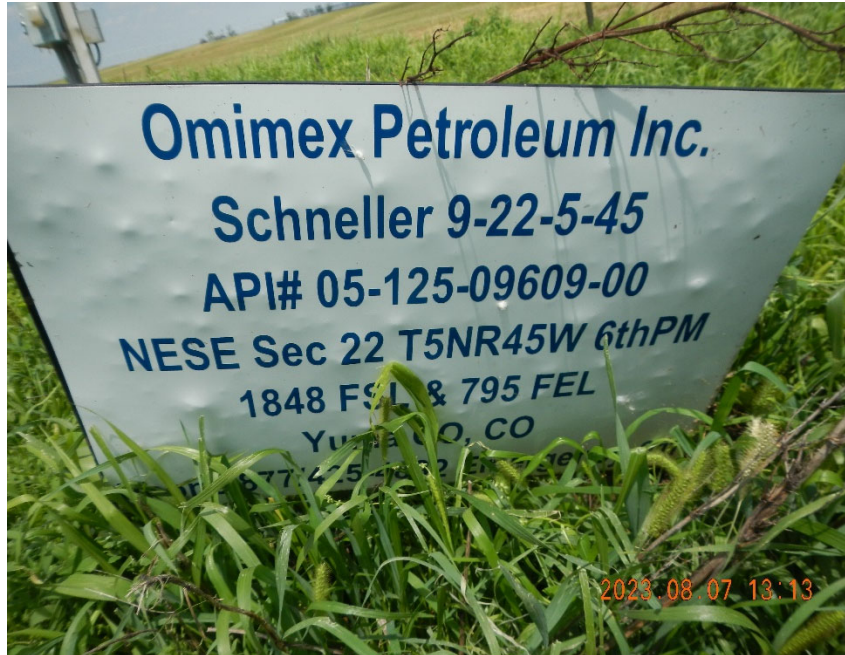
1. Well sign at well location. Note vegetation.

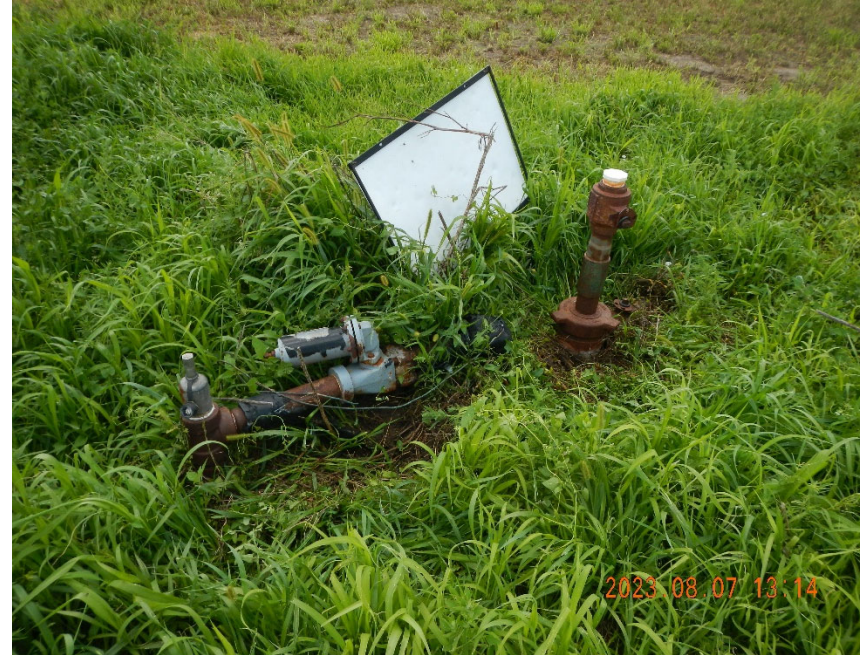
2. View of Wellhead. Note vegetation.

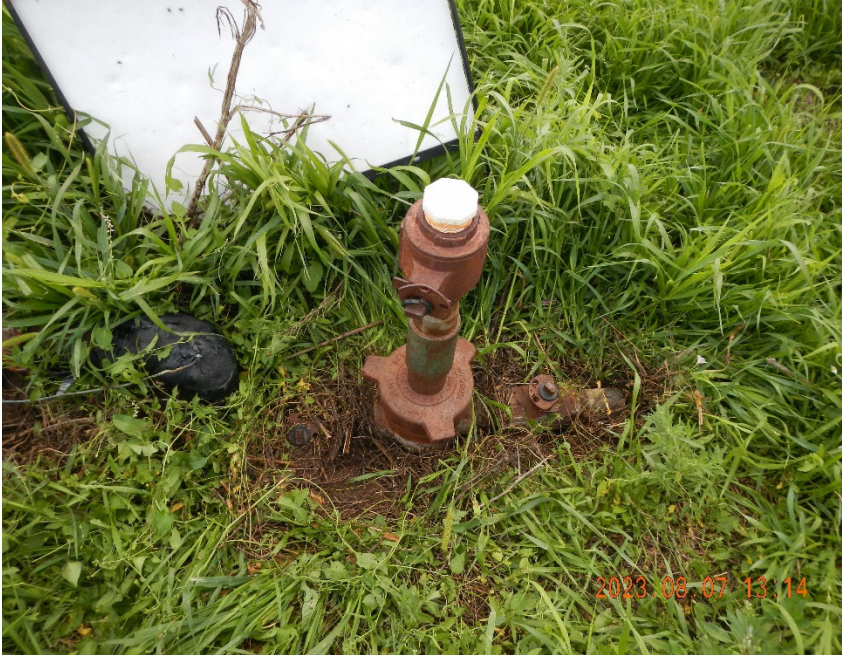
3. View of Wellhead and Casing valves.

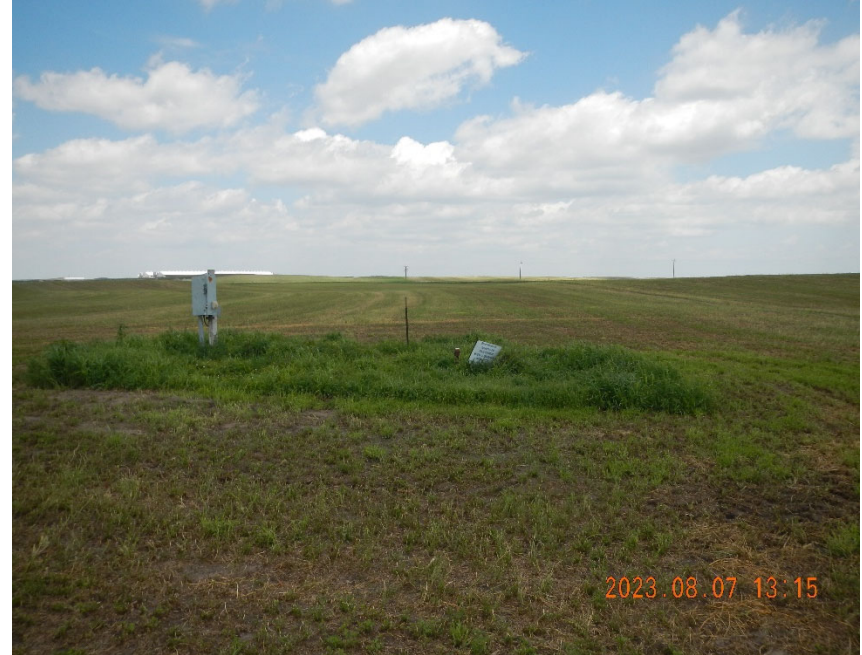
4. Well location overview. Note vegetation.

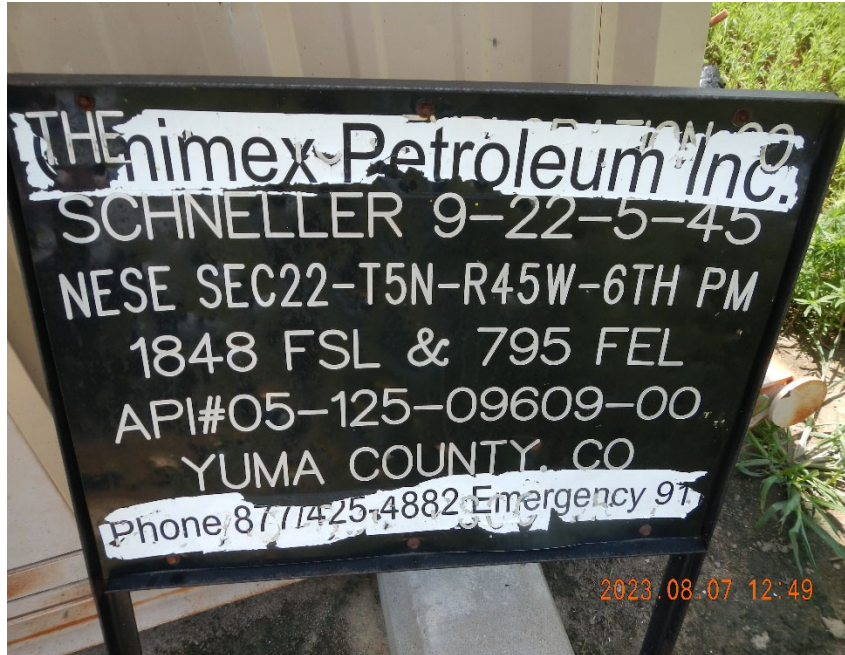
5. Well sign at remote Gas Meter Run.

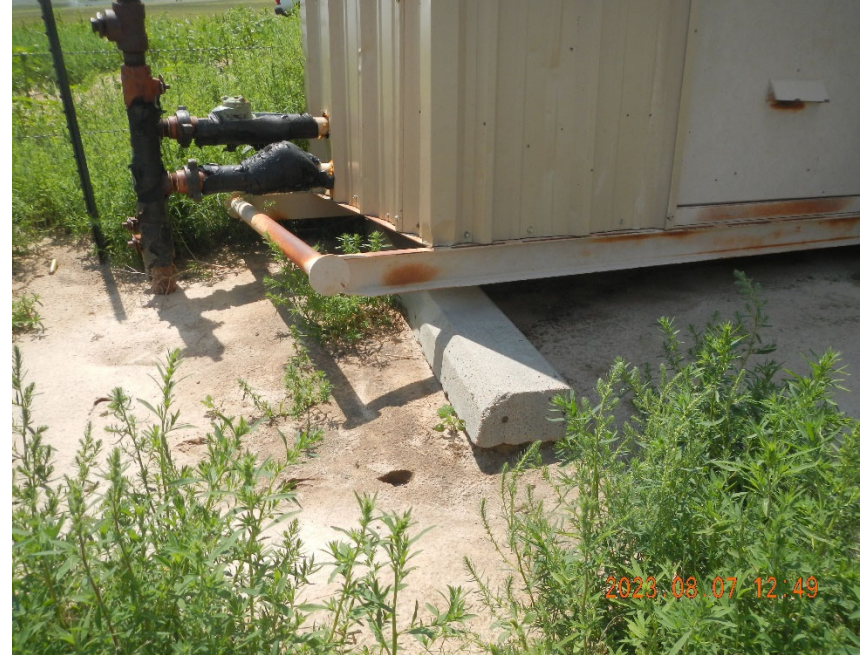
6. Meter Shed coming off supports and leaning backwards placing tension on the flowlines.

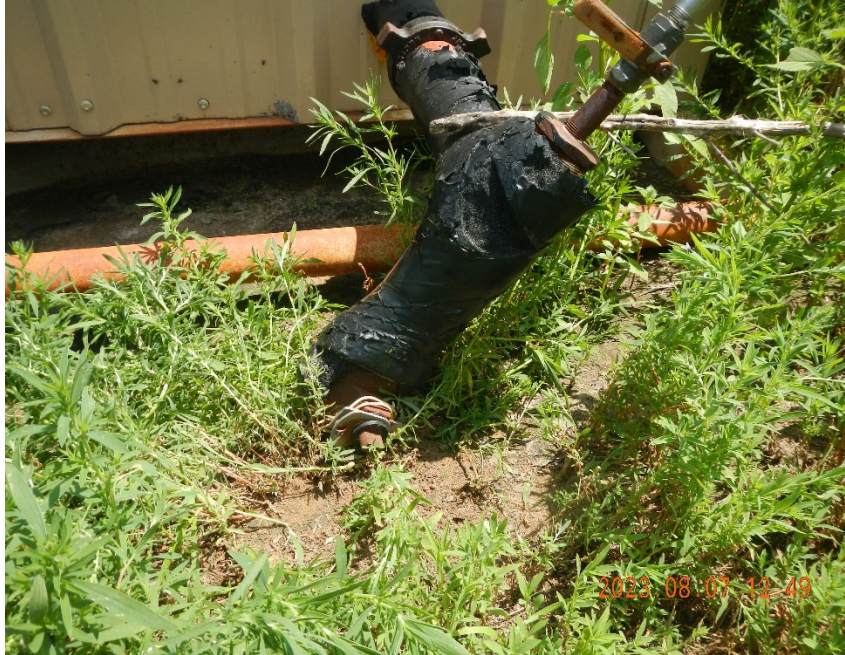
7. Inlet flowline being bent due to Meter Shed leaning. Note vegetation.

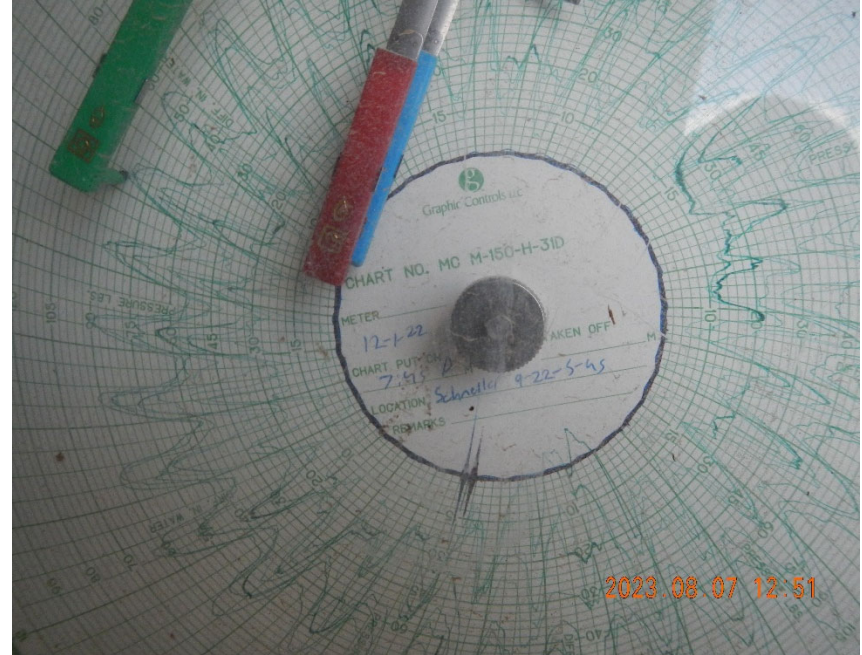
8. View of Chart in Meter Box at time of inspection.

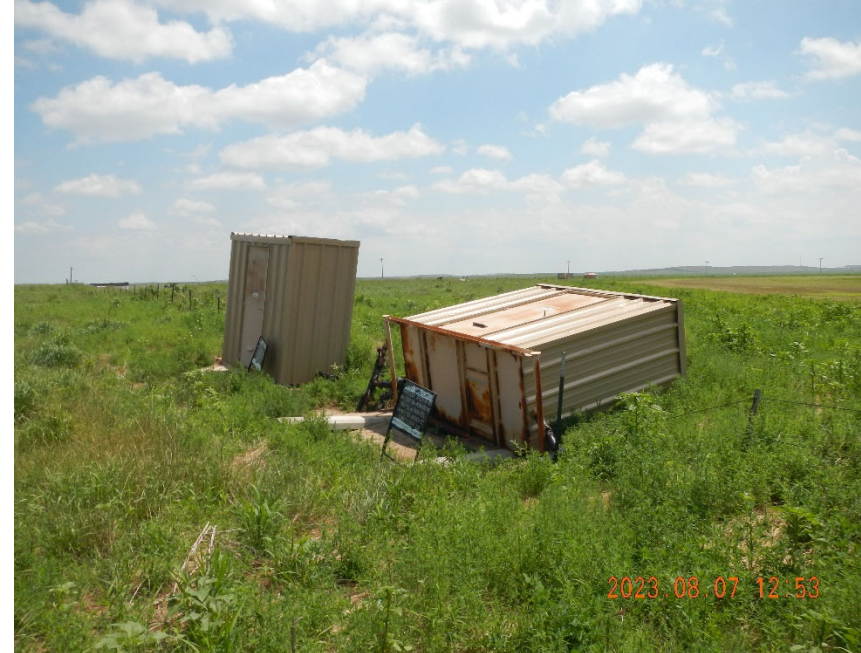
10. View of remote Meter Run location with Meter House for the Schneller 10-22-5-45 already blown over. Note vegetation.
