Inspection Photos

Operator: LARAMIE ENERGY LLC #10433

Location Number: 335595

CC/0697-15-23 Pad, #335595 Issue Report

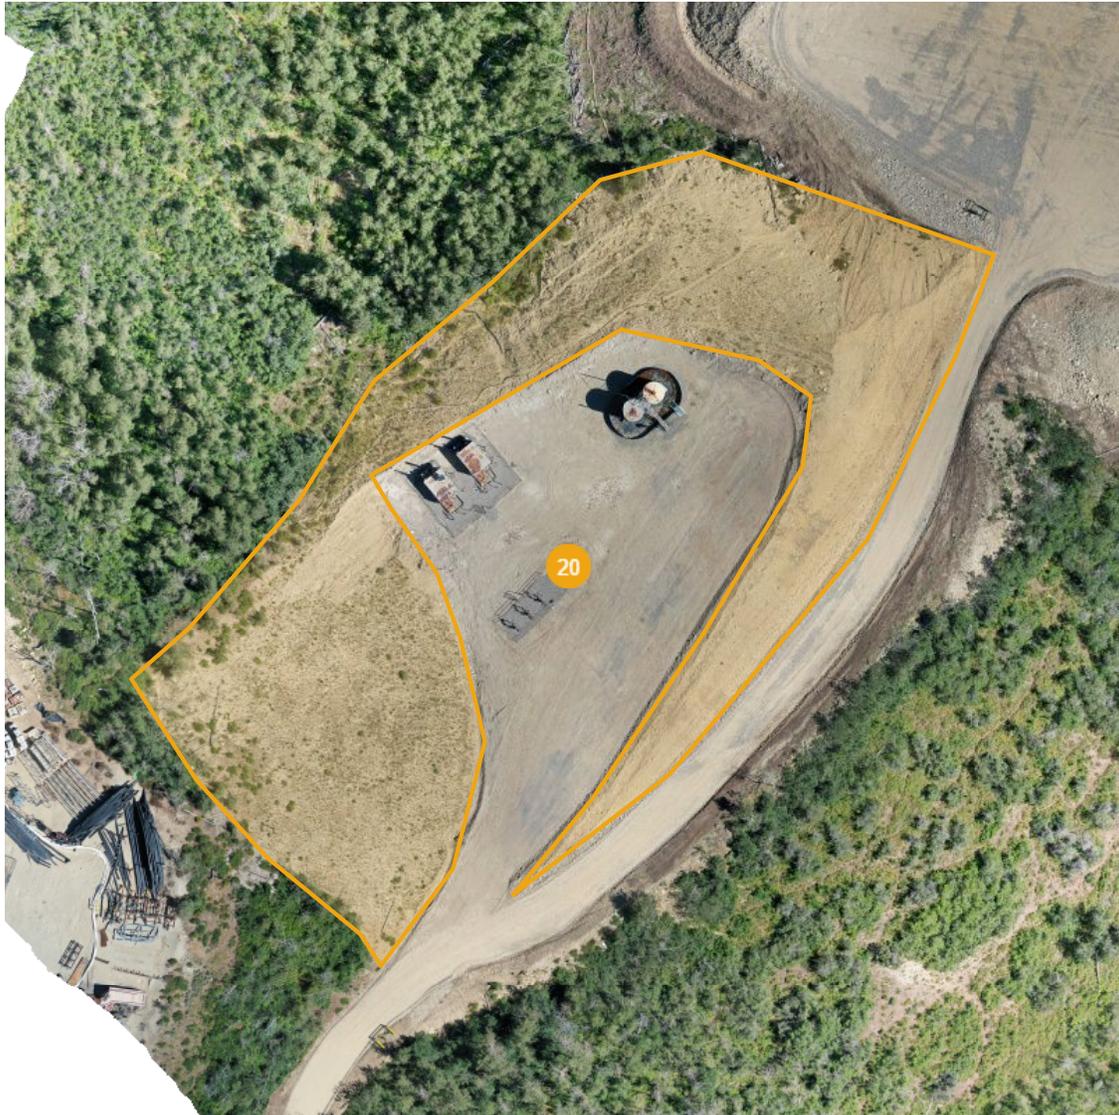
20 - Observation

Summary: Slopes predominantly bare and un stabilized. Stormwater and Erosion control measures to stabilize slopes, as well as and to manage runoff in a manner that minimizes erosion, degradation and sediment transport inadequate on the Location. Interim areas not progressing towards 1003 reclamation standards.

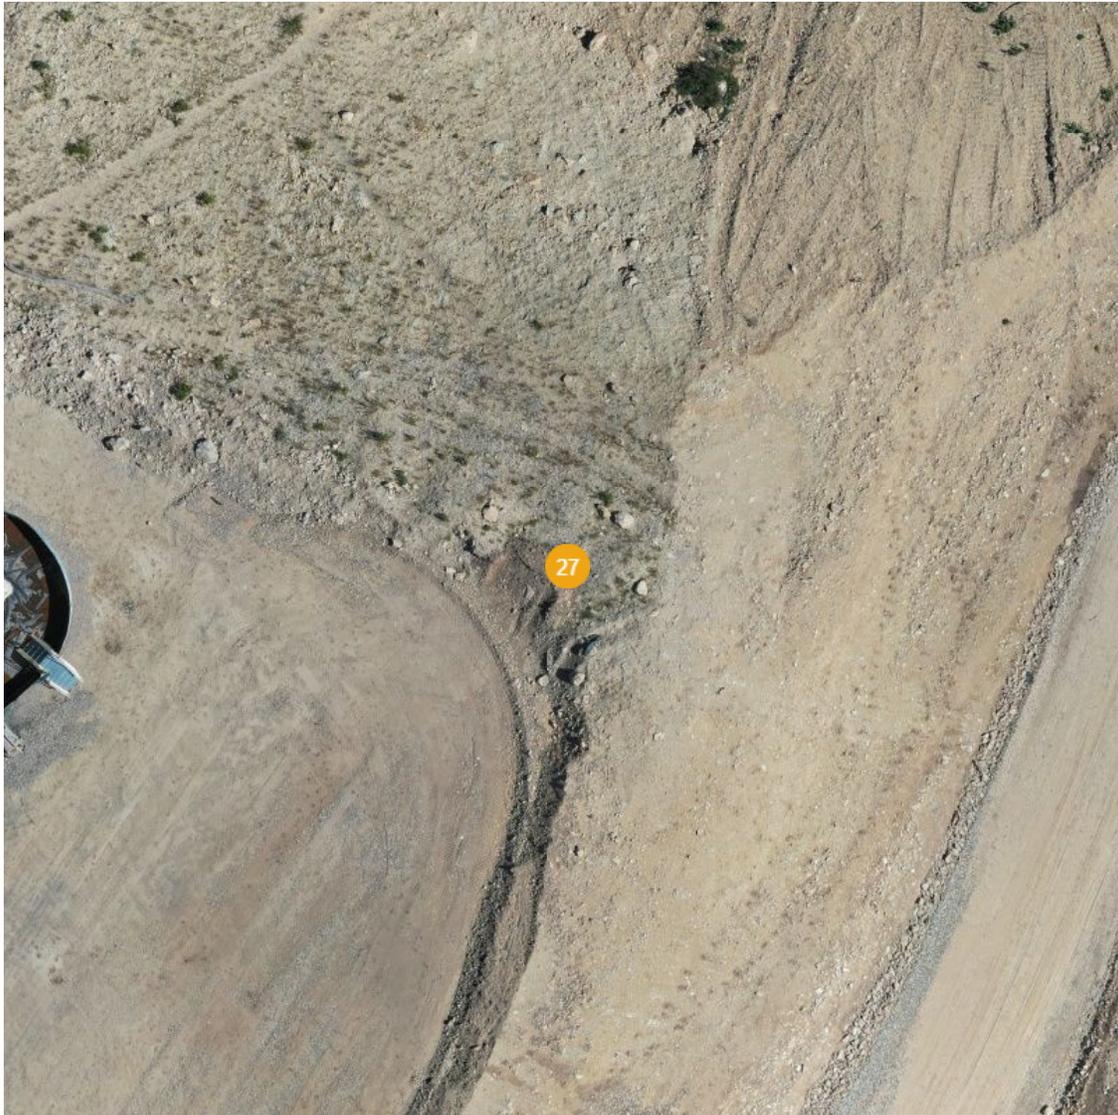
27 - Observation

Trash Debris

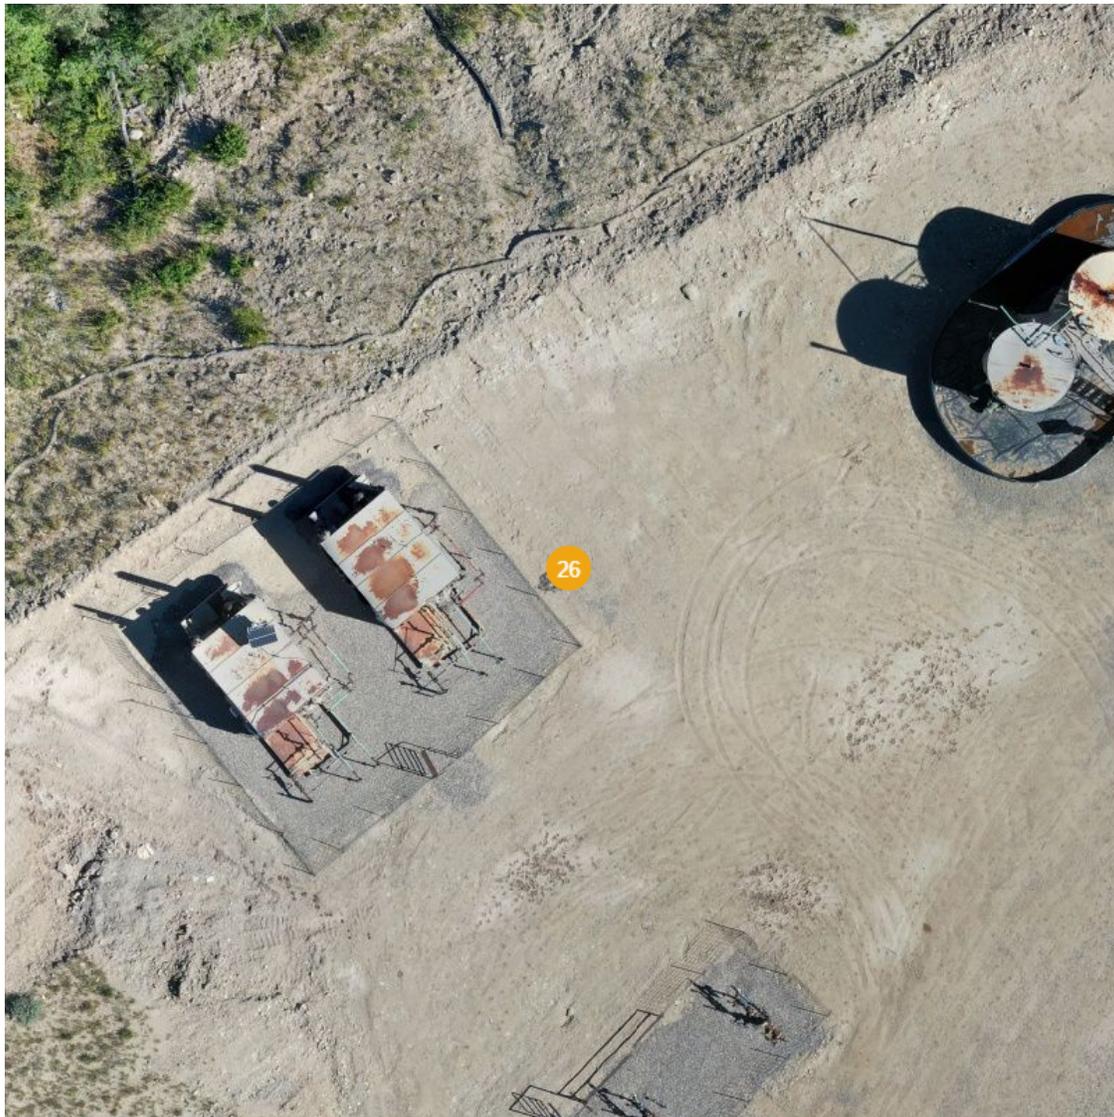
26 - Observation

Trash Debris

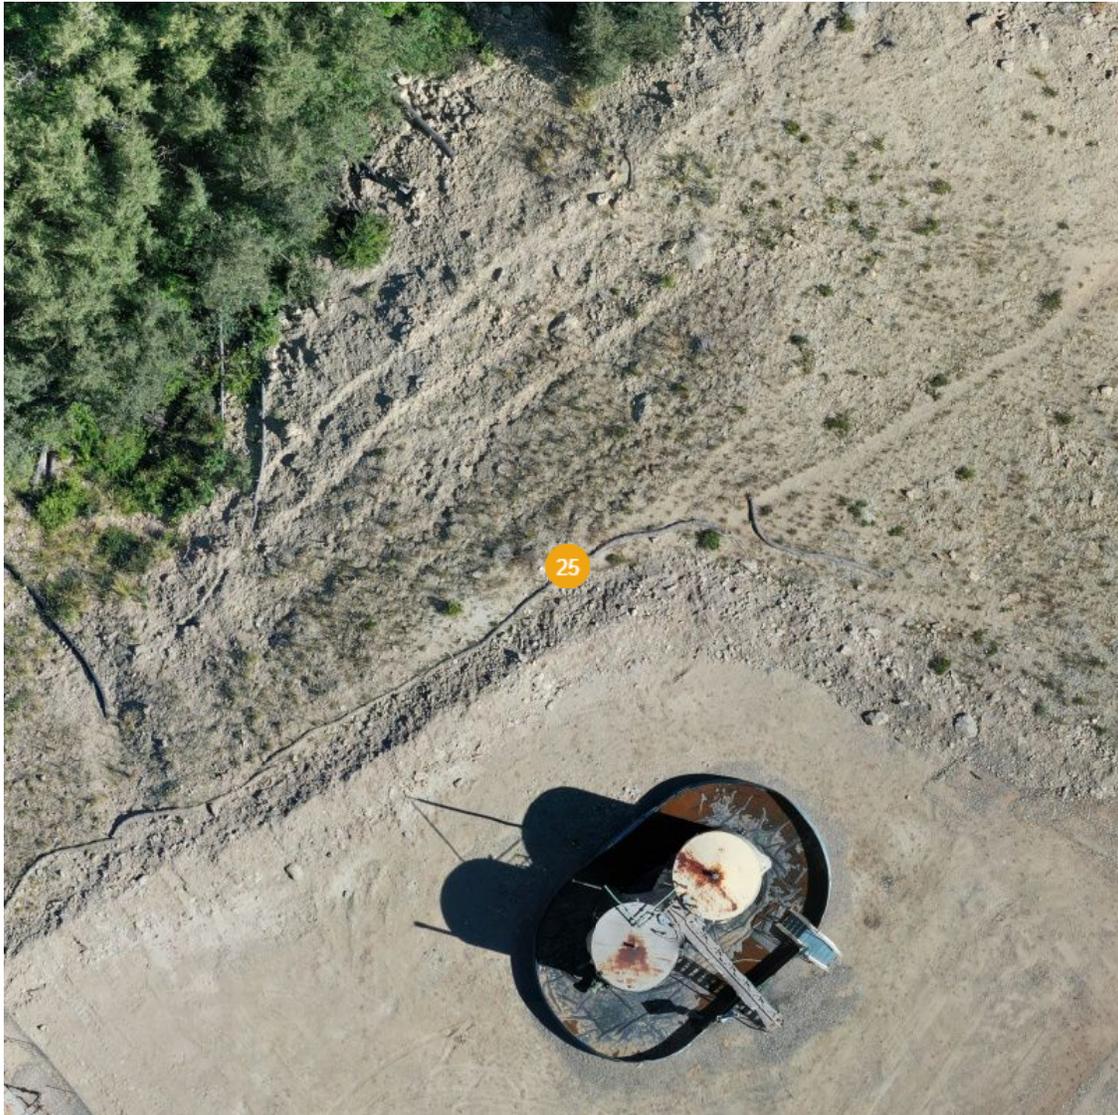
25 - Observation

Summary:	Erosion Logs have not been installed or maintained in accordance with good engineering practices.
Created:	Aug 10, 2023, 8:46am by Aaron Trujillo
Cost of Repair:	—
Lat/Long:	39.5257023, -108.2002427
Northing:	1627684.7 US ft
Easting:	2238423.9 US ft
Elevation:	37.42 US ft
NAD83(2011) / Colorado Central (ftUS) (US survey foot)

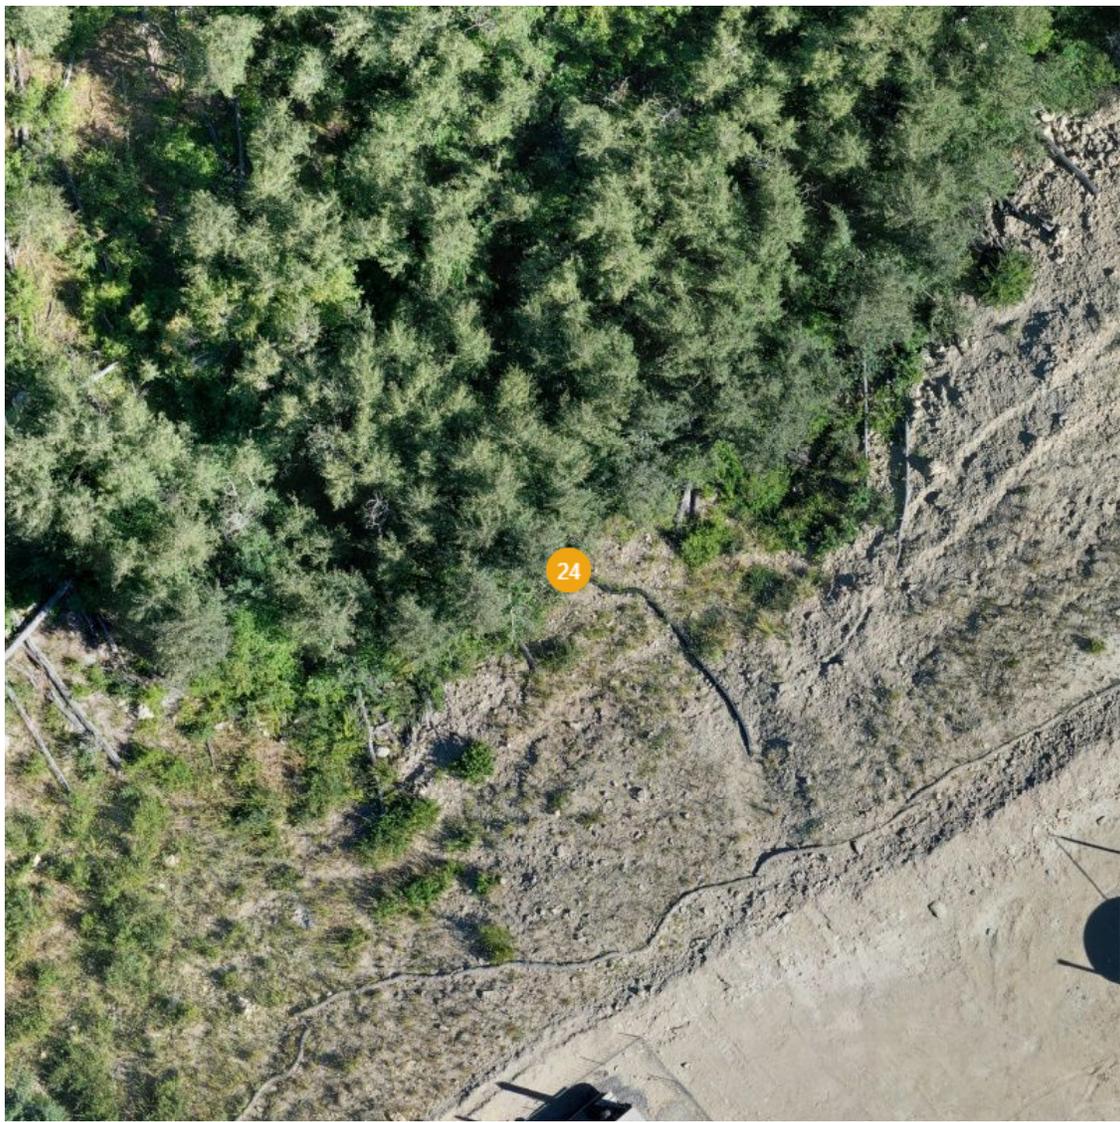
24 - Observation

Summary:	Slope drain has not been constructed with a properly engineered and armored outlet.
Created:	Aug 10, 2023, 8:46am by Aaron Trujillo
Cost of Repair:	—
Lat/Long:	39.5257147, -108.2005533
Northing:	1627691.8 US ft
Easting:	2238336.5 US ft
Elevation:	26.72 US ft

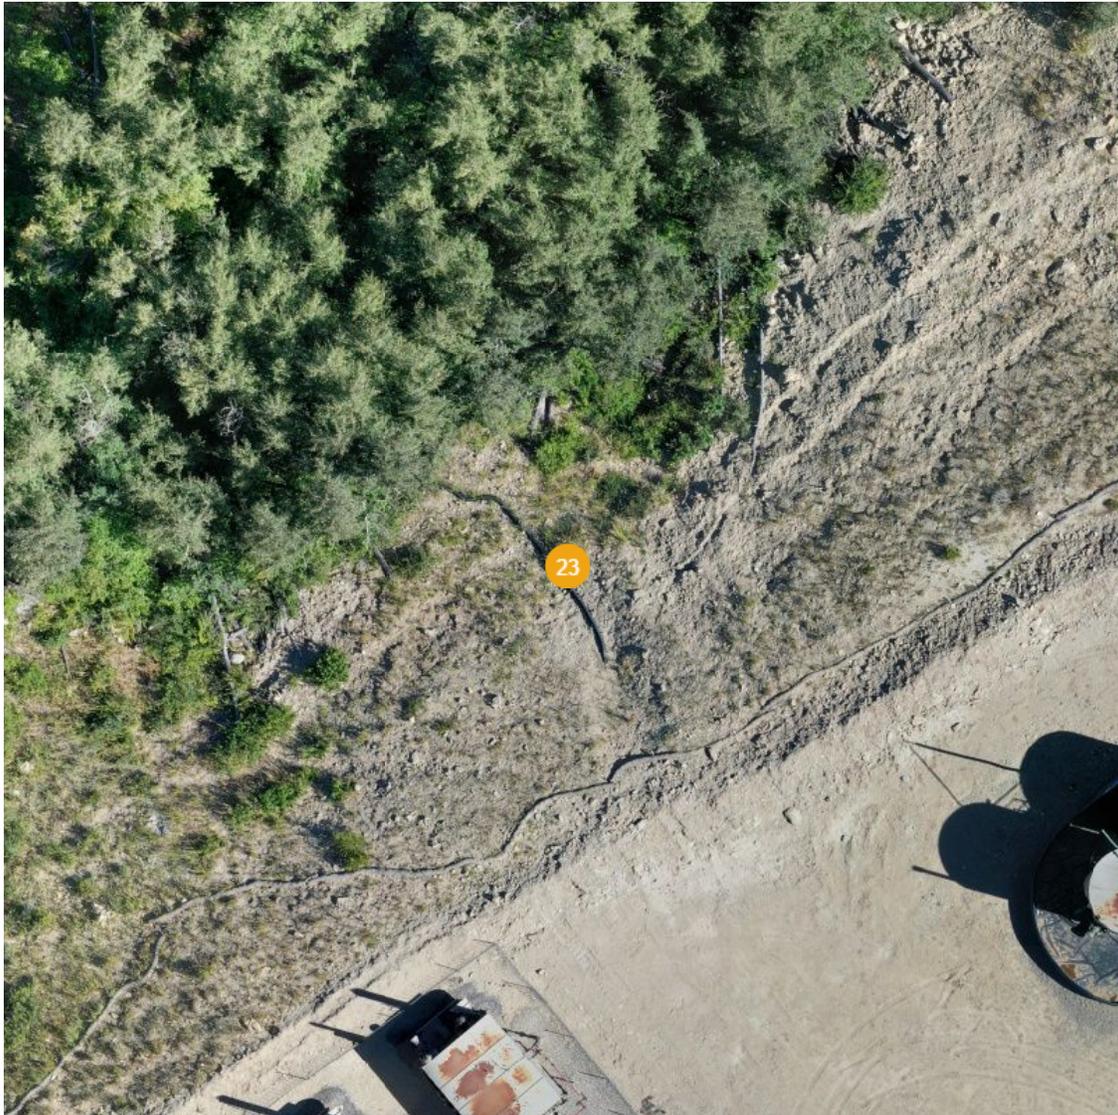
23 - Observation

Summary:	Slope drain has not been secured in accordance with good engineering practices.
Created:	Aug 10, 2023, 8:45am by Aaron Trujillo
Cost of Repair:	—
Lat/Long:	39.5256816, -108.2004835
Northing:	1627679.2 US ft
Easting:	2238355.8 US ft
Elevation:	17.69 US ft

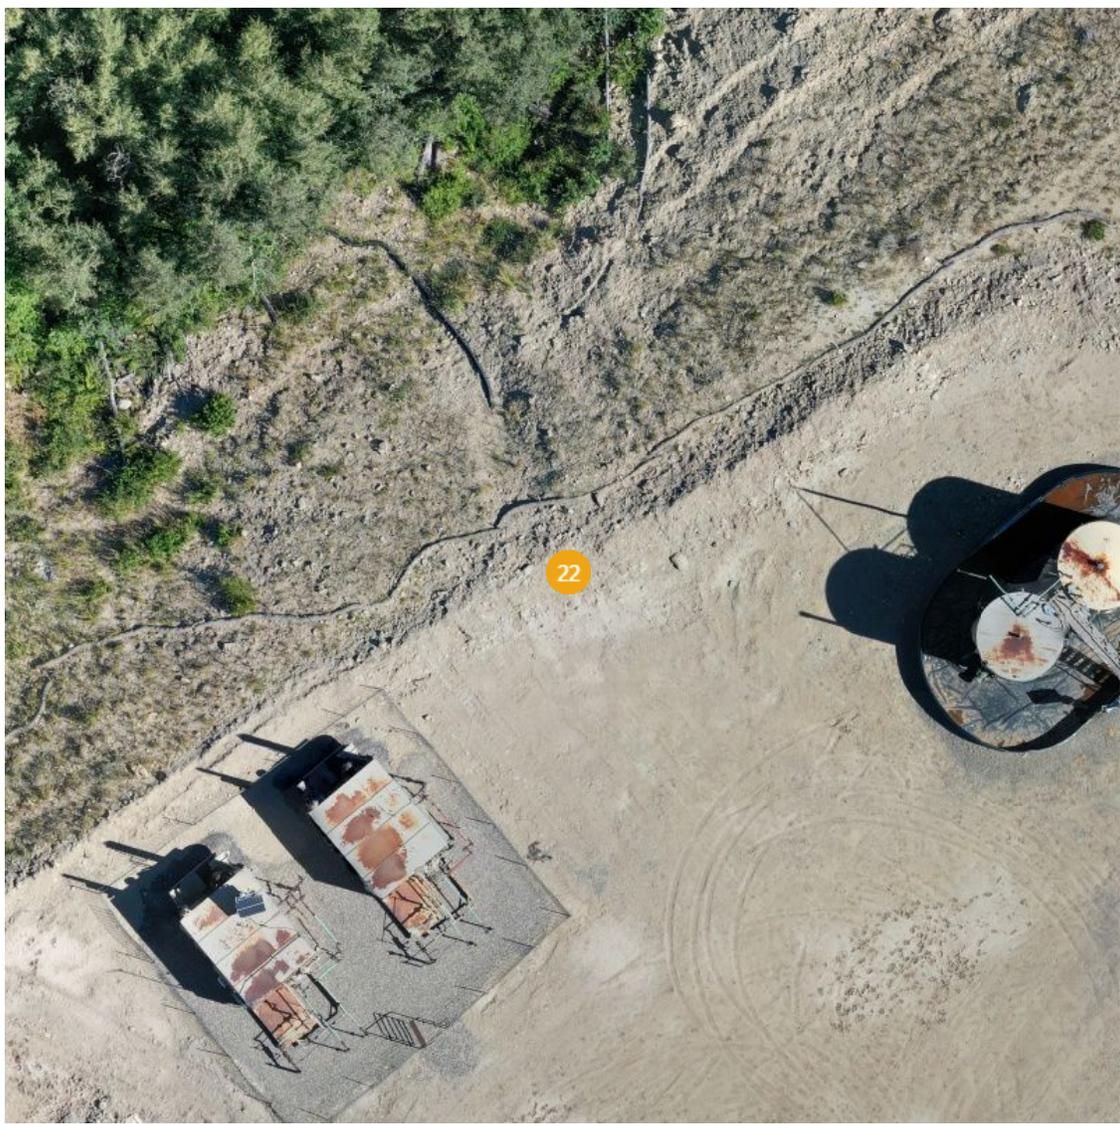
22 - Observation

Summary: Slope drain outlet from the working pad surface of the Location has filled with sediment, and is not longer in proper functioning condition.

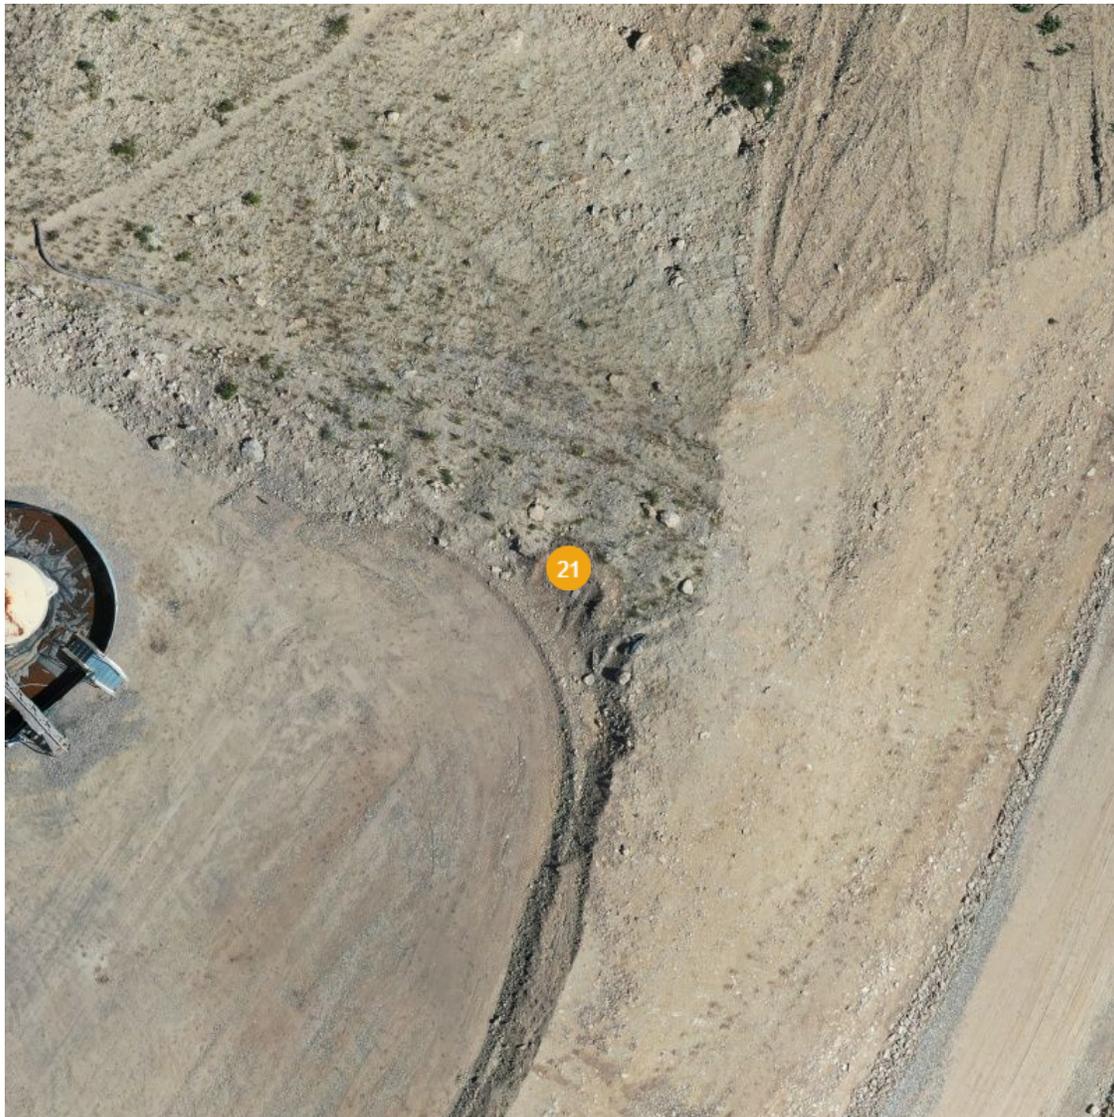
21 - Observation

Summary: Berms along perimeter of the working pad surface largely unconsolidated material. This does not comport with good engineering practices.

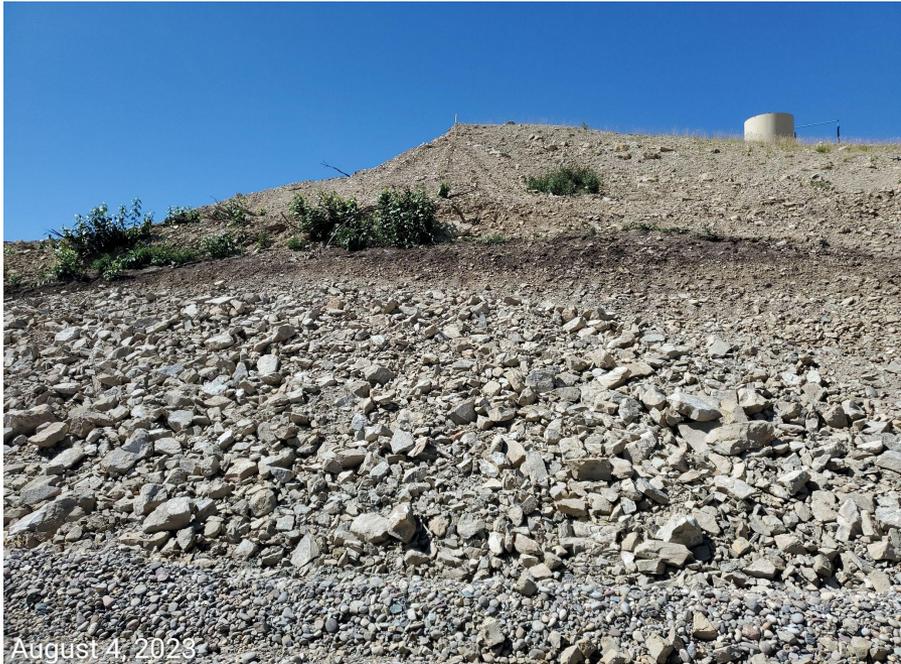
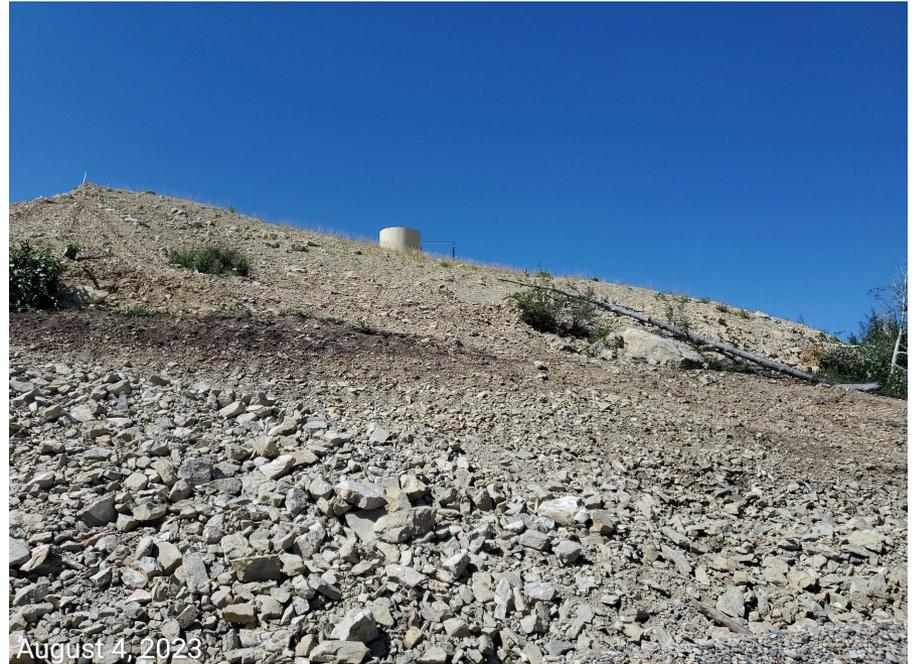
Photo 1: Photos taken from the northeast end of the Location, facing south and southwest. Photos show interim areas of the Location are bare, unstabilized and not progressing towards 1003 standards; stormwater erosion and control measures to stabilize the slopes and manage runoff are inadequate.

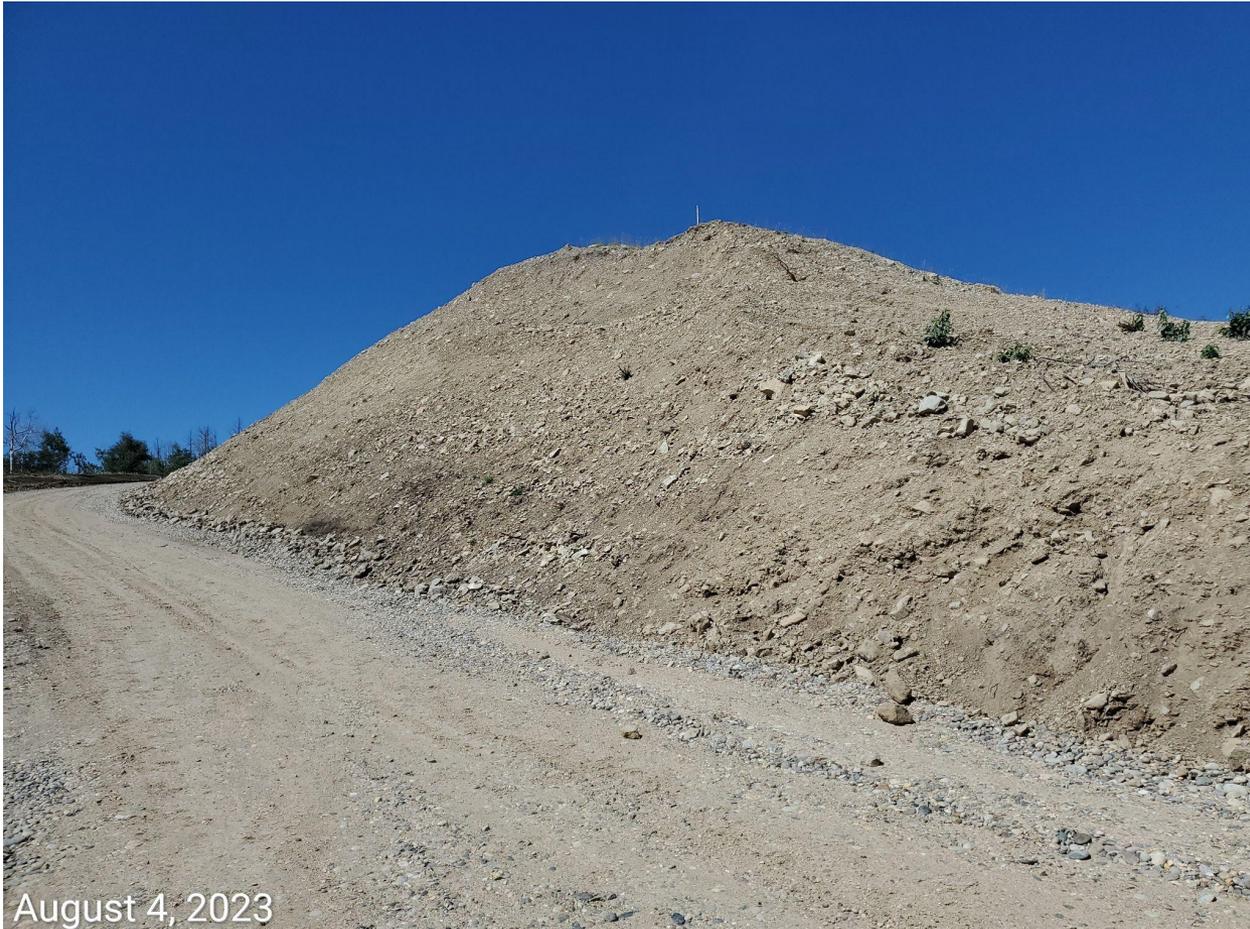
Photo 2: Photo taken from the east end of the Location, facing west. Photo shows steep slopes with unstabilize and bare soils; stormwater erosion and control measures to stabilize the slopes and manage runoff are inadequate.

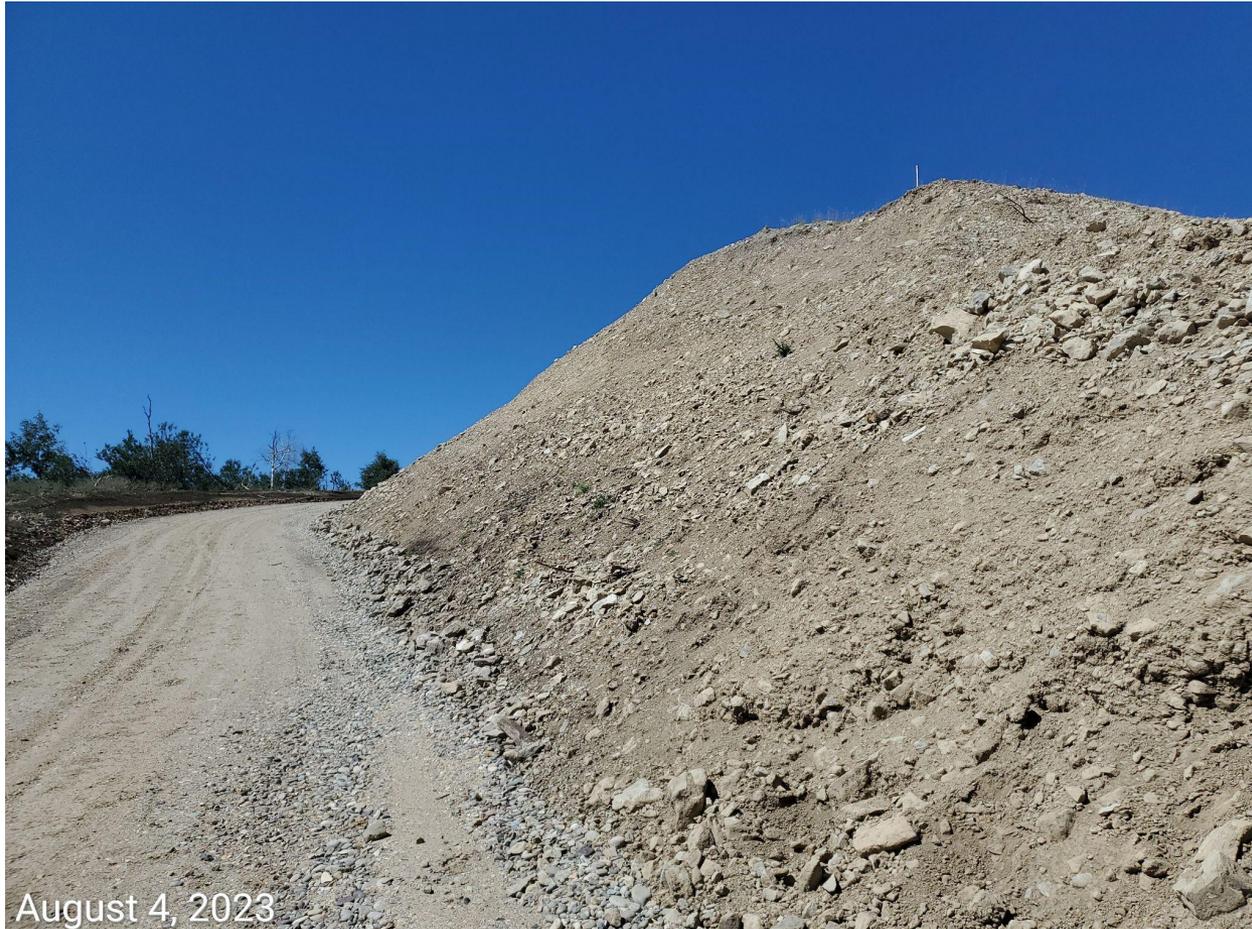
Photo 3: Photo taken from the east end of the Location, facing southwest. Photo shows steep slopes with unconsolidated and bare soils; stormwater erosion and control measures to stabilize the slopes and manage runoff are inadequate.

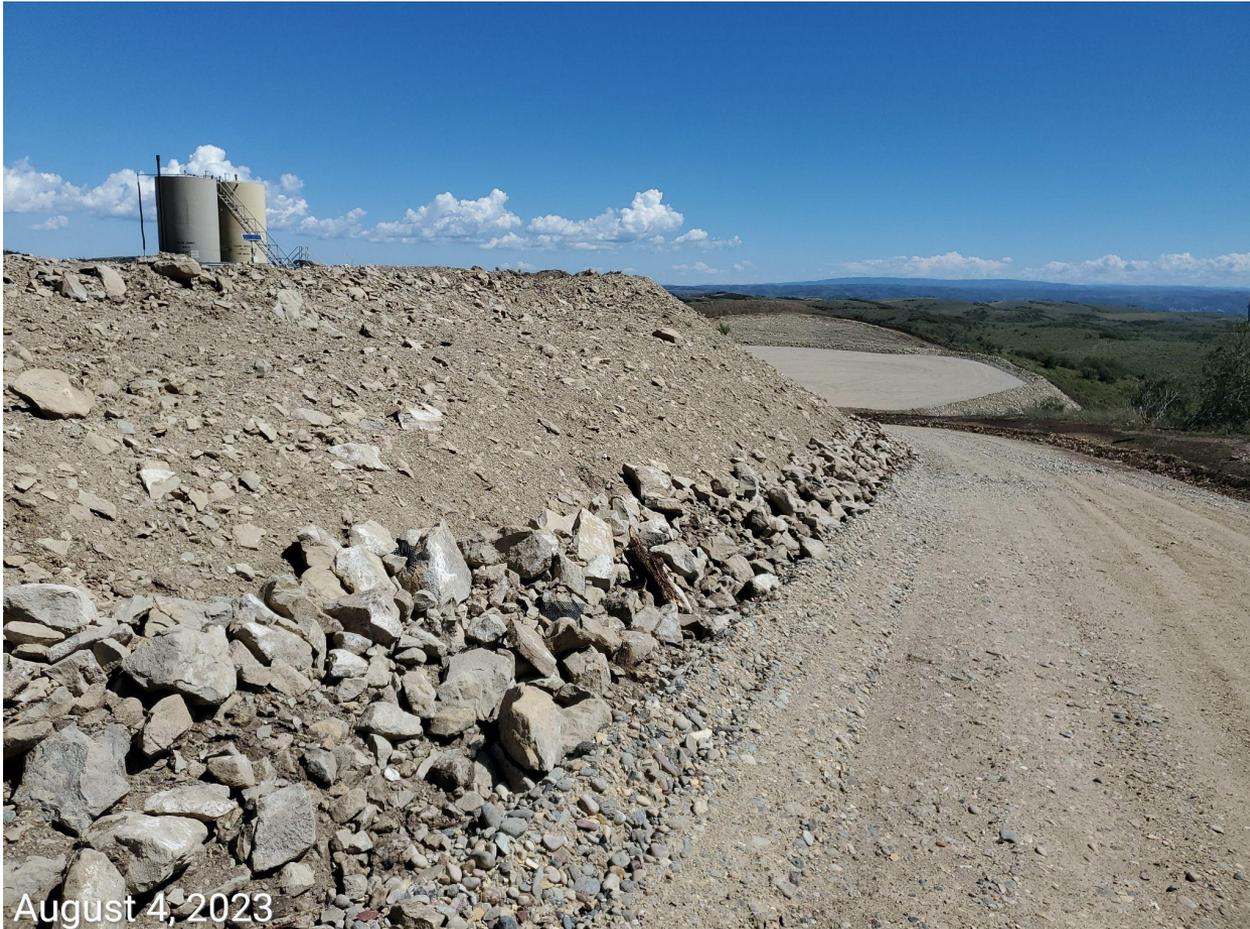
Photo 11: Photo taken from the south end of the Location, facing northeast. Photo shows steep slopes with unstabilize and bare soils; stormwater erosion and control measures to stabilize the slopes and manage runoff are inadequate.

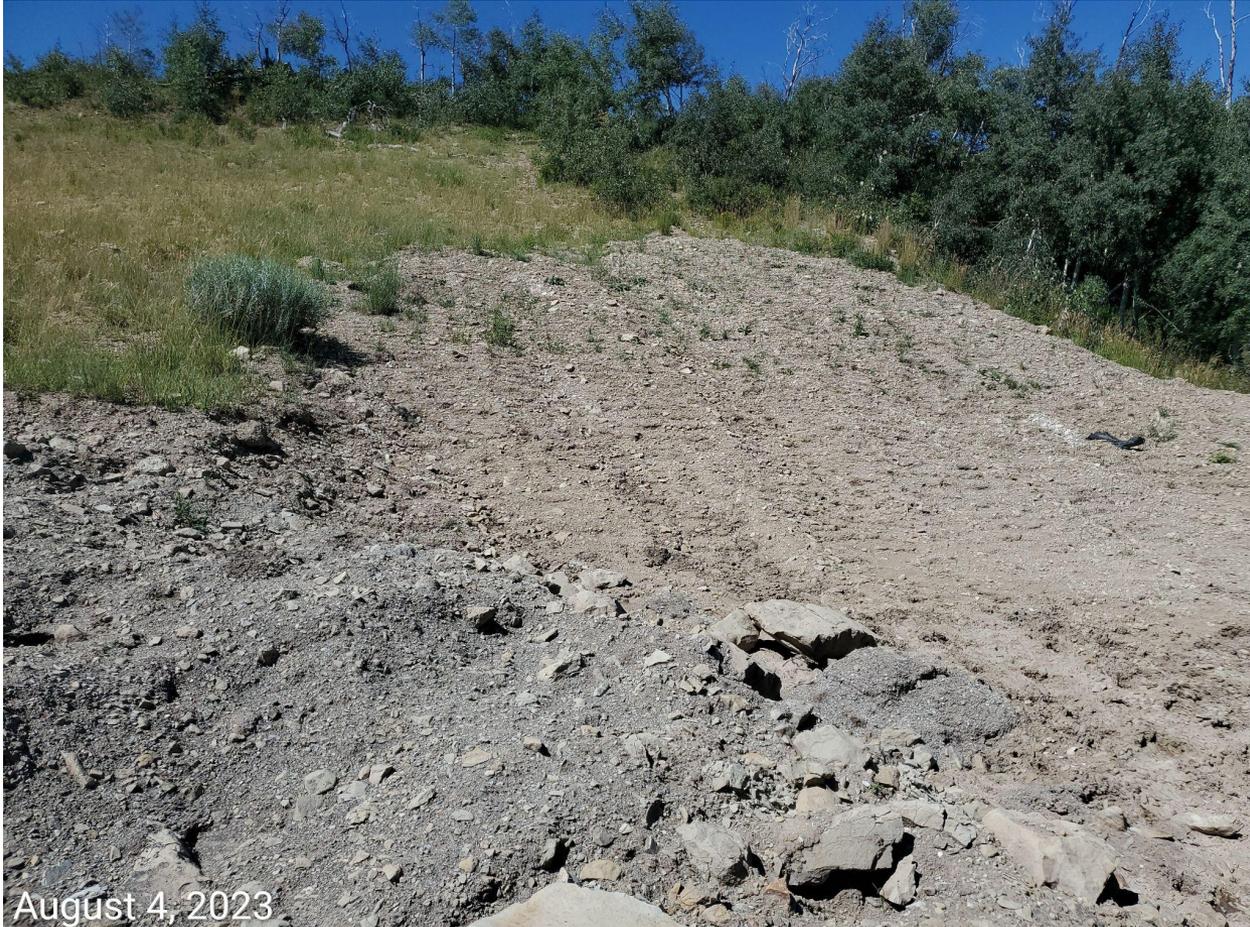
Photo 5: Photo taken from the west end of the Location, facing west. Photo shows bare and unstabilize interim areas not progressing towards 1003 standards

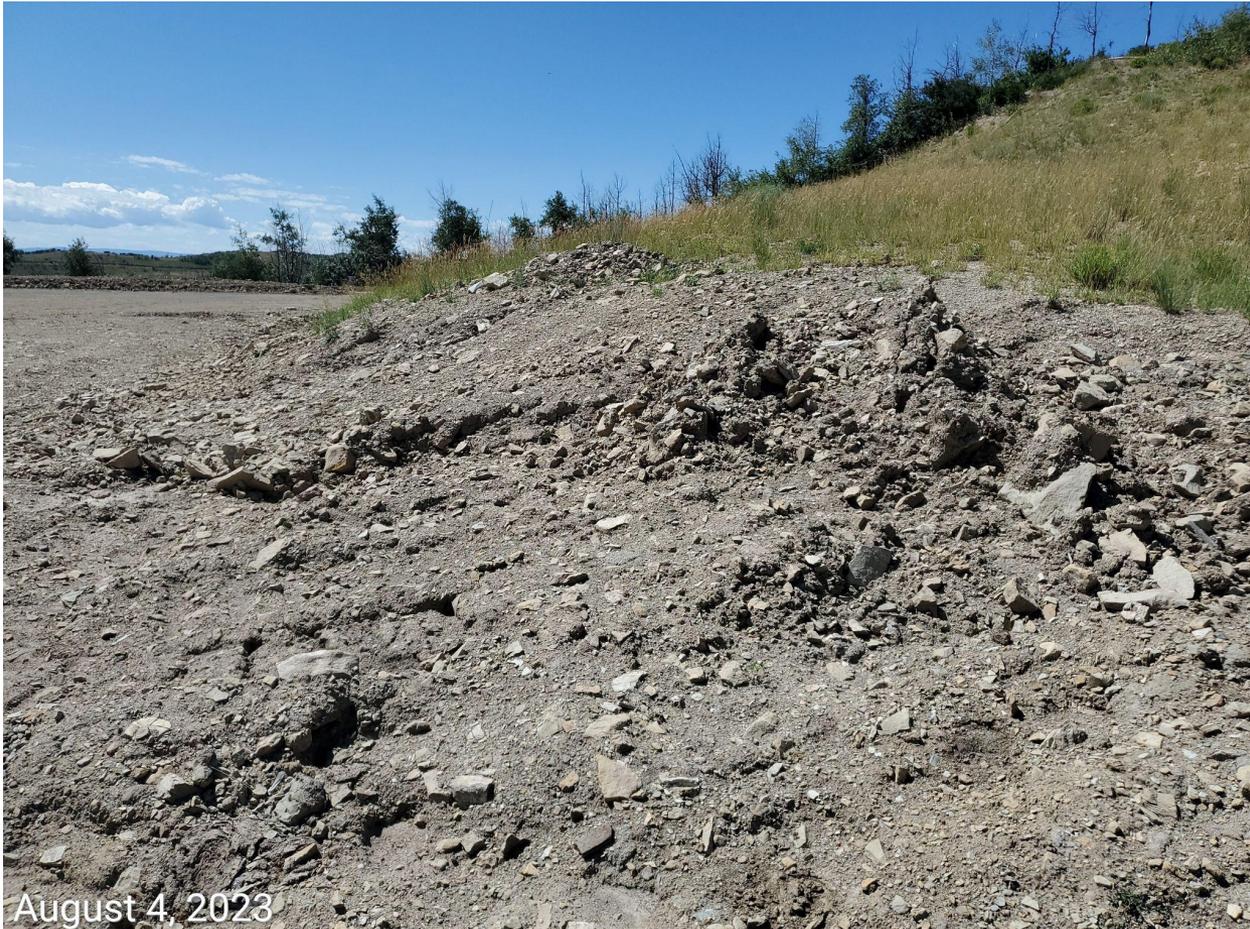
Photo 6: Photo taken from the west end of the Location, facing south. Photo shows bare and/or unstabilize interim areas not progressing towards 1003 standards

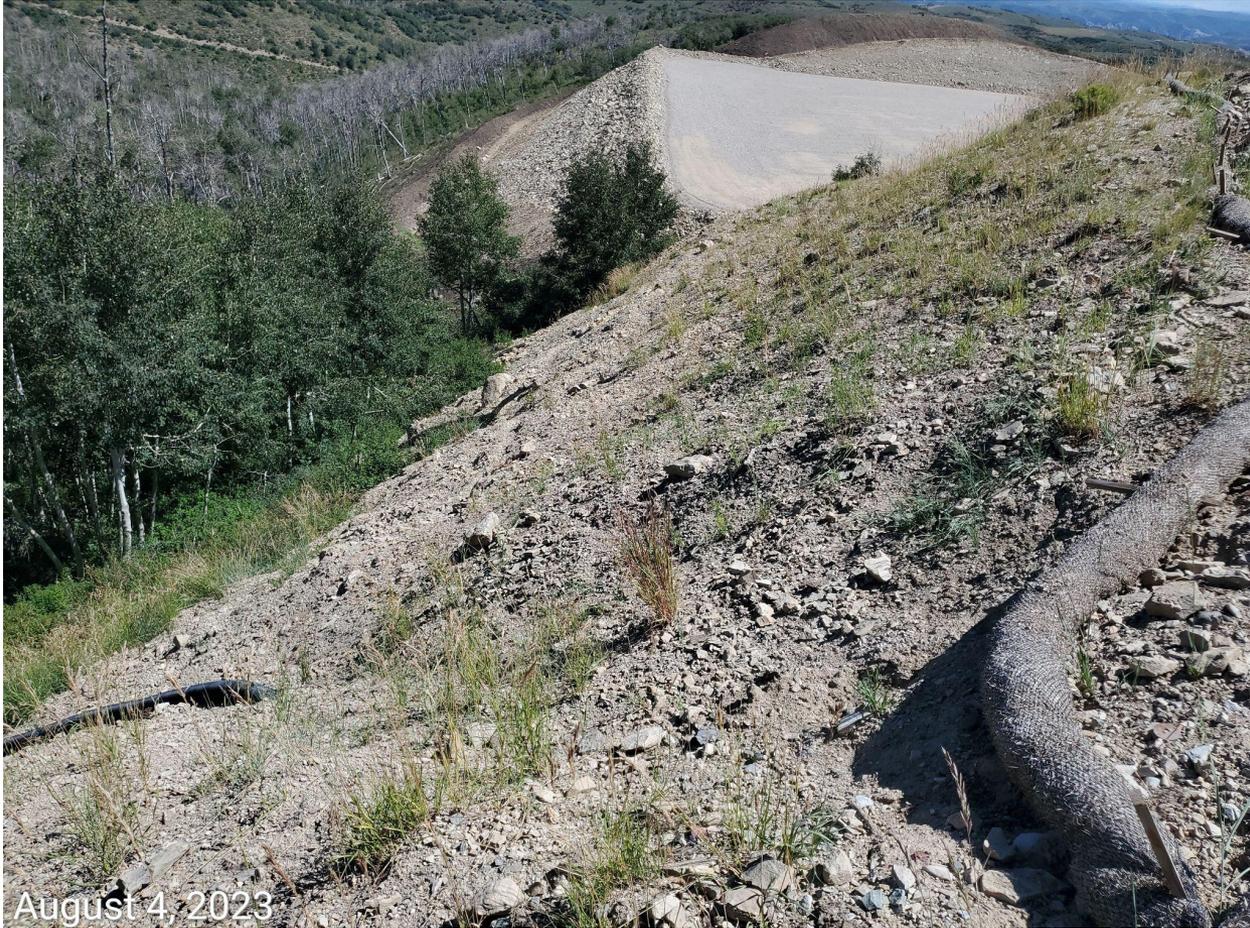
Photo 7: Photo taken from the interim areas on the northwest end of the Location, facing northeast. Interim areas are not progressing towards an 80% uniform desirable perennial vegetative cover to that of the adjacent reference.

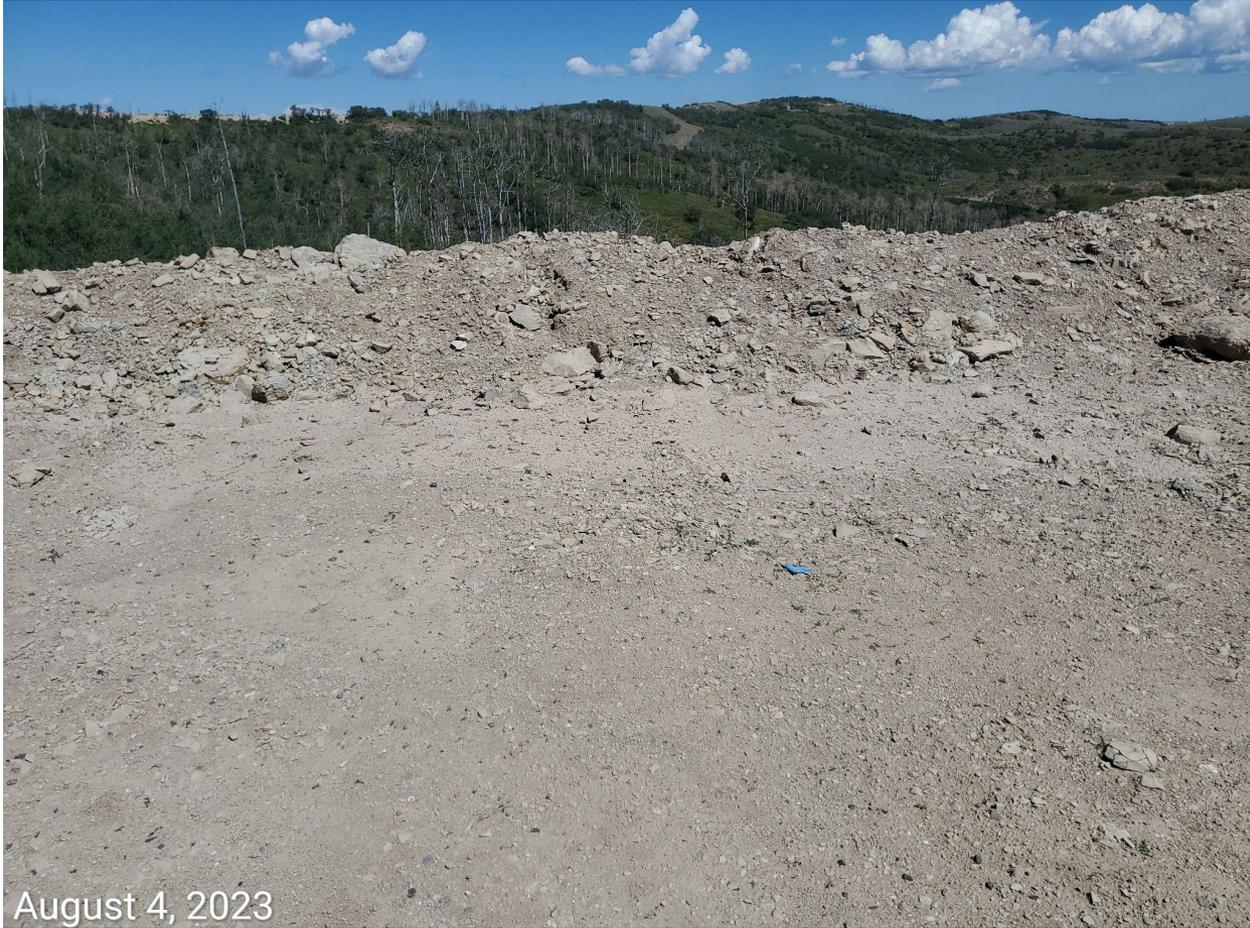
Photo 8: Outlet from the working pad surface to the slope drain on the west end of the Location no longer apparent, or in proper functioning condition.

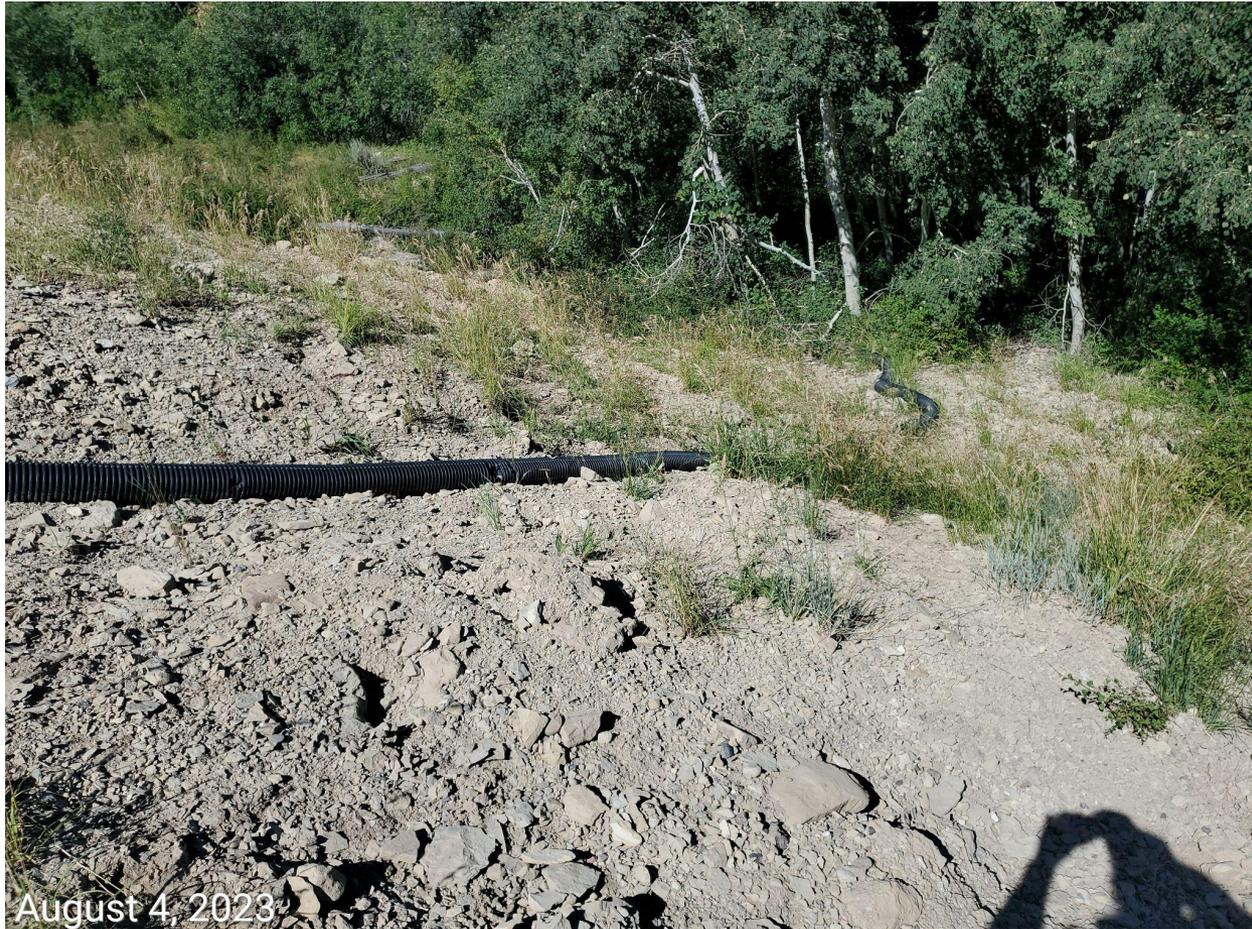
Photo 9: Slope drain has not been secured in accordance with good engineering practices.

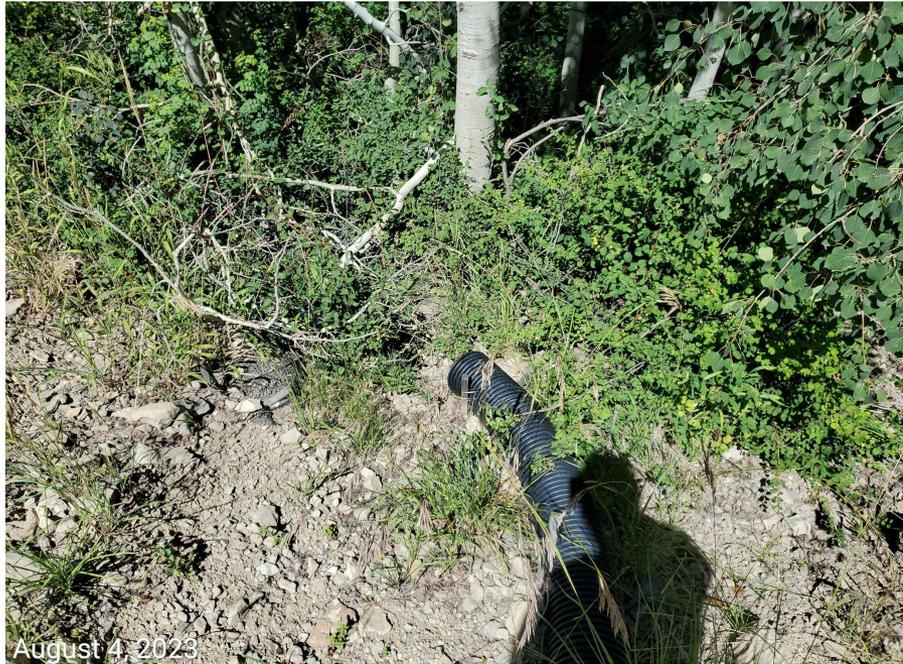
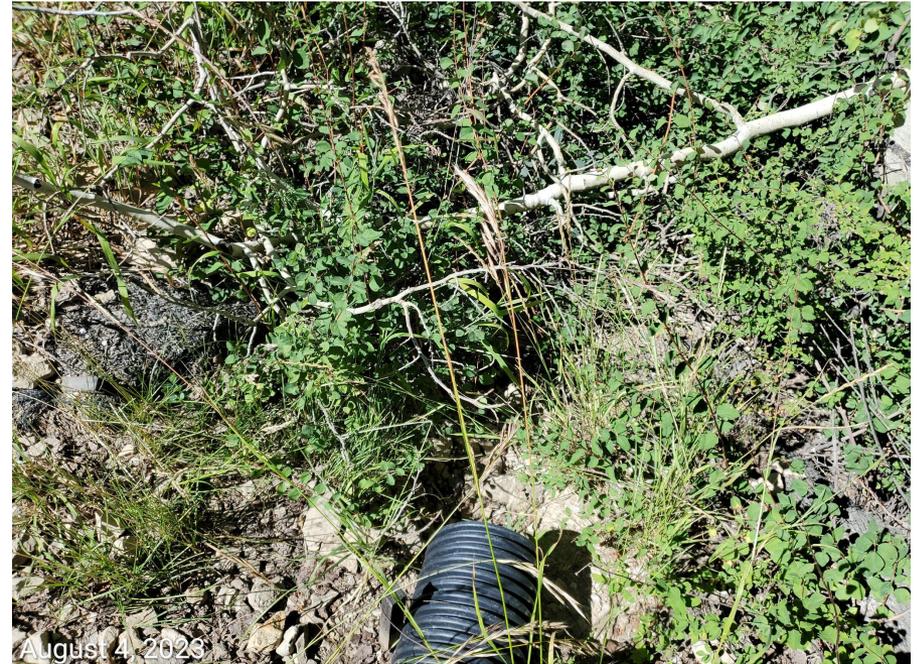
Photo 10: Photo shows slope drain outlet; slope drain has not been constructed with a properly engineered and armored outlet; degradation apparent.
