Inspection Photos

Operator: LARAMIE ENERGY LLC #10433

Location Number: 335595

CC/0697-15-23 Pad, #335595 Issue Report

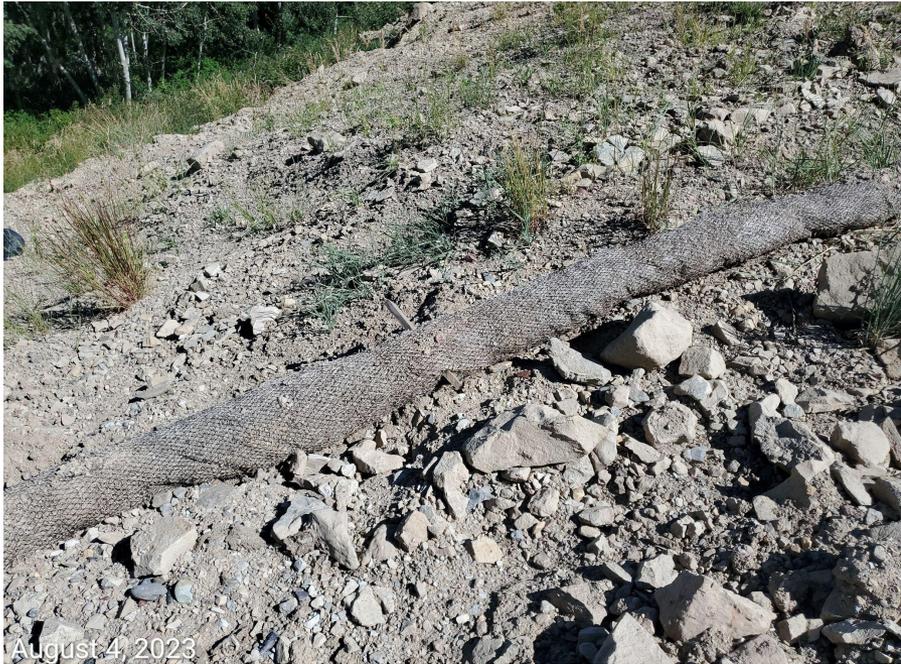
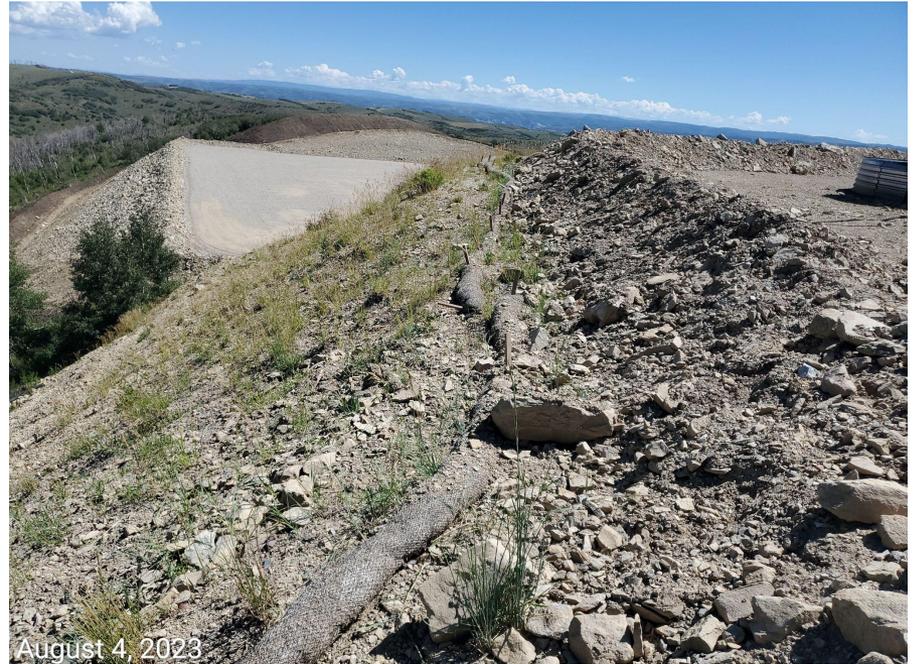
Photo 11: Photos example showing the single row or erosion log (straw wattles) installed on the western and northern interim areas of the Location. Control measures has not been installed or maintained in accordance with good engineering practices; control measure alone is inadequate to manage runoff or stabilize the steep slopes of the Location.

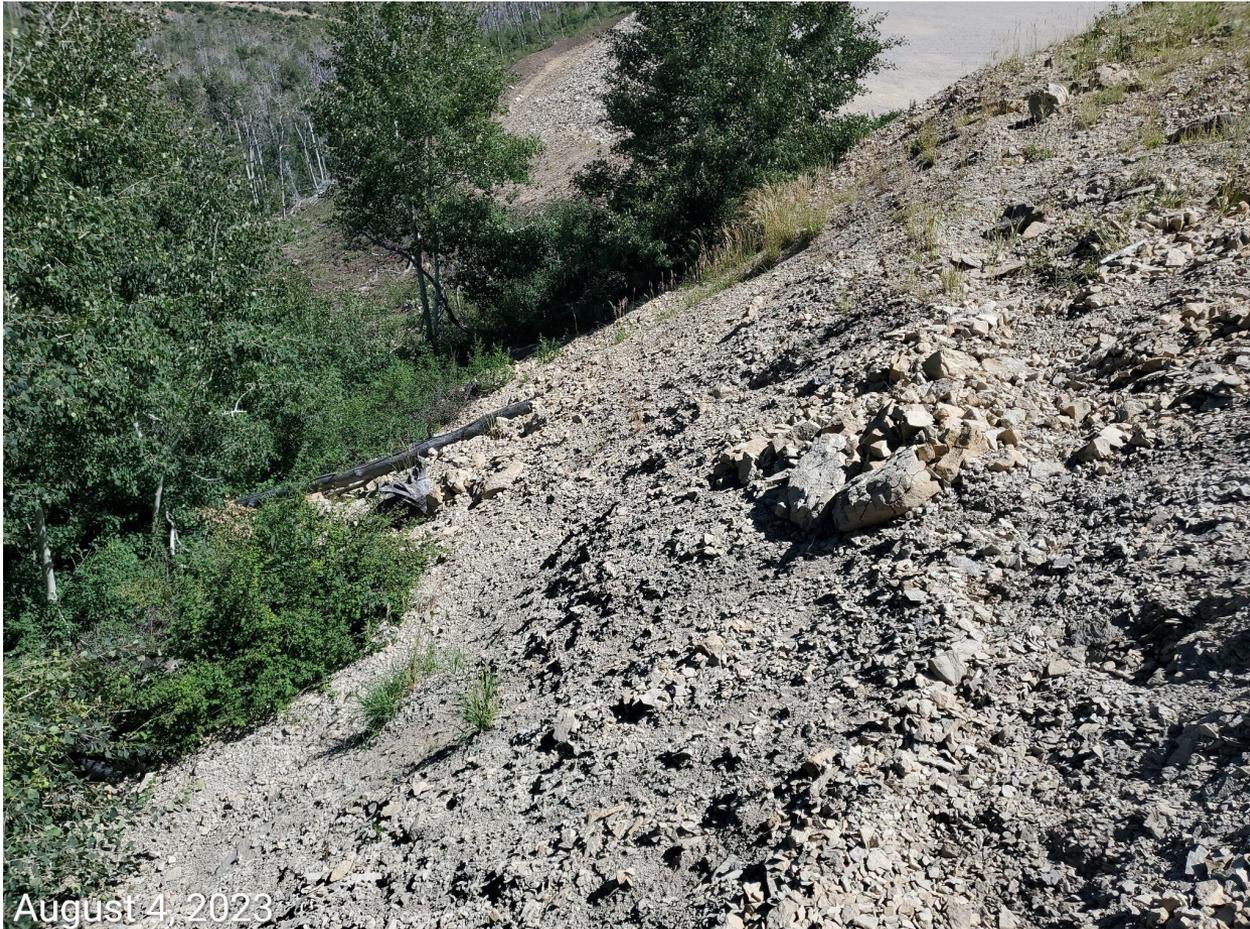
Photo 12: Photo taken from the interim areas on the northwest end of the Location, facing north. Photo shows bare and unstabilized soils; perimeter control measures to manage runoff not observed; interim areas not progressing towards 1003 standards.

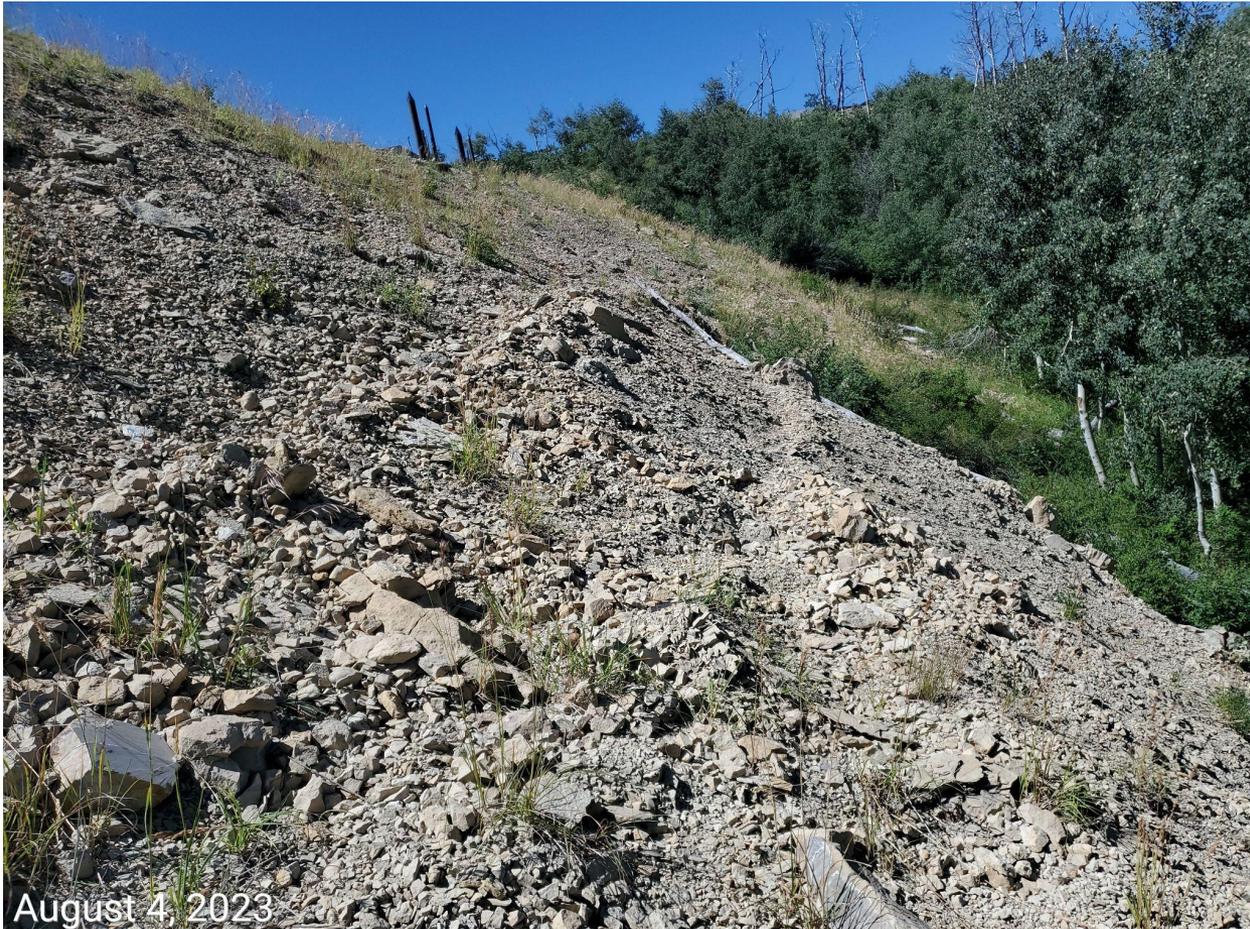
Photo 13: Photo taken from the interim areas on the northwest end of the Location, facing southwest. Photo shows bare and unstabilized soils; perimeter control measures to manage runoff not observed; interim areas not progressing towards 1003 standards.

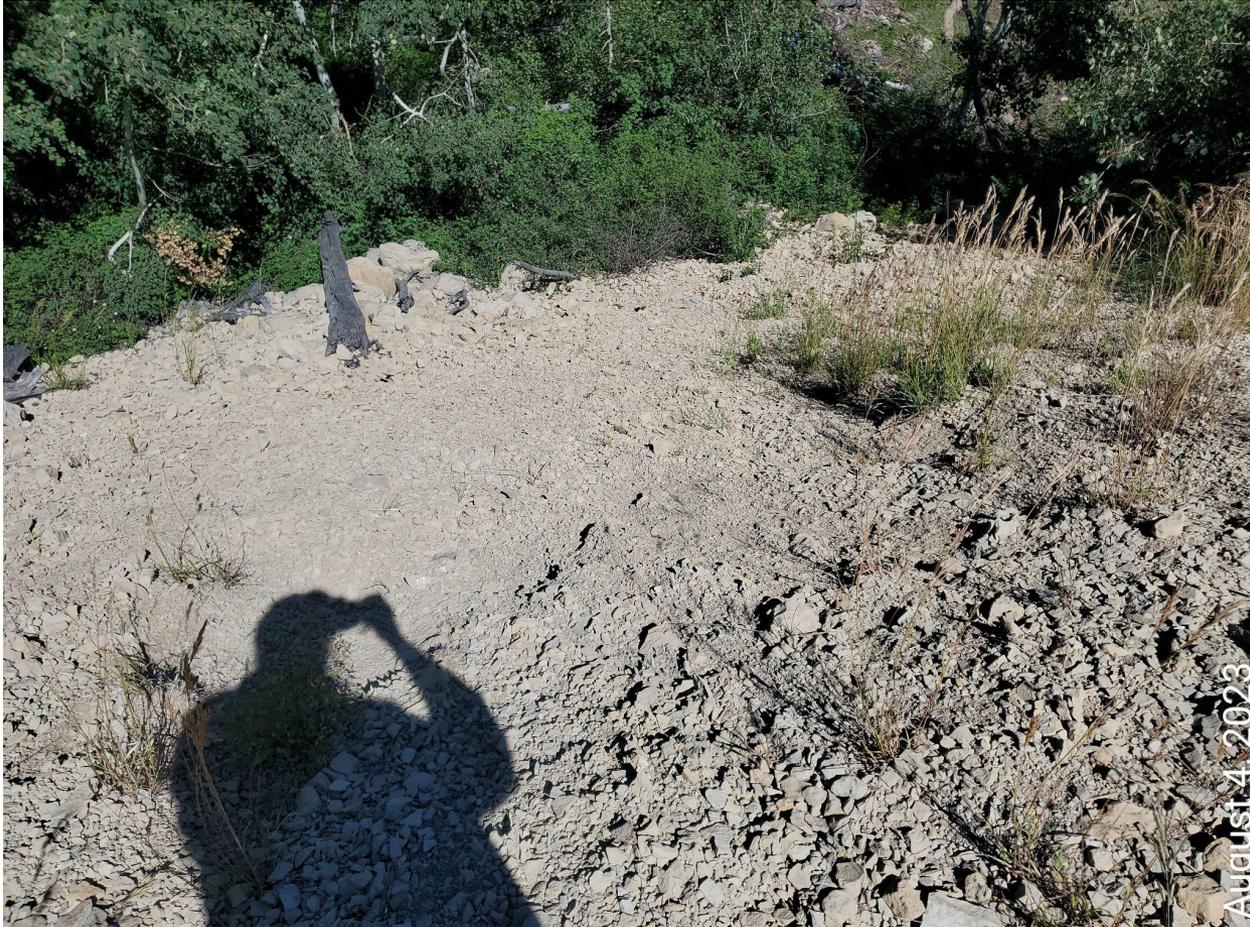
Photo 14: Photo shows bare and unstabilized soils; perimeter control measures to manage runoff not observed; interim areas not progressing towards 1003 standards. Sediment/fill material encroachment onto vegetation within adjacent areas of the Location.

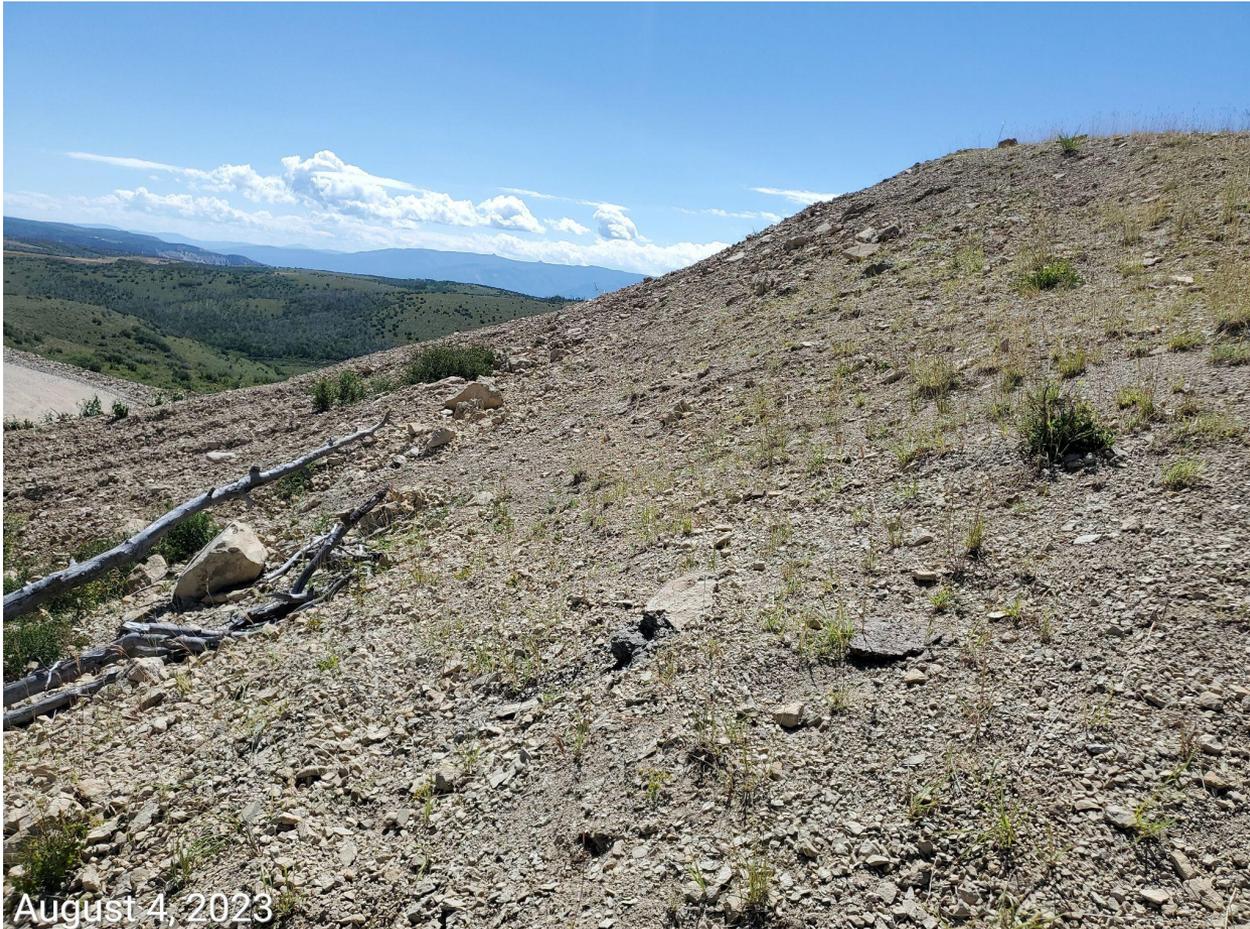
Photo 15: Photo taken from the interim areas on the north end of the Location, facing southeast. Photo shows bare and unstabilized soils; perimeter control measures to manage runoff not observed; interim areas not progressing towards 1003 standards.

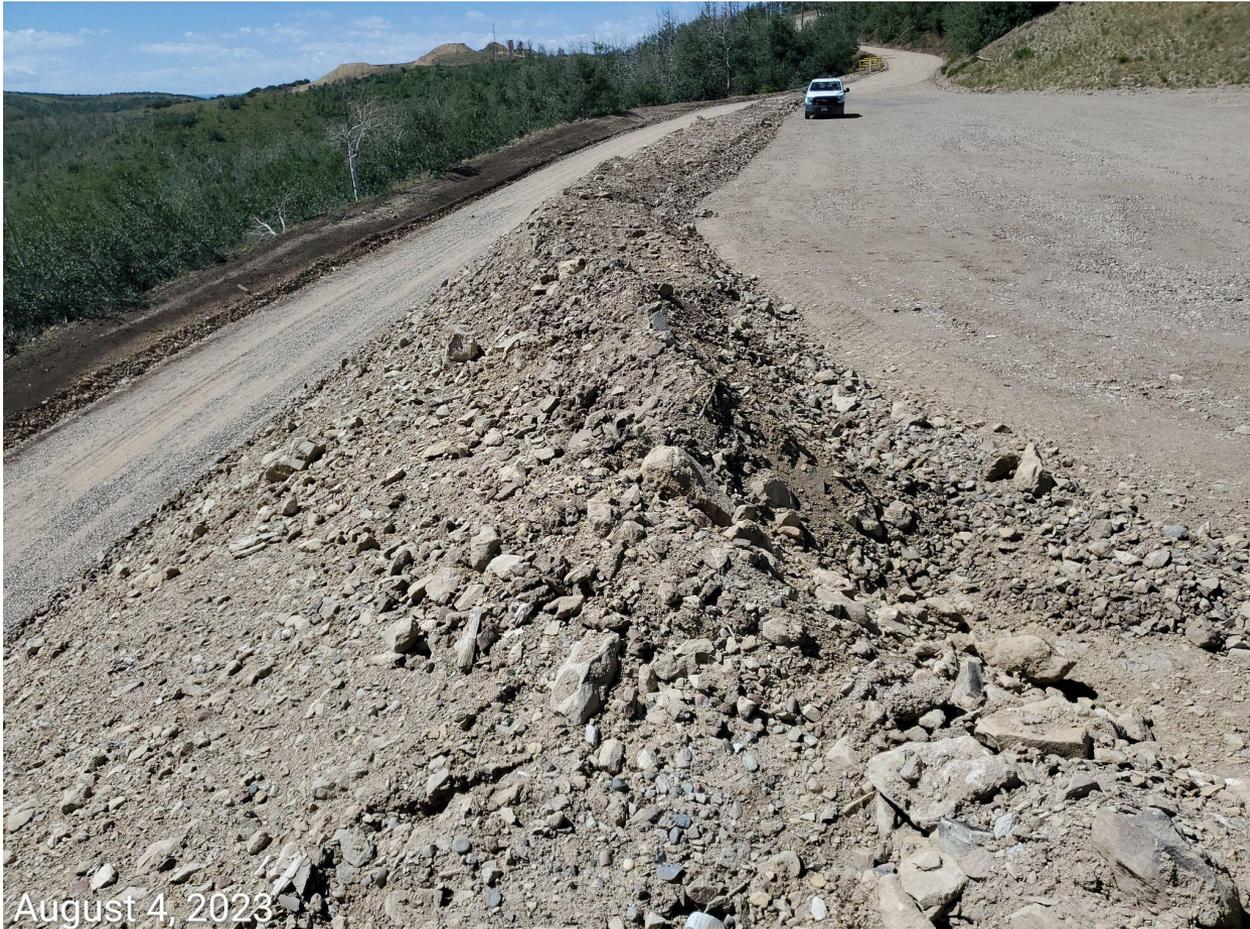
Photo 16: Photo taken from the eastern working pad surface, facing southwest. Photo example showing the berm has not been consolidated in accordance with good engineering practices.

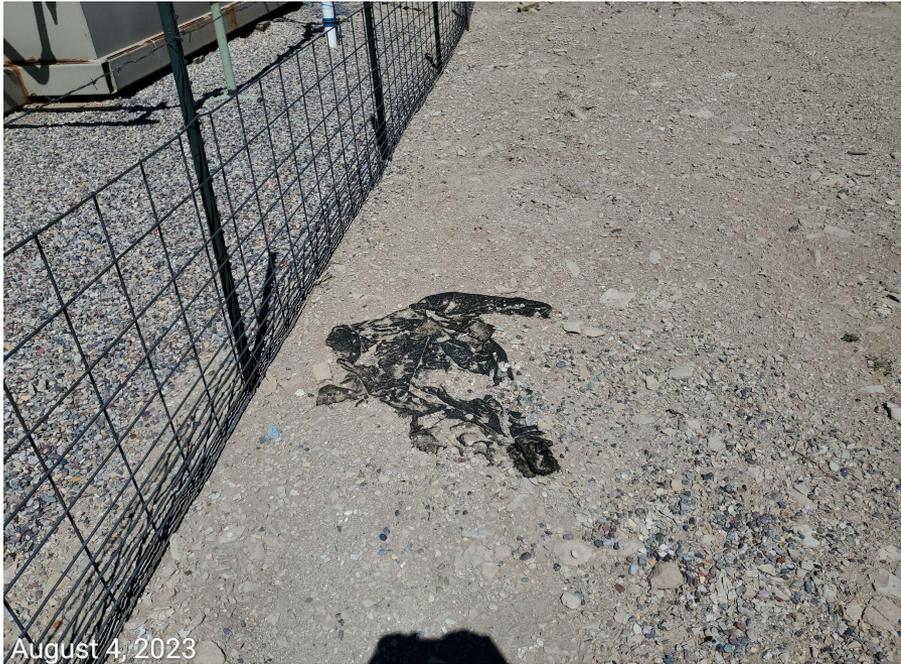
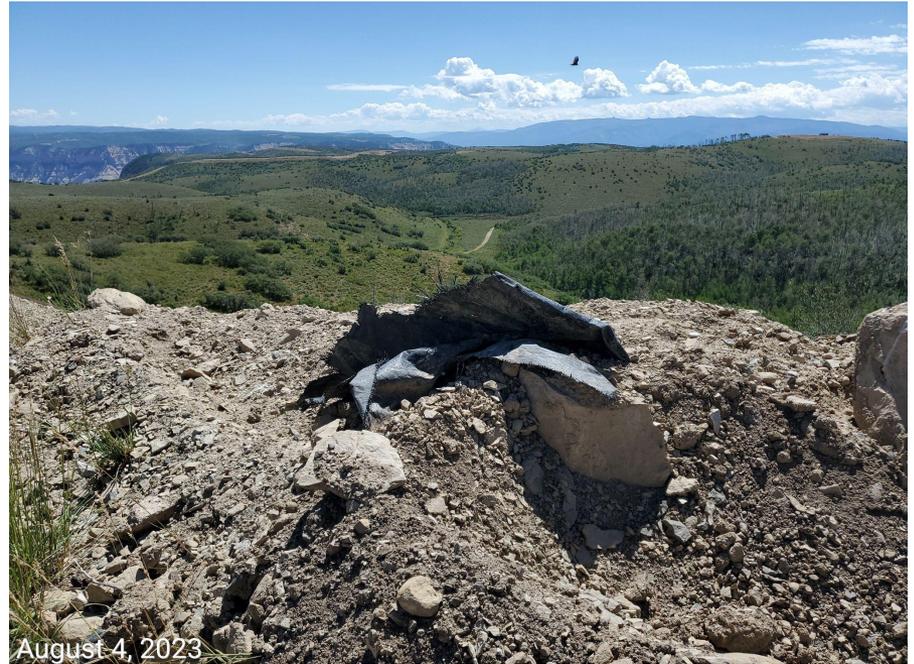
Photo 17: Trash debris north of the separator equipment, and northeastern working pad perimeter.
