Inspection Photos

8/4/2023

Operator: LARAMIE ENERGY LLC #10433

Location Number: 335647

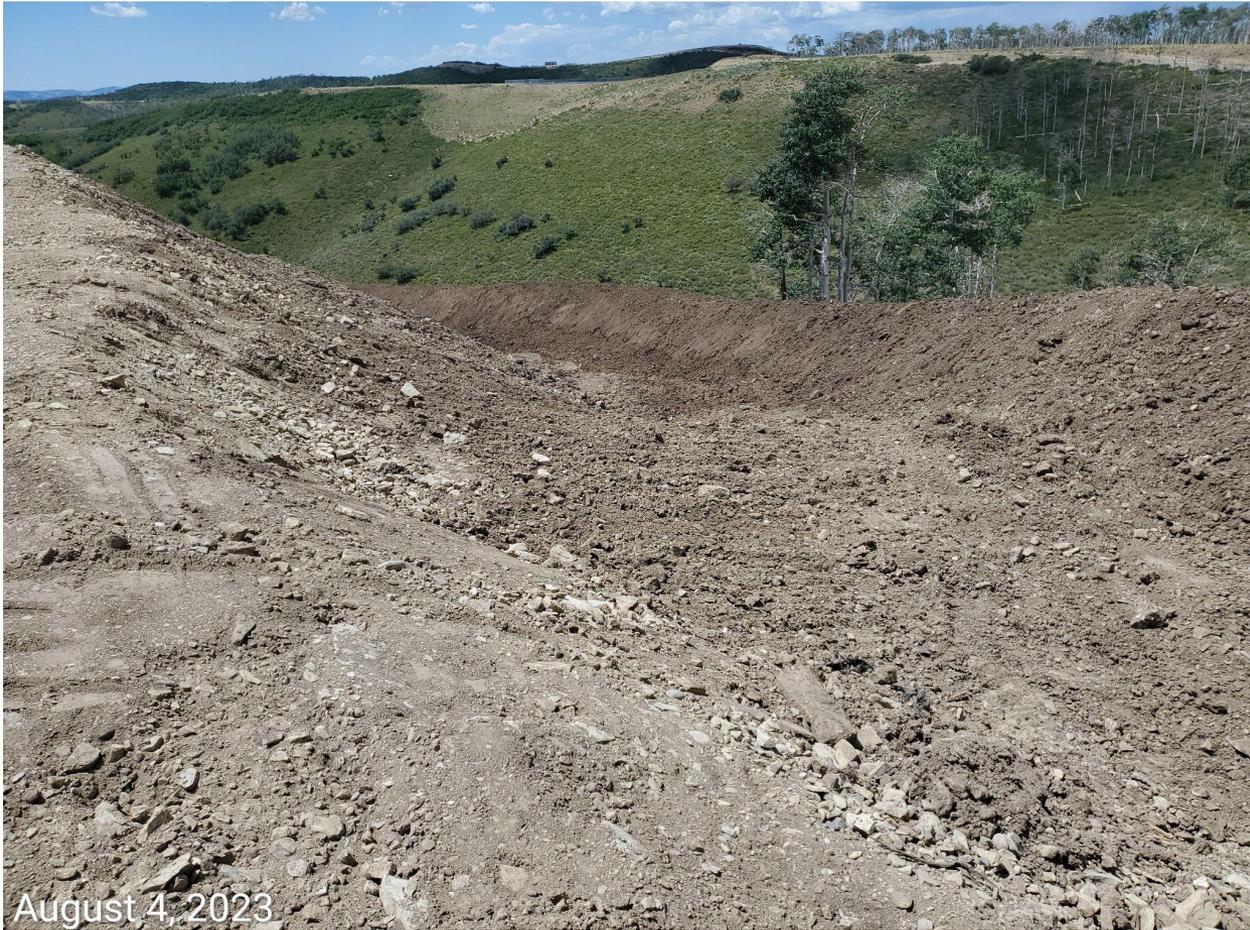
Photo 1: Photo taken from the north end of the Location, facing west. Photo shows Operator's attempts to remove the fill material from the topsoil stockpile. Photo also shows BMPs to ensure soils remain segregated, protected from weeds, wind and water erosion, as well as BMPs to stabilize, minimize degradation and sediment transport remain missing or insufficient.

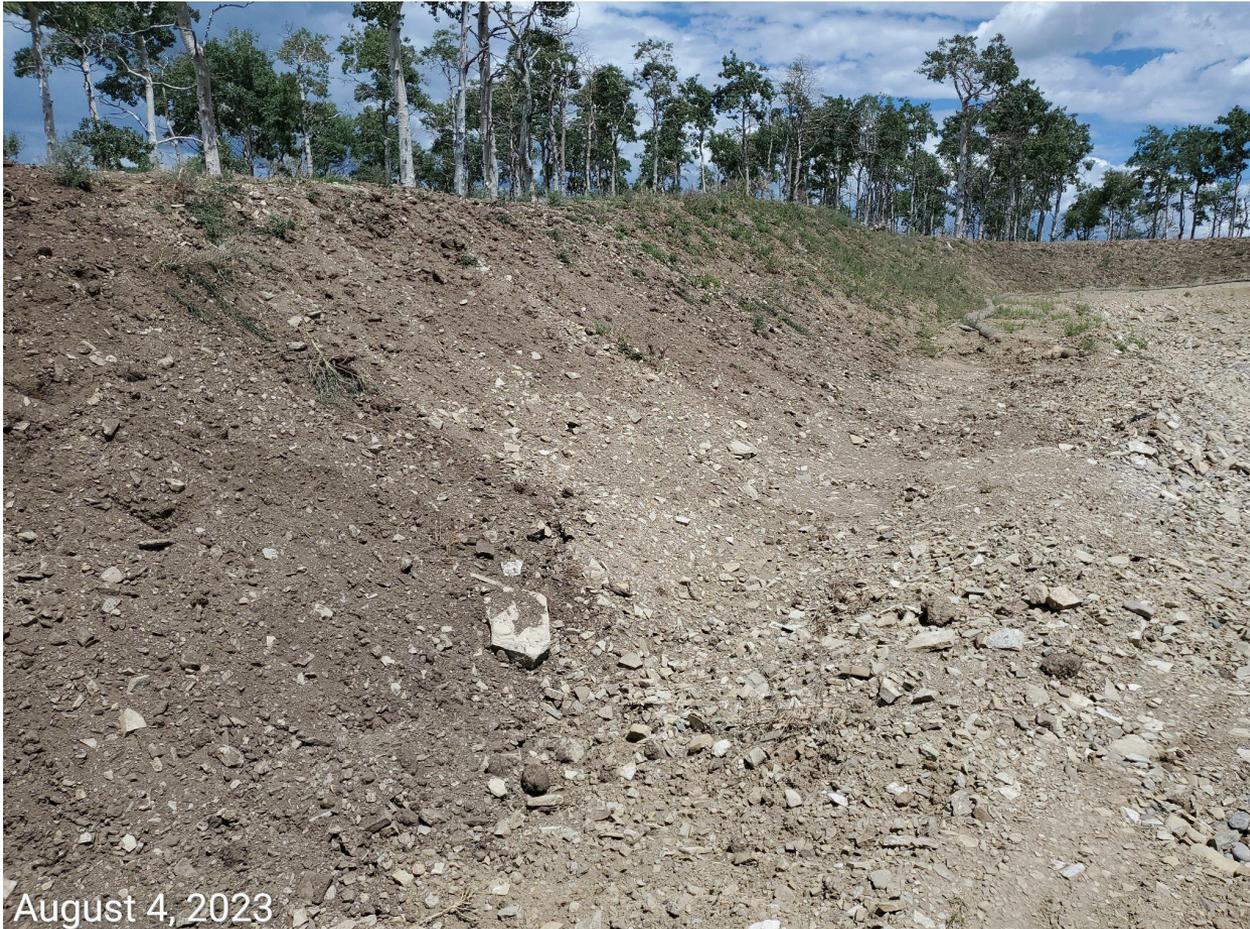
Photo 2: Photo of topsoil stockpile on the north end of the Location. Photo shows BMPs to ensure soils remain segregated, protected from weeds, wind and water erosion, as well as BMPs to stabilize, minimize degradation and sediment transport remain missing or insufficient.

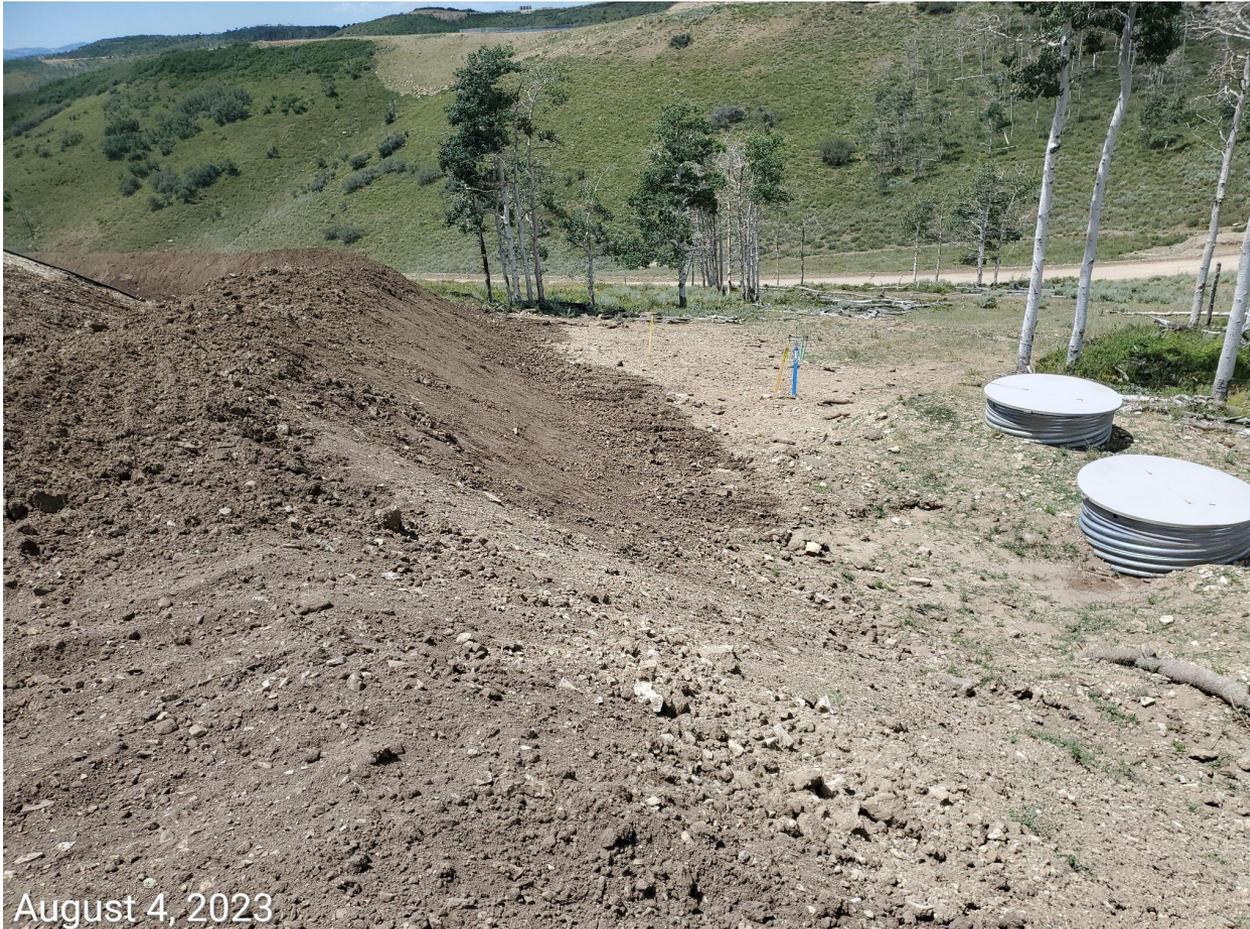
Photo 3: Photo of topsoil stockpile on the north end of the Location. Photo shows BMPs to ensure soils remain segregated, protected from weeds, wind and water erosion, as well as BMPs to stabilize, minimize degradation and sediment transport remain missing or insufficient.

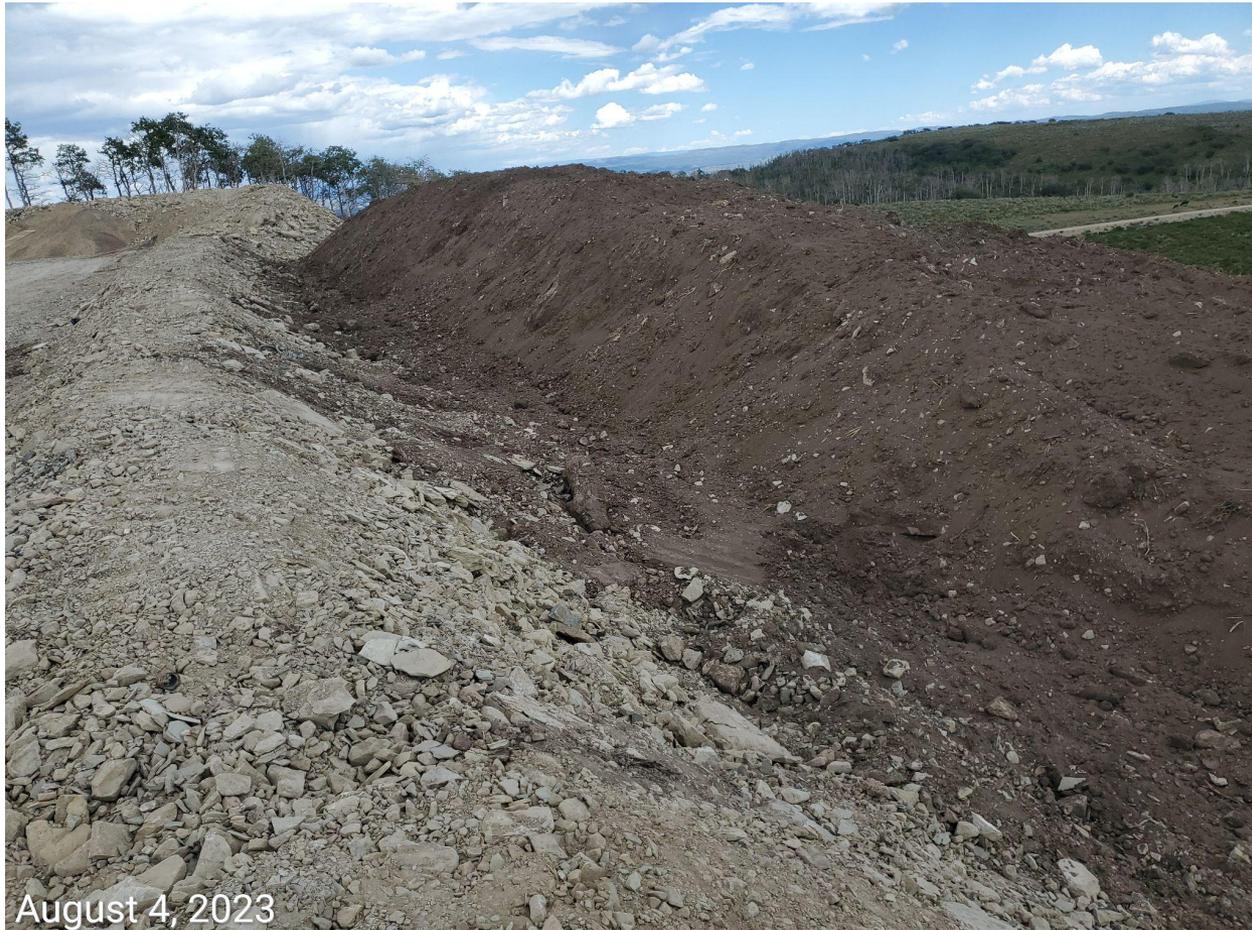
Photo 4: Photo taken from the south end of the Location, facing west. Photo shows Operator's attempts to remove the fill material from the topsoil stockpile. Photo also shows BMPs to ensure soils remain segregated, protected from weeds, wind and water erosion, as well as BMPs to stabilize, minimize degradation and sediment transport remain missing or insufficient.

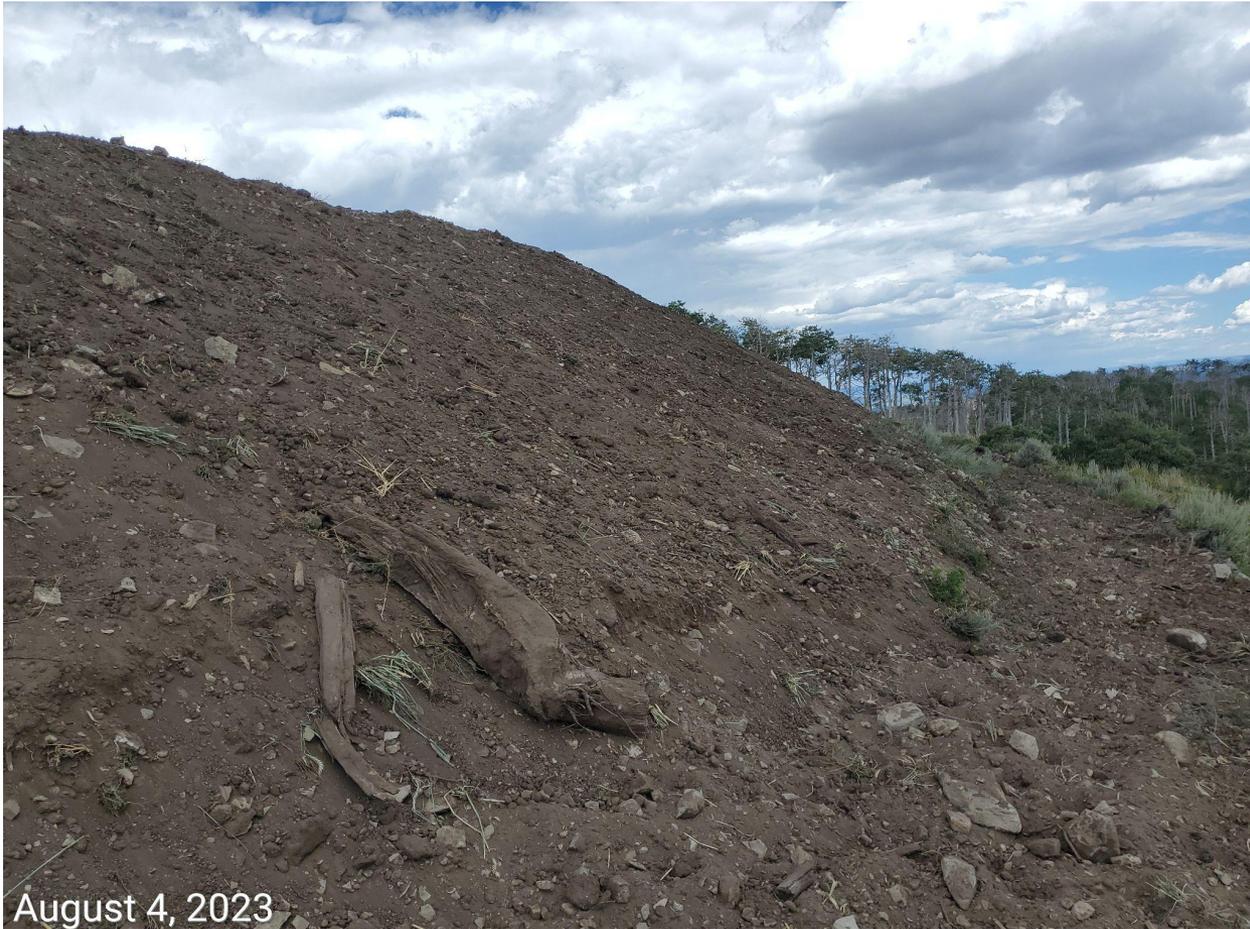
Photo 5: Photo shows BMPs to ensure soils remain segregated, protected from weeds, wind and water erosion, as well as BMPs to stabilize, minimize degradation and sediment transport remain missing or insufficient.

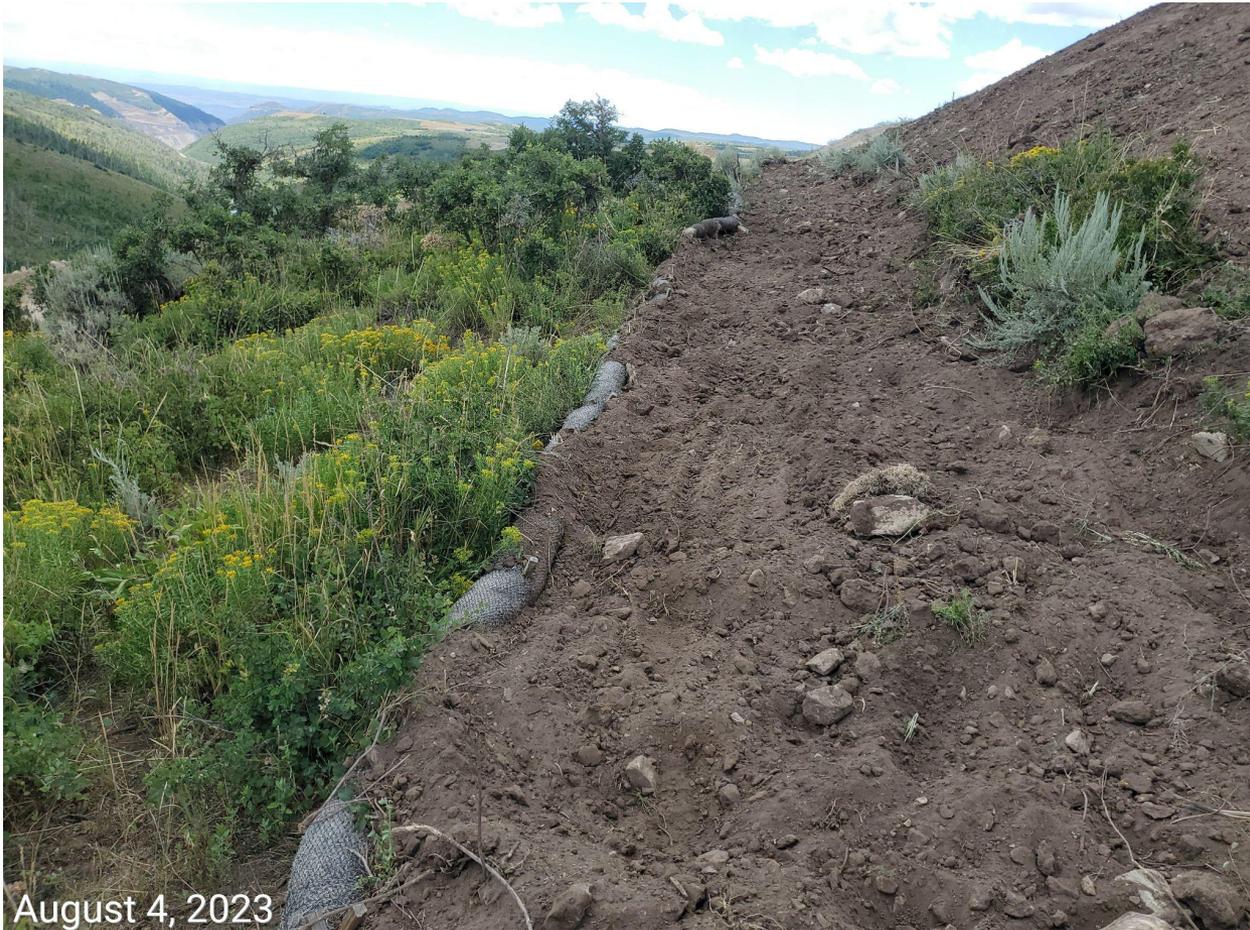
Photo 6: Photo shows BMPs to ensure soils remain segregated, protected from weeds, wind and water erosion, as well as BMPs to stabilize, minimize degradation and sediment transport remain missing or insufficient.

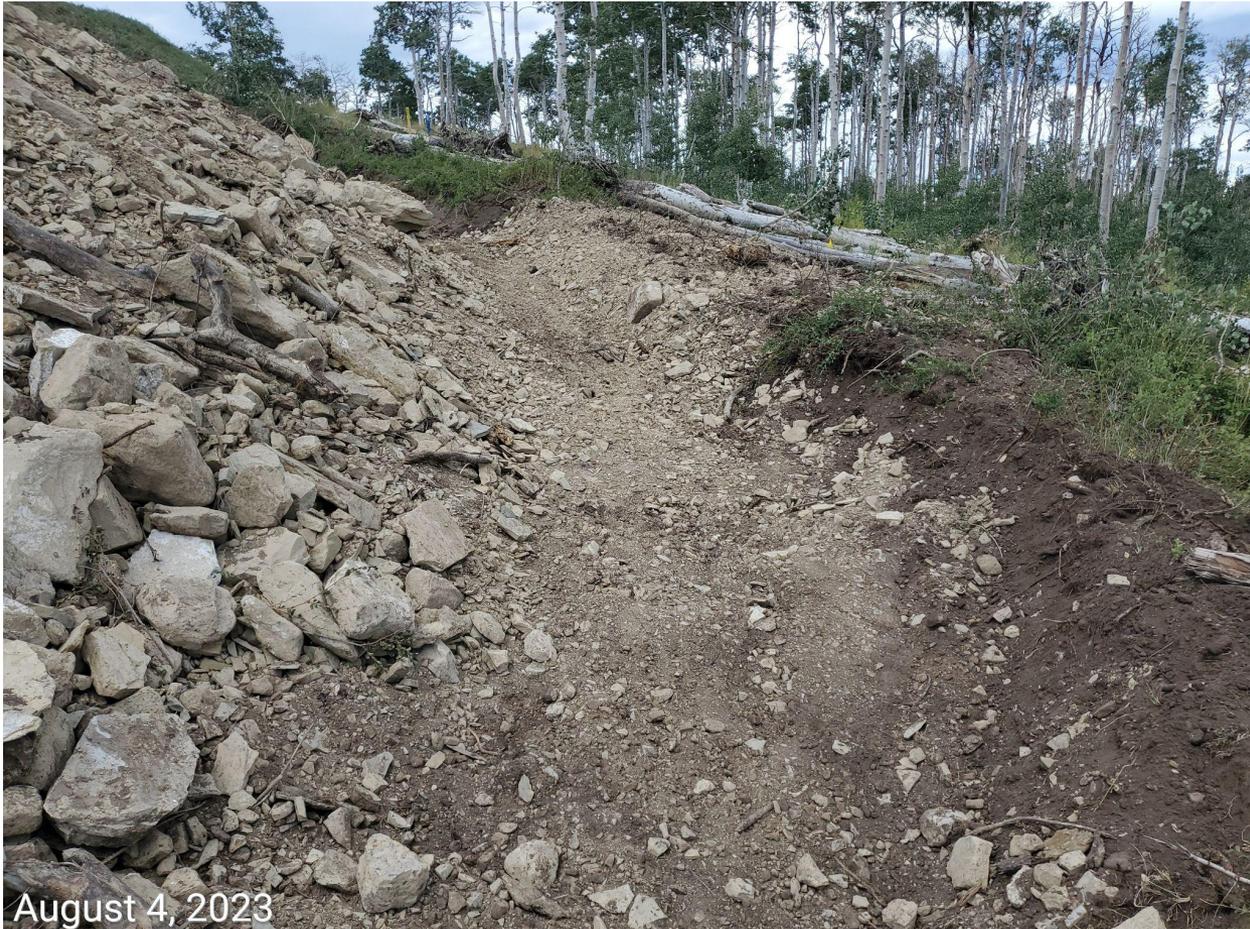
Photo 7: Photo taken from the southeast end of the Location. Photo shows ditch appears to have been constructed with topsoil materials. Fill material remains spread over topsoil and off-site.

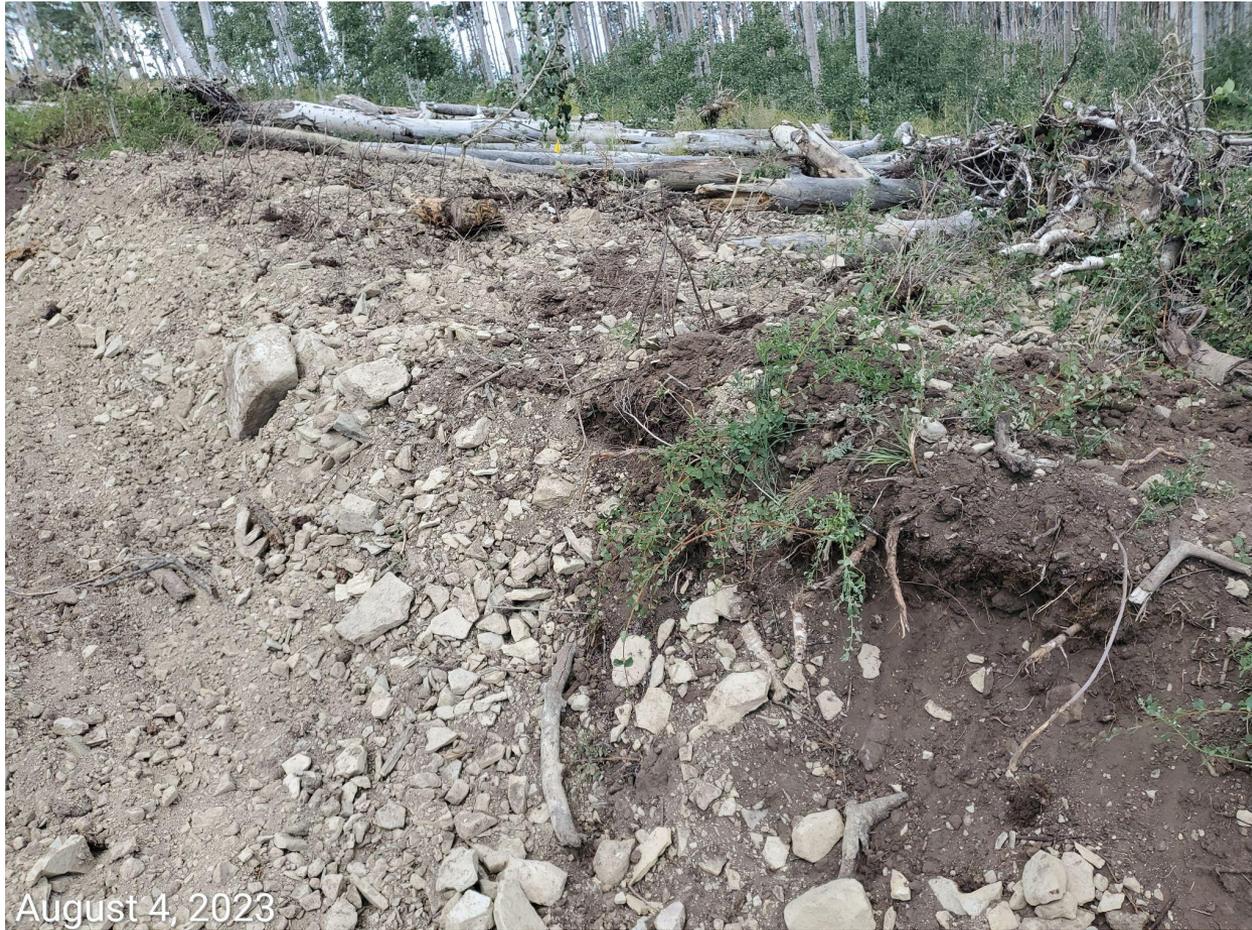
Photo 8: Fill material remains spread over topsoil and off-site.

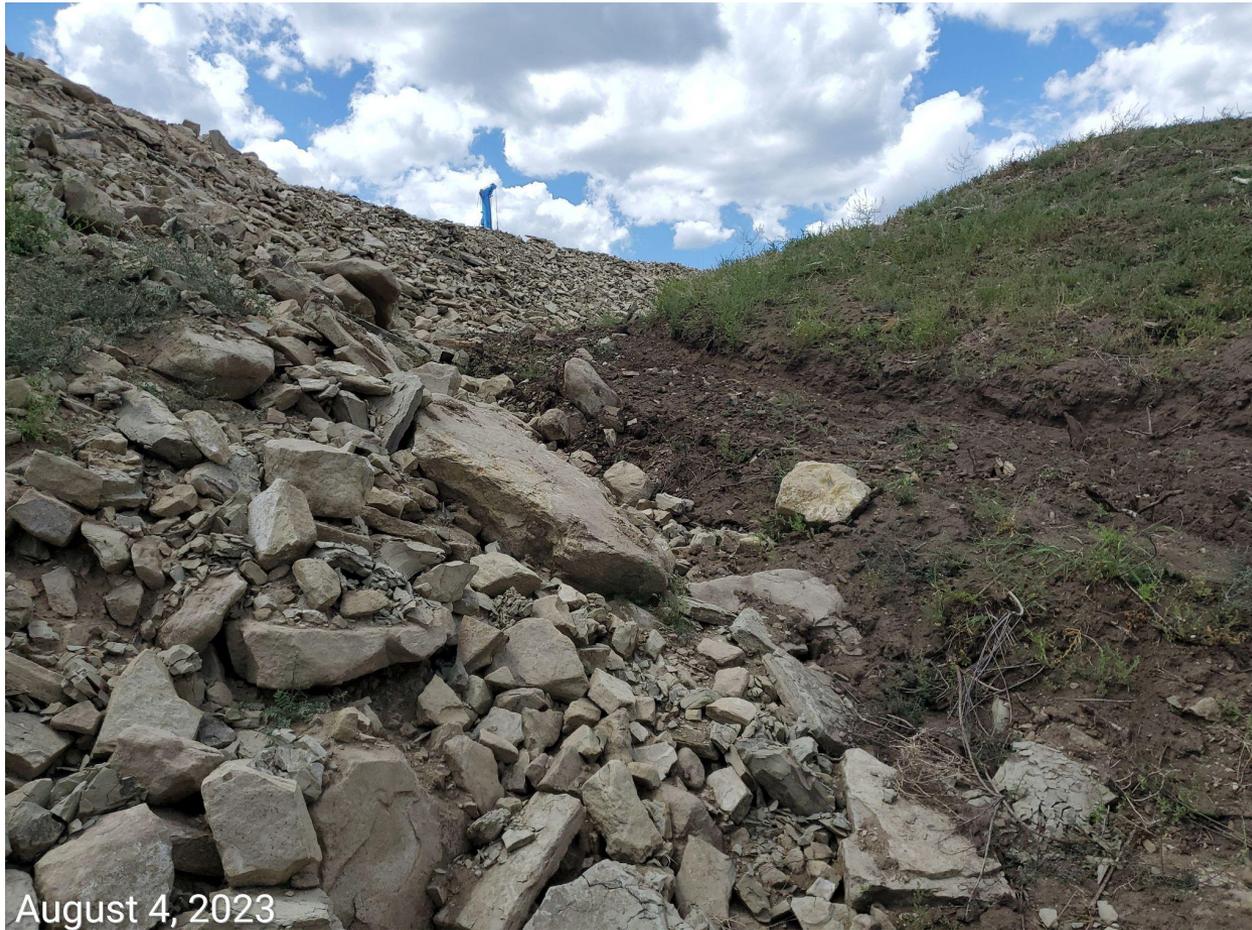
Photo 9: Photo taken from the east end of the Location. Photo shows BMPs to ensure soils remain segregated, protected from weeds, wind and water erosion, as well as BMPs to stabilize, minimize degradation and sediment transport remain missing or insufficient; Perimeter controls at stockpile (silt fence) completely removed.

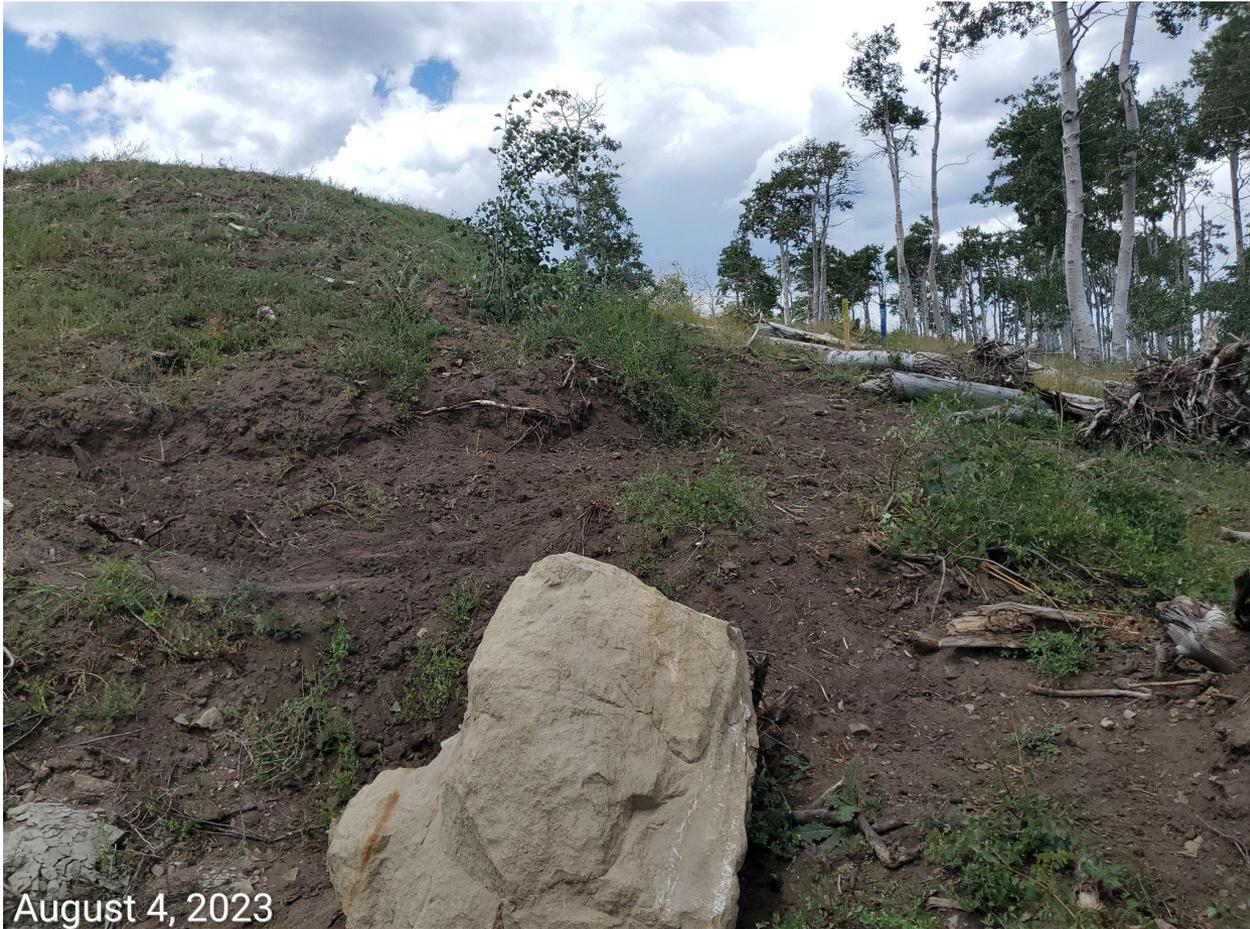
Photo 10: Photo taken from the east end of the Location. Photo shows BMPs to ensure soils remain segregated, protected from weeds, wind and water erosion, as well as BMPs to stabilize, minimize degradation and sediment transport remain missing or insufficient; Perimeter controls at stockpile (silt fence) completely removed.

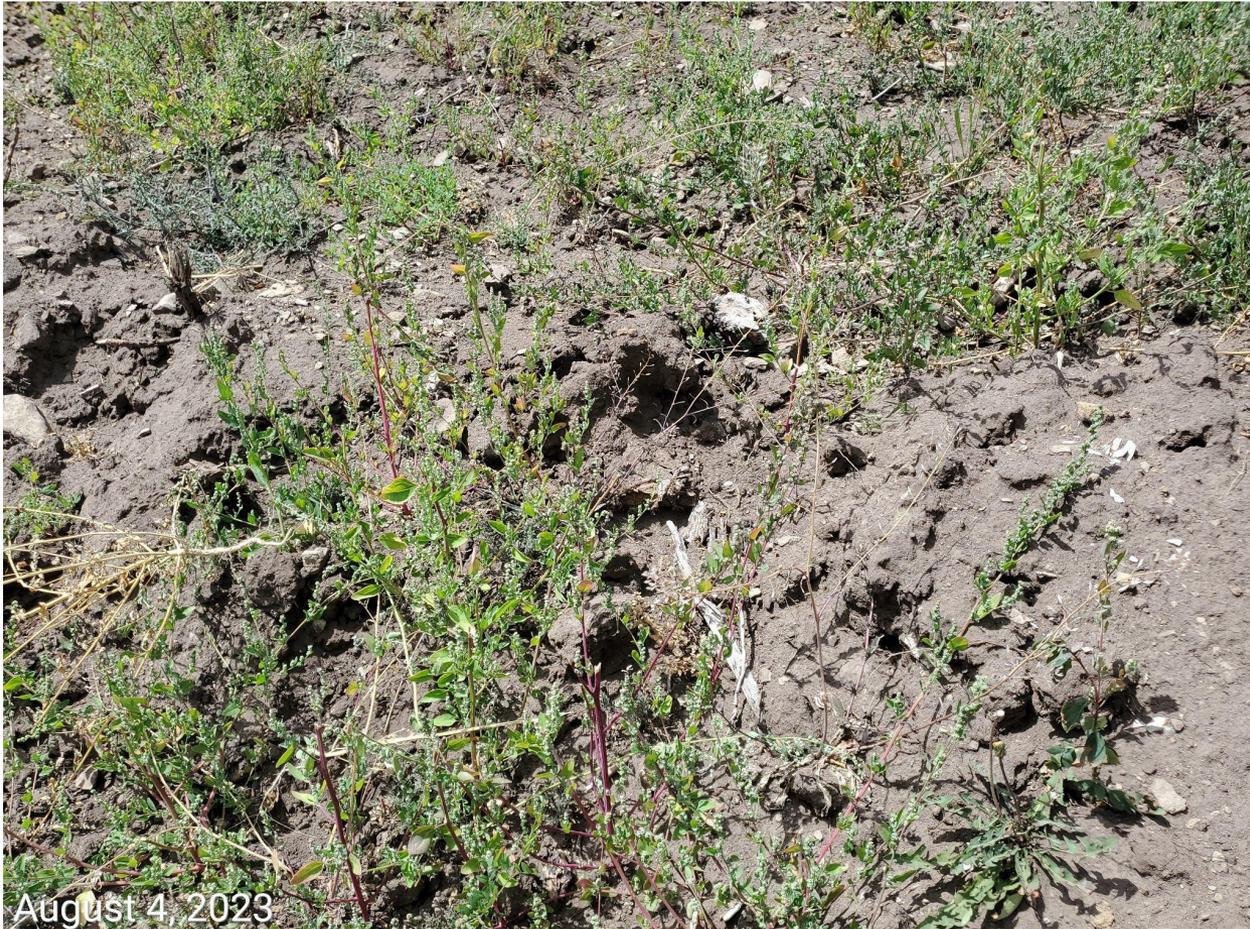
Photo 11: Photo shows vegetation on topsoil stockpile; vegetation observed predominantly Undesirable Plant Species; weeds include Ameranth, various introduced mustard species, prostrate knotweed, etc... BMPs to protect topsoil from weeds remains inadequate.

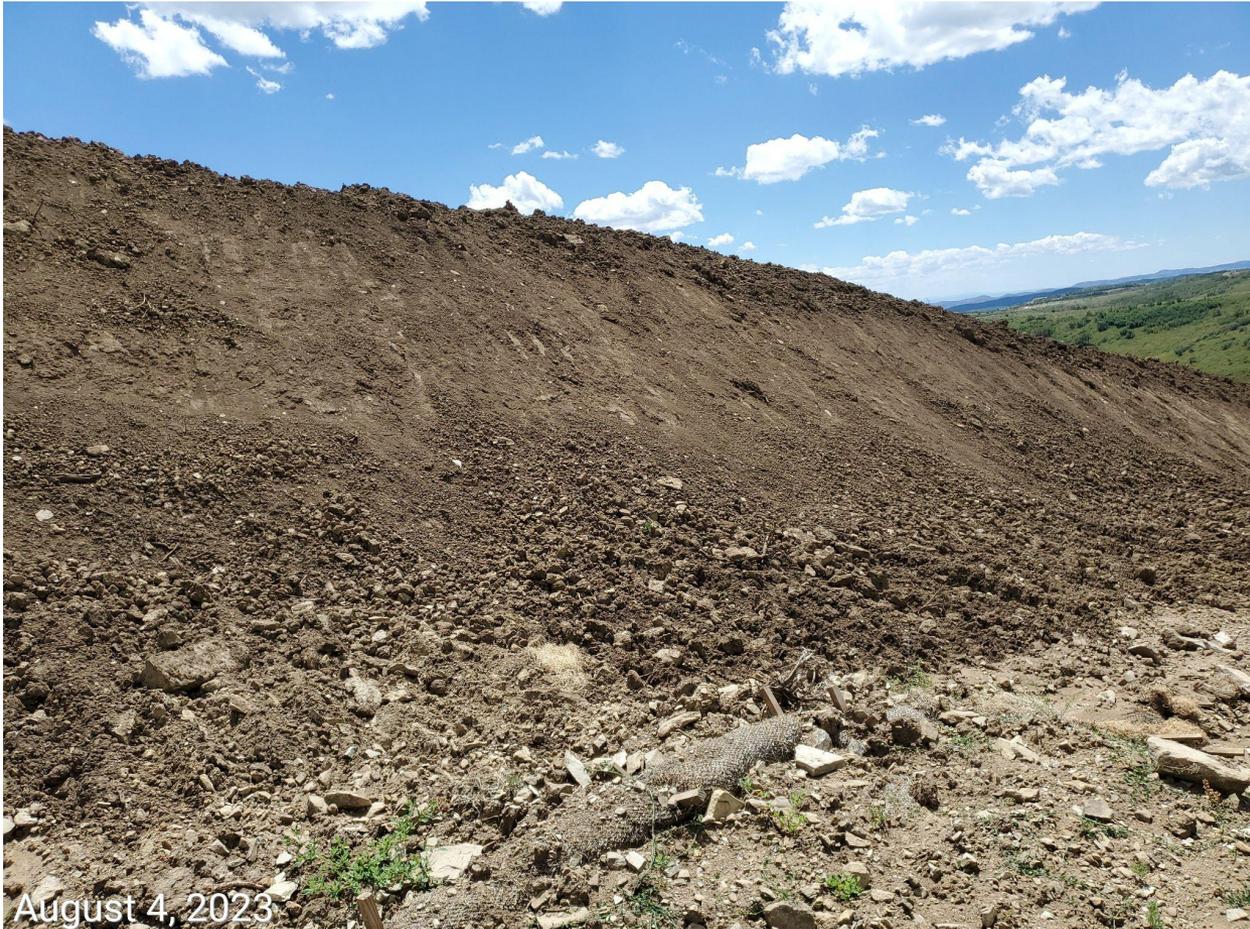
Photo 12: Photo shows BMPs to ensure soils remain segregated, protected from weeds, wind and water erosion, as well as BMPs to stabilize, minimize degradation and sediment transport remain missing or insufficient.

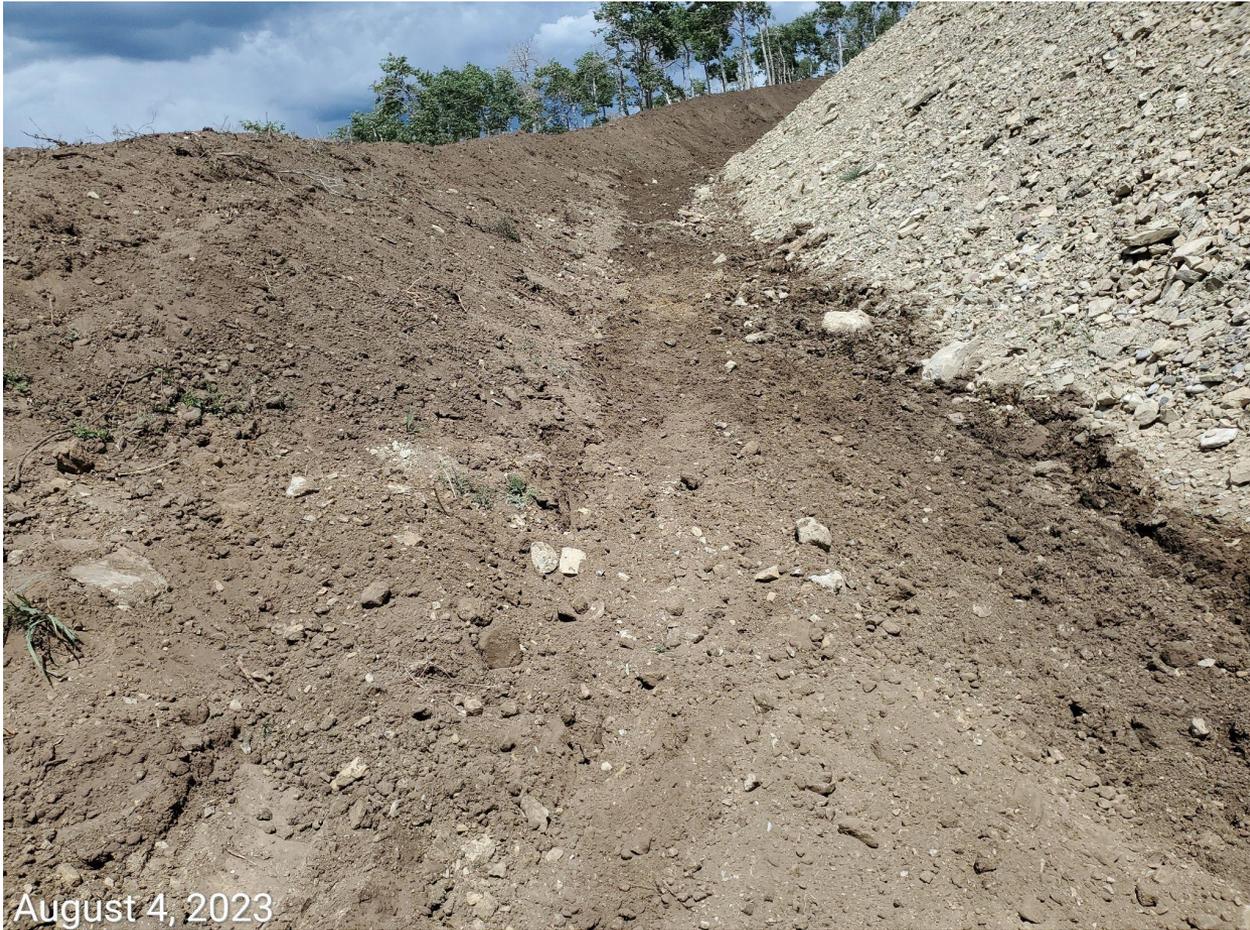
Photo 13: Photo taken from the “ditch” on the northwest end of the Location. Ditch is not per good engineering practices and remains predominantly topsoil material; photo shows BMPs to ensure soils remain segregated, protected from weeds, wind and water erosion, as well as BMPs to stabilize, minimize degradation and sediment transport remain missing or insufficient.

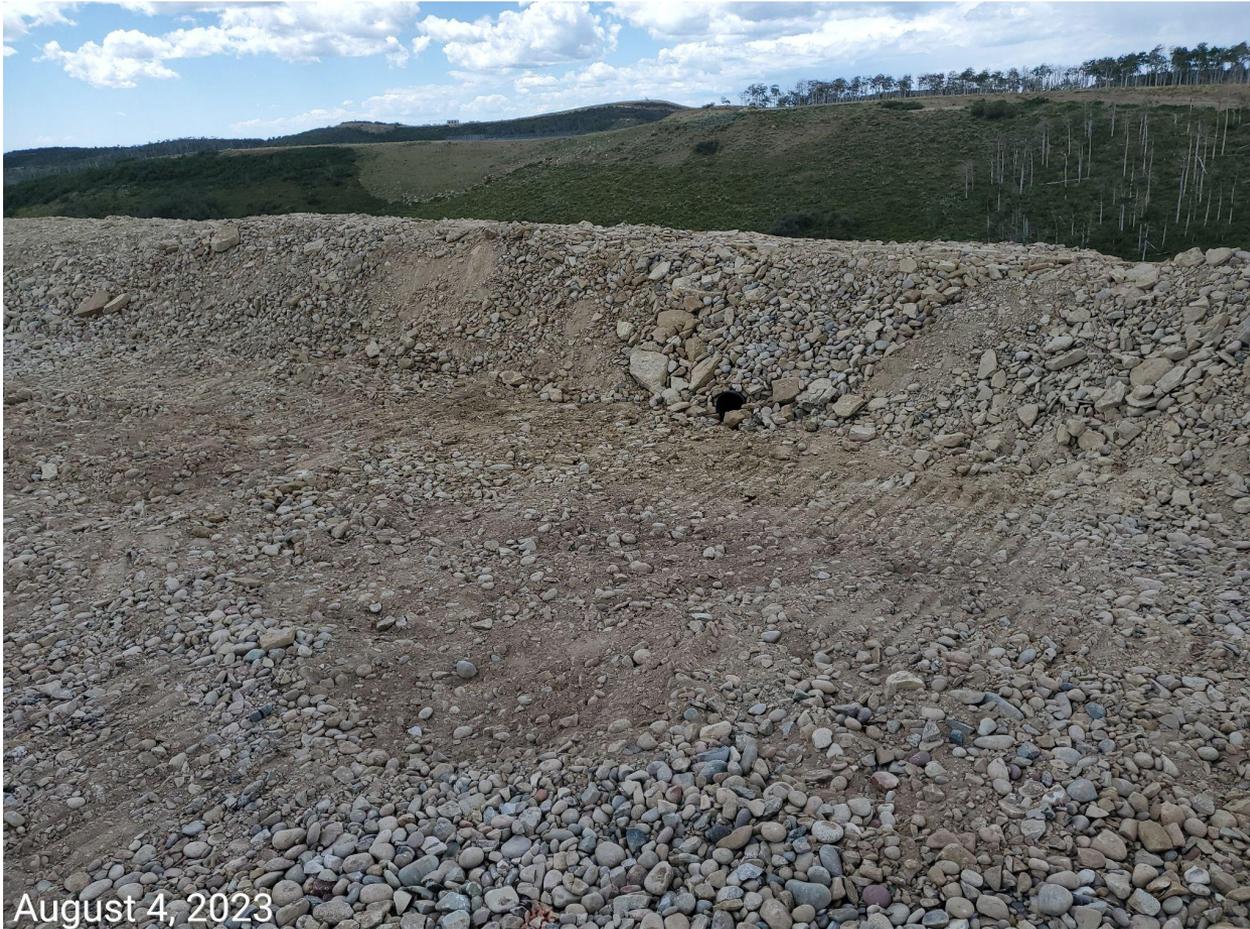
Photo 14: Photo taken from the western working pad surface. Photo example showing 1 of the 2 slope drains installed on Location; per SWMP, Operator was to implement a slope drain in conjunction with a sediment trap on the WPS, connected to a sediment trap at the toe of the slope; outlet has not been constructed per the SWMP.

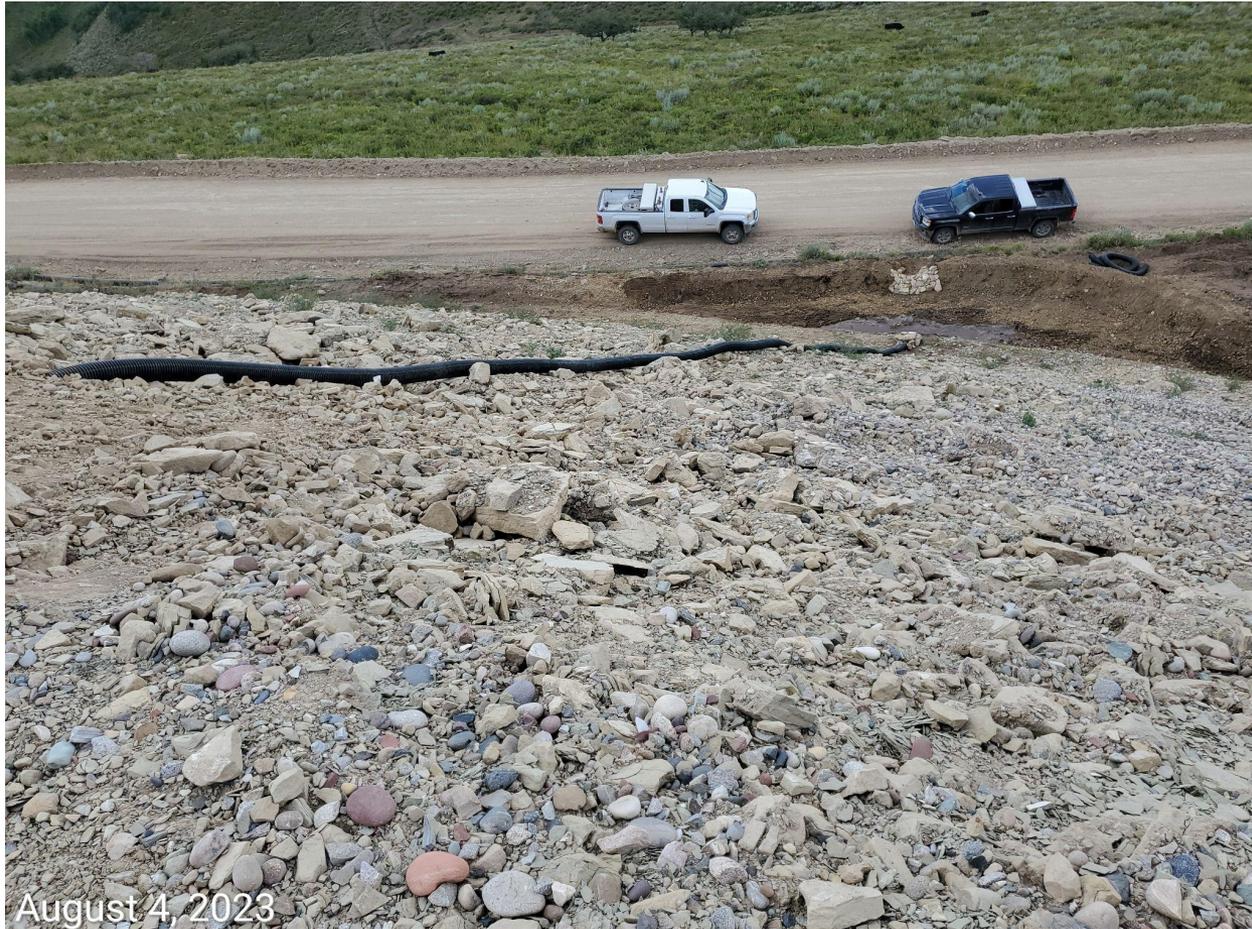
Photo 15: Photo example showing slope drain has not been properly secured per good engineering practices.

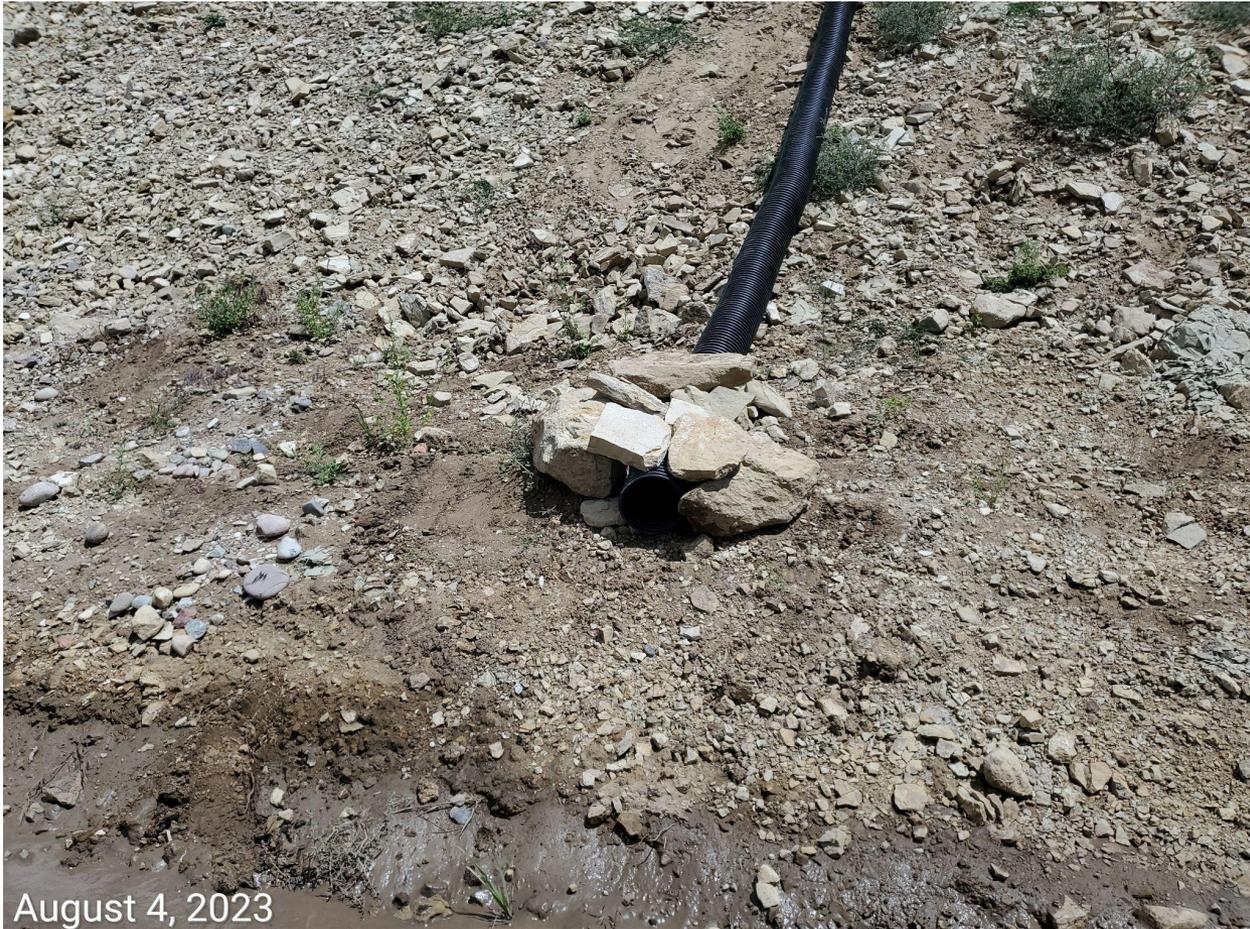
Photo 16: Photo example showing slope drains have not been constructed with a properly engineered and armored outlet.

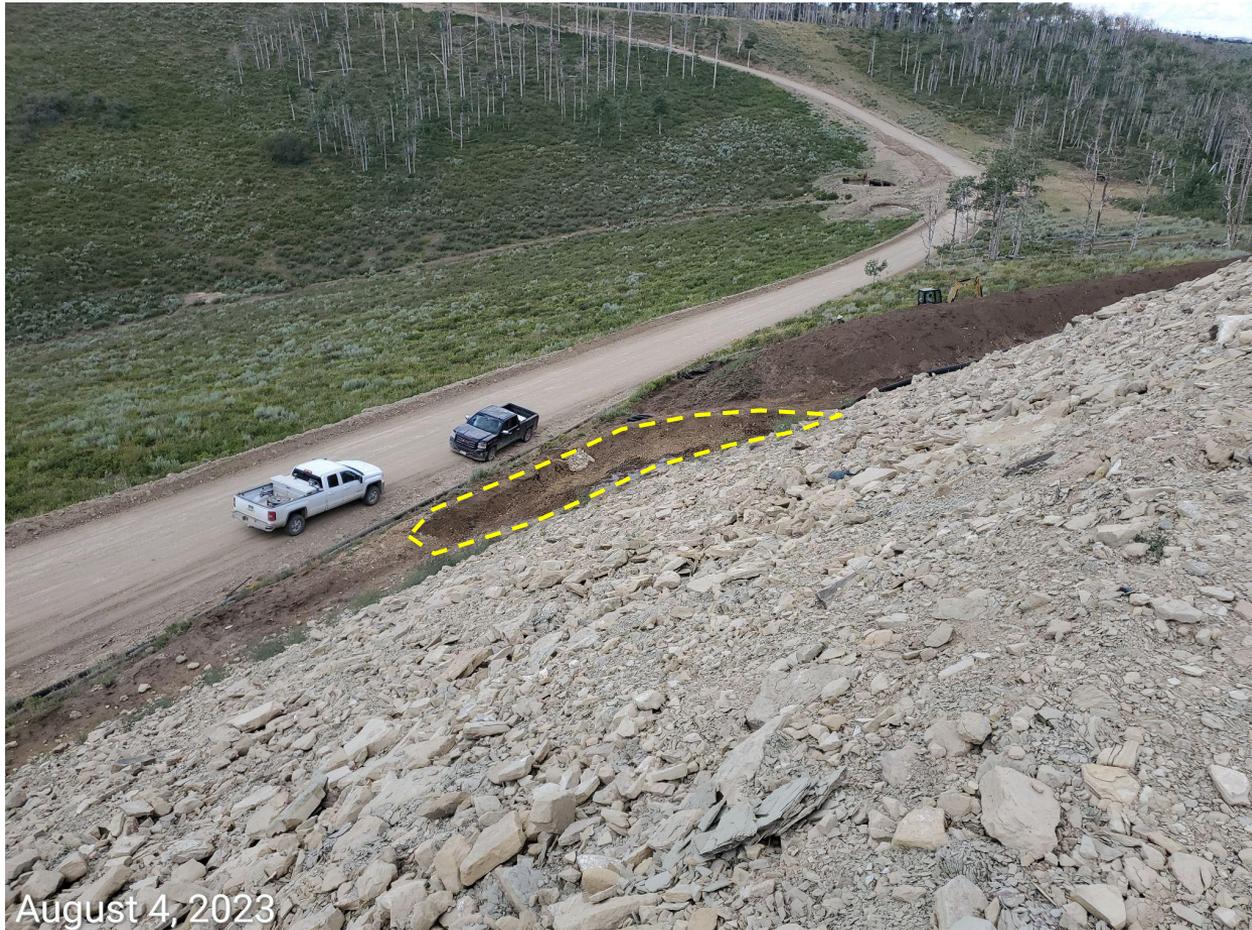
Photo 17: Photo taken from the west end of the Location. Photo shows a single sediment trap constructed on the west end of the location; control measure is inadequate in size to manage runoff from the 3.7 acre working pad.

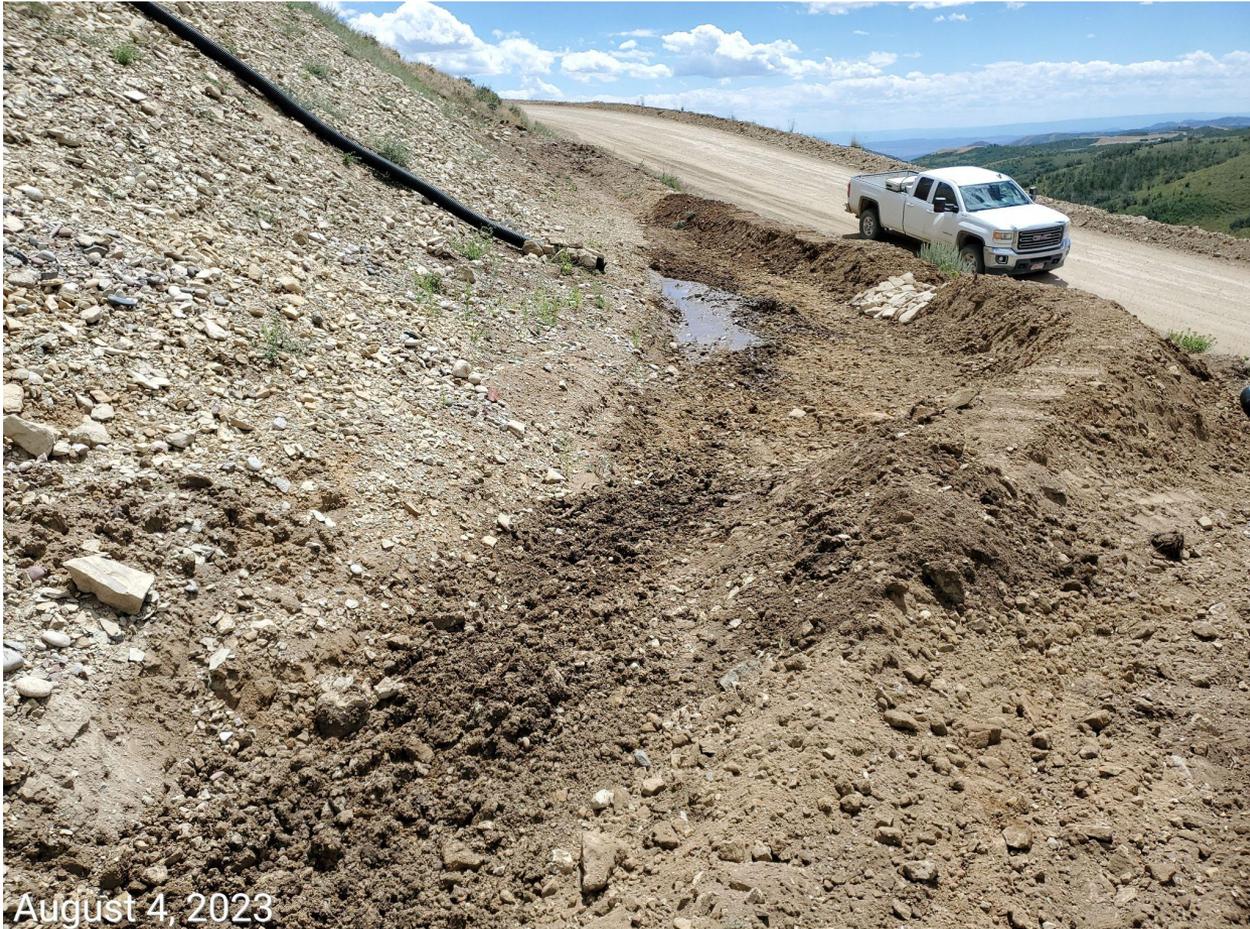
Photo 18: Photo taken from the sediment trap on the west end of the Location. Control measure is inadequate in size to manage runoff from the 3.7 acre working pad.
