Inspection Photos

8/4/2023

Operator: LARAMIE ENERGY LLC #10433

Location Number: 335647

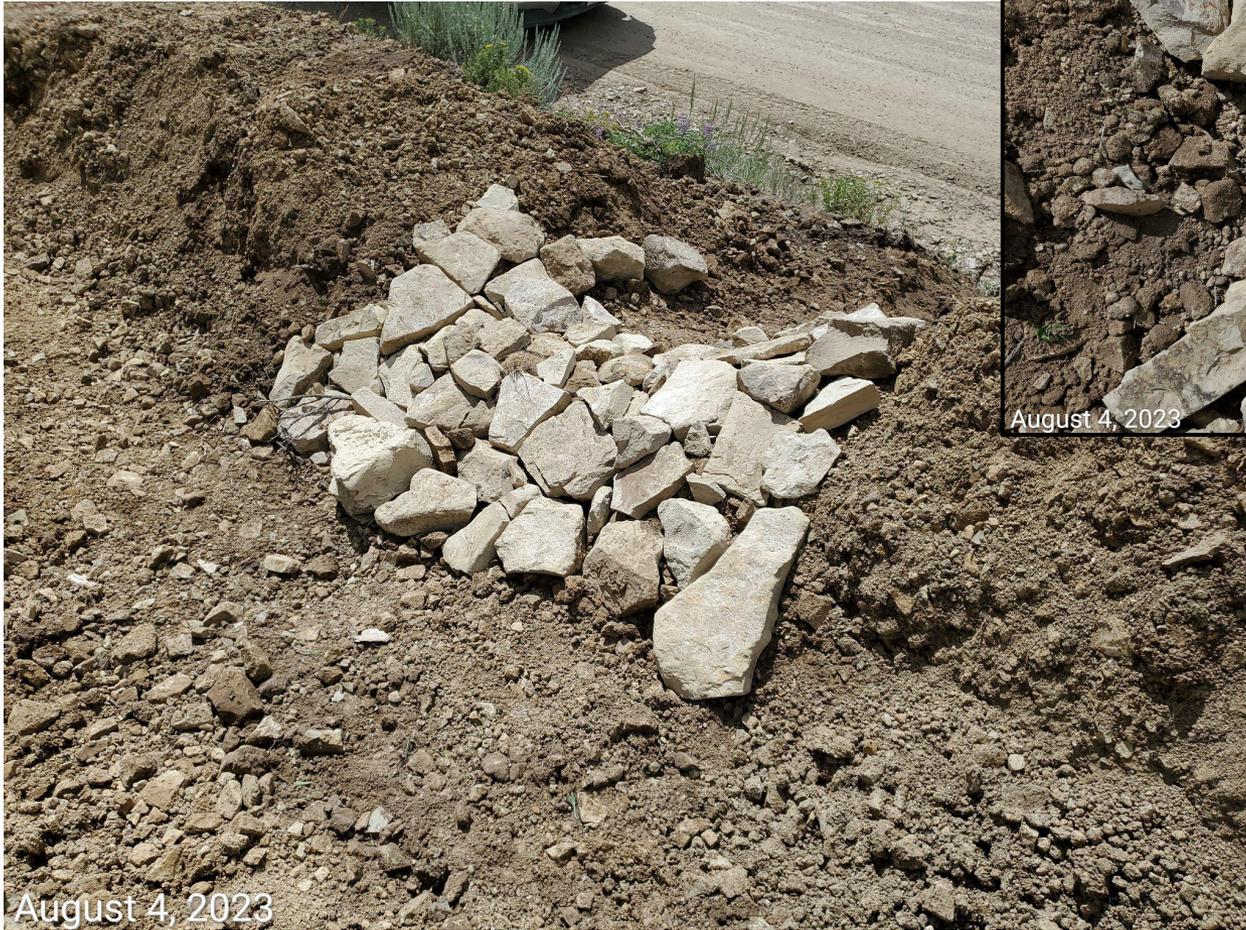
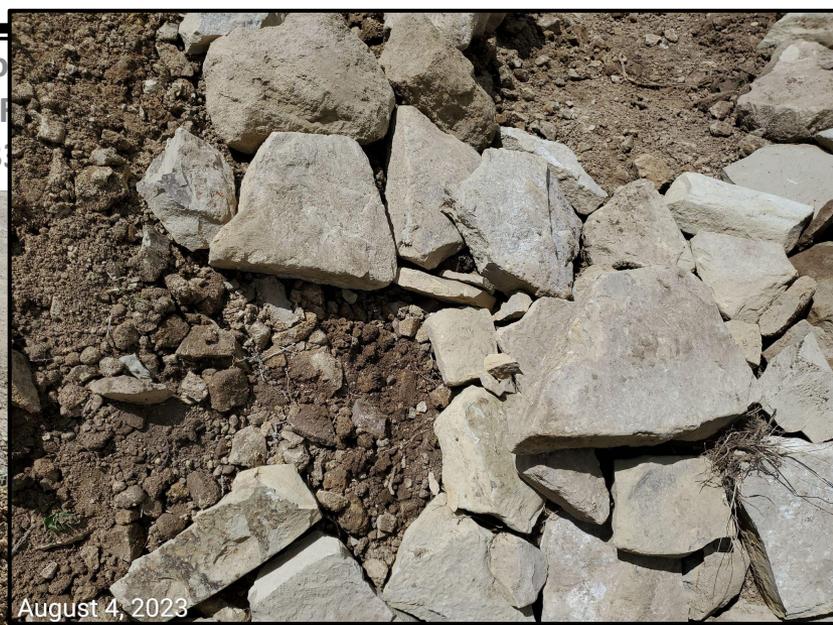
Photo 19: Photo shows outlet/spillway of the sediment trap. Control has been constructed per good engineering practices; outlet only partially armored and not in conjunction with geotextile lining.

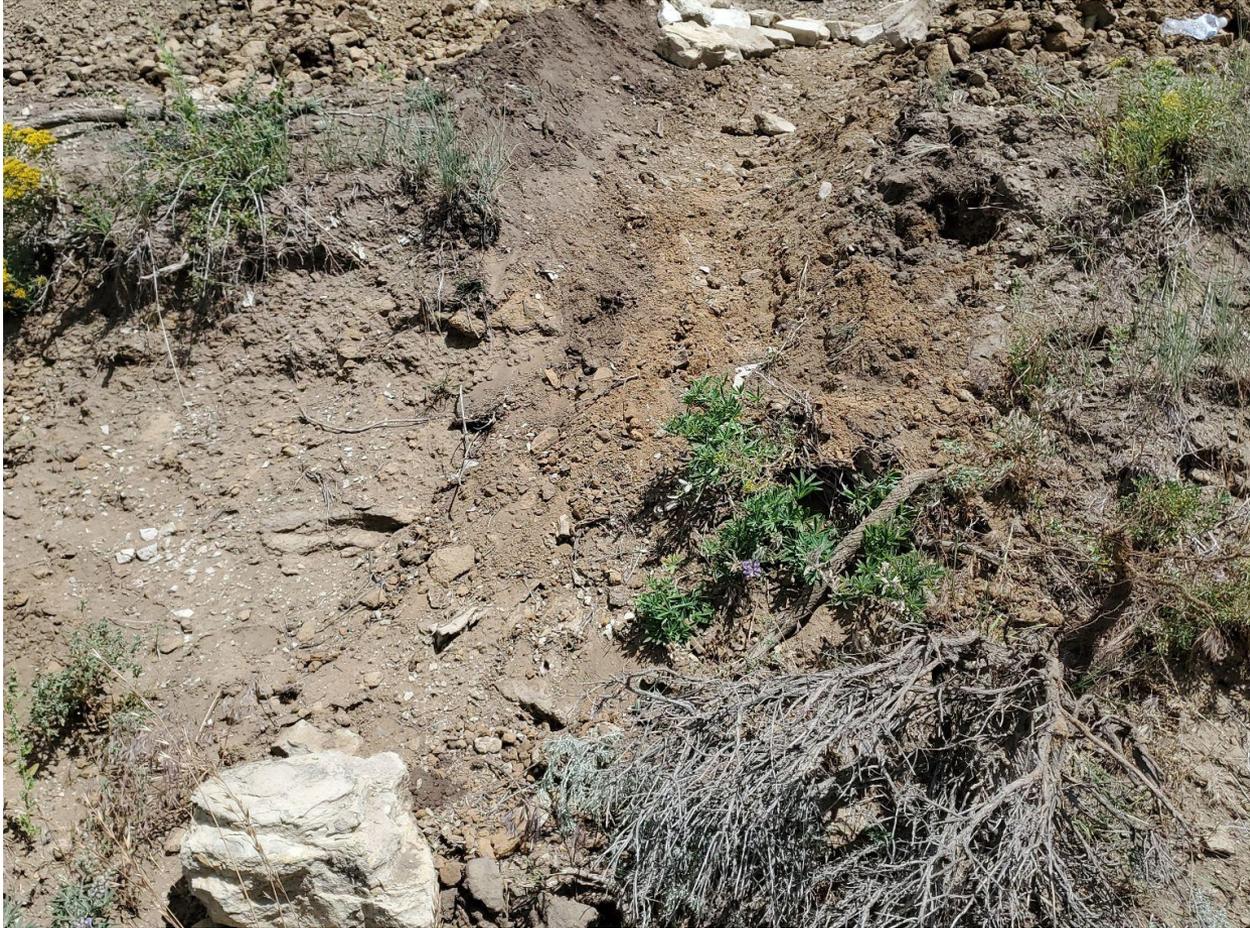
Photo 20: Photo shows outlet/spillway of the sediment trap. Control has been constructed per good engineering practices; outlet only partially armored and not in conjunction with geotextile lining.

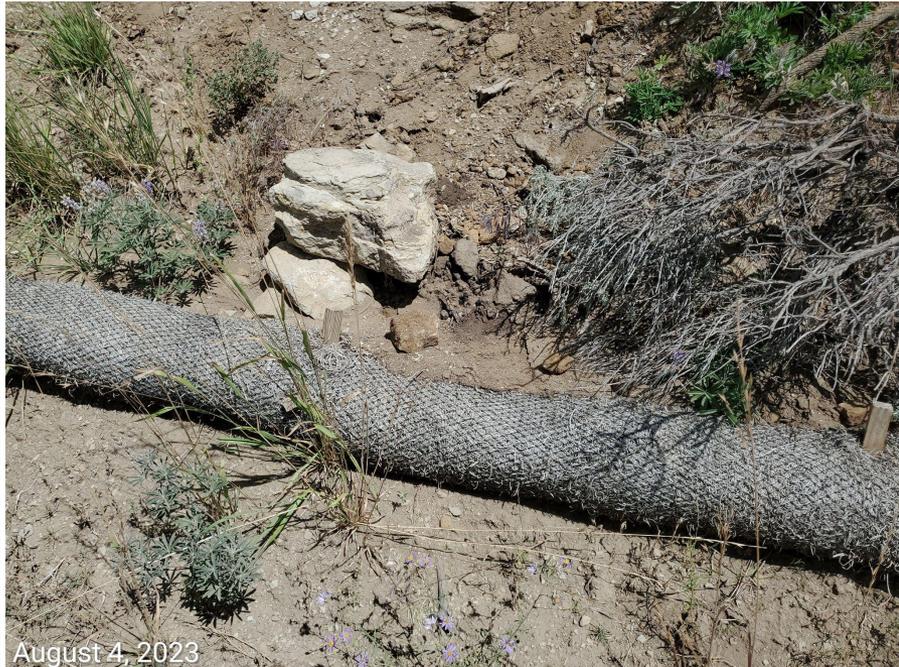
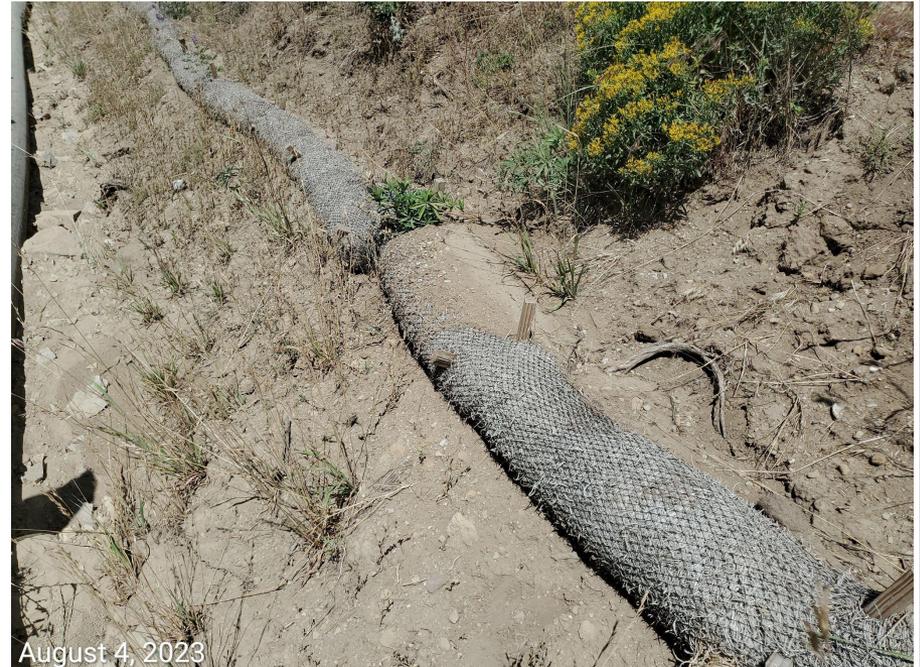
Photo 21: Photo taken from below the outlet of the sediment trap. Photo shows outlet has not been constructed in accordance with good engineering practices. Erosion degradation and sediment transport apparent.
