Inspection Photos

Location Name: TEP ROCKY MOUNTAIN LLC, FEDERAL-67S96W/3NWNW

Location ID: 334818

Date: 8/8/2023

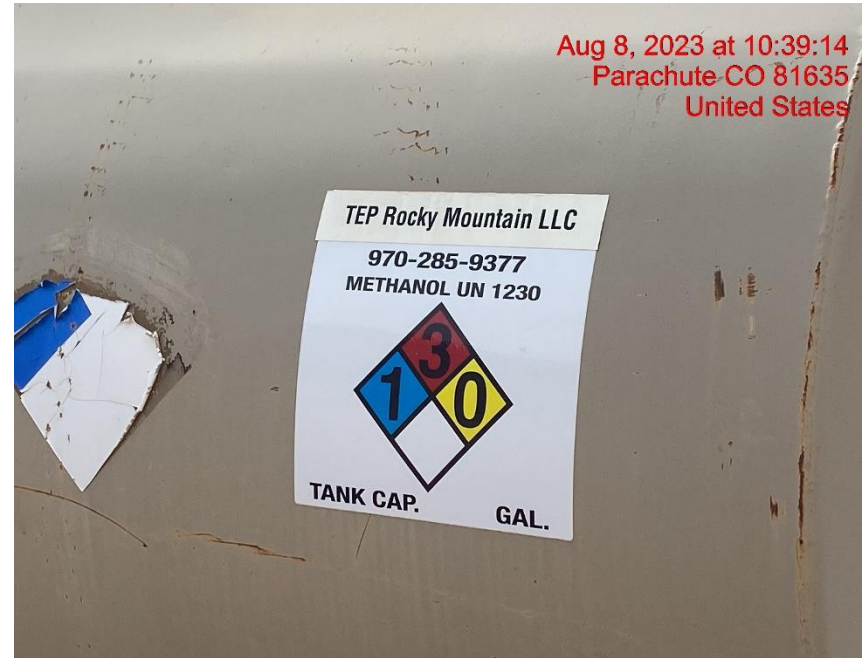
Methanol Tank Label Does Not State Tank Capacity – Photo #05665

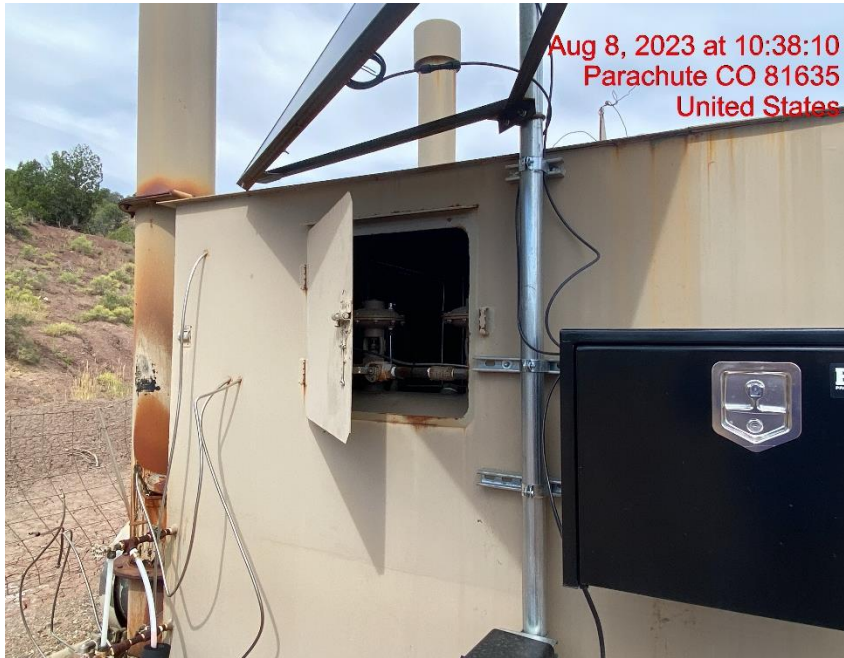
Separator Hatch Unsecured – Photo #05663

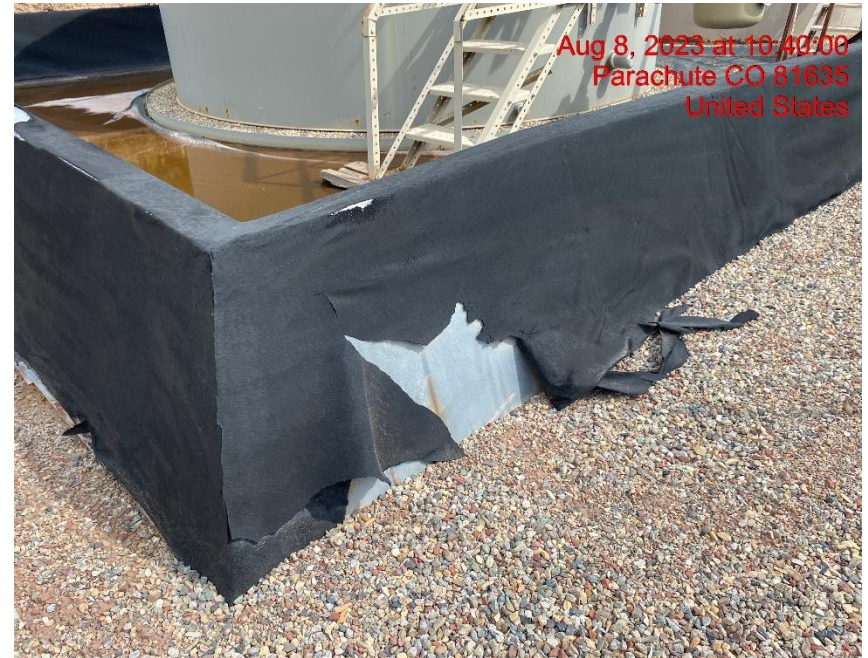
Damaged Berm Liner – Photo #05667

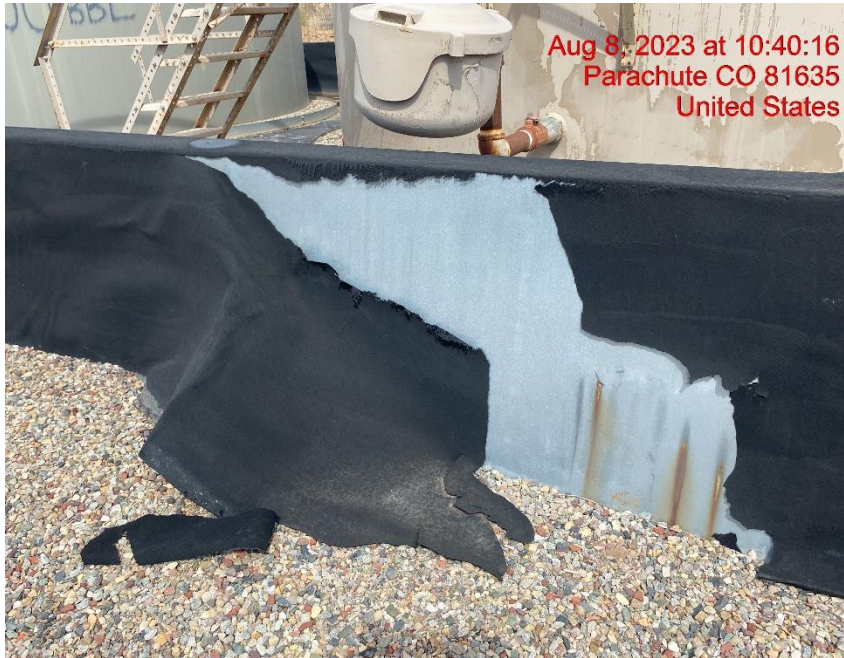
Damaged Berm Liner – Photo #05668

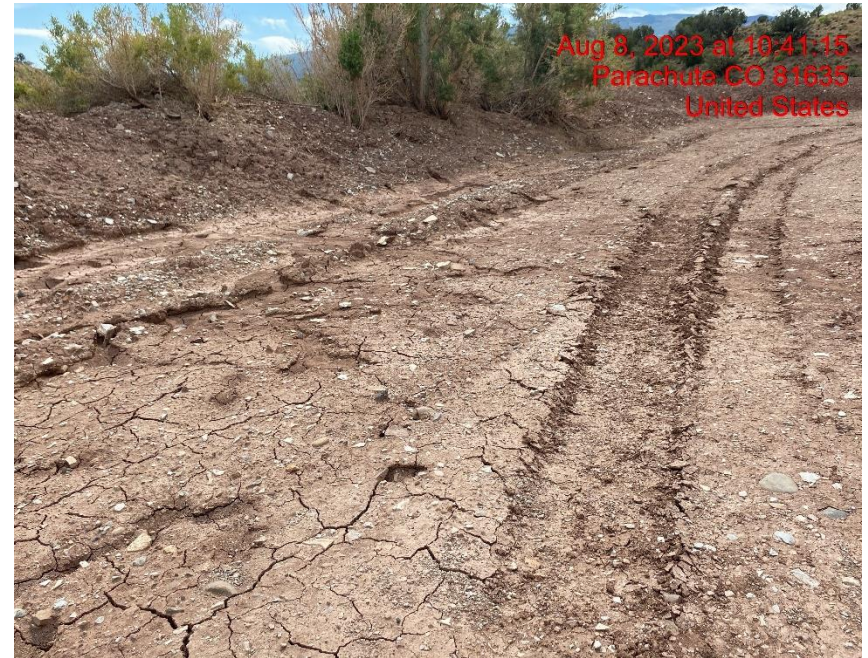
Location Lacks Stabilization – Photo #05670

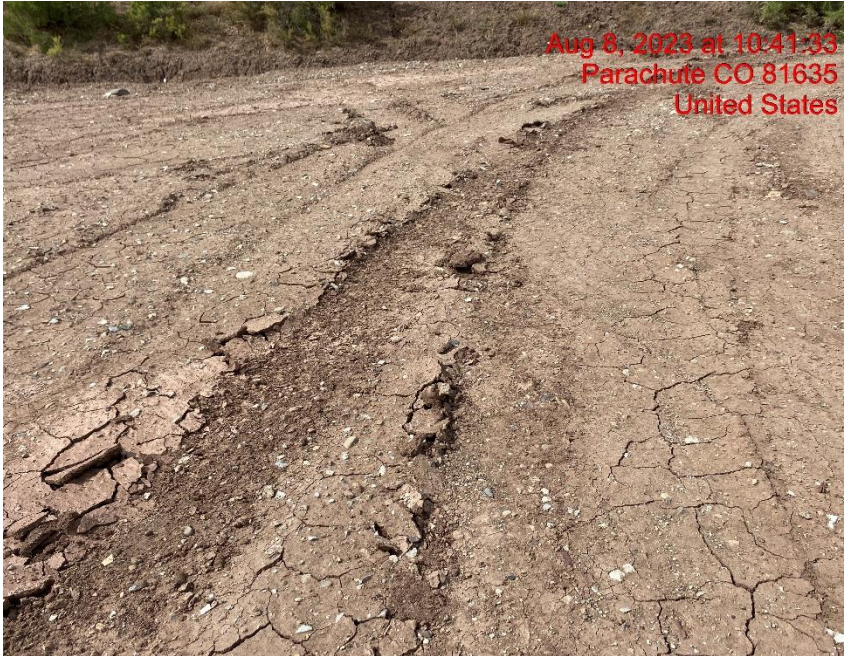
Location Lacks Stabilization – Photo #05671

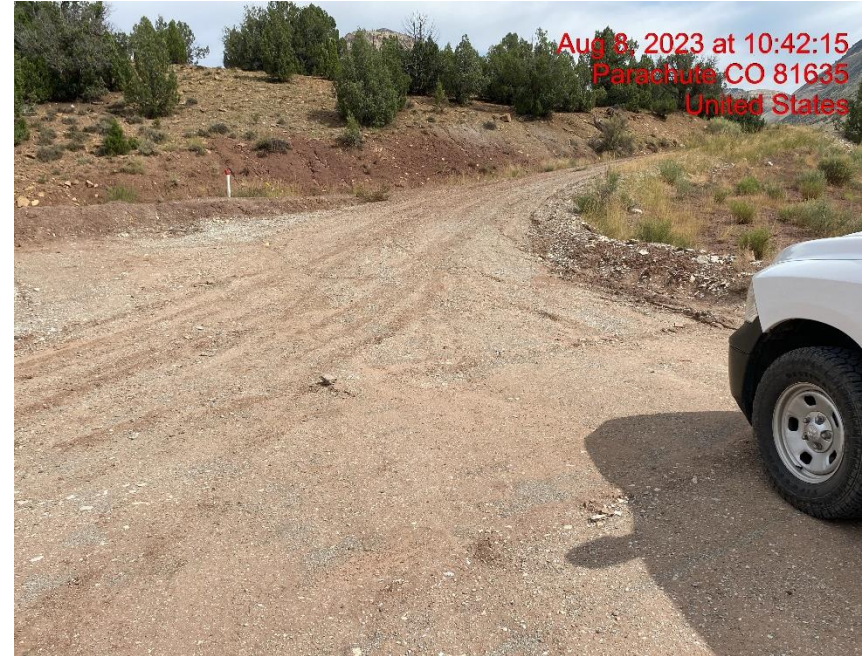
**Insufficient Vehicle Tracking BMPs at Location Entrance/Exit
– Photo #05672**

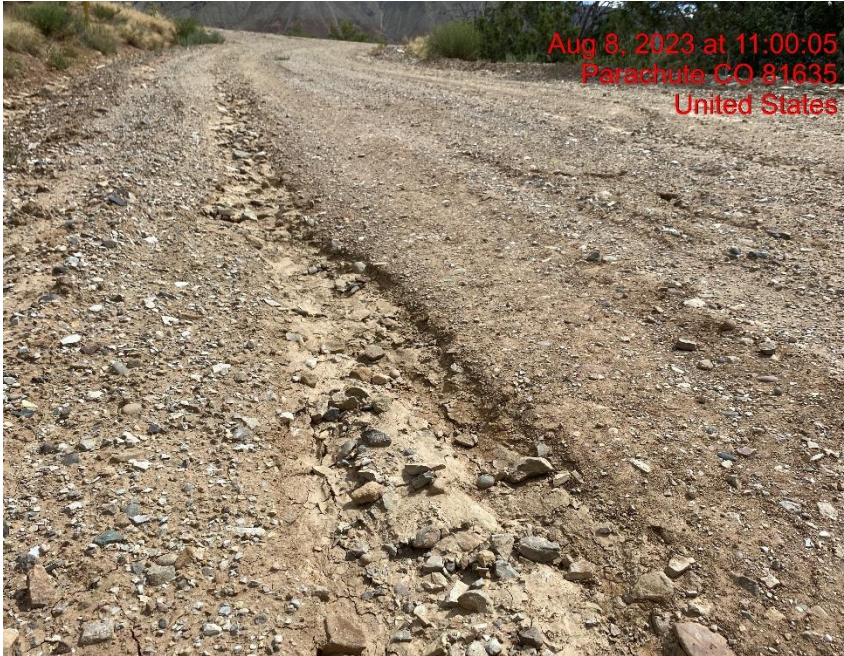
Rill Erosion Cutting Through Lease Road – Photo #05674

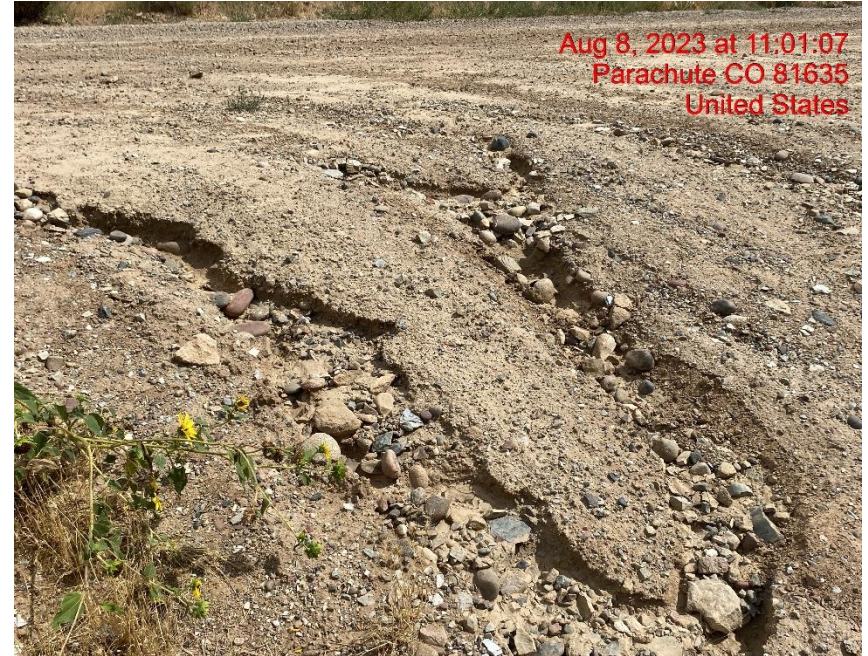
Rill Erosion Cutting Through Lease Road – Photo #05676

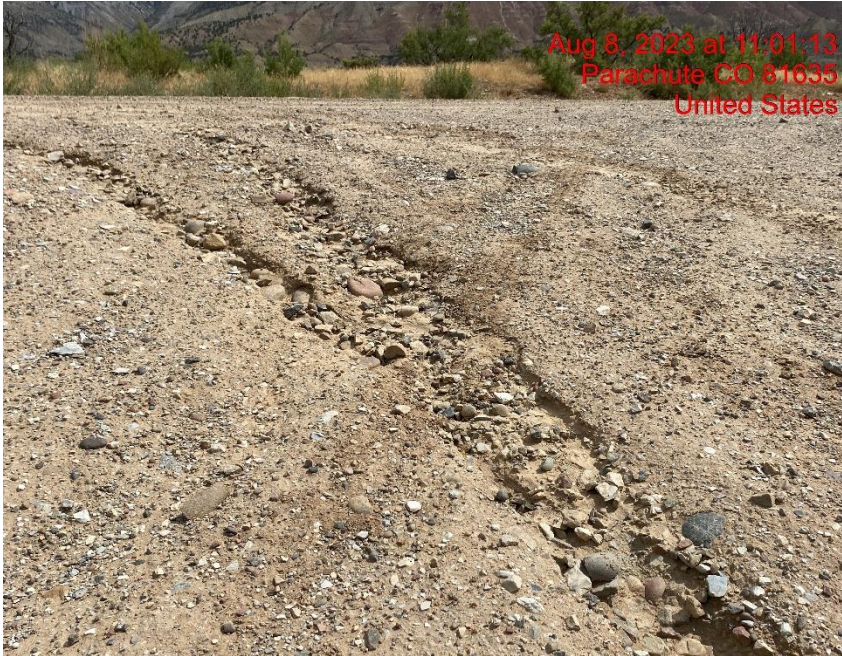
Rill Erosion Cutting Through Lease Road – Photo #05677
