Inspection Photos

Location Name: TEP ROCKY MOUNTAIN LLC, FEDERAL-67S96W/3SENW

Location ID: 334882

Date: 8/8/2023

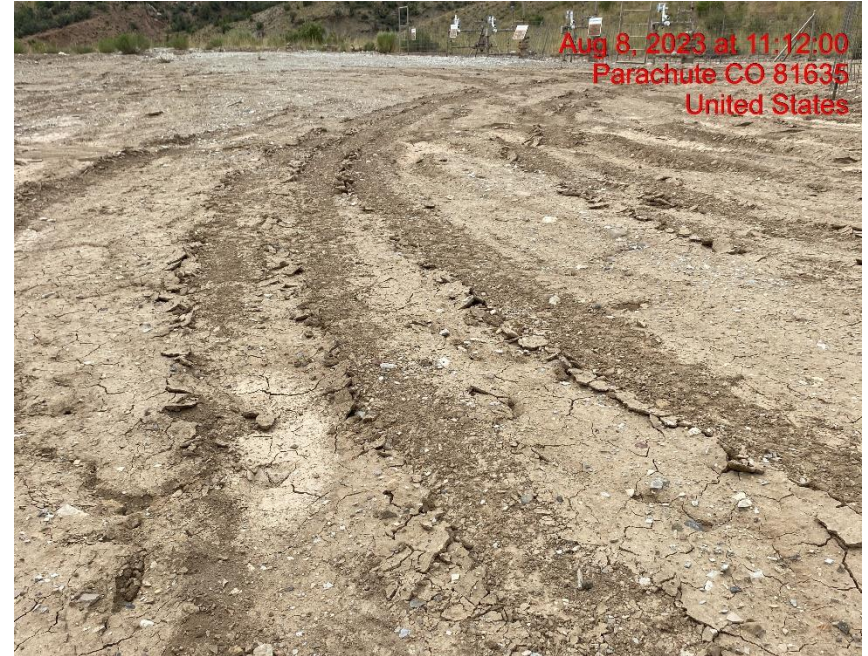
Location Lacks Stabilization – Photo #05689

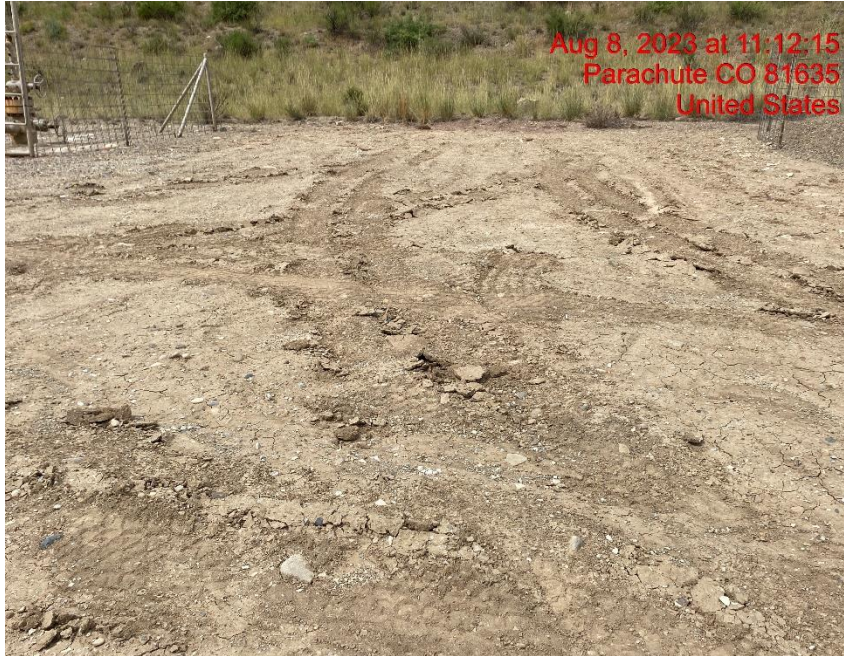
Location Lacks Stabilization – Photo #05690

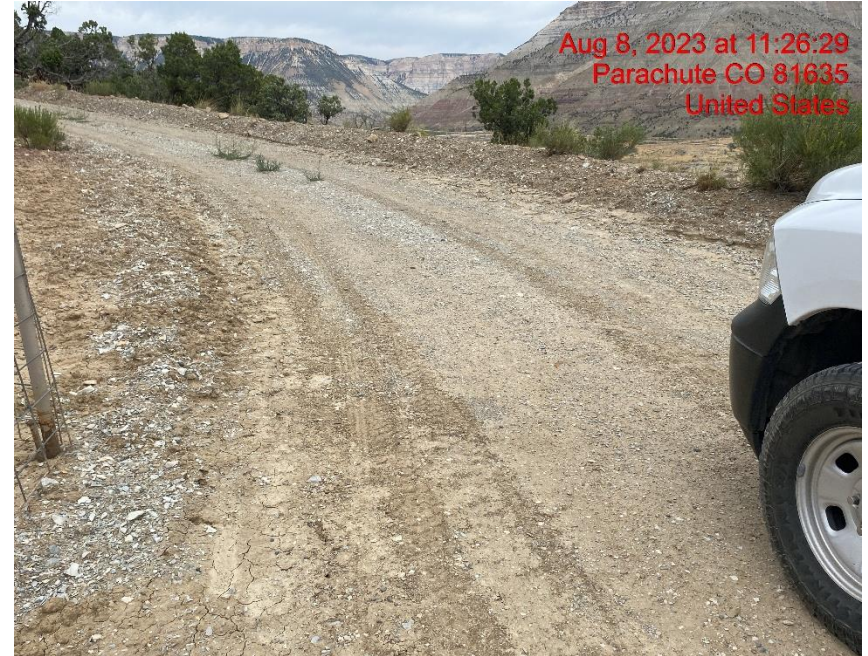
**Insufficient Vehicle Tracking BMPs at Location Entrance/Exit
– Photo #05691**

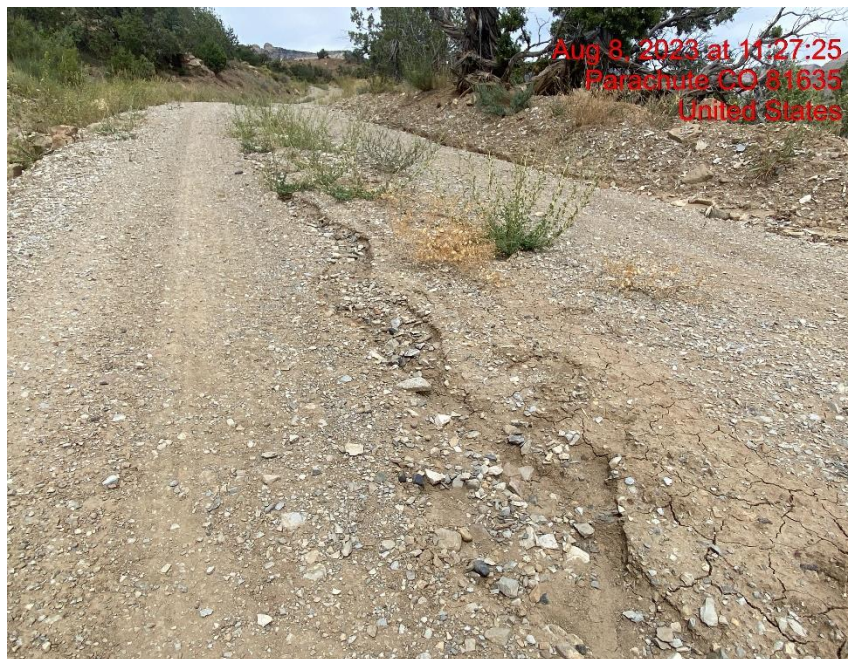
Rill Erosion Cutting Through Lease Road – Photo #05693

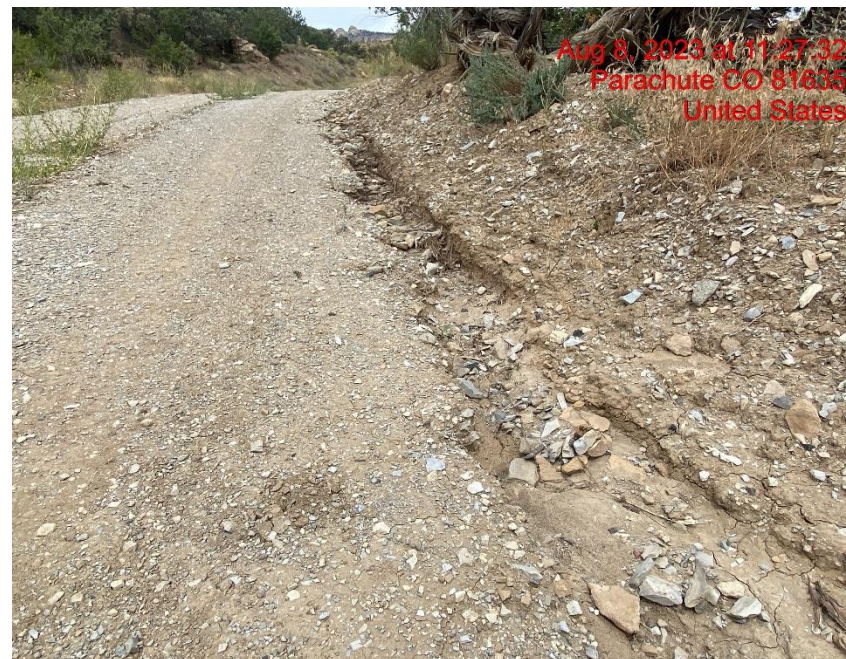
Rill Erosion Cutting Through Lease Road – Photo #05694

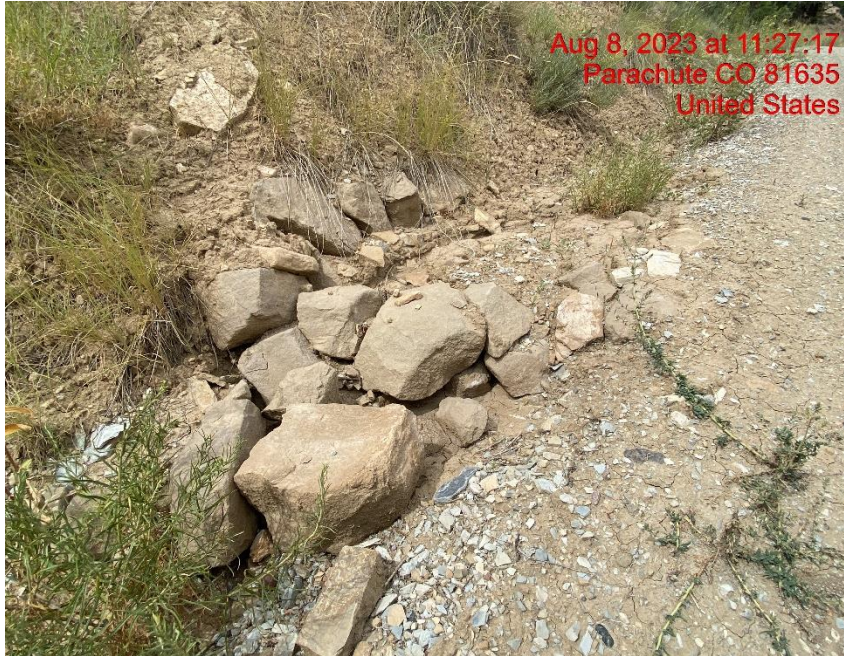
Check Dam Needs Maintenance – Photo #05692

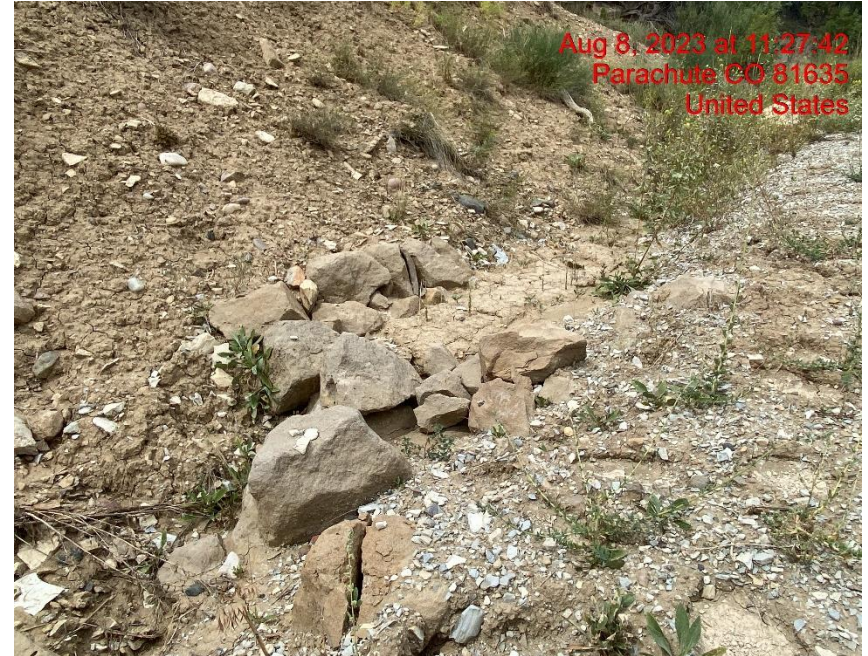
Check Dam Needs Maintenance – Photo #05695
