Interim Reclamation and Stormwater Inspection

August 3 and 7, 2023

Operator: UPLAND EXPLORATION LLC- #10701

Location ID: 456651

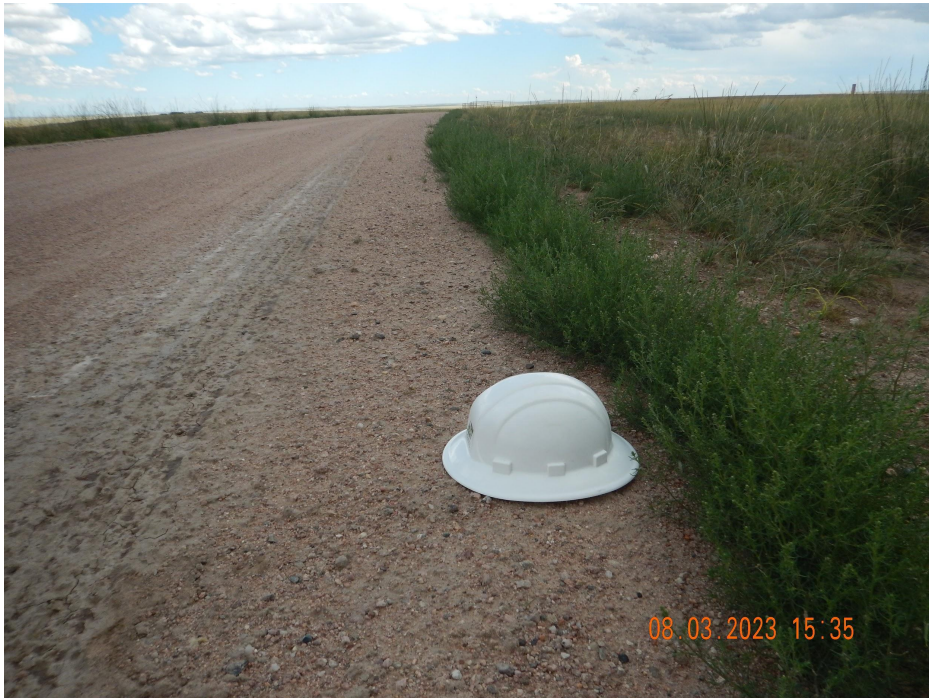
Photo 1. Photo taken from a portion of the access road, illustrating Russian thistle growth.

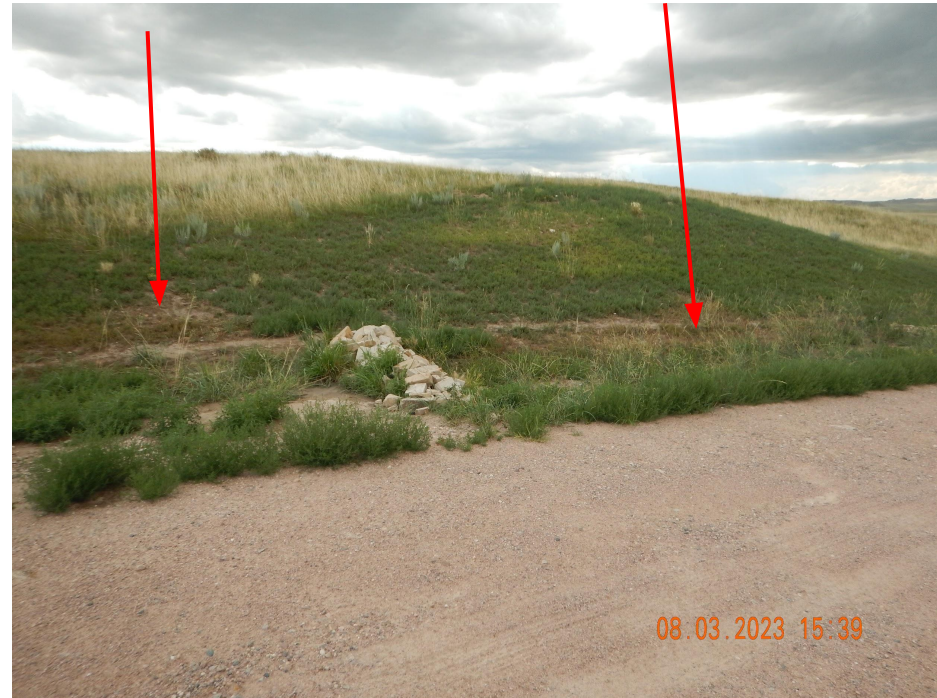
Photo 2. Photo taken from a portion of the access road, illustrating Russian thistle growth along the cut slope.

Red arrows point to areas that appear to be sprayed with herbicide; however, the rest of the cut slope does not appear to be treated.

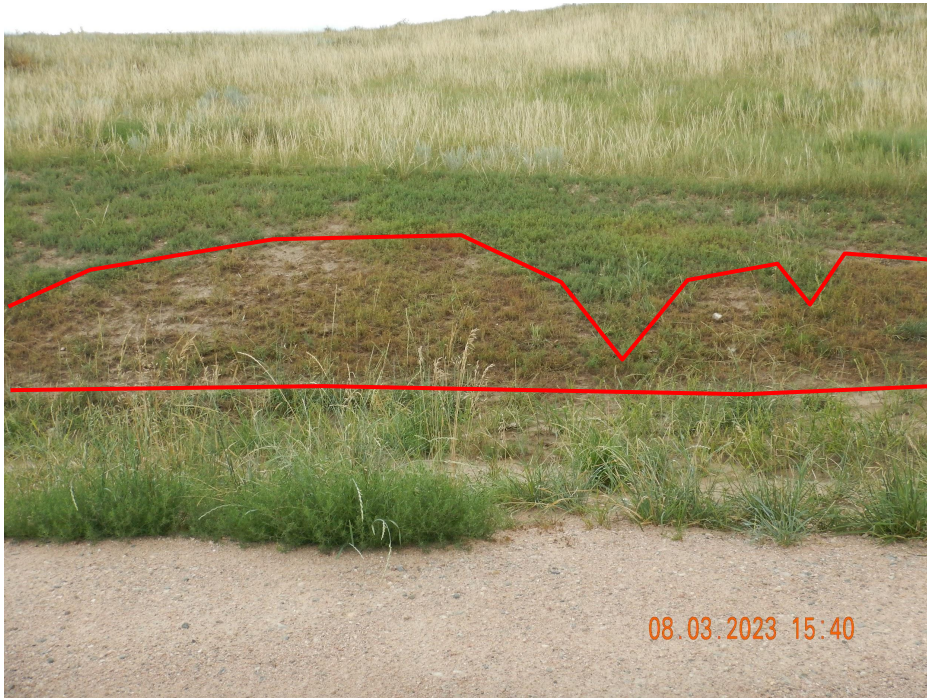
Photo 3. Photo taken from a portion of the access road, illustrating continued inconsistent herbicide applications.

Red polygon illustrates an area that appears to be sprayed with herbicide; however, above the red polygon is Russian thistle growth. Reference vegetation is in the background.

Note- topsoil is stored along the windrowed ditch area.

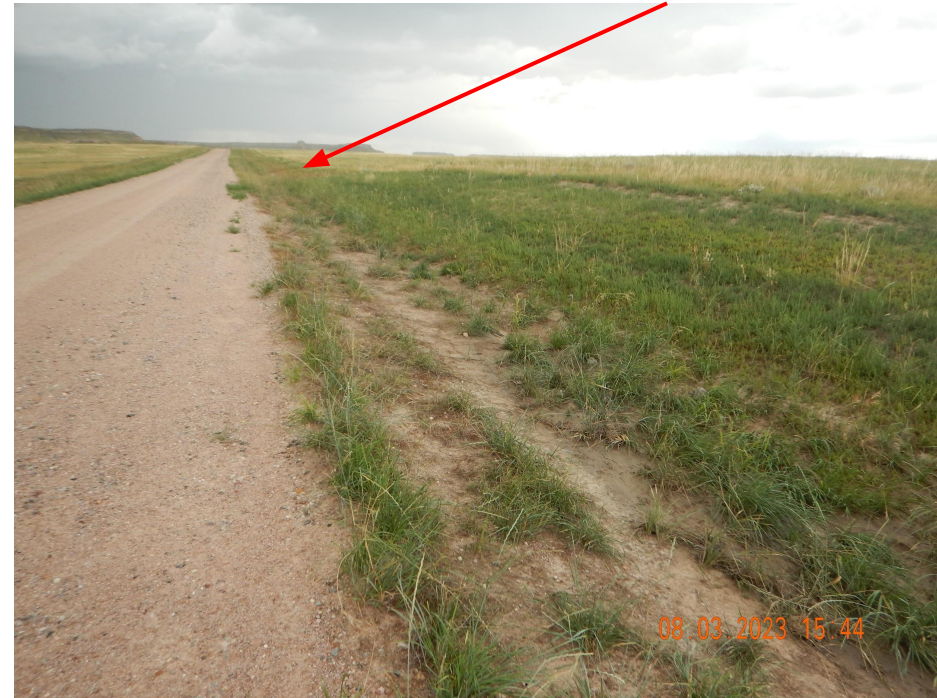
Photo 4. Photo taken from another portion of the access road, illustrating Russian thistle growth along the cut slope.

Red arrows point to areas that appear to be sprayed with herbicide; however, most of the entire area in the foreground (dark green vegetation) is that of Russian thistle. Reference vegetation is in the background.

Note- topsoil is stored along the windrowed ditch area.

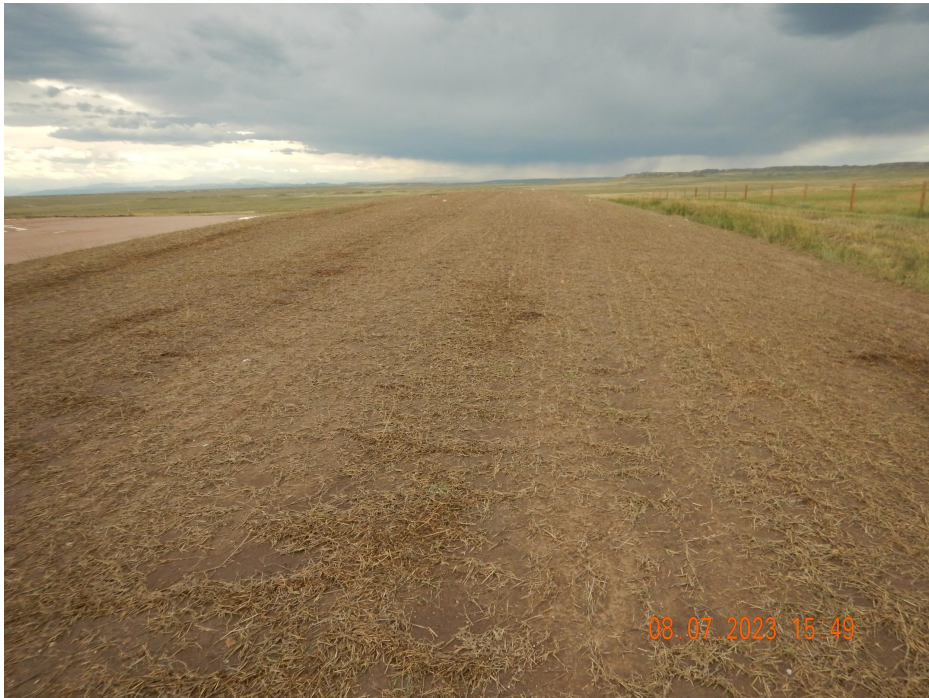
Photo 5. Photo taken from the topsoil stockpile, facing West. Photo illustrates the Operator has attempted to reseed the stockpile. There appeared to be some desirable germination but not comparable to the South Little Lady stockpile.

Staff will make a future evaluation on whether the reseeded attempt was successful.

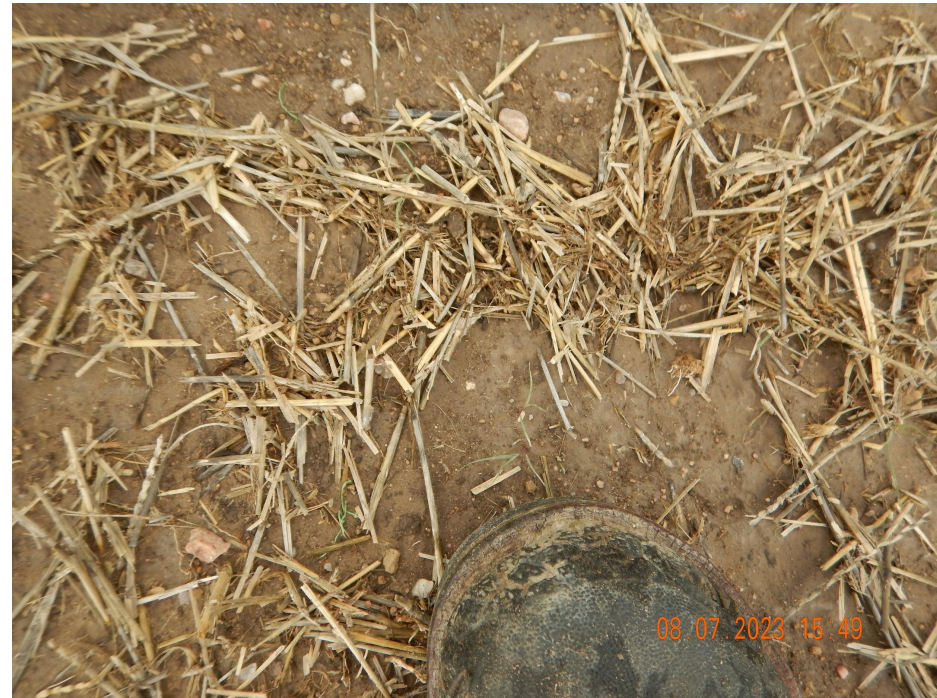
Photo 6. Close up photo illustrating some of the desirable germination.

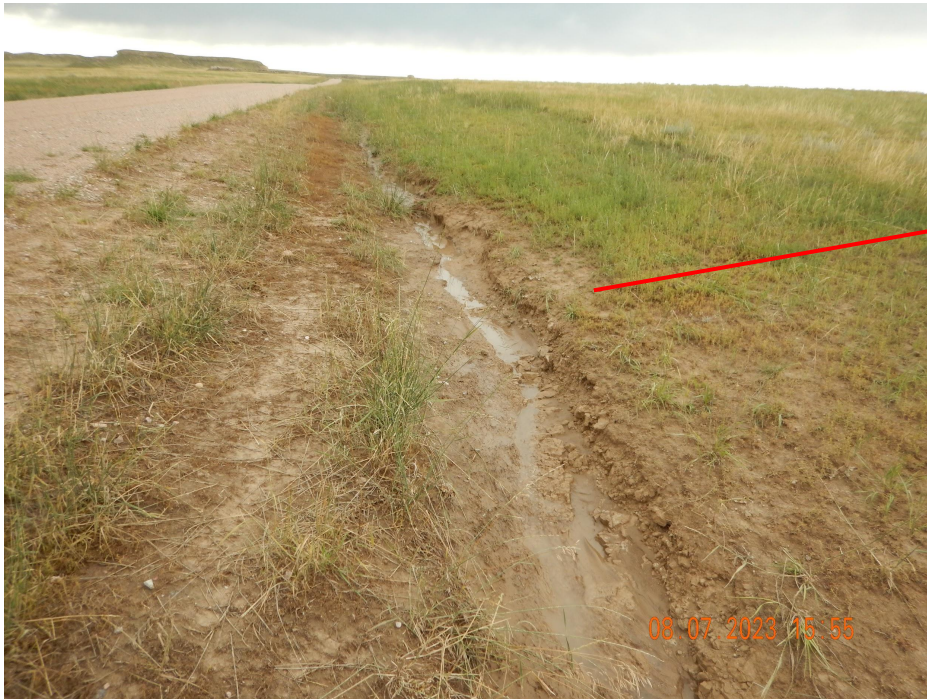
Photo 7. Photo taken from a portion of the access road, illustrating weed management and stormwater erosion. Weed growth is observed beyond the red line; however, weeds appear to be sprayed with herbicide in the foreground.

Rill erosion is turning into gully erosion along a section of the ditch which lacks any type of stormwater BMP.

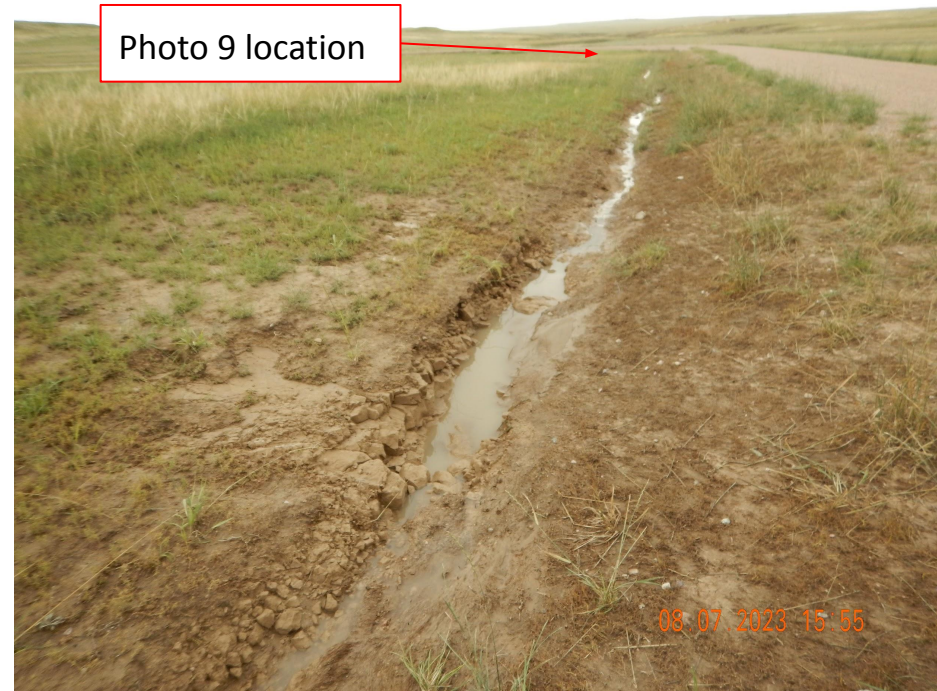
Photo 8. Photo taken from the previous photo location, facing the opposite direction. Again, photo illustrates weed management issues and stormwater erosion issues.

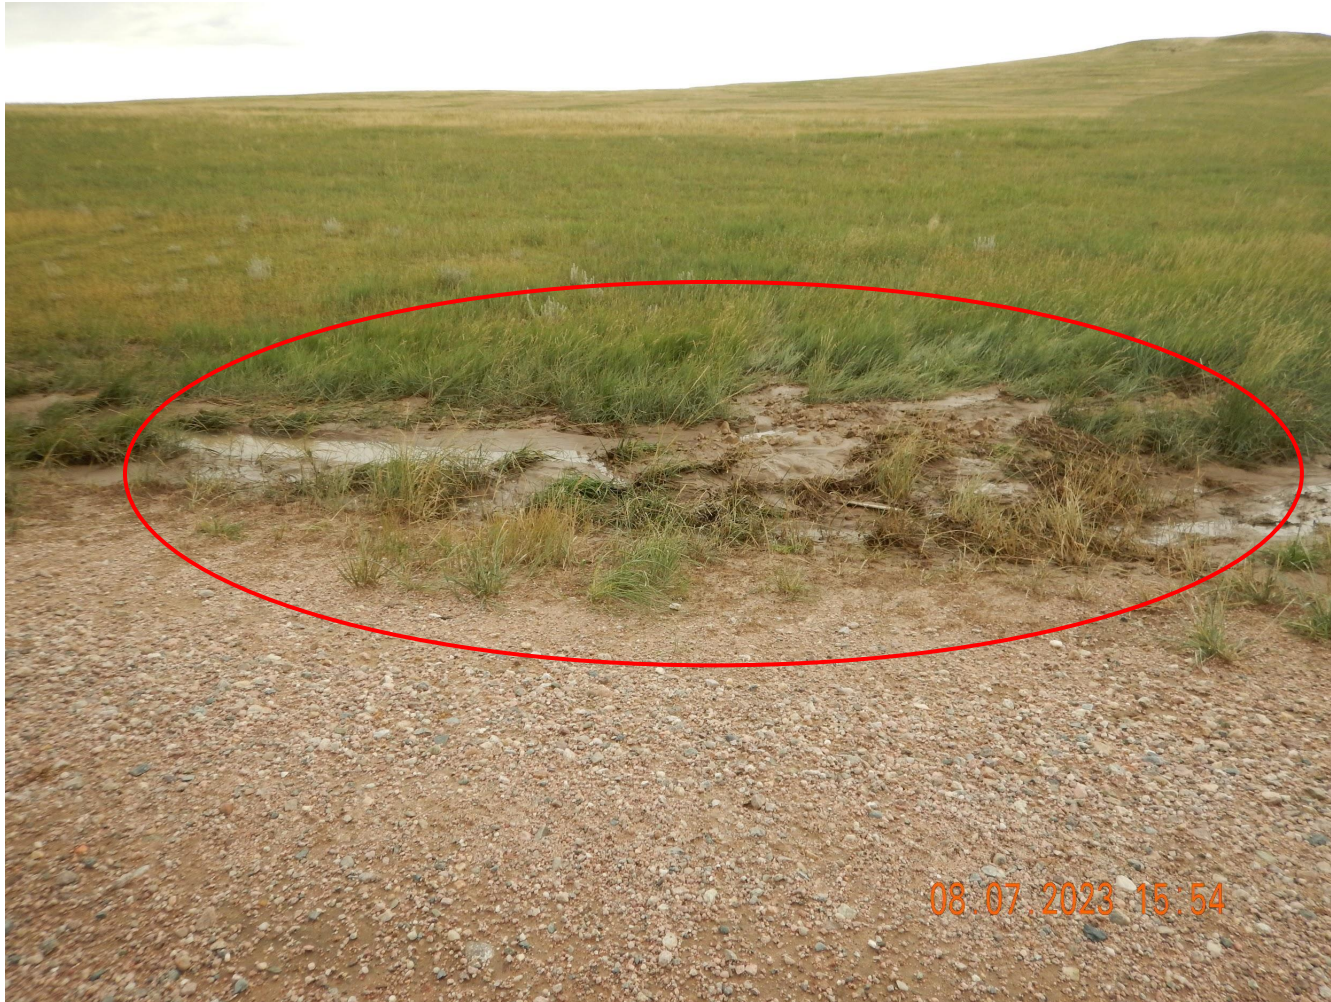
Photo 9. Photo illustrates sediment accumulation at the bottom of the slope from unstabilized ditch areas along the access road previously shown in Photos 7-8.

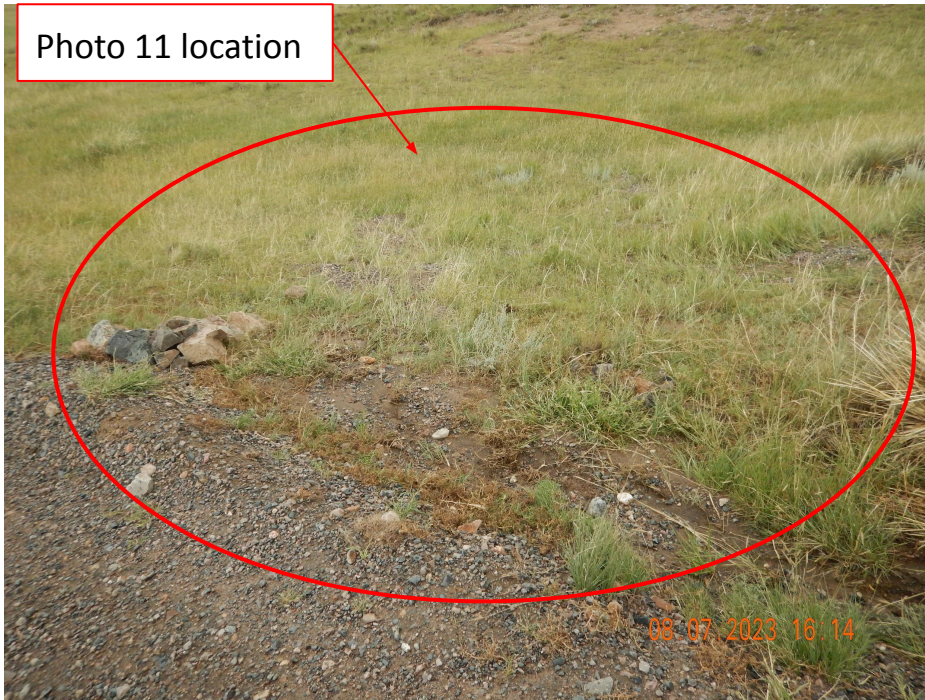
Photo 10. Photo taken from a portion of the access road, illustrating stormwater management issues. The check dam BMP is not in proper functioning condition and has not been installed per good engineering practices. Sediment and gravel are eroding off the lease road. Insufficient BMPs are leading to increased erosion and lease road damage.

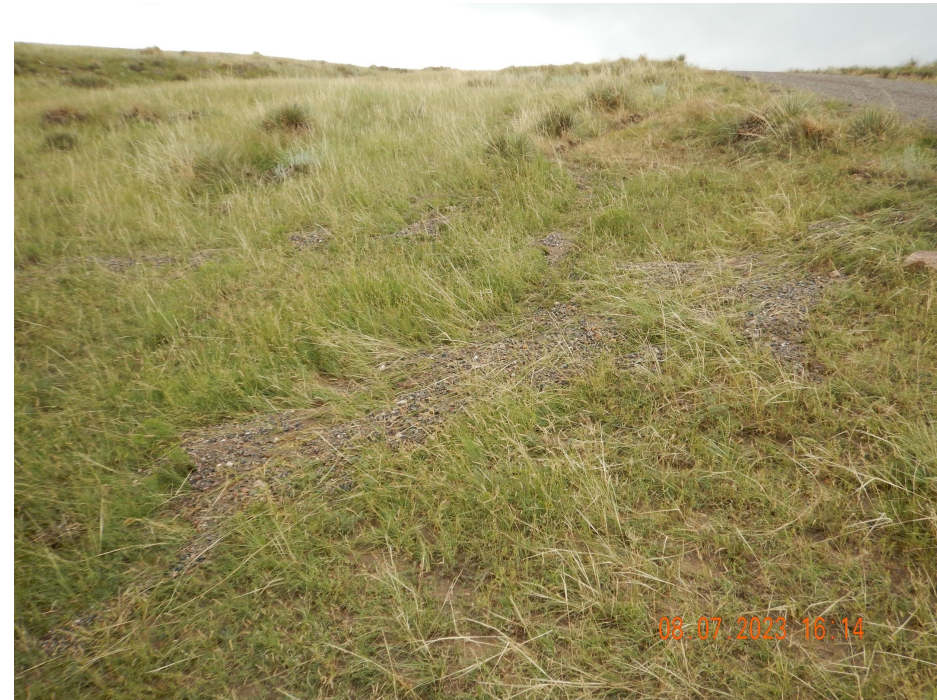
Photo 11. Photo illustrating sediment and gravel eroding off the lease road.

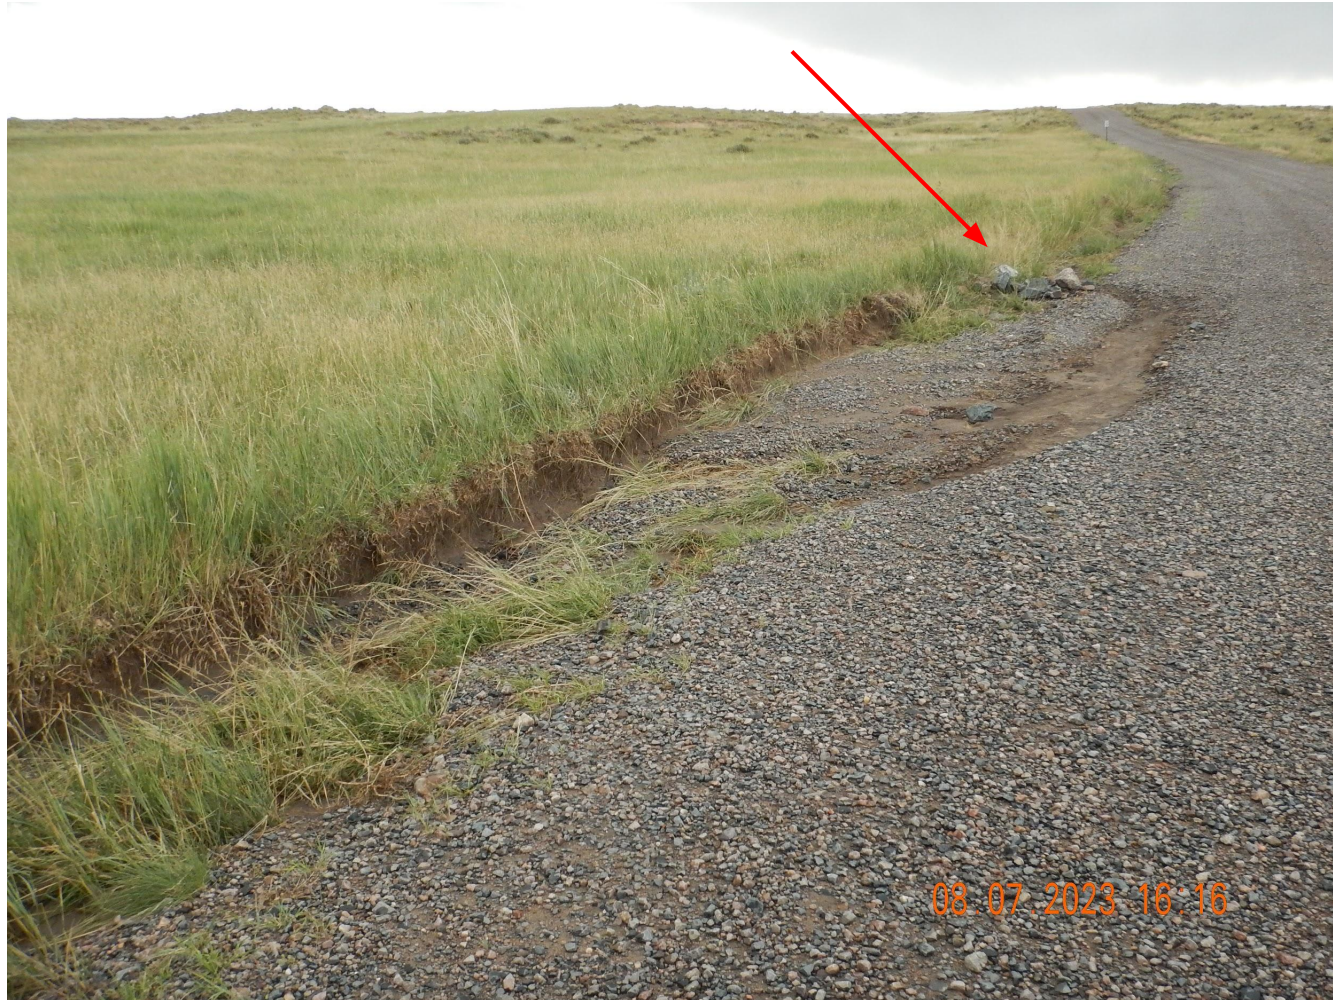
Photo 12. Photo illustrates another check dam BMP which is not in proper functioning condition and an example of increased erosion undercutting the bank of the lease road.

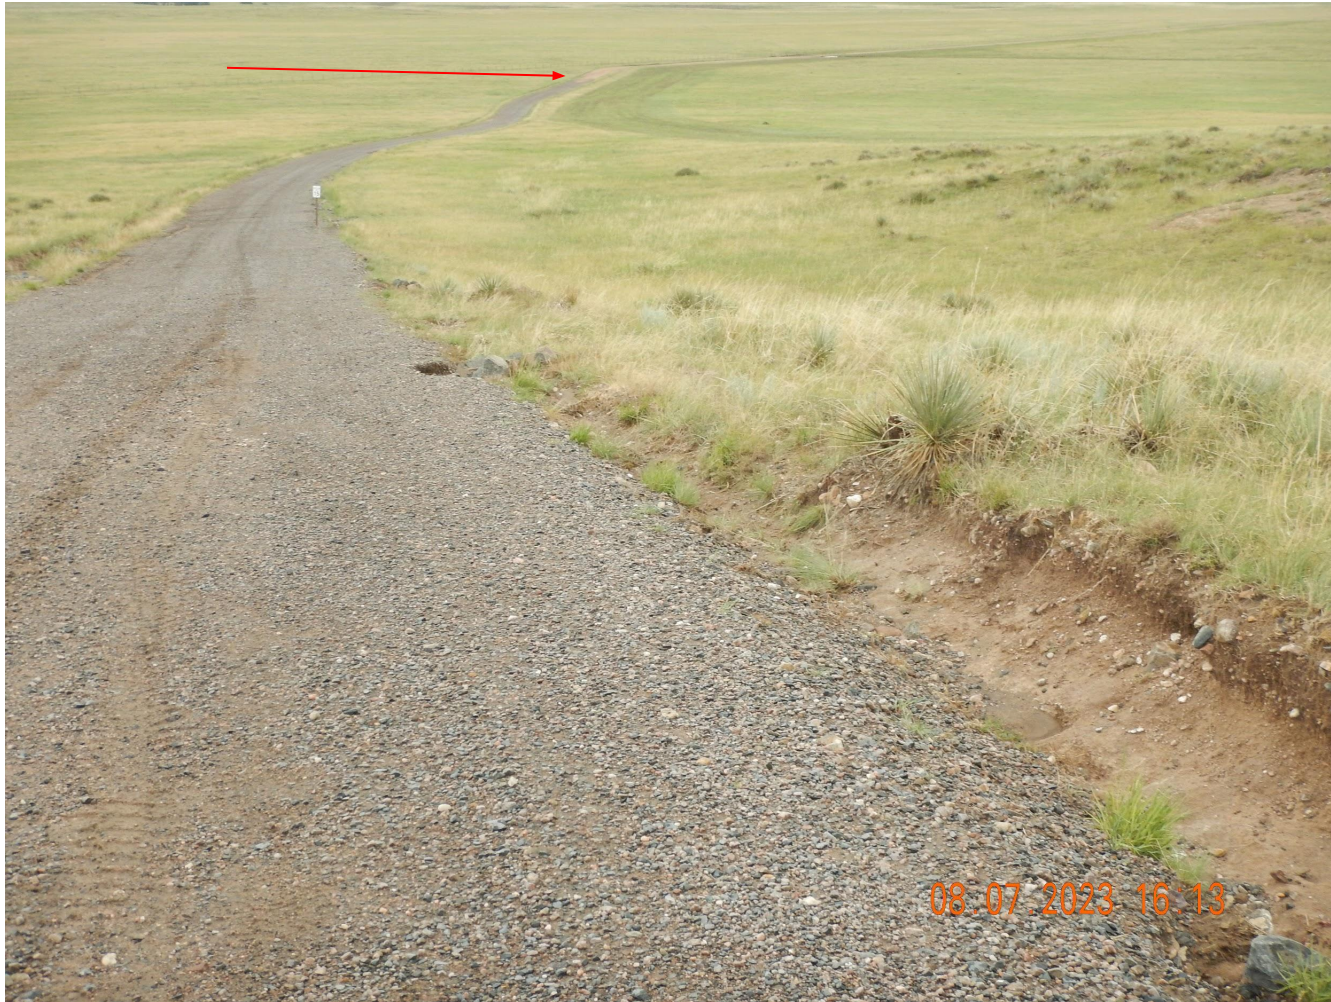
Photo 13. Photo illustrates the Operator imported new road base (lighter color) but stopped around the 2 mile marker. When Staff traveled on this road back on July 14th, dust was minimized along the new import but dust increased once on the darker road base sections. Operator has not completed dust mitigation work.

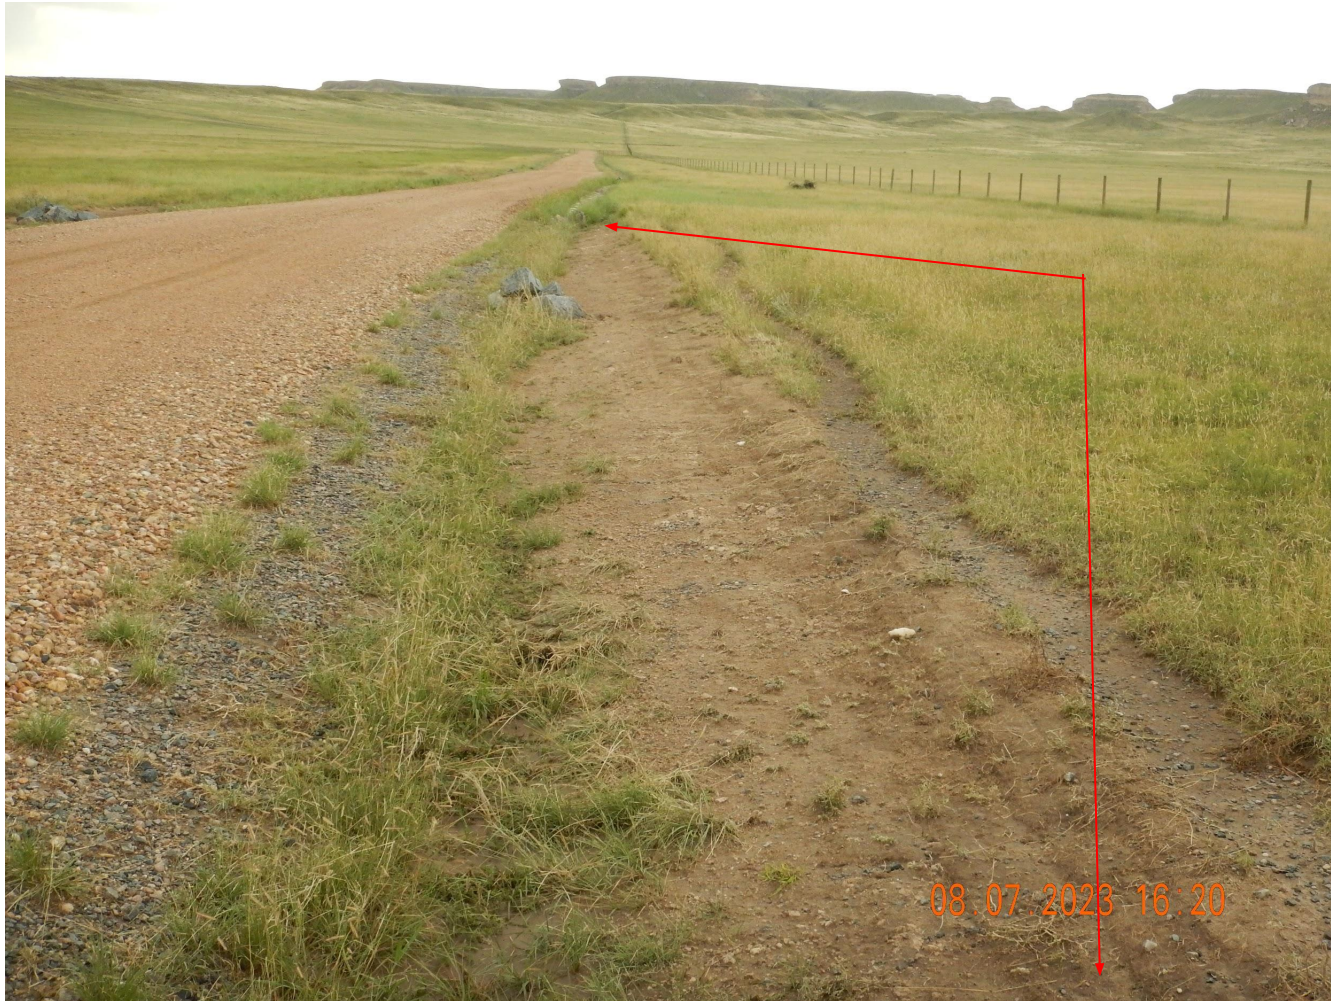
Photo 14. Photo illustrates a section of the ditch area that the Operator disturbed during snow removal. Operator attempted to correct the disturbed area by increasing the ditch side slopes by scrapping with a motor grader, then tried to seed directly into the disturbed area. Operator scrapped off much of the topsoil with the motor grader and topsoil is mixed with road base.

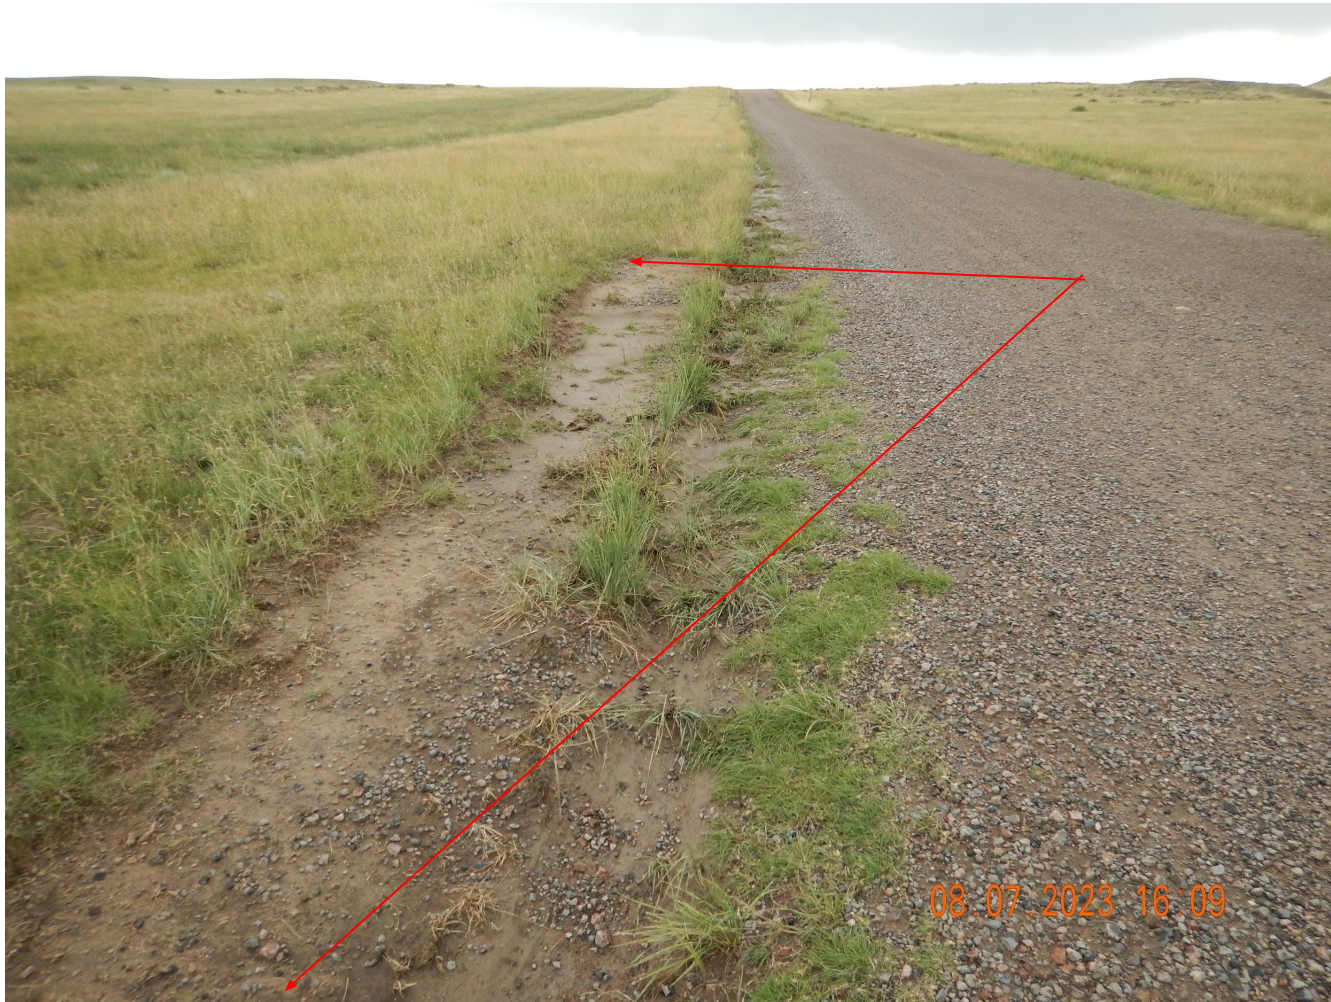
Photo 15. Photo illustrates another section which is off the lease road that the Operator disturbed during snow removal. In this example, Operator scrapped off the topsoil from the area and has failed to reclaim sections like these throughout the access road. These sections are being left unstabilized, causing erosion and weed establishment is occurring along these sections.

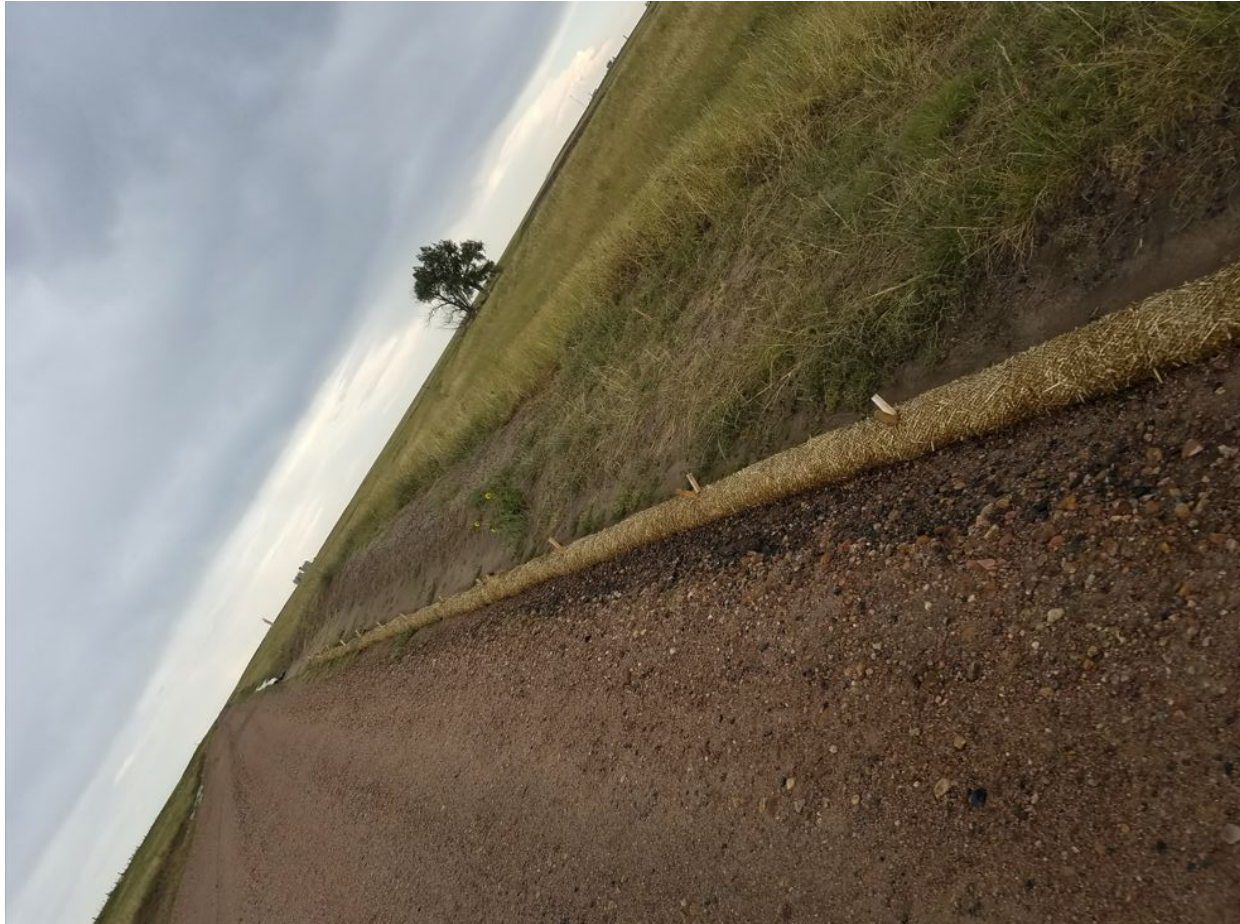
Photo 16. Photo taken east of Geary Creek, facing East. Photo illustrates an improperly installed straw wattle that appears to be for a section of cut slope along the access road. Operator still has not installed sufficient BMPs to minimize erosion into Geary Creek.

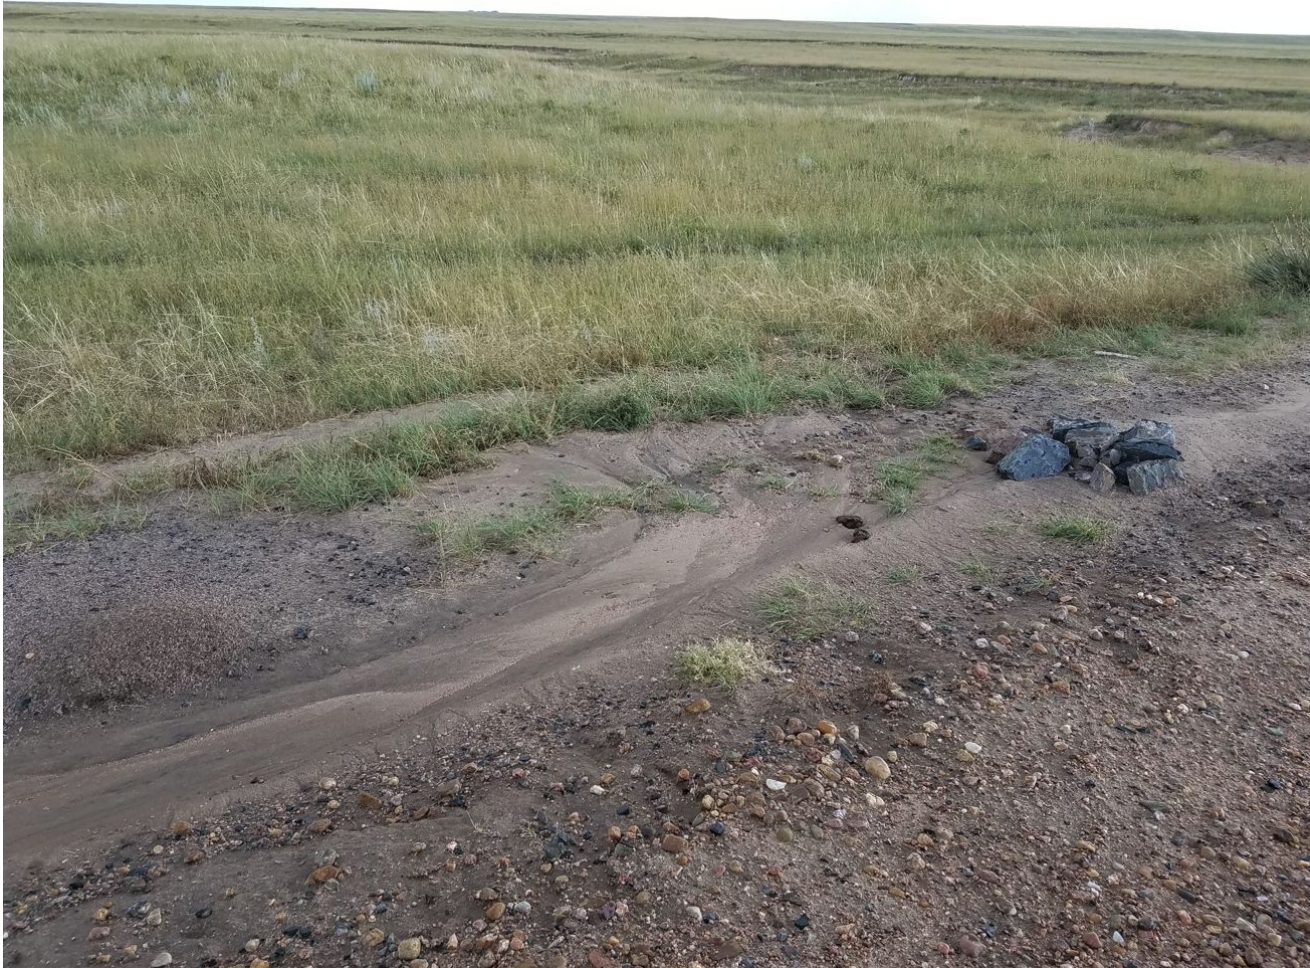
Photo 17. Photo taken east of Geary Creek, facing South. Photo illustrates a check dam BMP that is not in proper functioning condition and Operator still has not installed sufficient BMPs to minimize erosion into Geary Creek. This BMP has remains in the same configuration since the previous inspection in June.

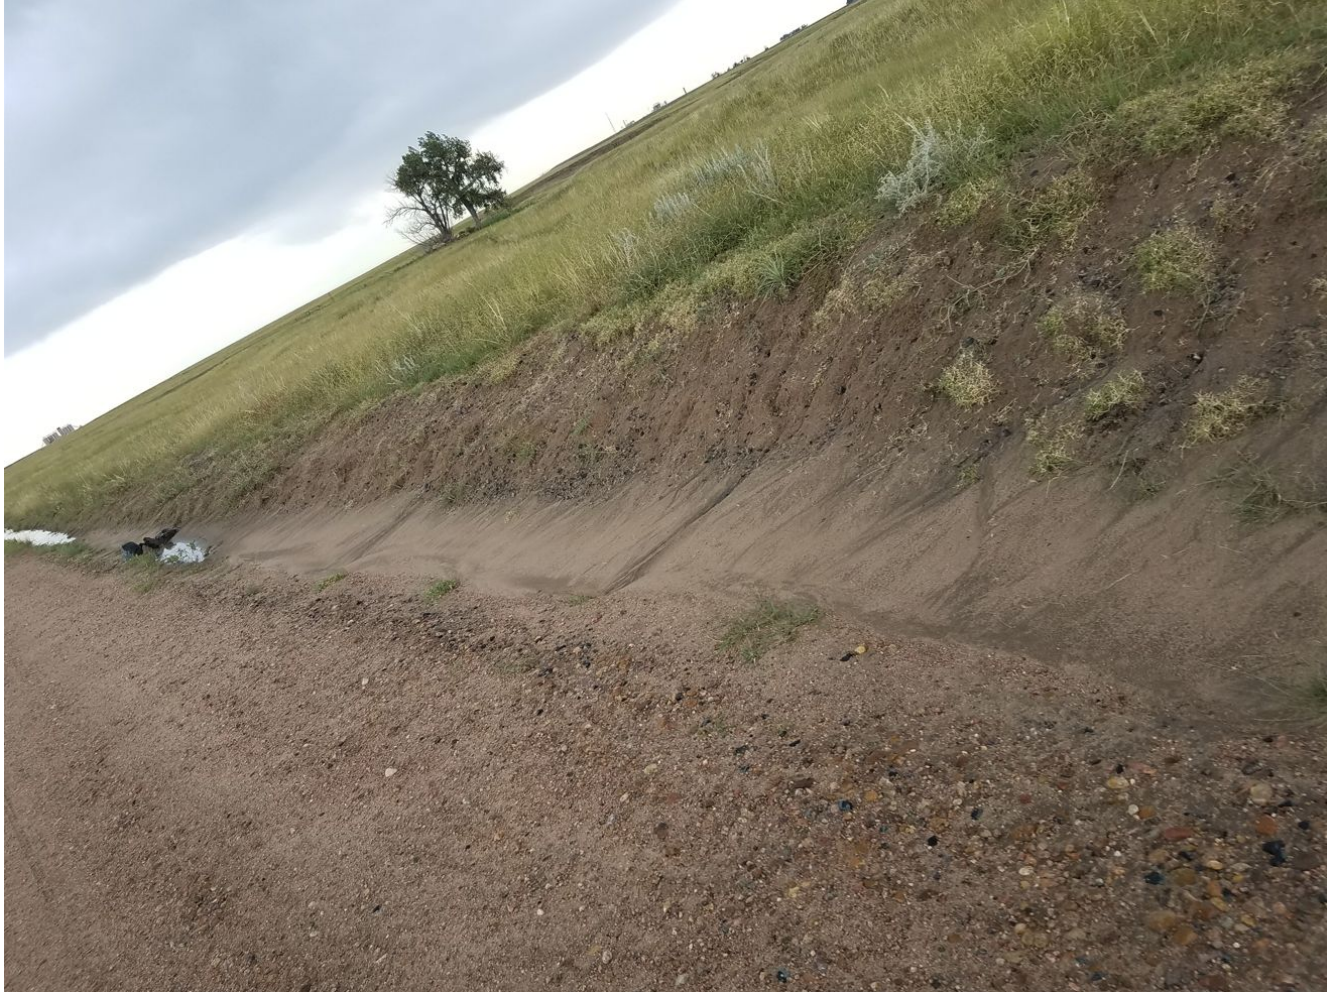
Photo 18. Photo taken east of Geary Creek, facing Southeast. Photo illustrates a section of cut slope that was disturbed during snow removal. Operator has failed to reclaim and stabilize the cut slope that continues to erode into Geary Creek.

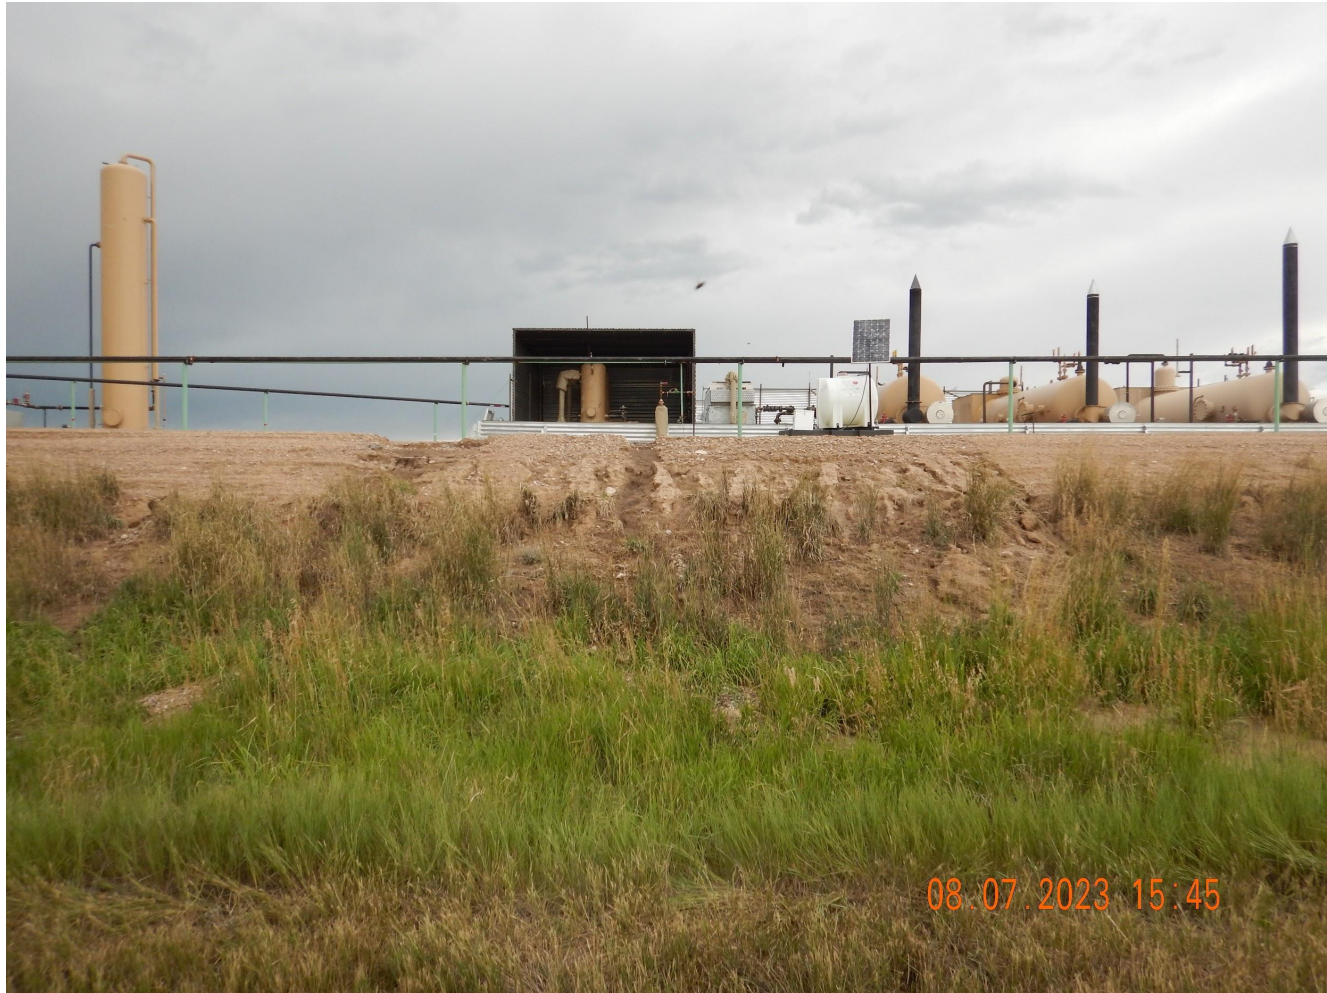
Photo 19. Photo taken along the southern location, facing North. Photo illustrates erosion repairs are needed.

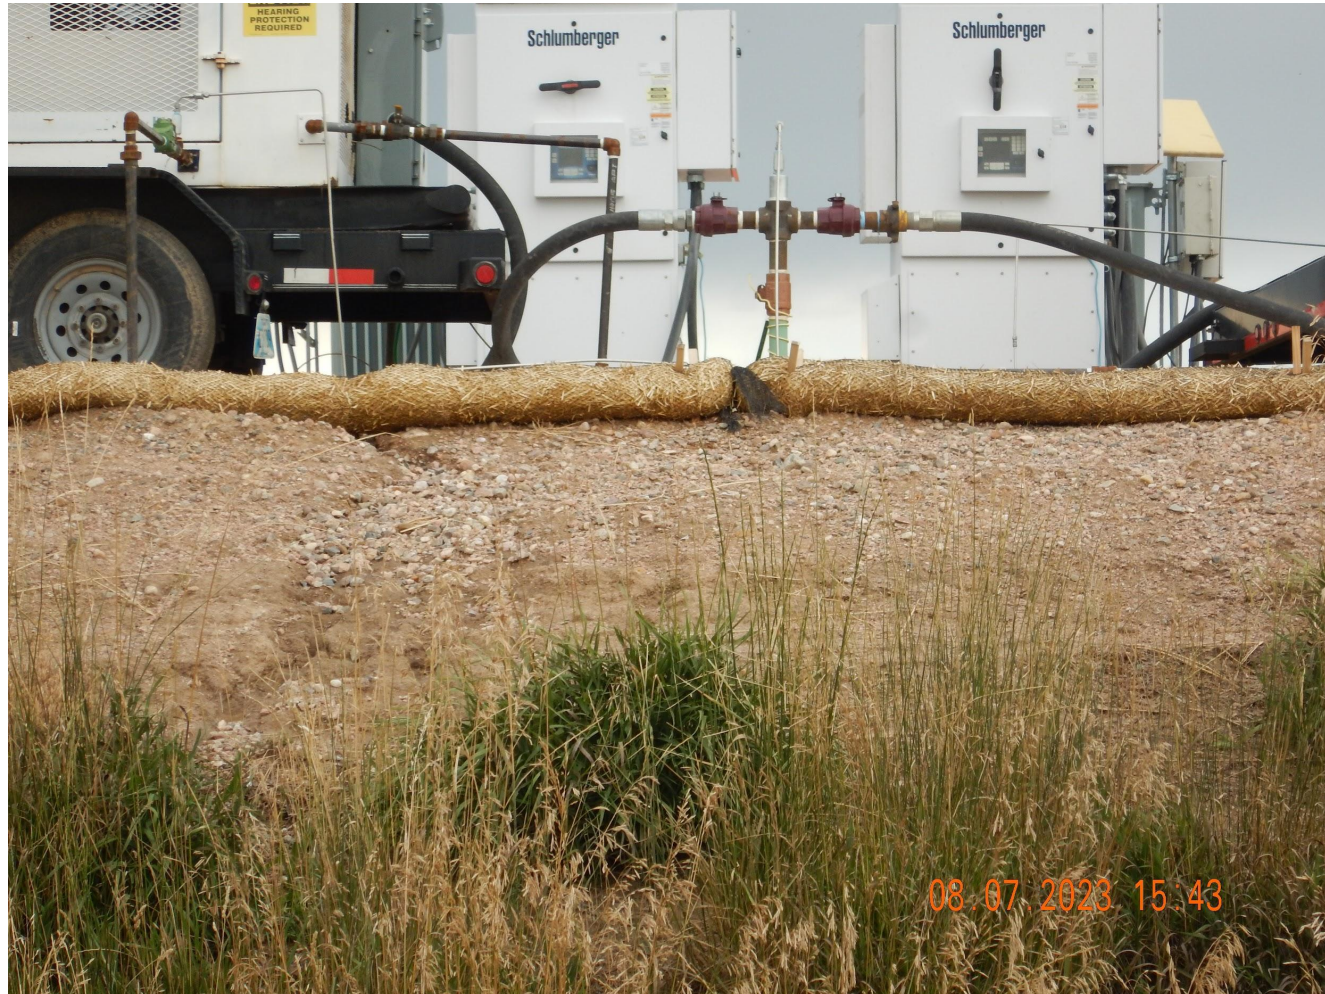
Photo 20. Photo taken along the southern location, facing North. Photo illustrates the BMP has not been properly installed (has not been trenched or proper overlap) and stormwater is undermining the BMP.
