Storm Water Management and Erosion control
Location Name: CAERUS PICEANCE LLC P13W Pad
Location #: 334576

Location Overview: Location is approximately 285 yards from West Mamm Creek. Location is within High Priority/Density/Black Bear Habitat areas & in close proximity to NSO Habitat area.

Section/Township/Range: 13 7S93W

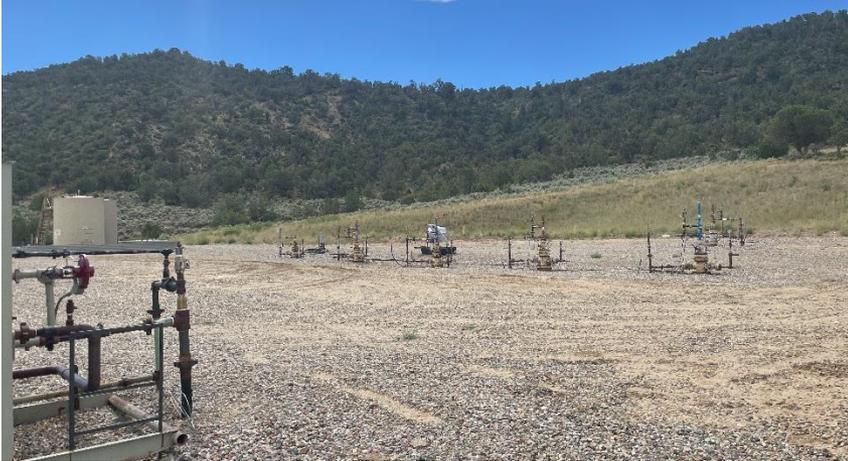
North West corner of location.

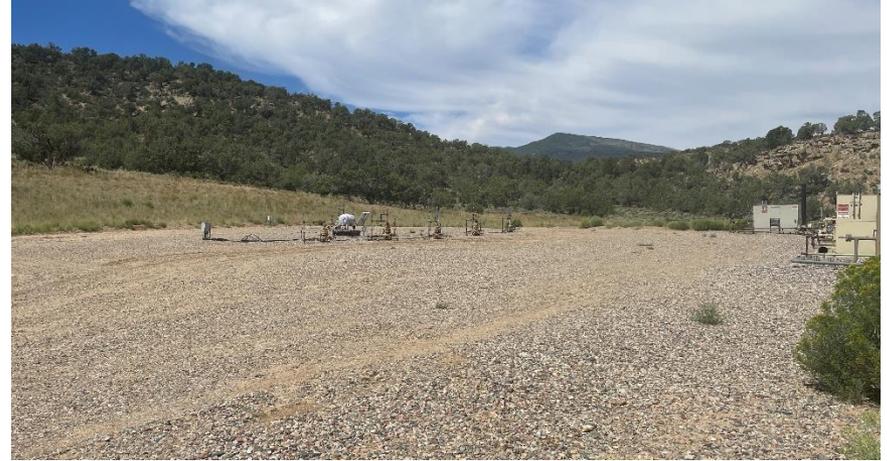
North East corner of location.

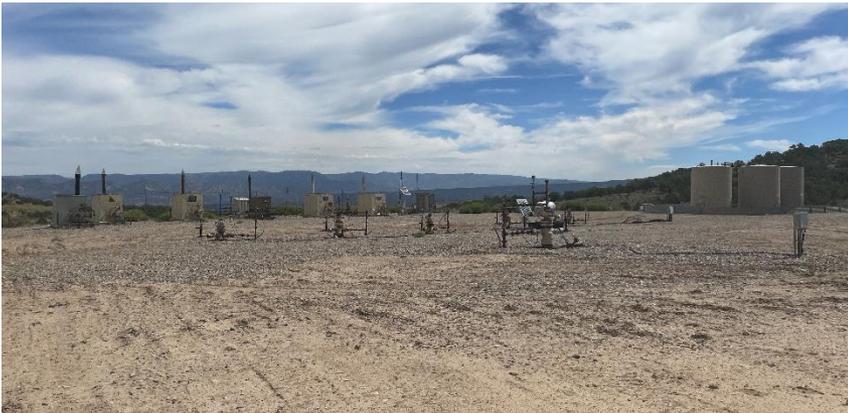
South West corner of location.

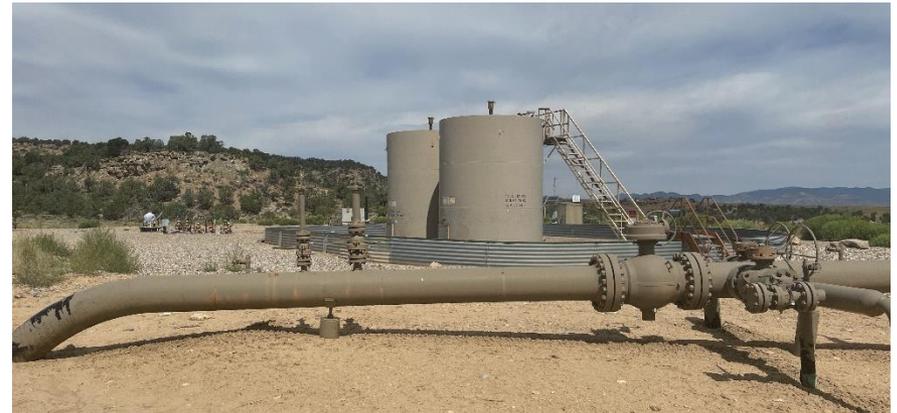
South East corner of location.

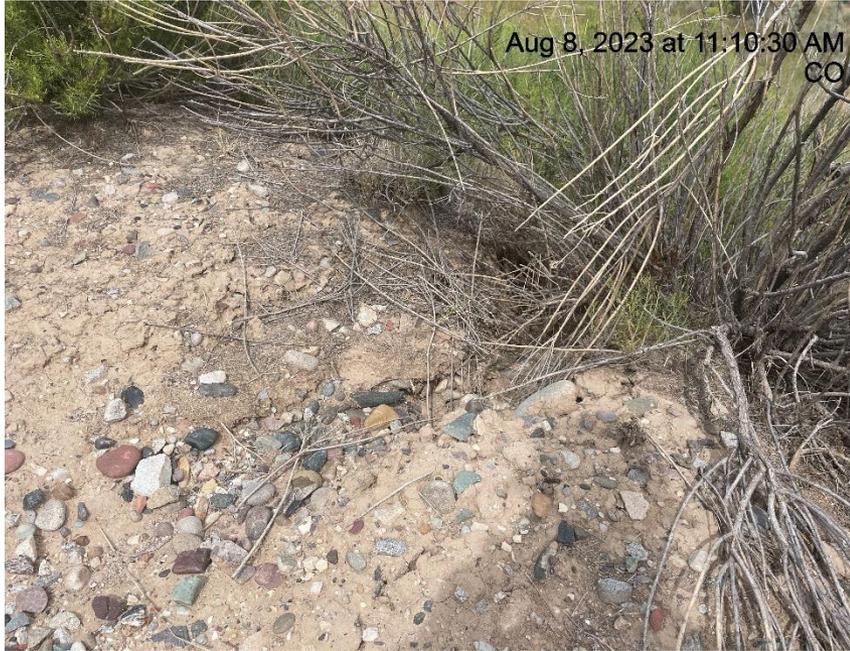
Photo # 5280 Erosion & transport of sediment off location (N/NW edge of pad behind ROLES 13-14A & COUEY 24-1C separator units)

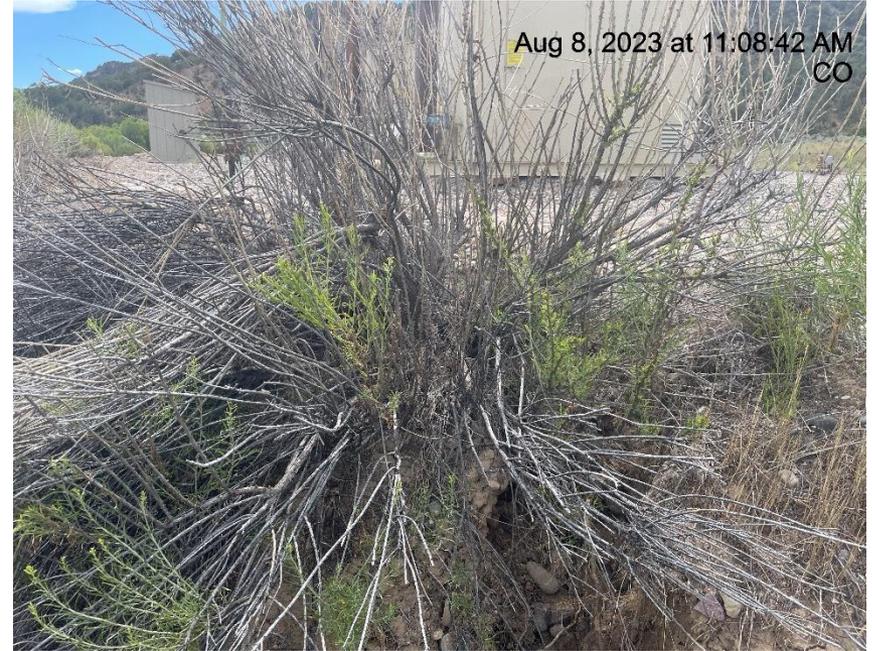
Photo # 5281 Erosion & transport of sediment off location (N/NW edge of pad behind ROLES 13-14A & COUEY 24-1C separator units)

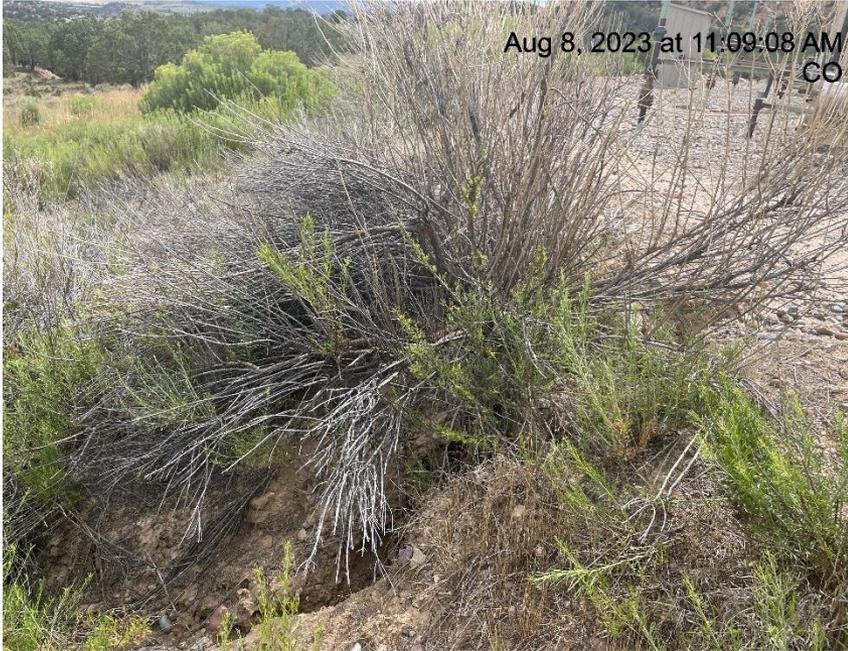
Photo # 5283 Erosion & transport of sediment off location (N/NW edge of pad behind ROLES 13-14A & COUEY 24-1C separator units)

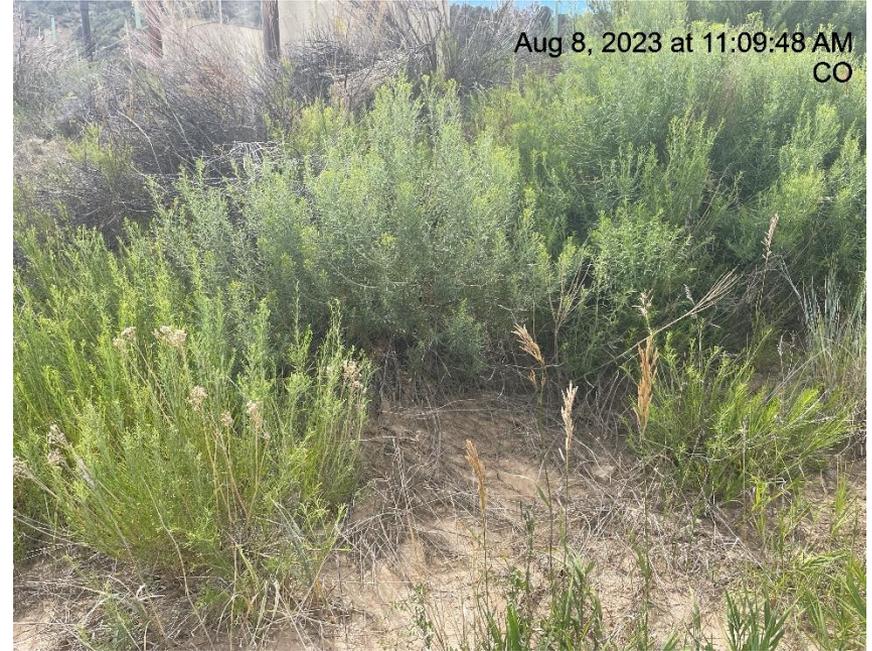
Photo # 5284 Erosion & transport of sediment off location (N/NW edge of pad behind ROLES 13-14A & COUEY 24-1C separator units)

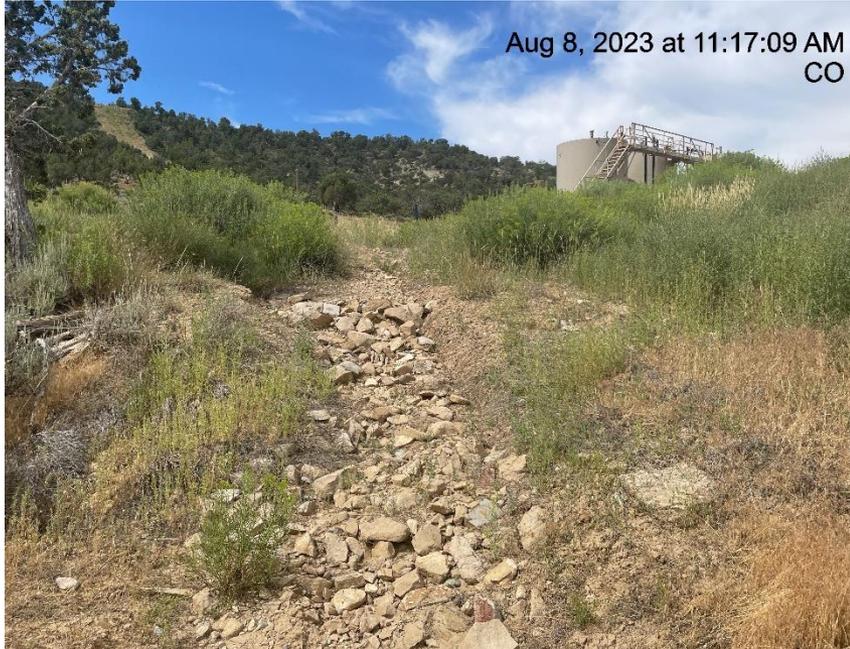
Photo # 5301 Rip Rap Run/BMP's need maintenance (East edge of location near tank battery)

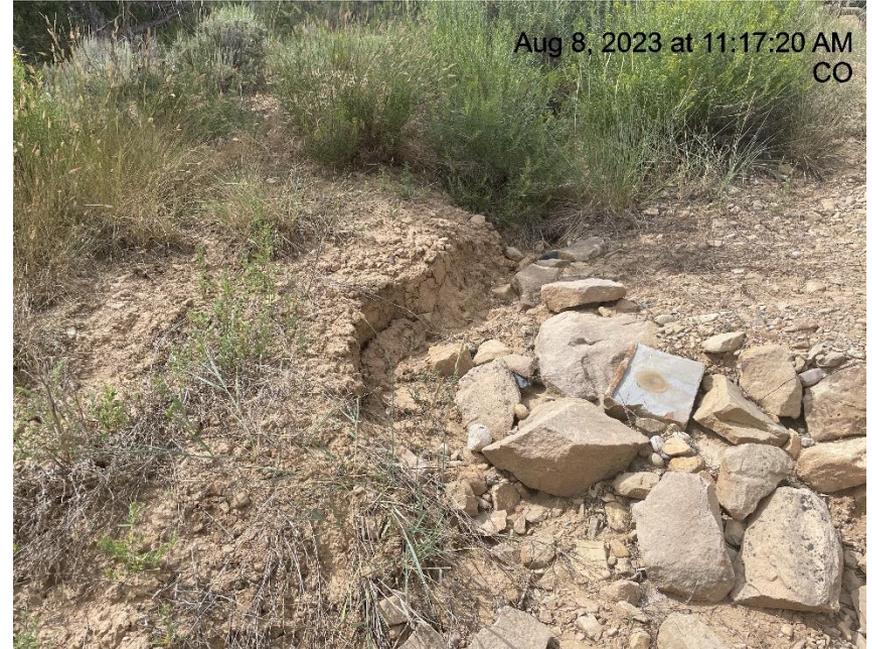
Photo # 5302 Rip Rap Run/BMP's need maintenance (East edge of location near tank battery)

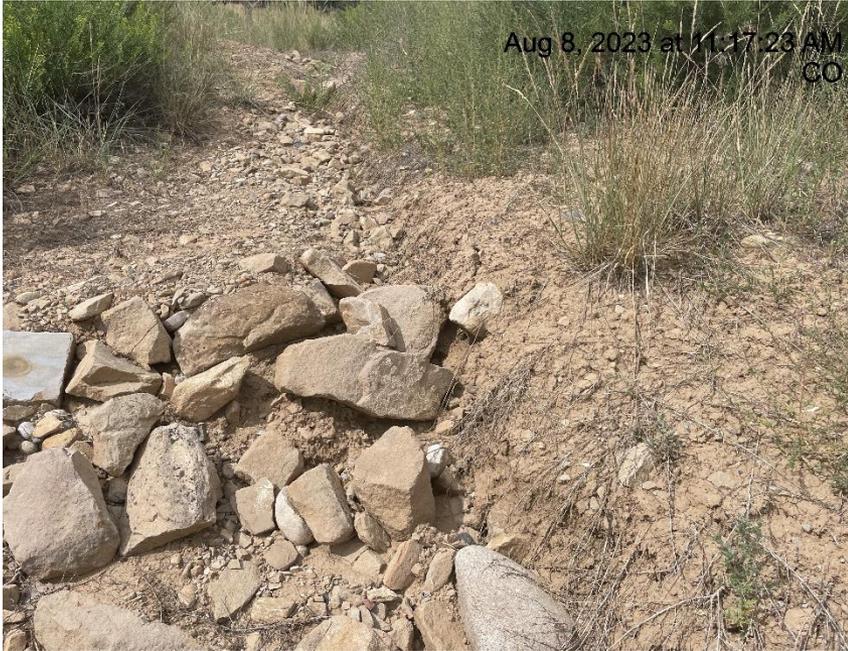
Photo # 5303 Rip Rap Run/BMP's need maintenance (East edge of location near tank battery)

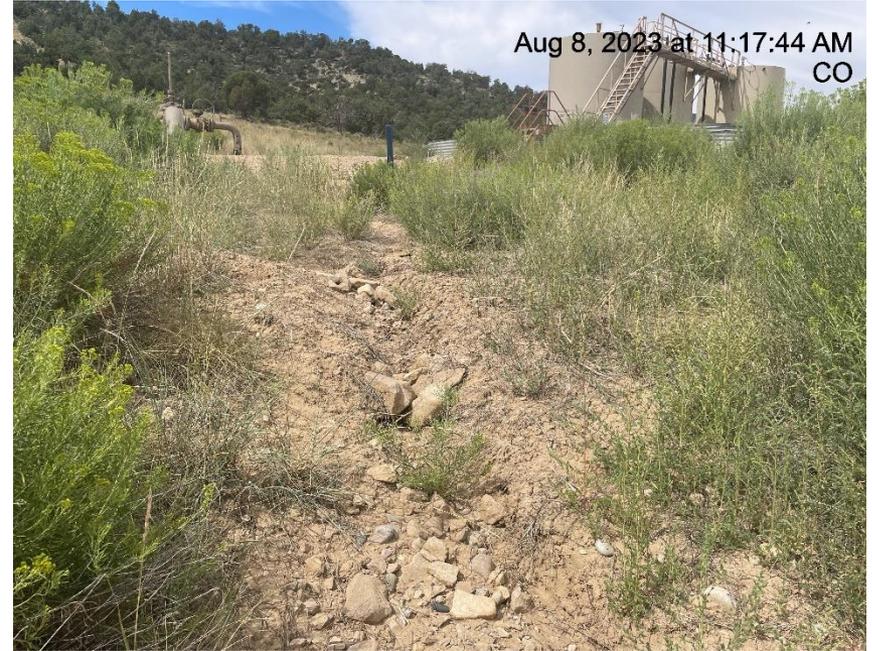
Photo # 5304 Erosion & transport of sediment/BMP's need maintenance (East edge of location near tank battery)

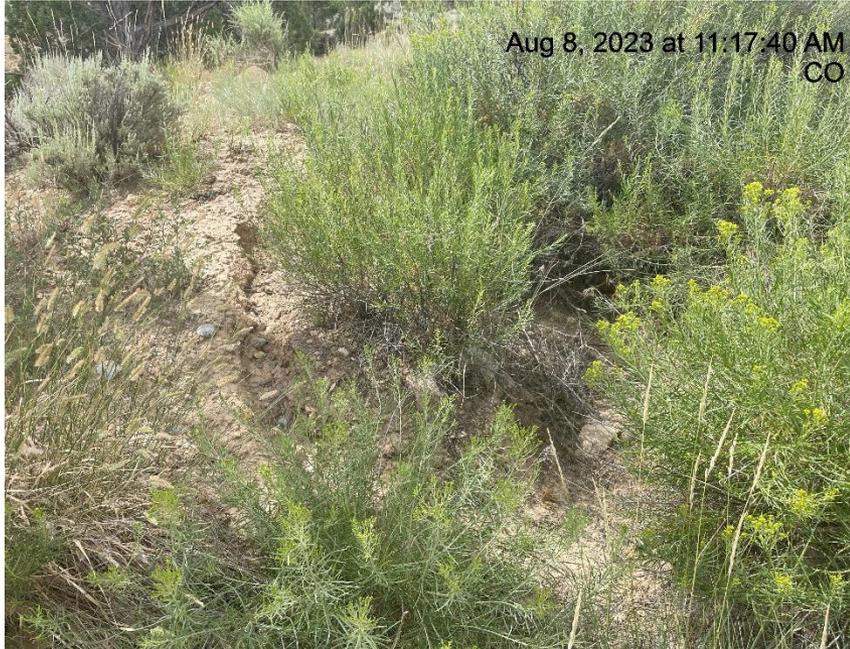
Photo # 5305 Erosion & transport of sediment (East edge of location near tank battery)

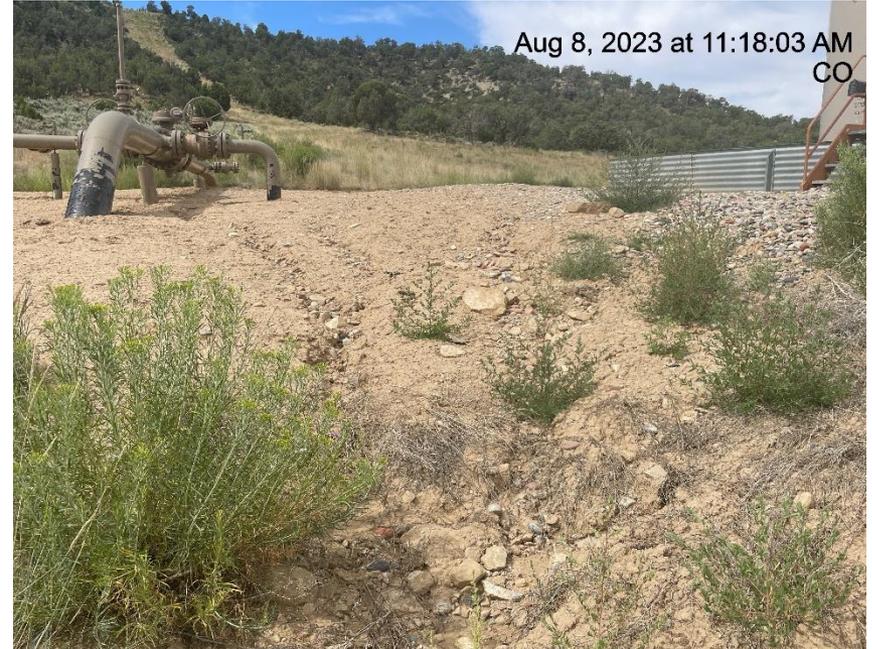
Photo # 5307 Erosion & transport of sediment (East edge of location near tank battery)

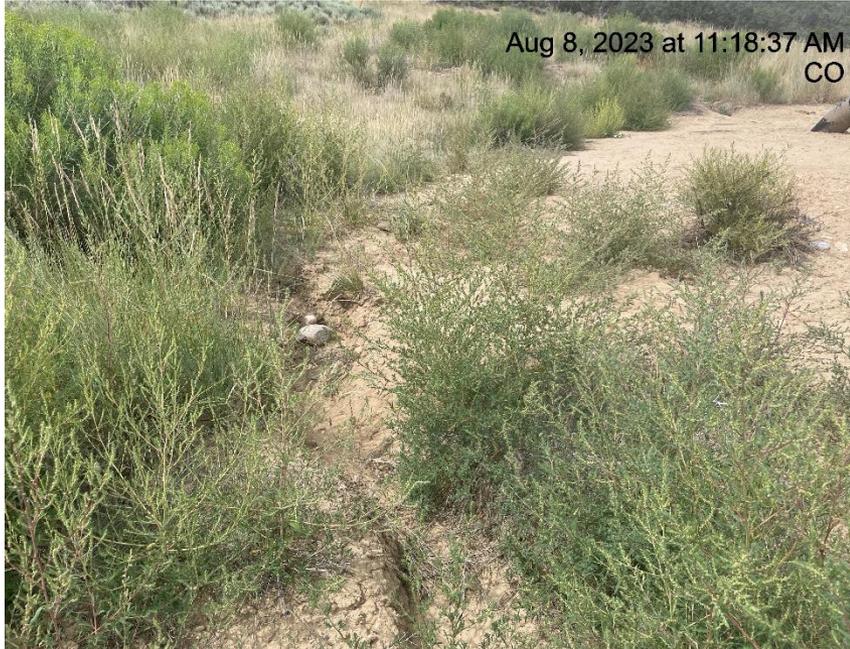
Photo # 5308 Erosion & transport of sediment (East edge of location near tank battery)

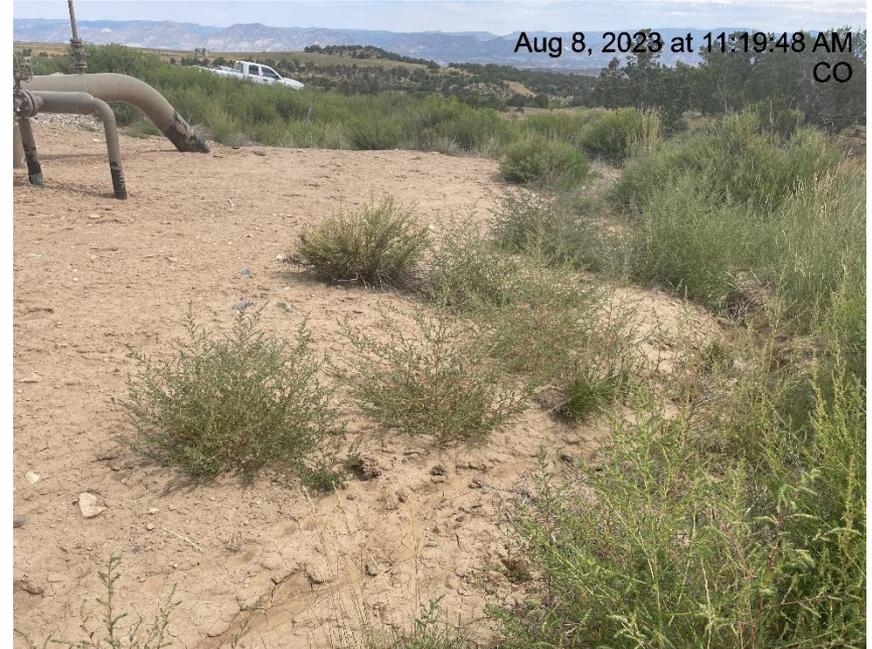
Photo # 5312 Erosion & transport of sediment (East edge of location near tank battery)

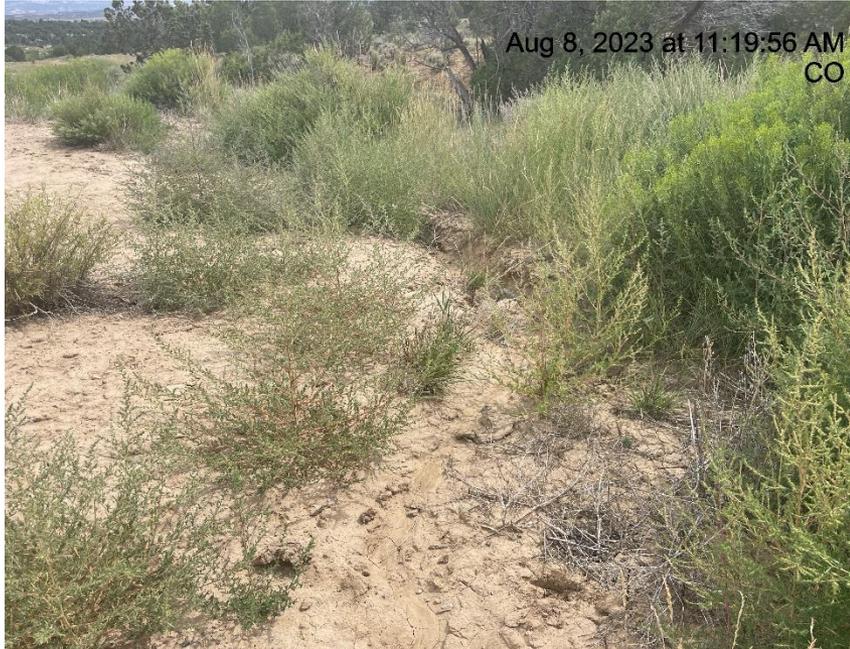
Photo # 5313 Erosion & transport of sediment (East edge of location near tank battery)

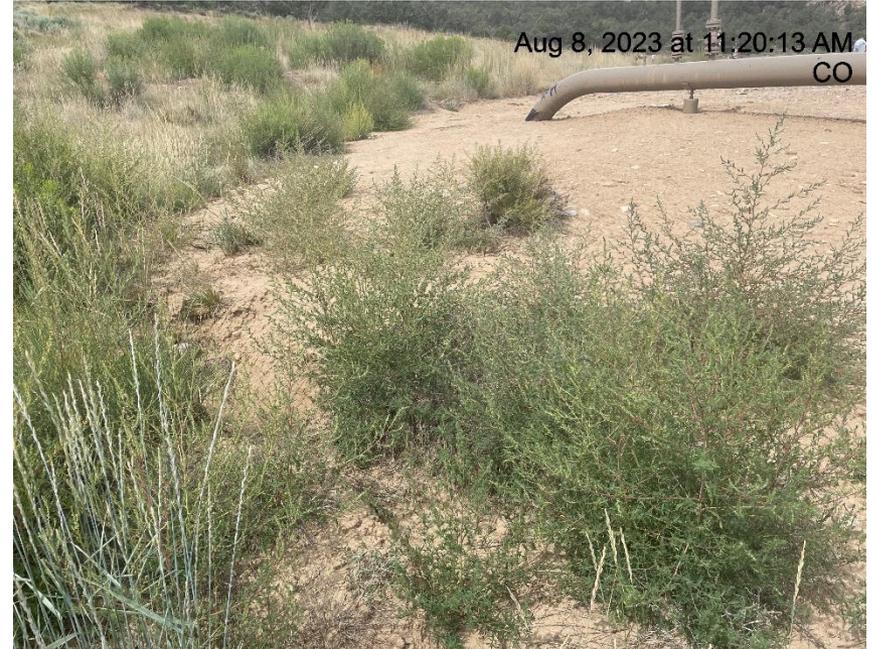
Photo # 5314 Erosion & transport of sediment (East edge of location near tank battery)

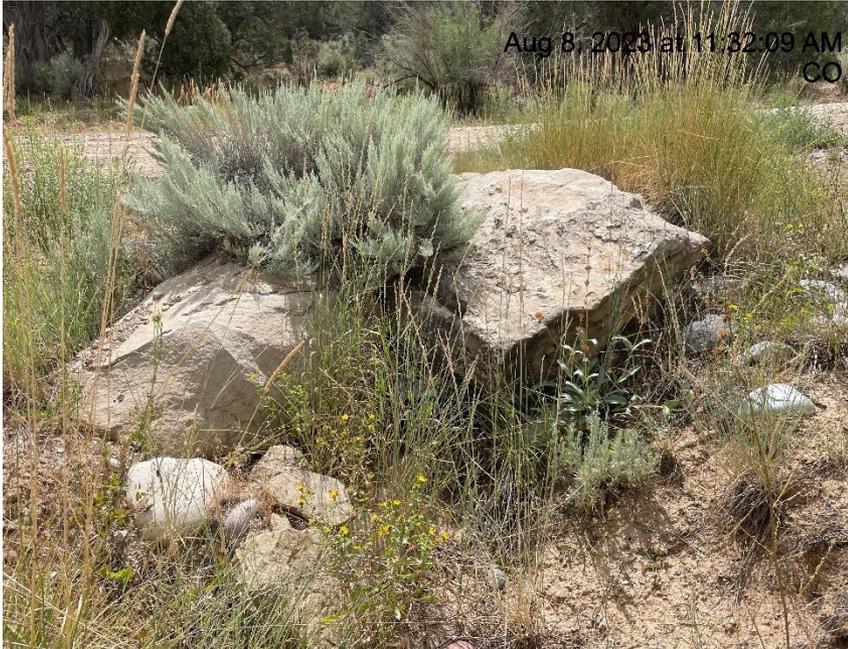
Photo # 5321 Culvert outlet (at beginning of spur road to location)

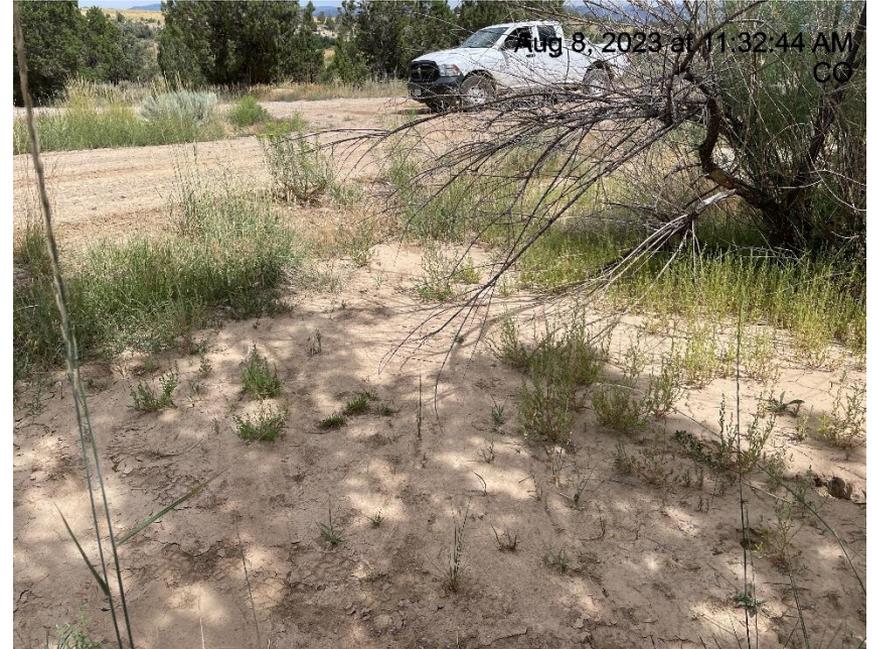
Photo # 5322 Unable to locate culvert inlet, appears to be buried under large amount of sediment - Culvert/BMP's need maintenance (at beginning of spur road to location) Culvert/BMP's need maintenance.
