Inspection Photos
Location Name: CAERUS PICEANCE LLC N18 Pad
Location #: 334933

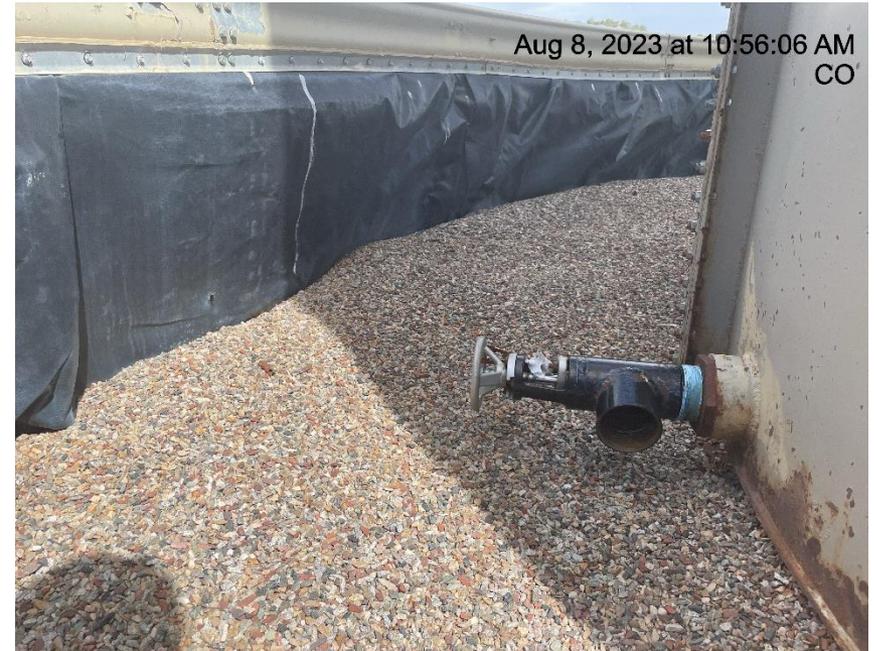
Photo # 5259 Open ended load line

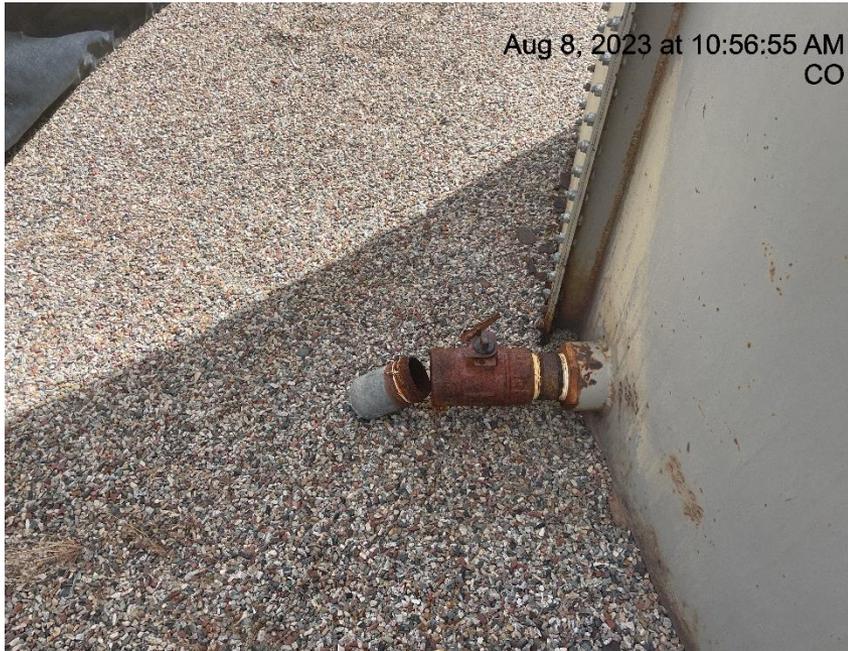
Photo # 5262 Open ended load line

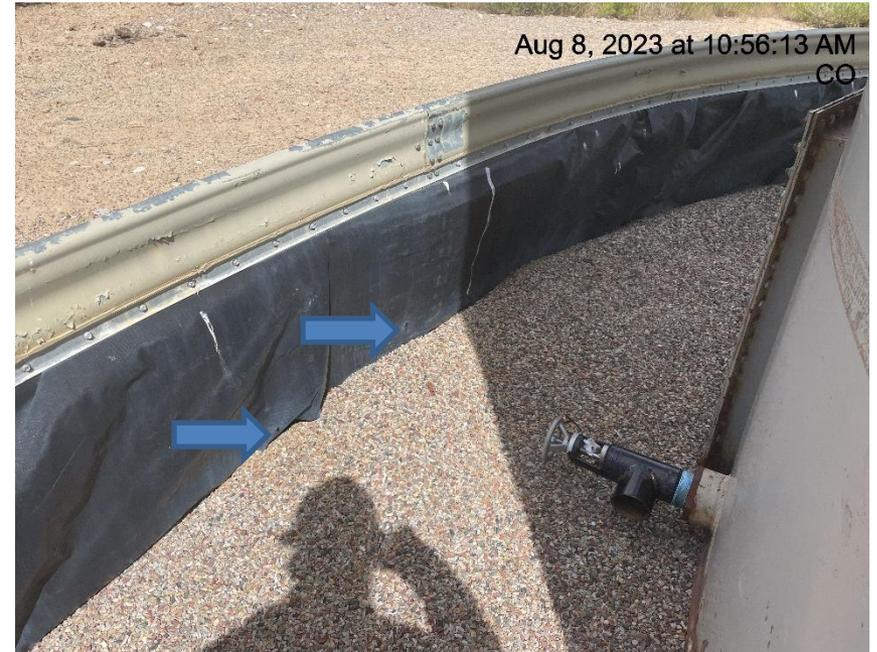
Photo # 5260 Holes in containment liner/liner needs maintenance

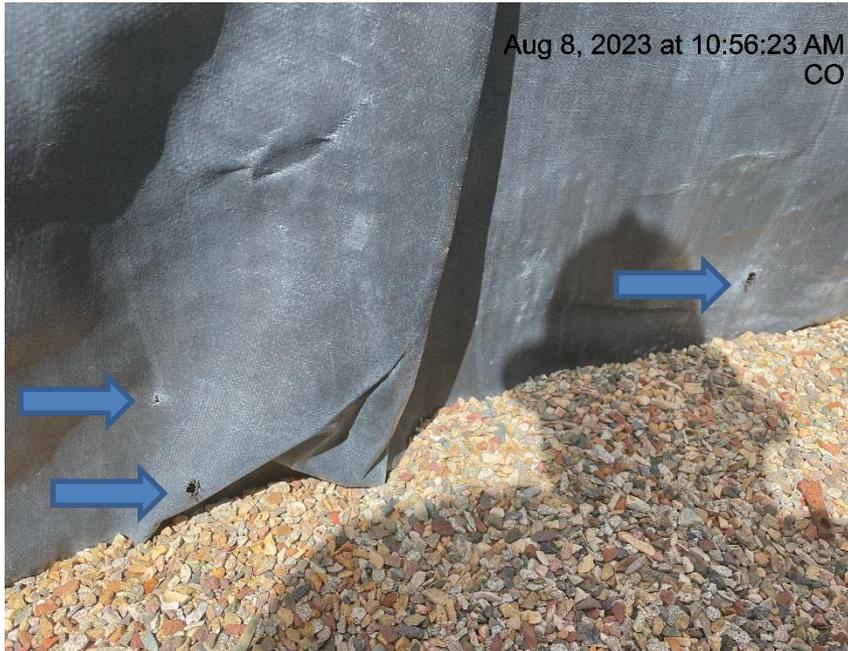
Photo # 5261 Holes in containment liner/liner needs maintenance

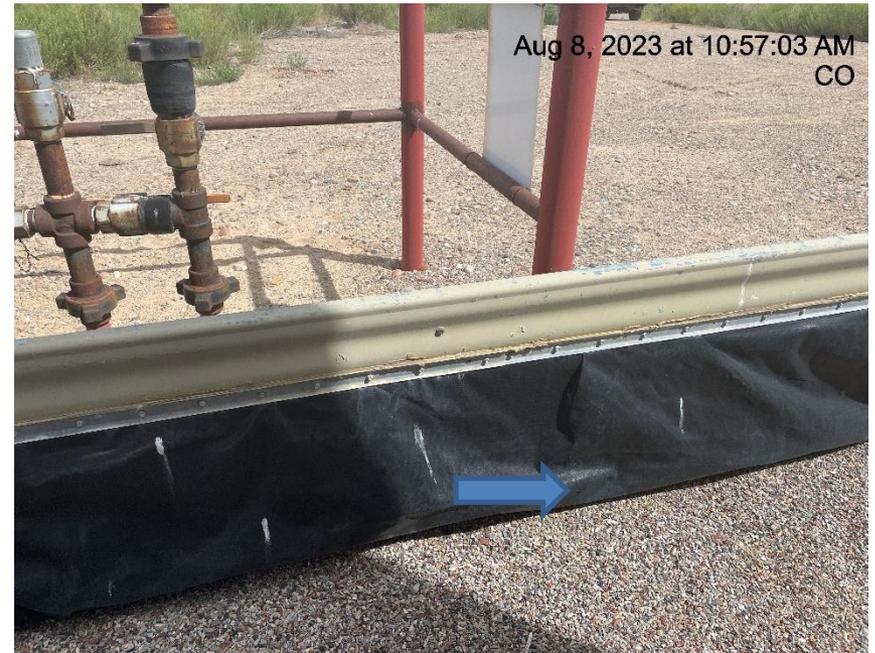
Photo # 5263 Hole in containment liner/liner needs maintenance

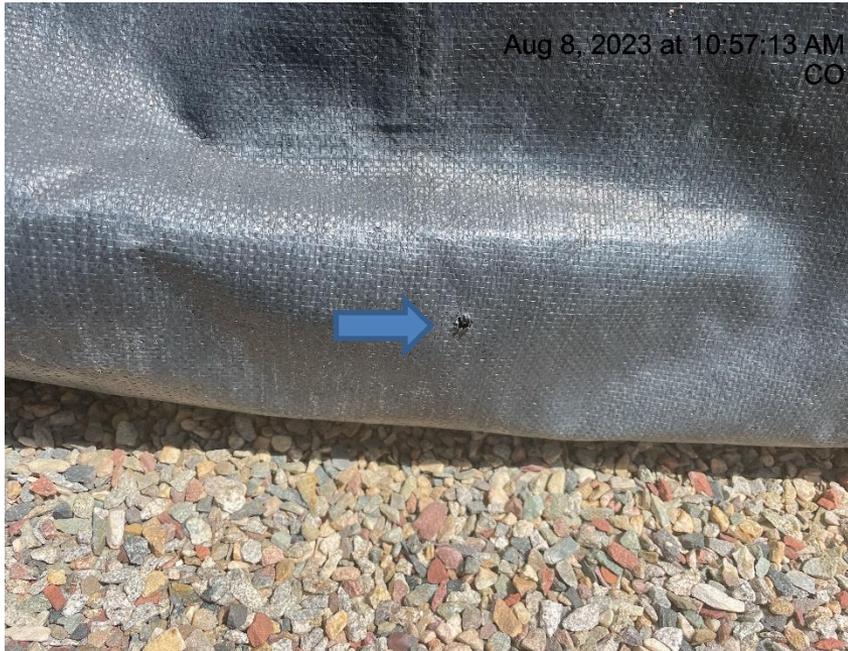
Photo # 5264 Hole in containment liner/liner needs maintenance

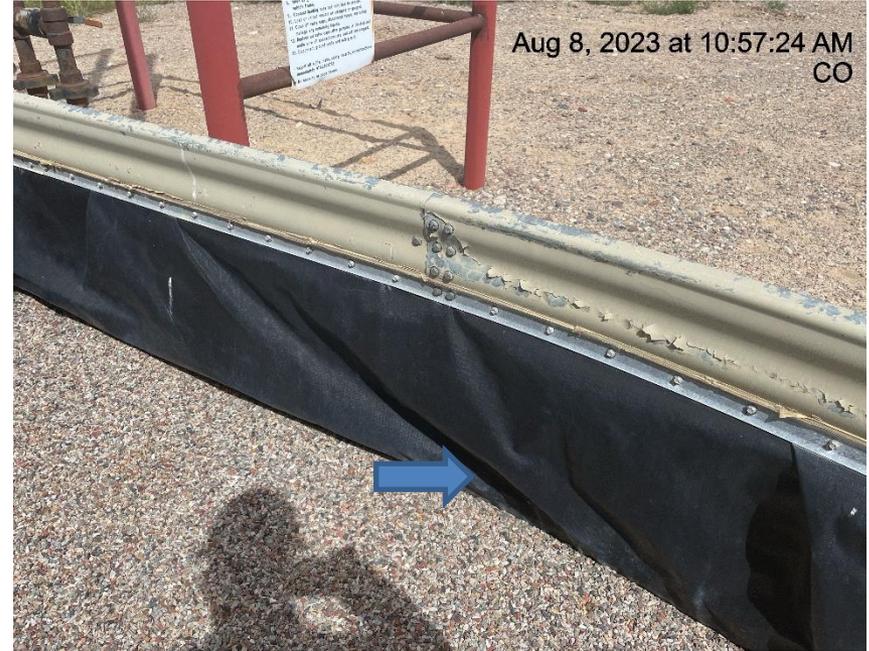
Photo # 5265 Hole in containment liner/liner needs maintenance

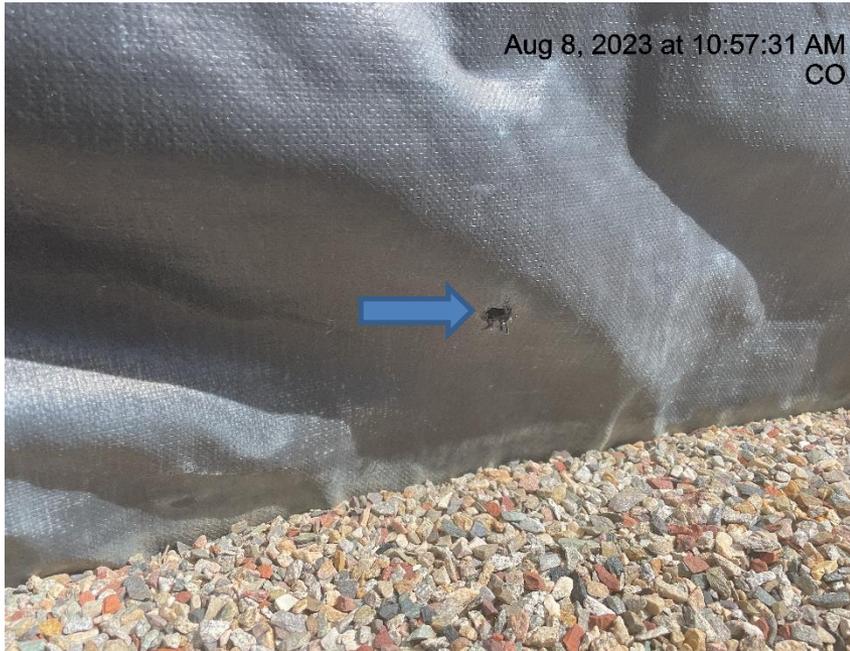
Photo # 5266 Hole in containment liner/liner needs maintenance

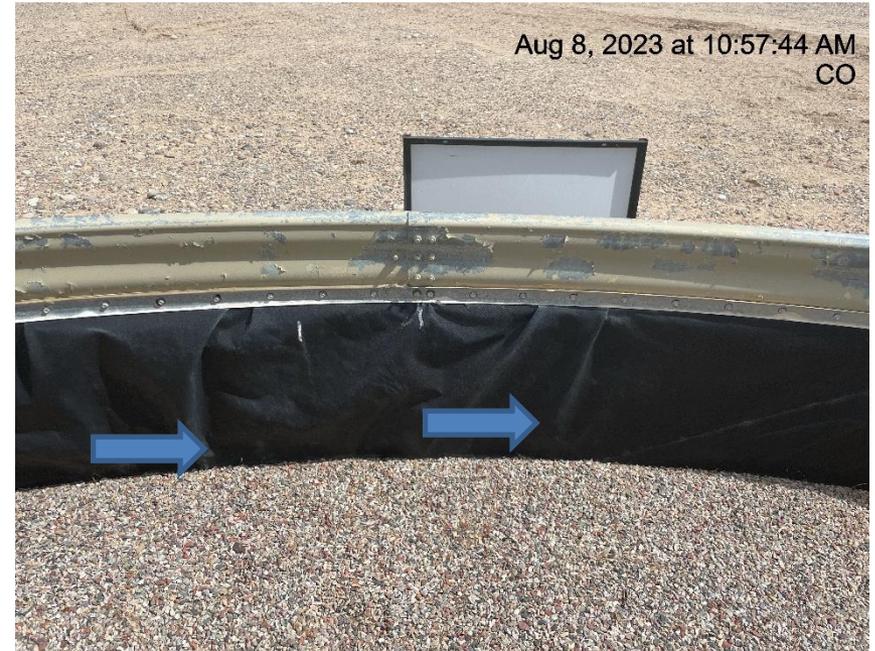
Photo # 5268 Holes in containment liner/liner needs maintenance

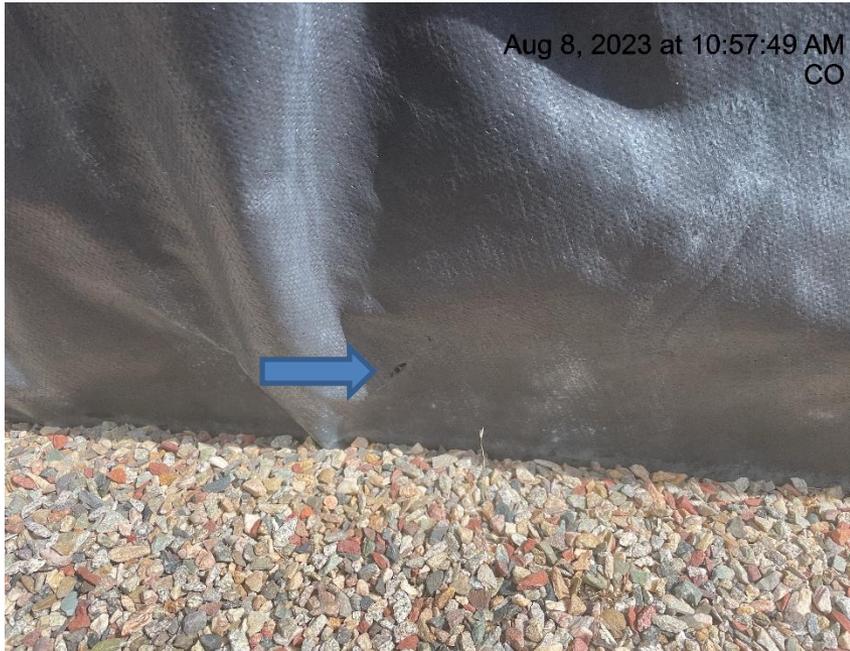
Photo # 5269 Hole in containment liner/liner needs maintenance

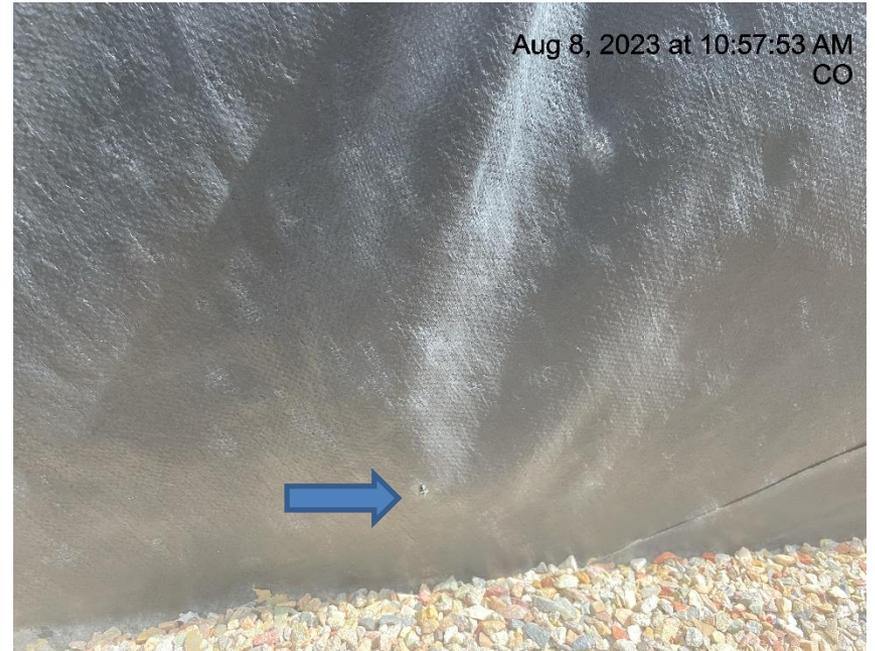
Photo # 5279 Hole in containment liner/liner needs maintenance
