Inspection Photos
Location Name: CAERUS PICEANCE LLC K17E Pad
Location #: 334791

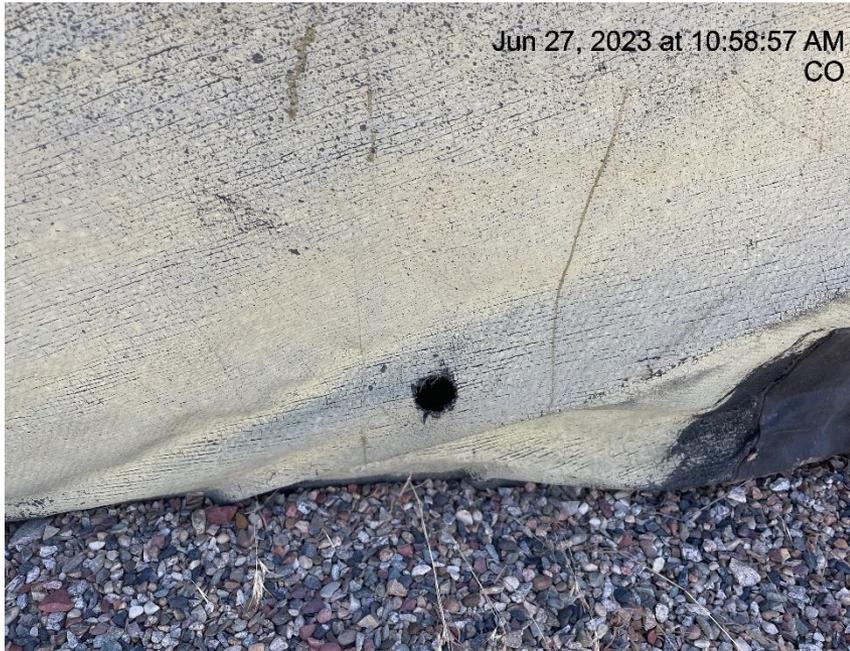
Photo # 2067 From Inspection 708900897 conducted on 06/27/2023 Hole in liner/liner needs maintenance

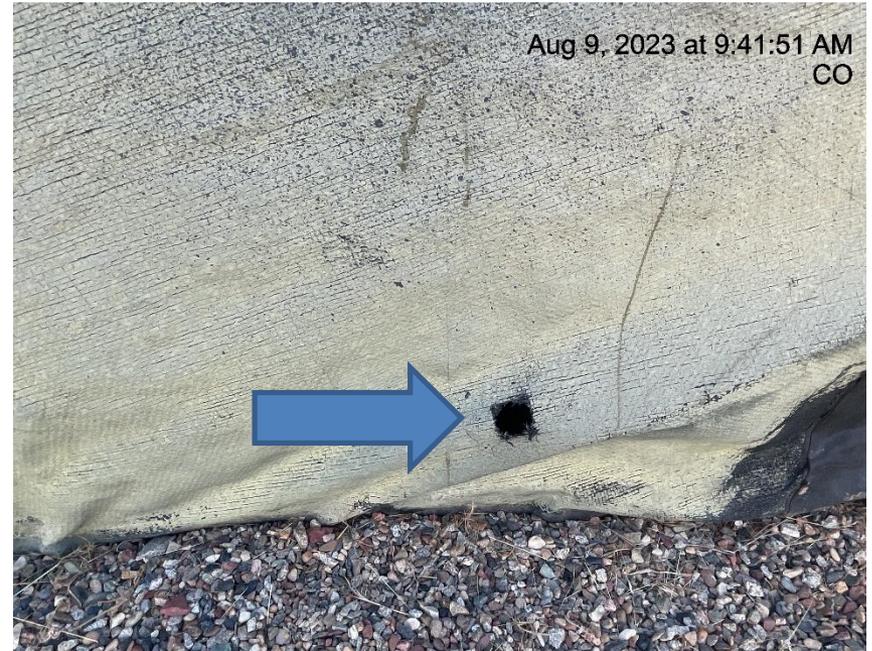
Photo # 5467 Hole in liner/liner needs maintenance

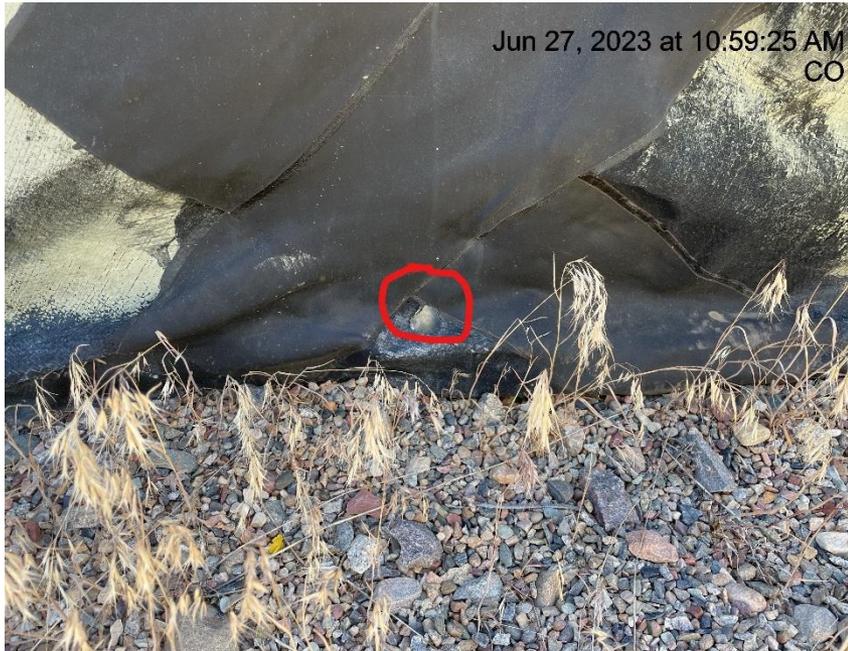
Photo # 2069 From Inspection 708900897 conducted on 06/27/2023 Hole in liner/liner needs maintenance

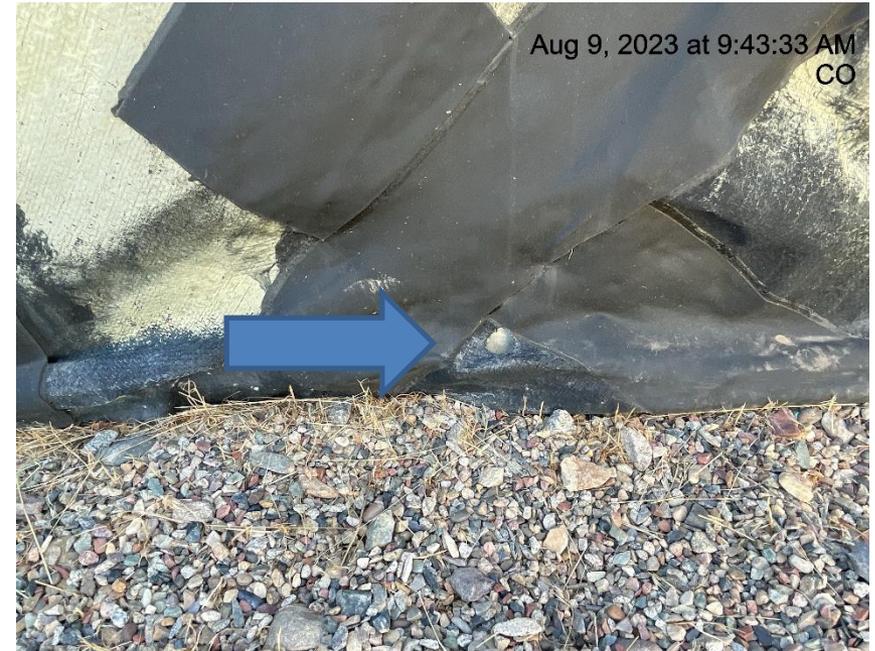
Photo # 5470 Hole in liner/liner needs maintenance

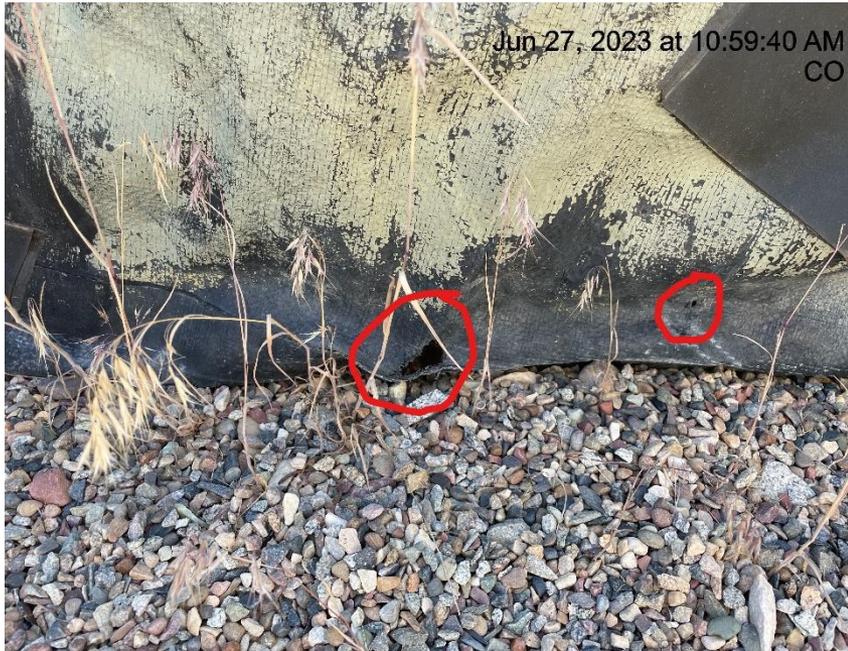
Photo # 2071 From Inspection 708900897 conducted on 06/27/2023 Holes in liner/liner needs maintenance

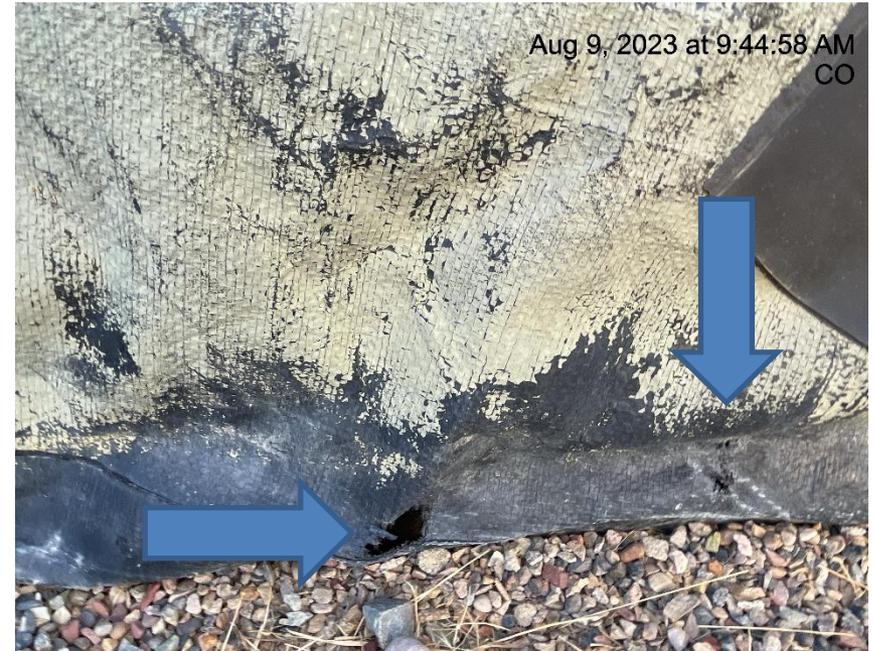
Photo # 5520 Holes in liner/liner needs maintenance

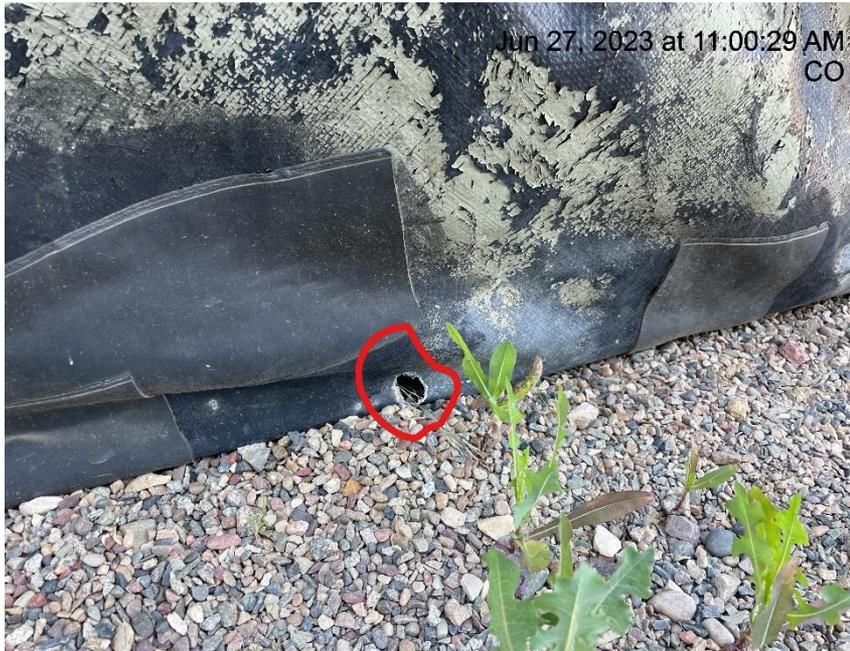
Photo # 1665 From Inspection 708900897 conducted on 06/27/2023 Hole in liner/liner needs maintenance

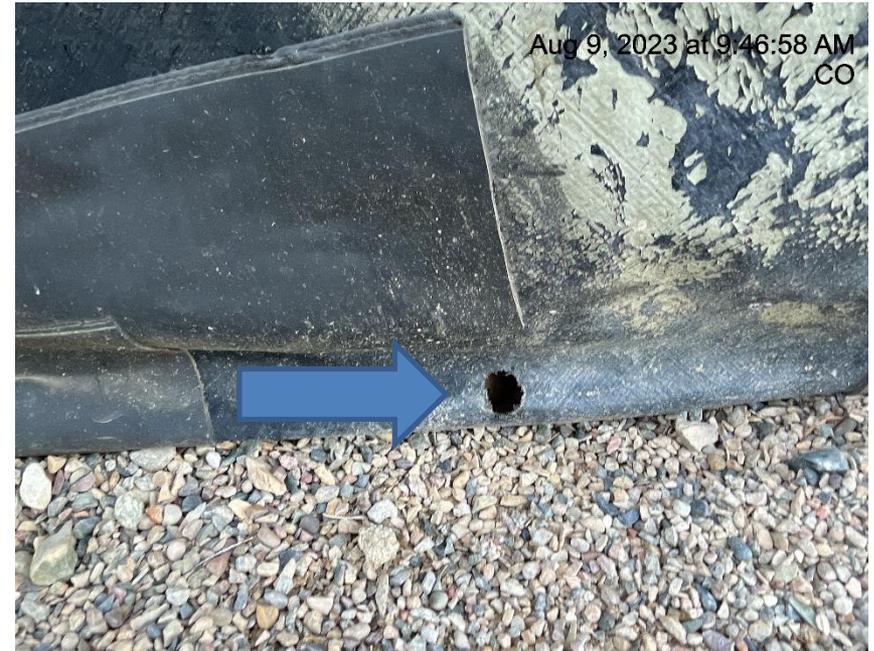
Photo # 5523 Hole in liner/liner needs maintenance
