Inspection Photos

API: 011-06018

Operator: RENEGADE OIL & GAS COMPANY LLC

Inspection Date: 8/9/2023

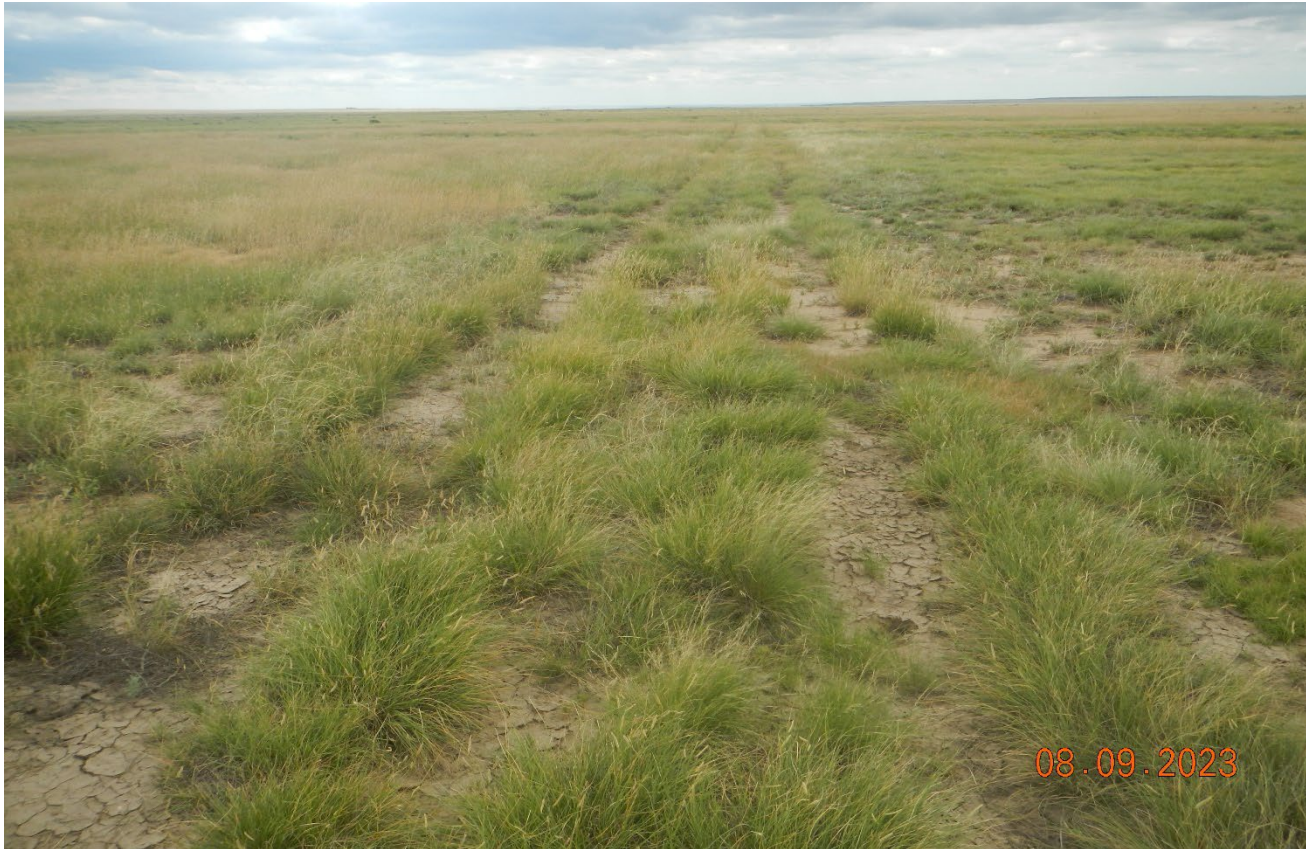
Photo 1. Facing south along the access road. The two track road remains but vegetation appears to have mostly re-established along the former access road.

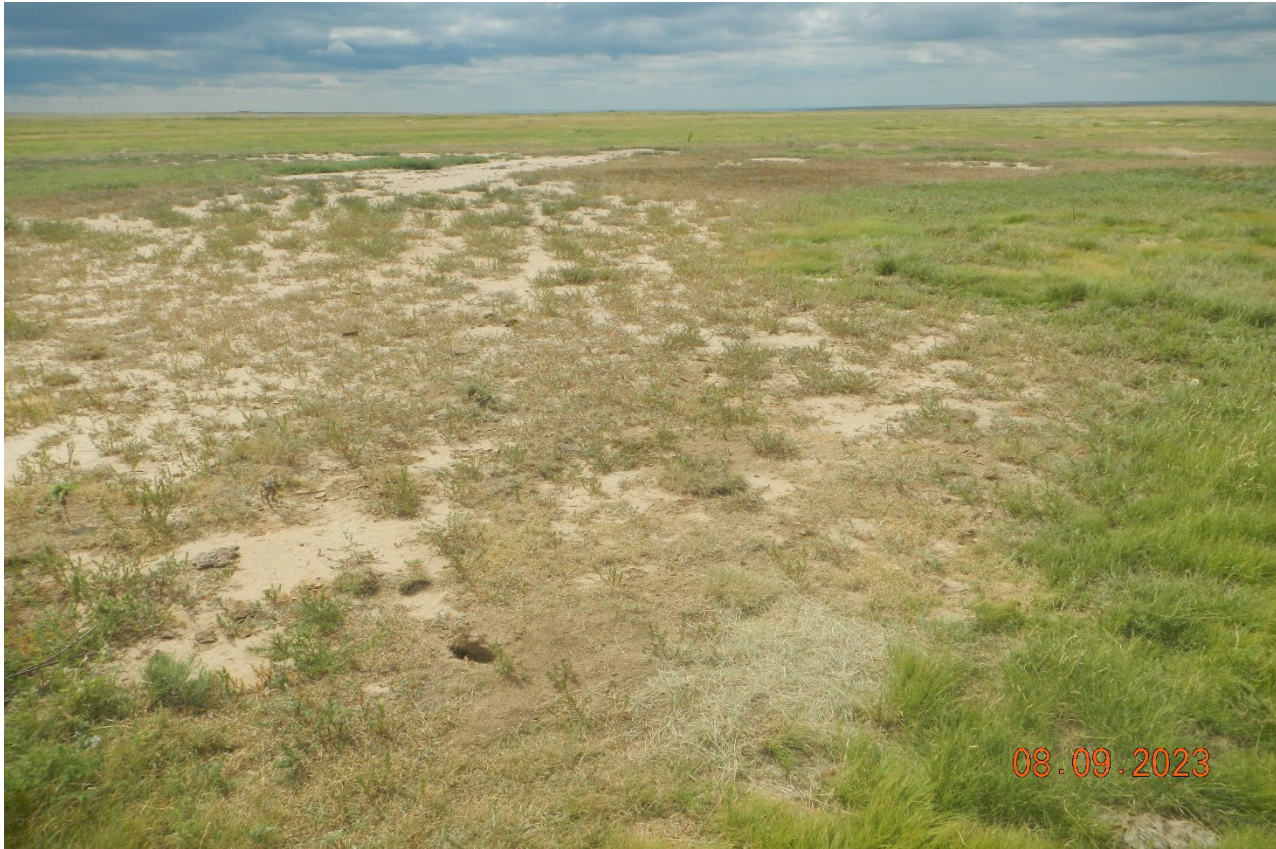
Photo 2. Facing southeast toward the location. The location consists primarily of undesirable weeds (*Kochia* sp.) and bare soil. The location has not reestablished a uniform vegetation cover of 80% of reference area levels.

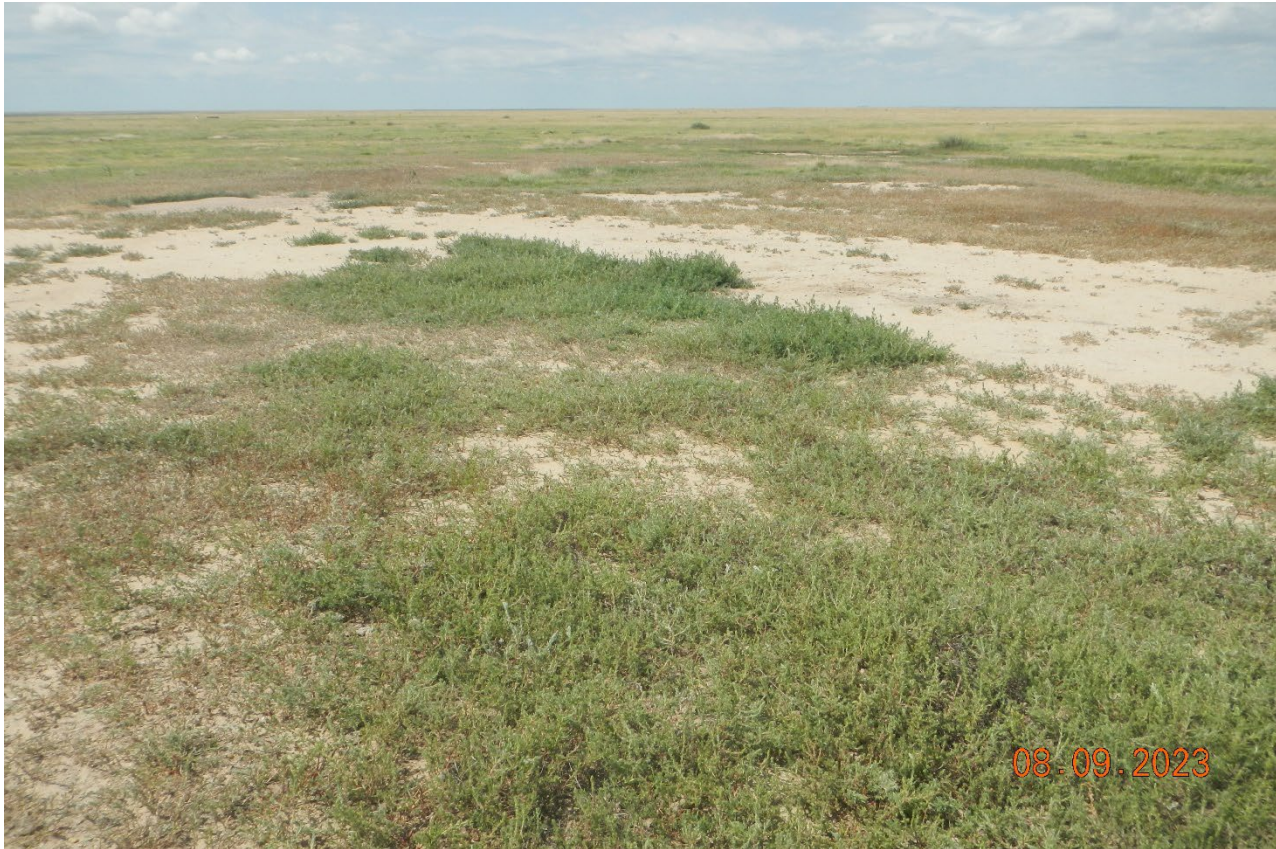
Photo 3. Facing southwest toward the location. The location consists primarily of undesirable weeds (*Kochia* sp.) and bare soil. The location has not reestablished a uniform vegetation cover of 80% of reference area levels.

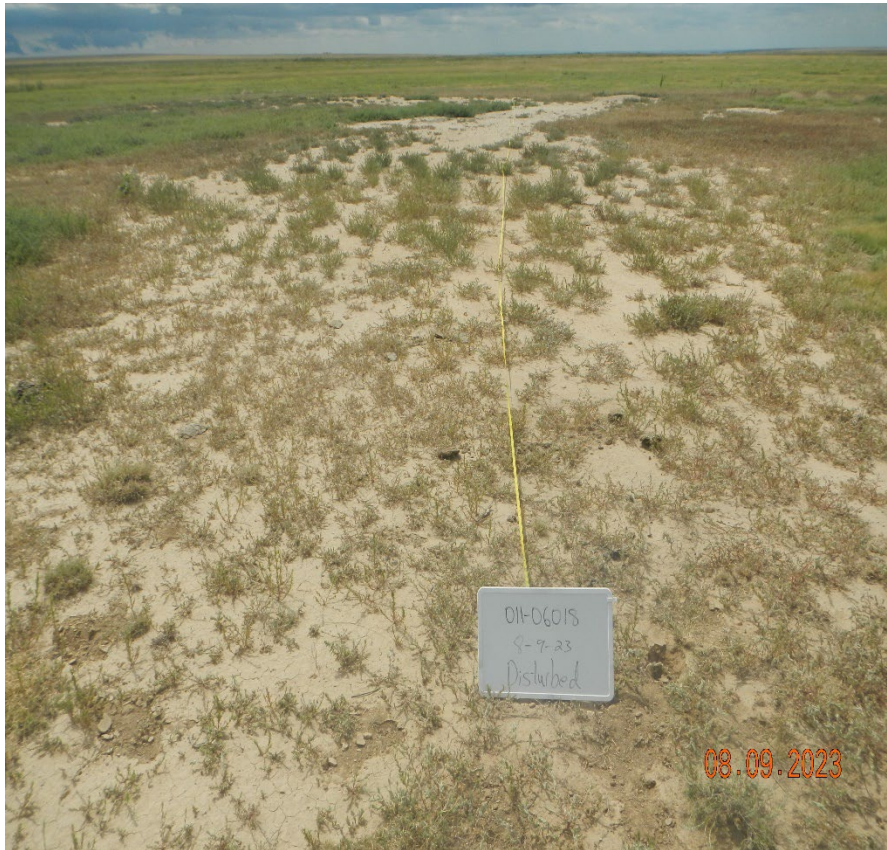
Photo 4. Disturbed 1 transect facing south at the location.

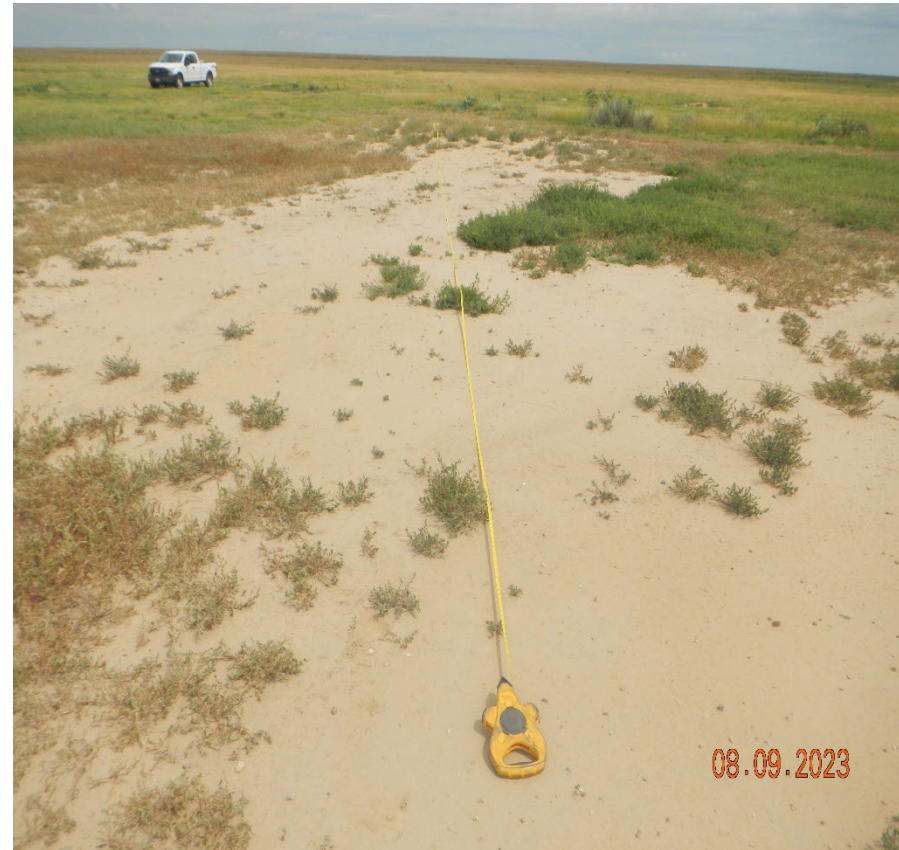
Photo 5. Disturbed 1 transect facing north at the location.

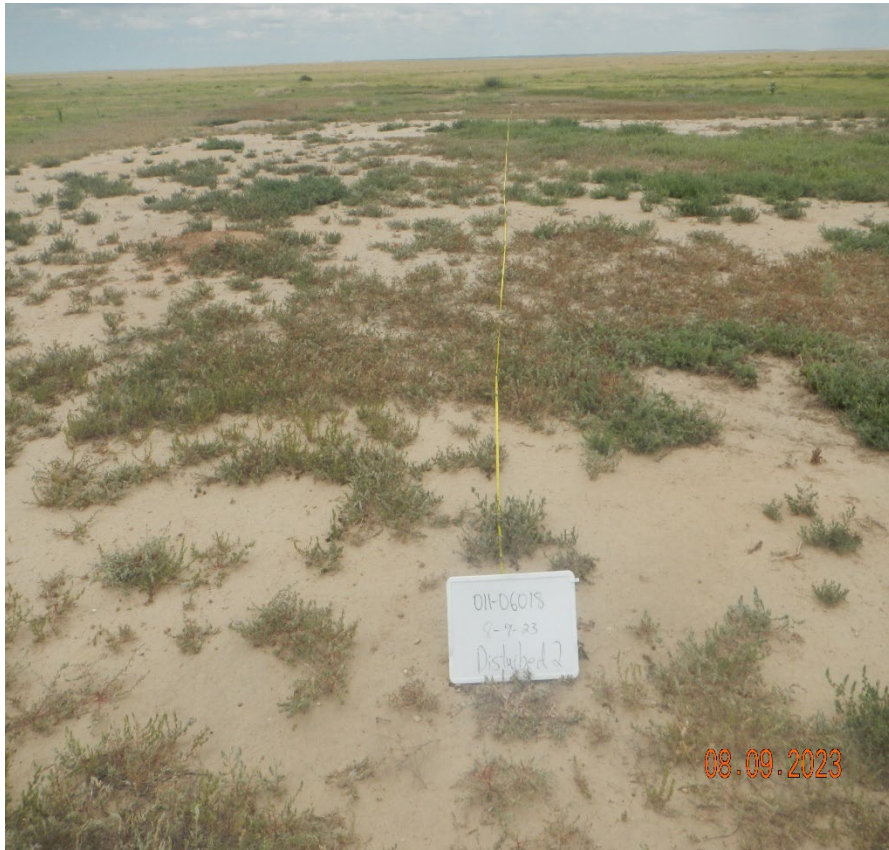
Photo 6. Disturbed 2 transect facing west at the location.

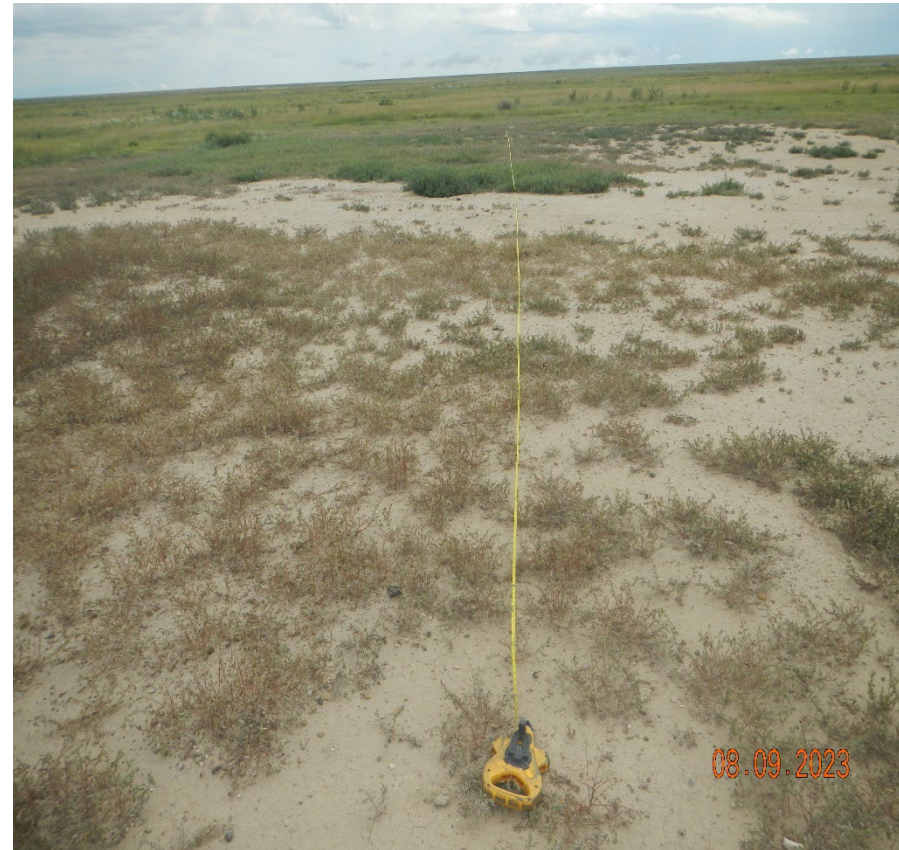
Photo 7. Disturbed 2 transect facing east at the location.

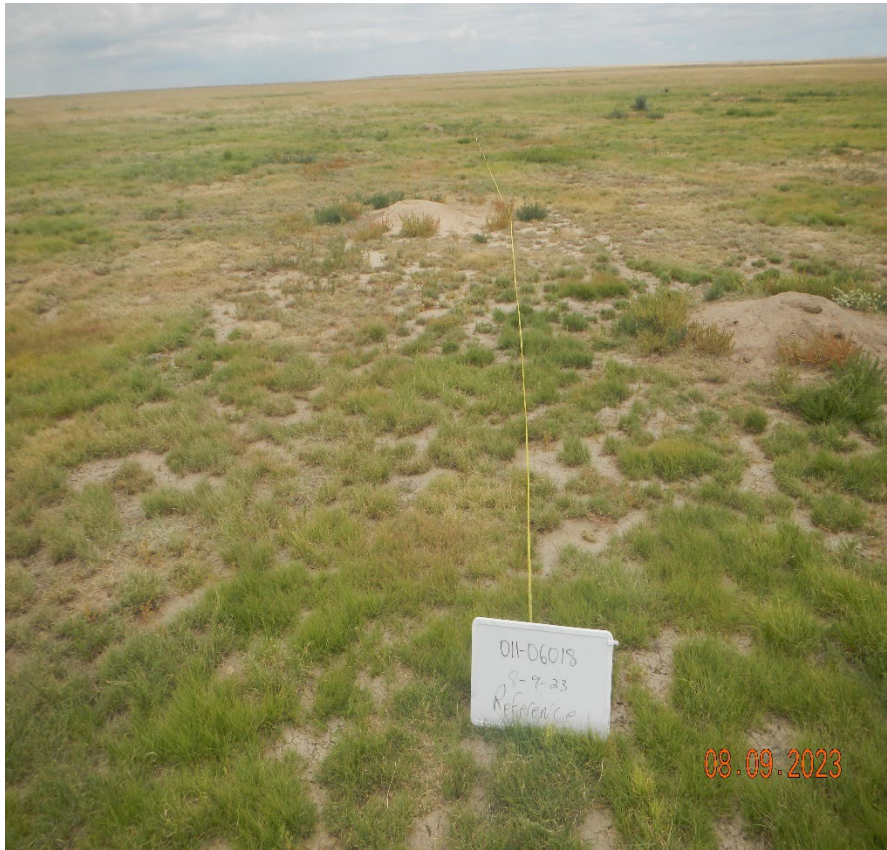
Photo 8. Facing northwest at the undisturbed reference area.

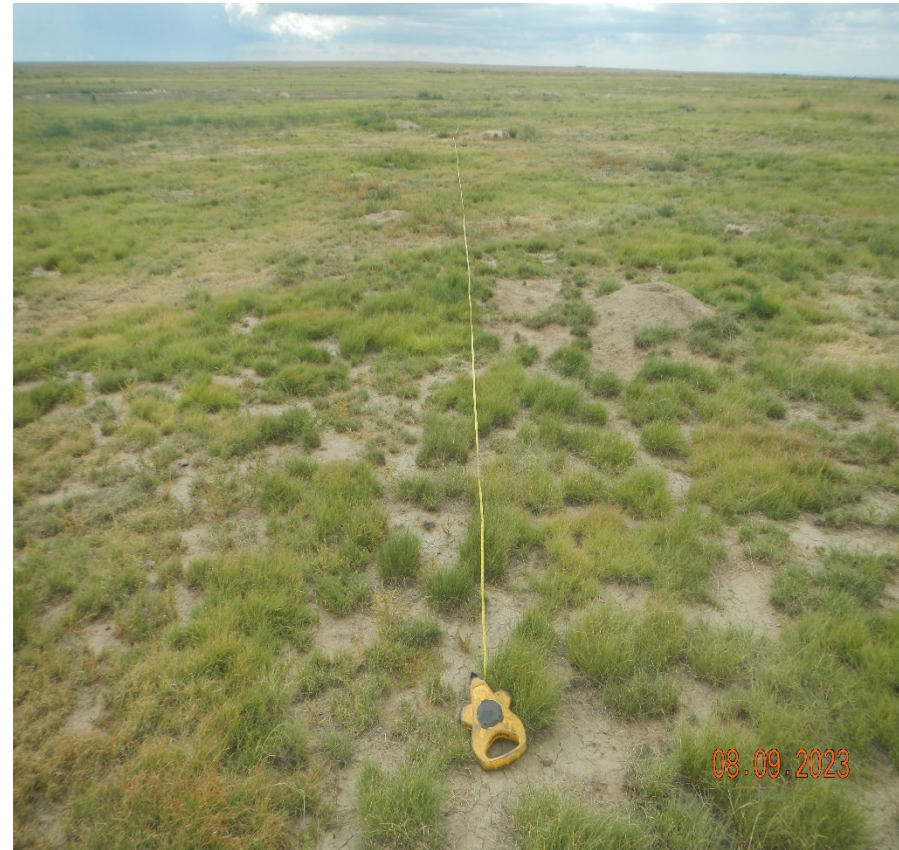
Photo 9. Facing southeast at the undisturbed reference area.

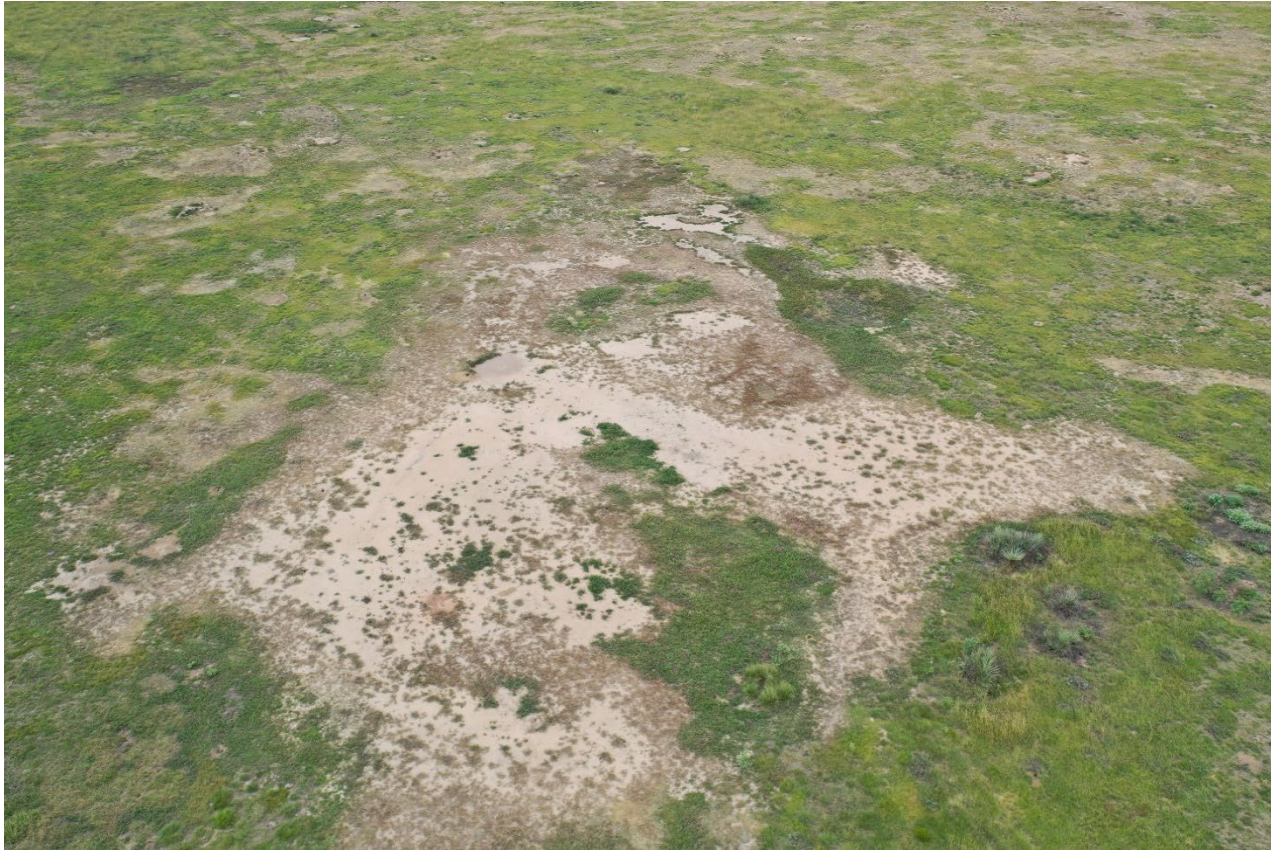
Photo 10. Drone aerial photo facing west down toward the location. There are areas bare vegetation which appear to be impacted from the wellsite operations.

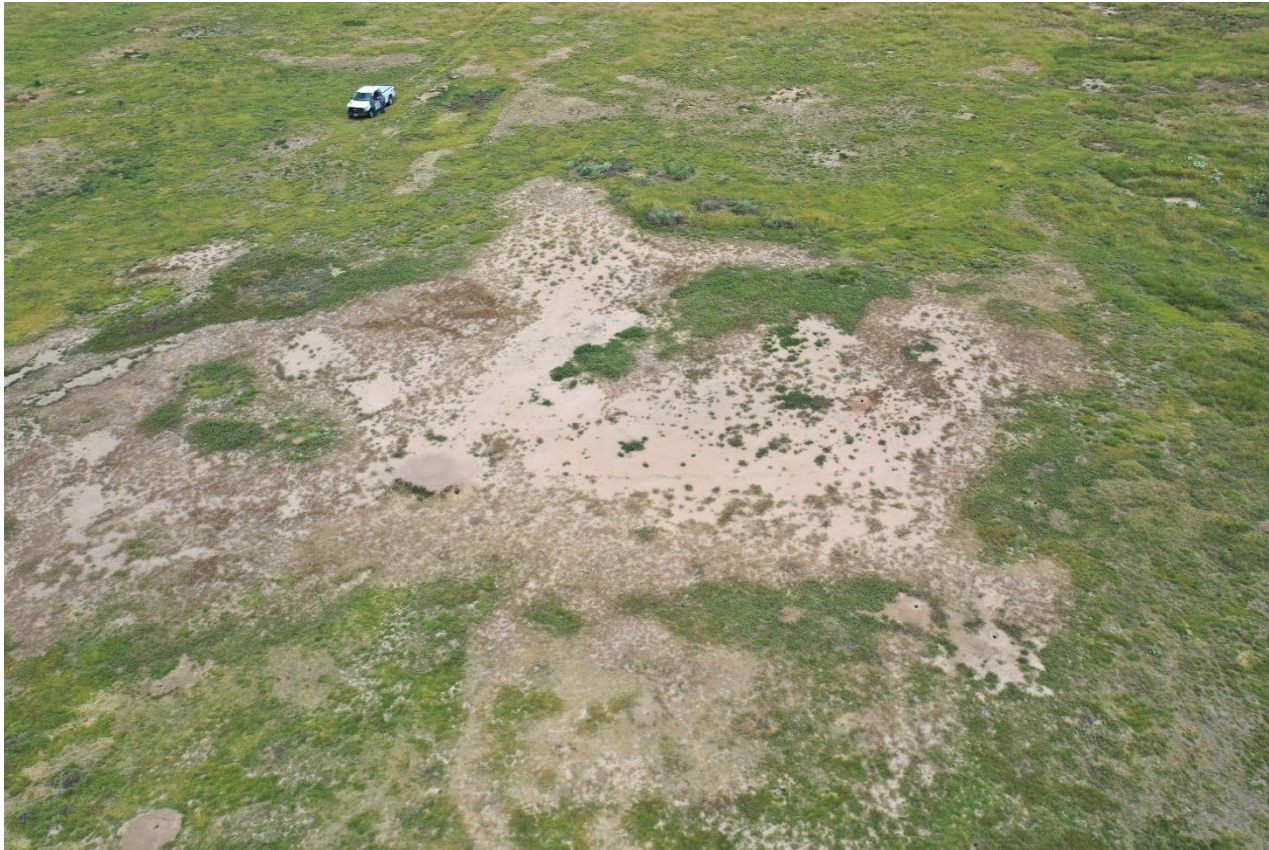
Photo 11. Drone aerial photo facing north down toward the location. The inspectors truck is shown in the upper left for scale.

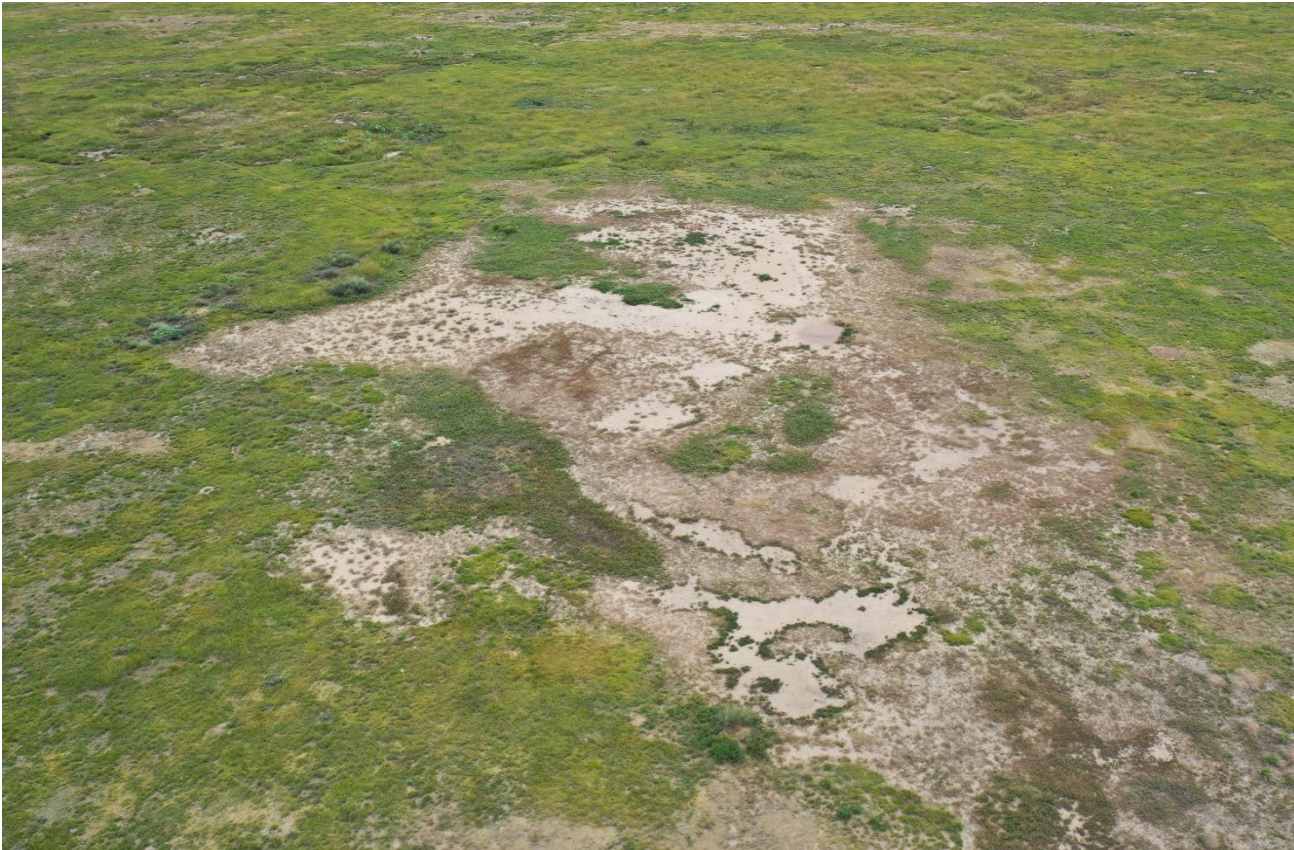
Photo 12. Drone aerial photo facing east down toward the location. There are areas bare vegetation which appear to be impacted from the wellsite operations.

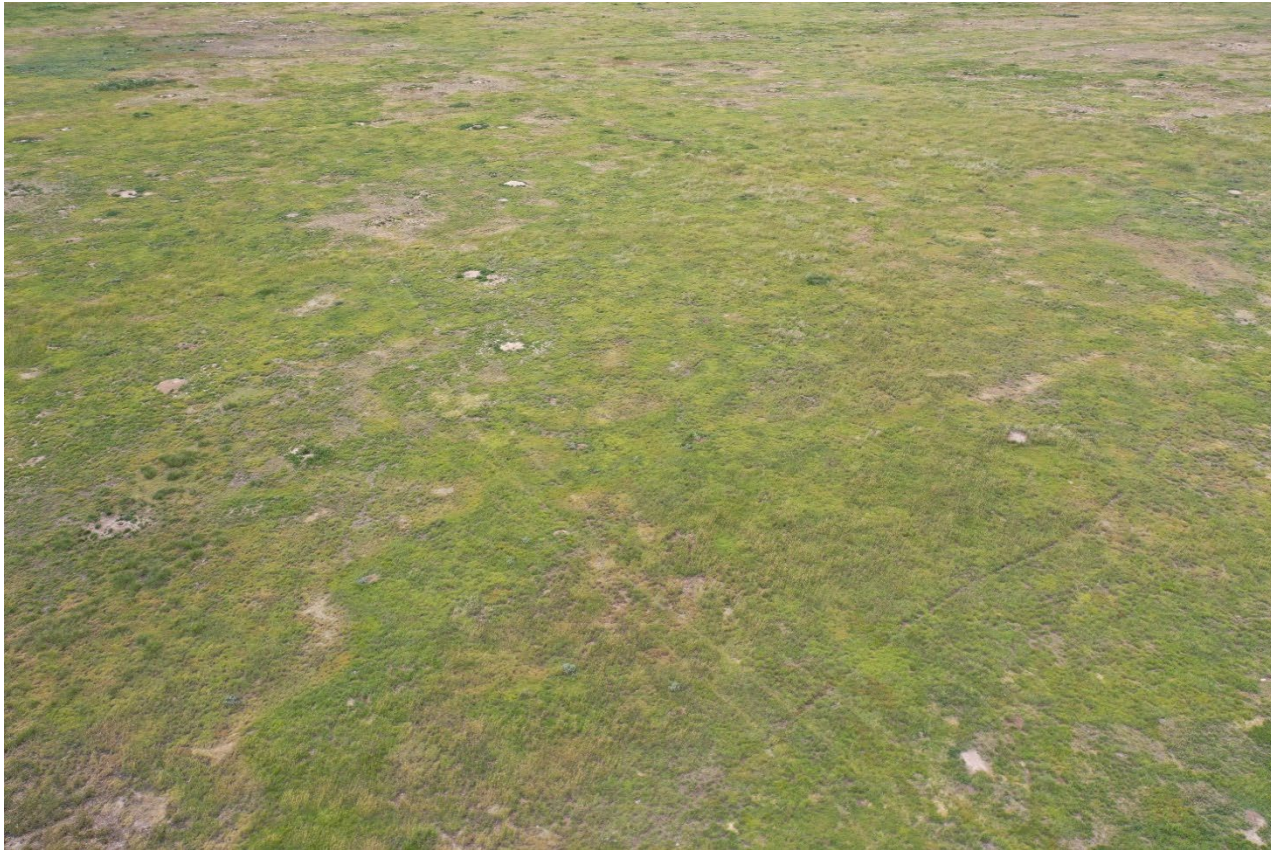
Photo 13. Drone aerial photo facing southeast toward the surrounding undisturbed reference area which has a uniform perennial vegetation cover.
