Inspection Photos

API: 011-06194

Operator: FOUNDATION ENERGY
MANAGEMENT

Inspection Date: 8/9/2023

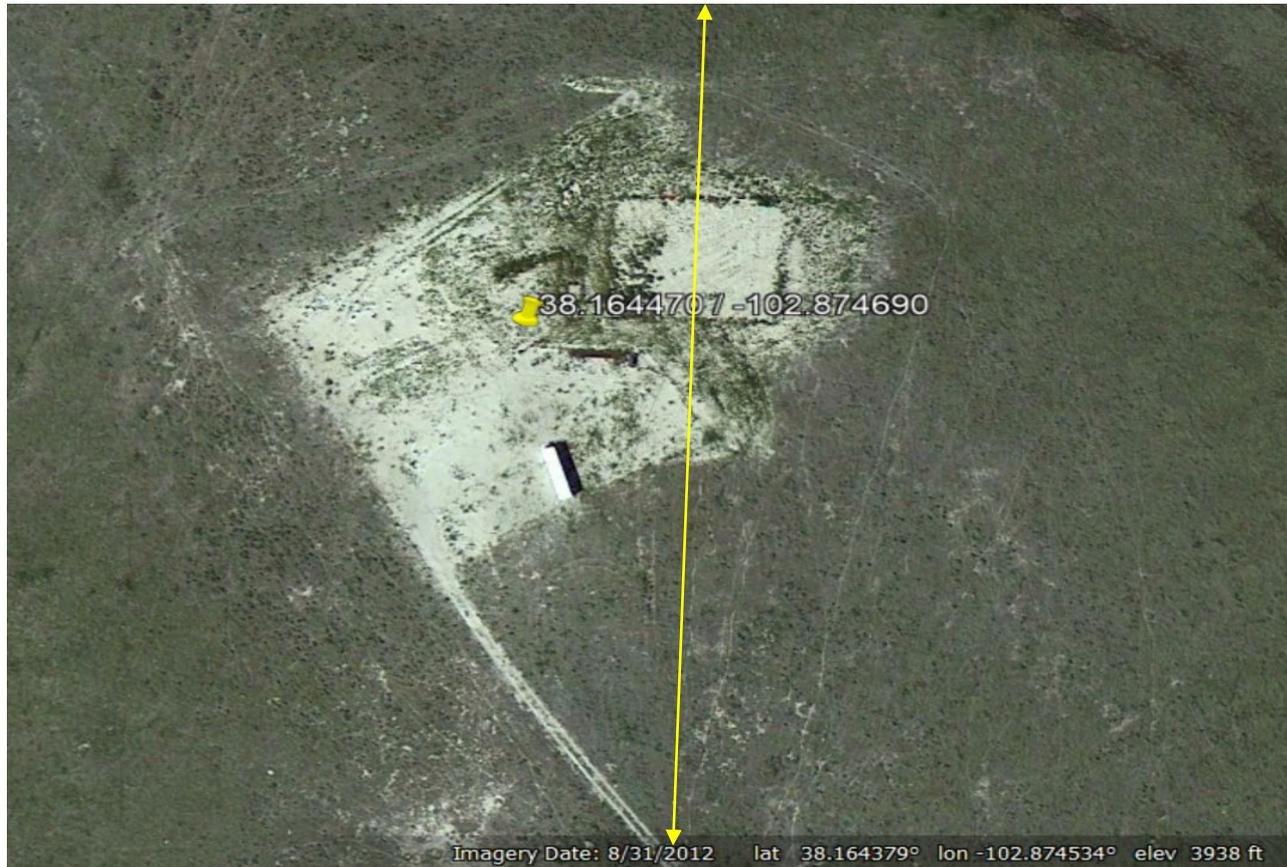
Photo 1. 2012 Aerial photo shows approximate disturbance of the location. The yellow line depicts the fence line which is also shown in the following photos for reference.

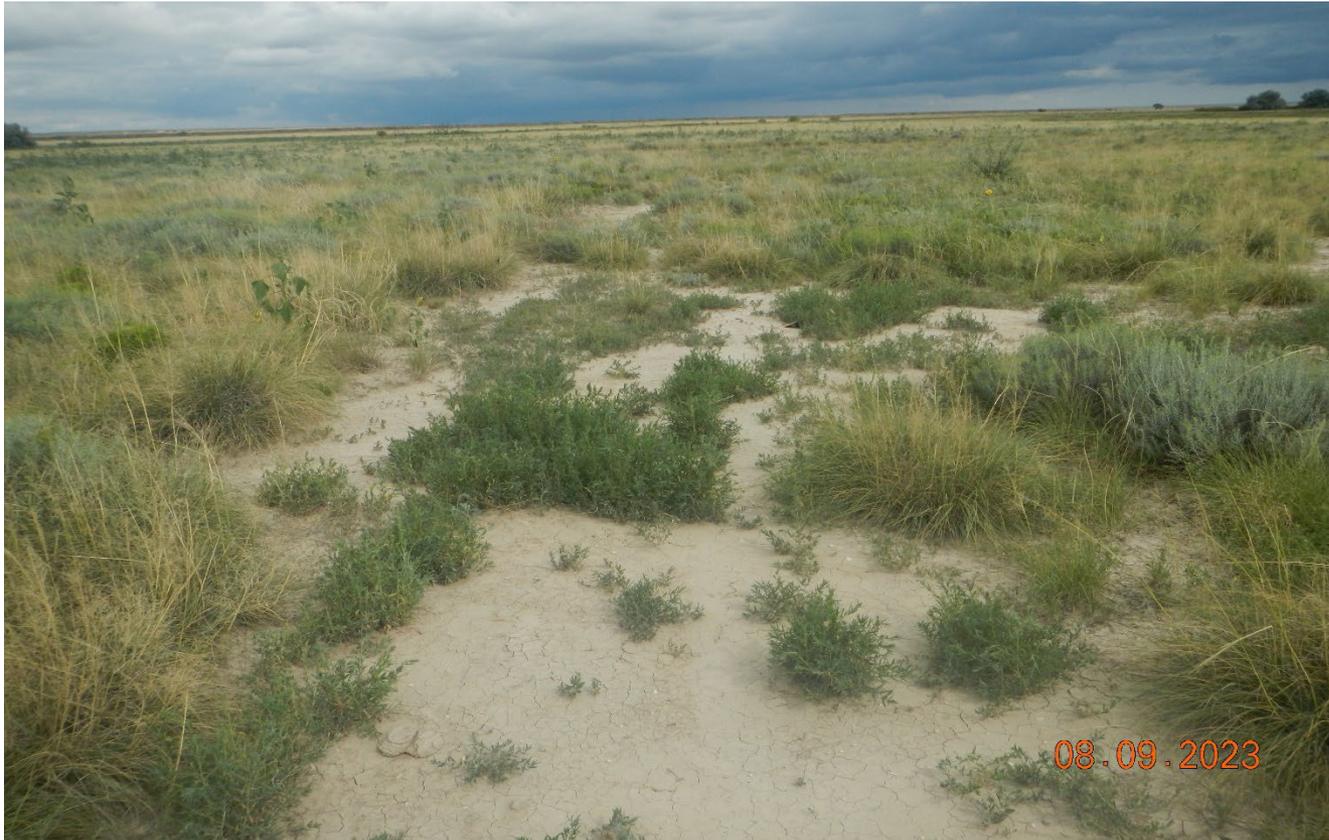
Photo 2. Facing north toward the location. This area about 60'x 10' has not established vegetation and may have compacted soils however the perennial vegetation at the west side of the location appears to be progressing.

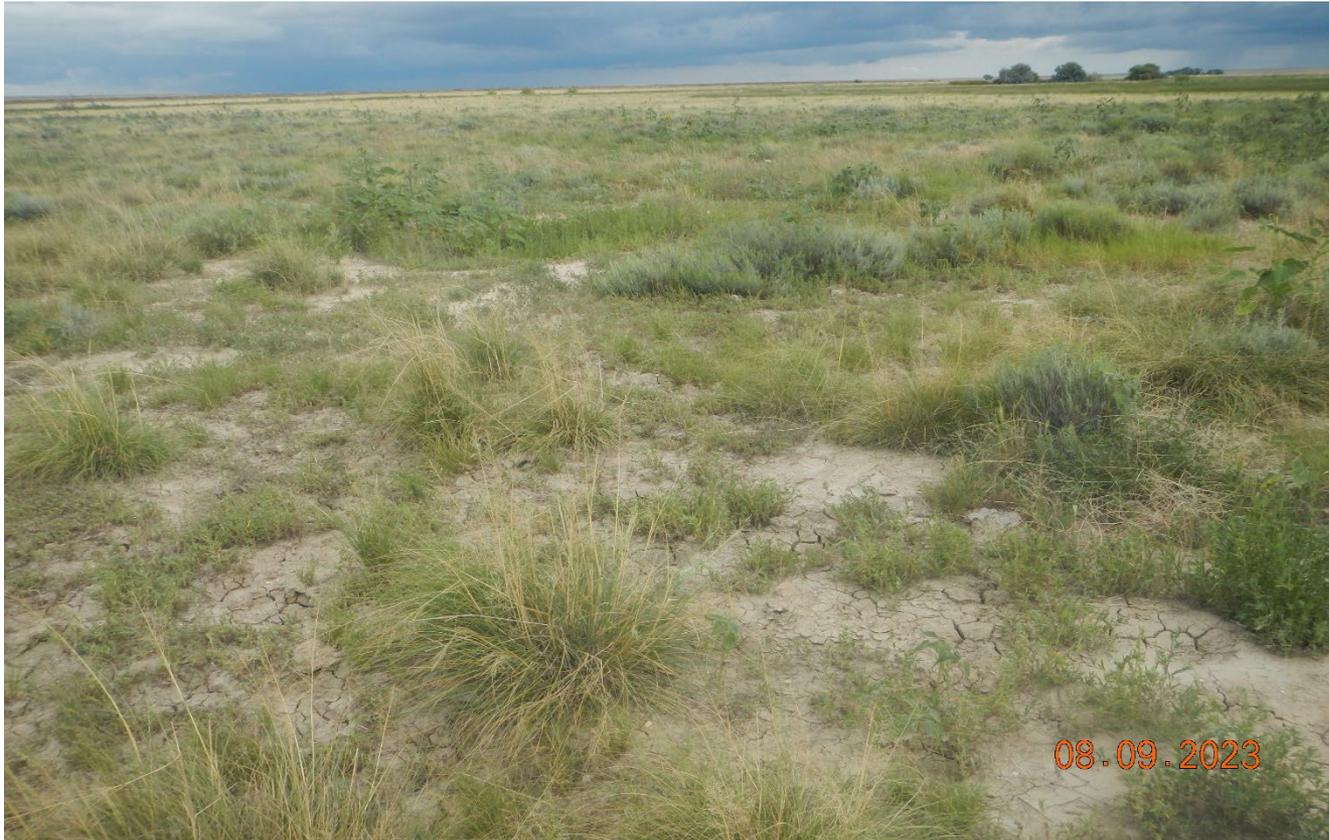
Photo 3. Facing north at the location. The perennial vegetation at the west side of the location appears to be progressing.

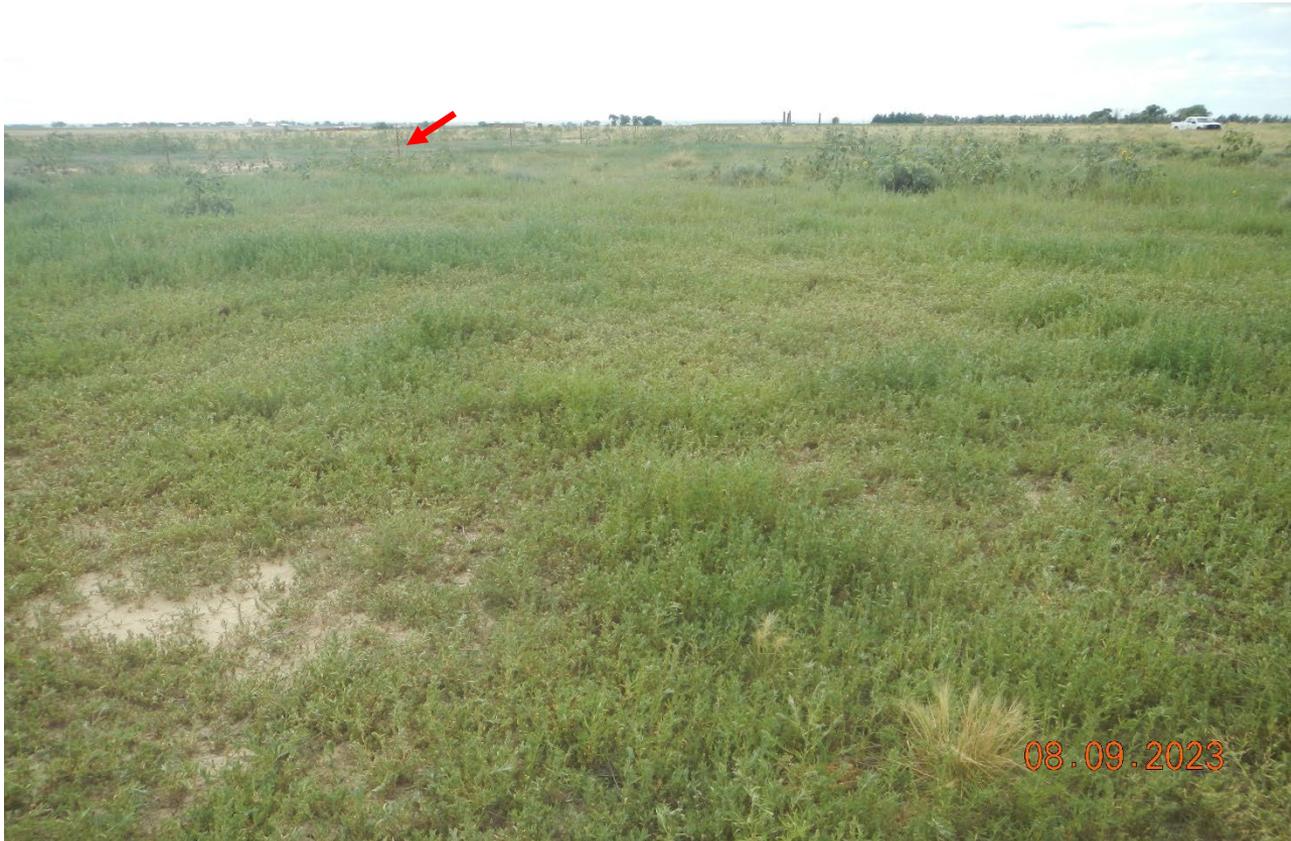
Photo 4. Northeast side of the location facing southeast. This area of the location where pit was location has not established desirable vegetation and consists mostly of undesirable weeds (Kochia). Red arrow points to the fence line.

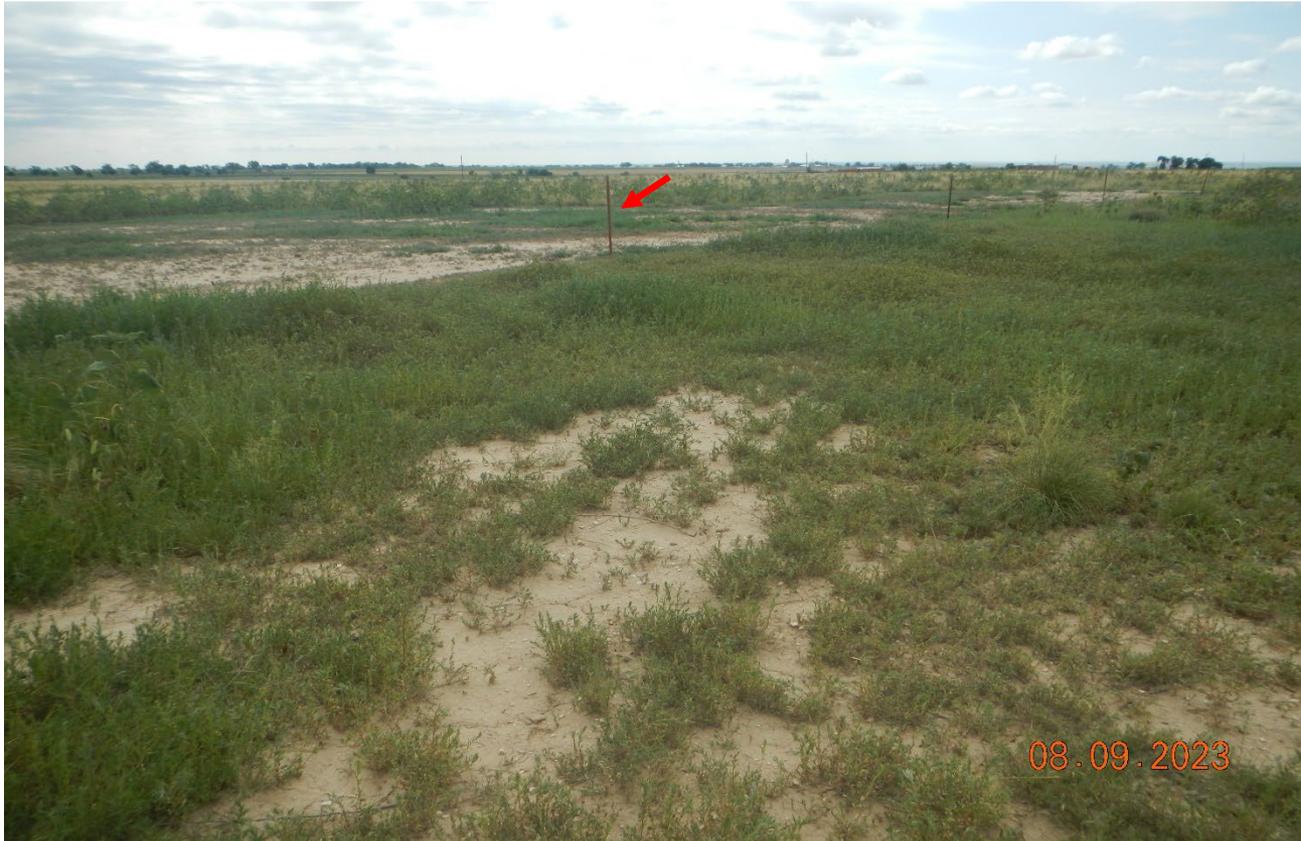
Photo 5. East side of the location facing southeast. This area of the location where pit was location has not established desirable vegetation and consists mostly of undesirable weeds (Kochia). Red arrow points to the fence line.

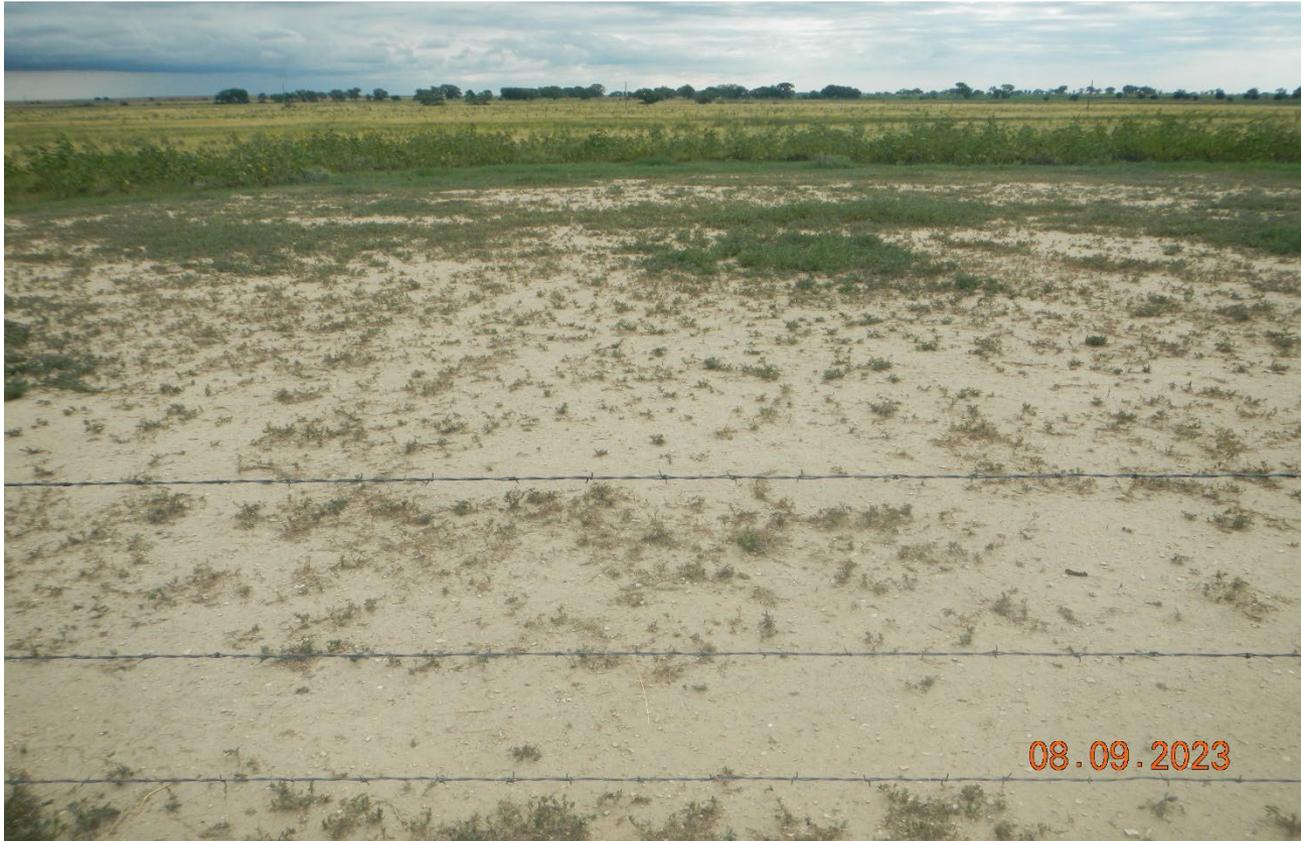
Photo 6. East side of the location facing east at the fence line. This area of the location where pit was location has not established desirable vegetation and consists mostly of undesirable weeds (Kochia).

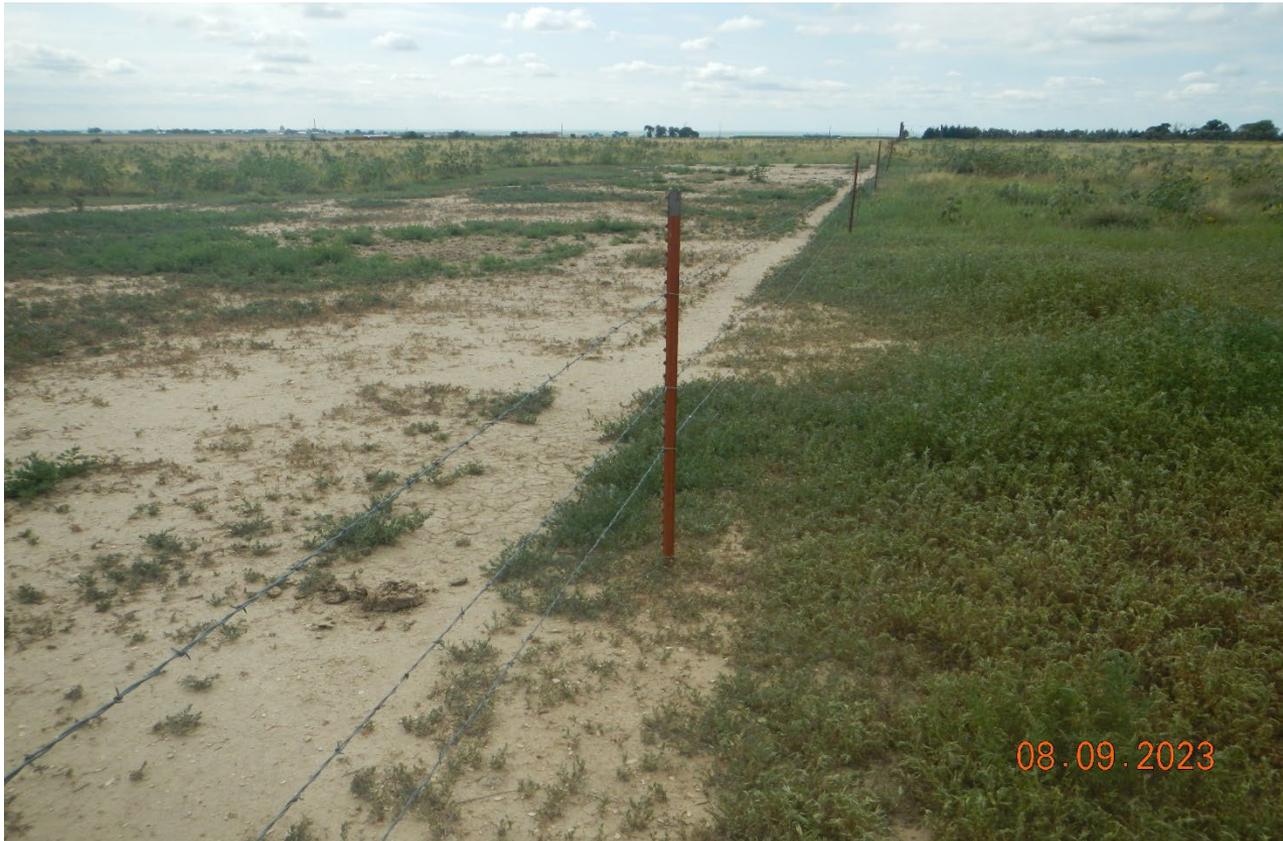
Photo 7. East side of the location facing southeast at the fence line. This area of the location where pit was location has not established desirable vegetation and consists mostly of undesirable weeds (Kochia).

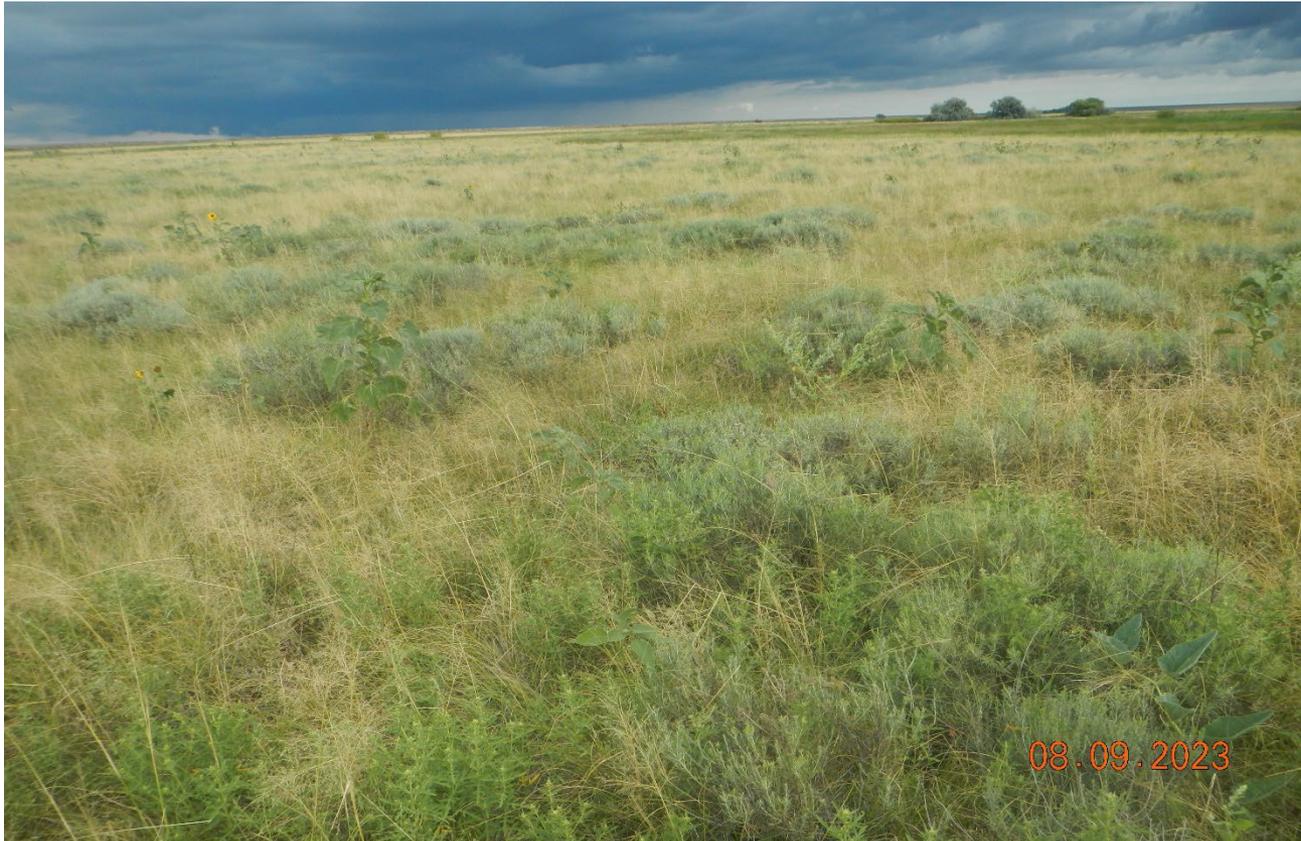
Photo 6. Facing north toward the surrounding undisturbed reference area.
