Inspection Photos
Location Name: CAERUS PICEANCE LLC N1B Pad
Location #: 334934

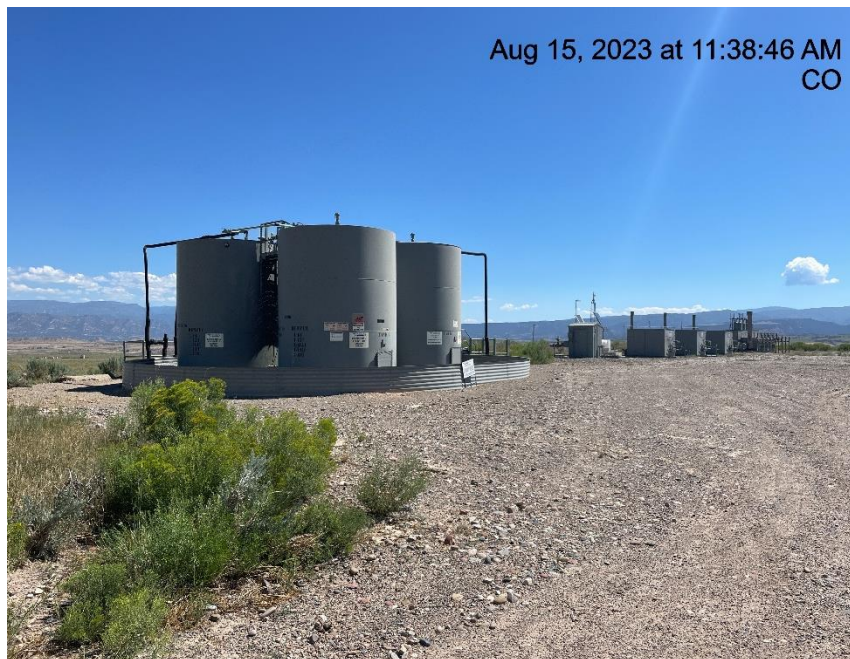
Photo # 5898 From entrance to location

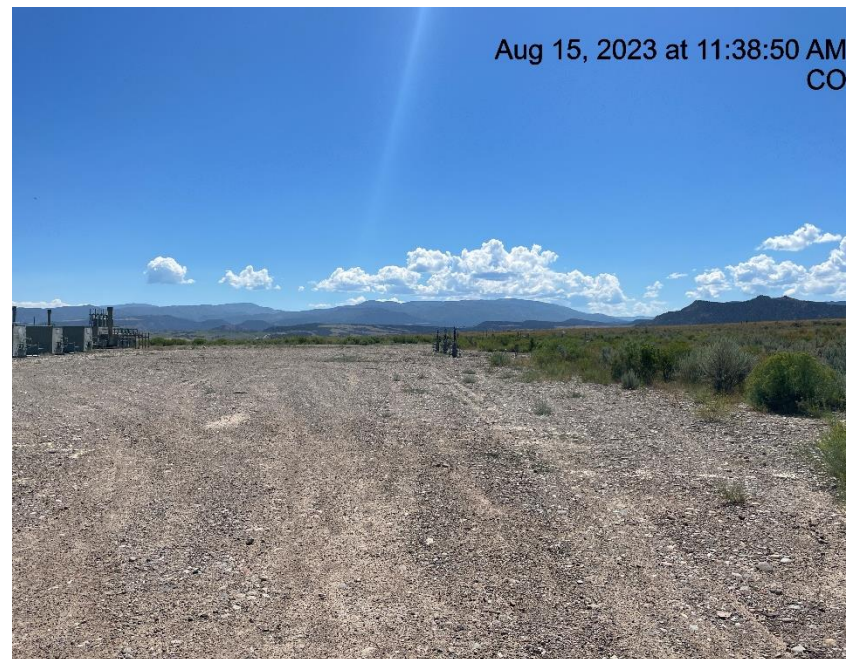
Photo # 5899 From entrance to location

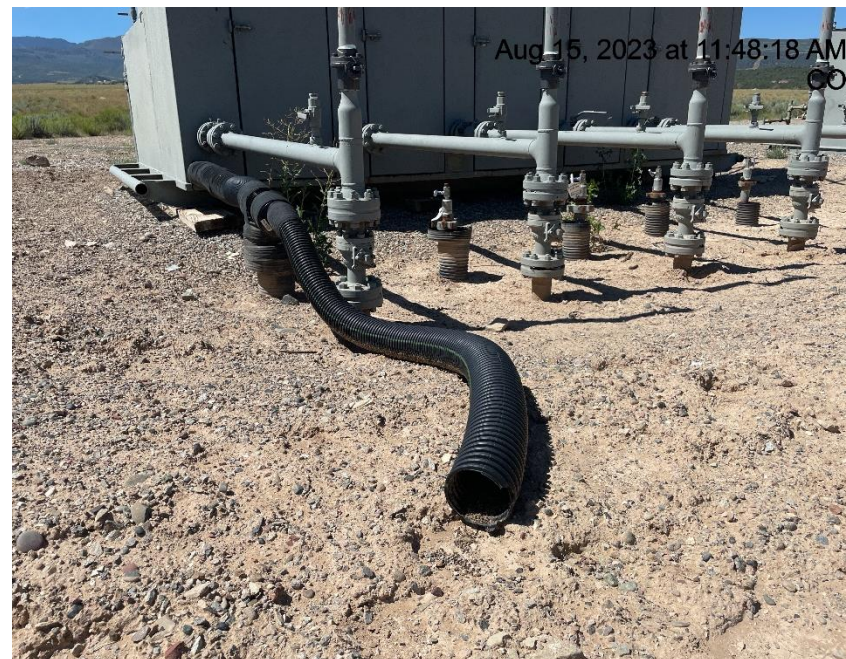
Photo # 5911 Flowline heating insulation open ended

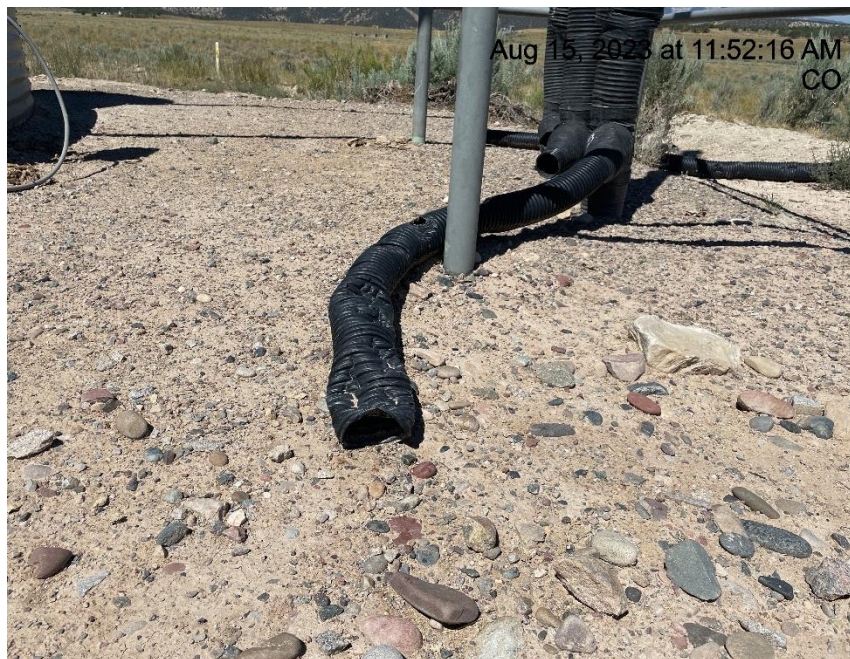
Photo # 5918 Flowline heating insulation open ended

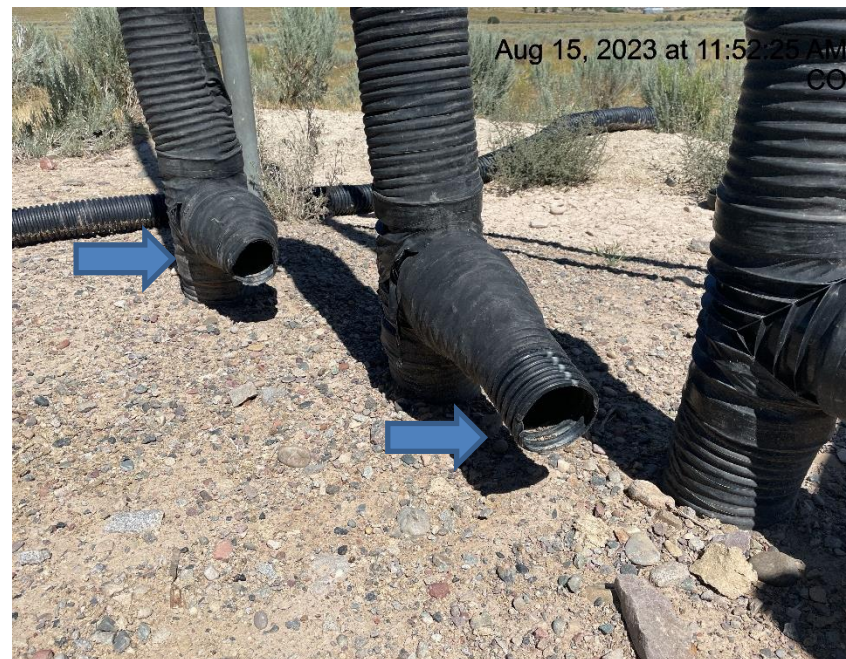
Photo # 5919 Flowline heating insulation open ended

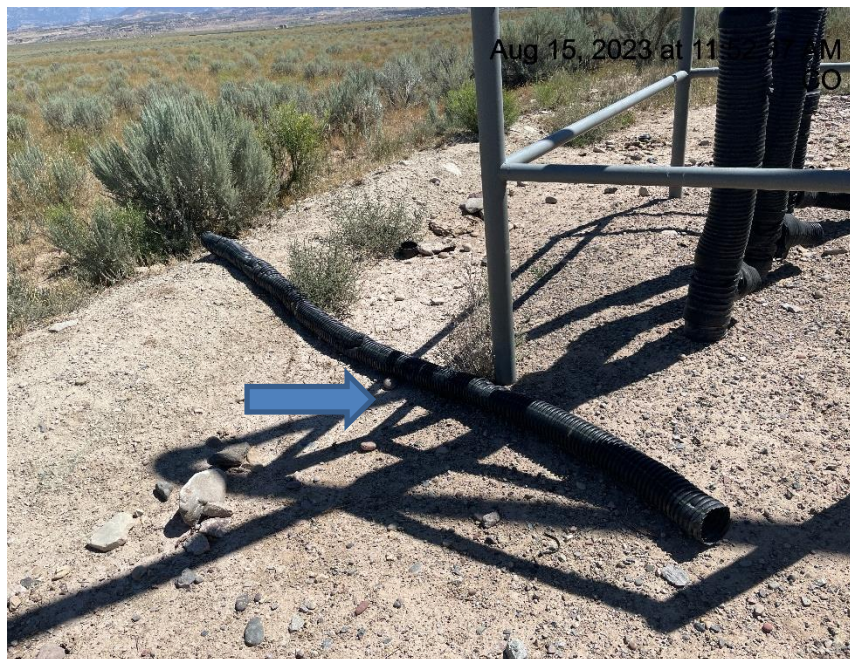
Photo # 5920 Debris

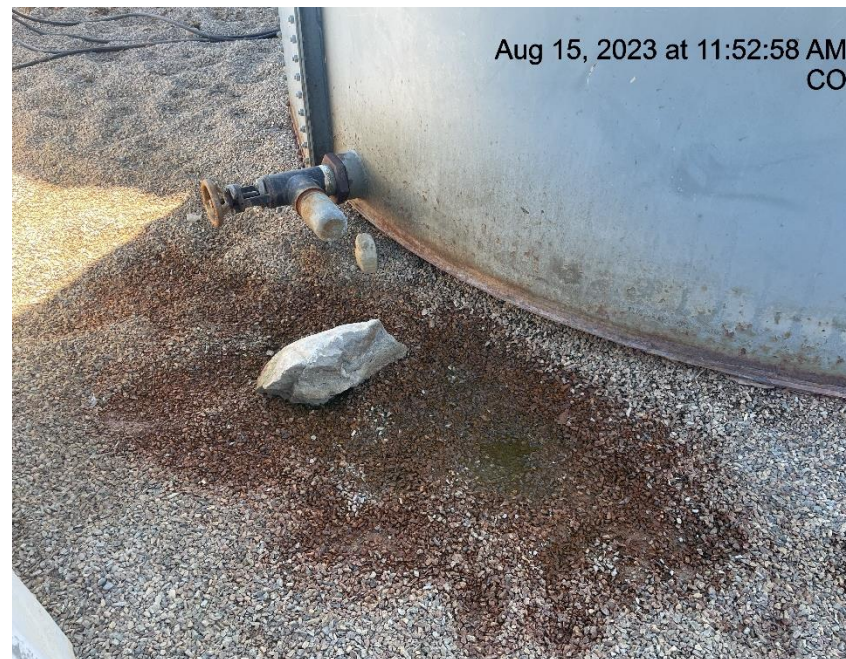
Photo # 5921 Stained gravel in secondary containment

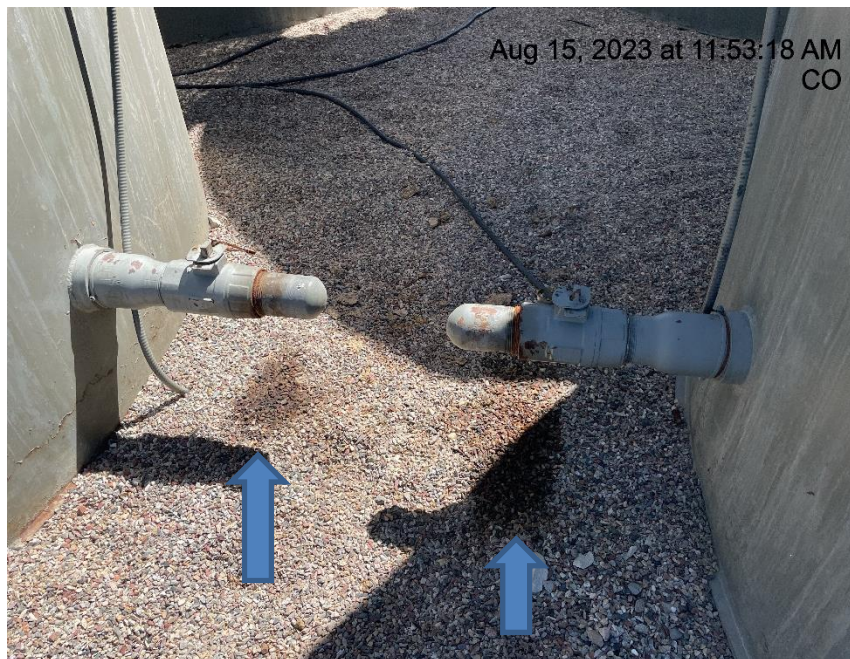
Photo # 5922 Stained gravel in secondary containment

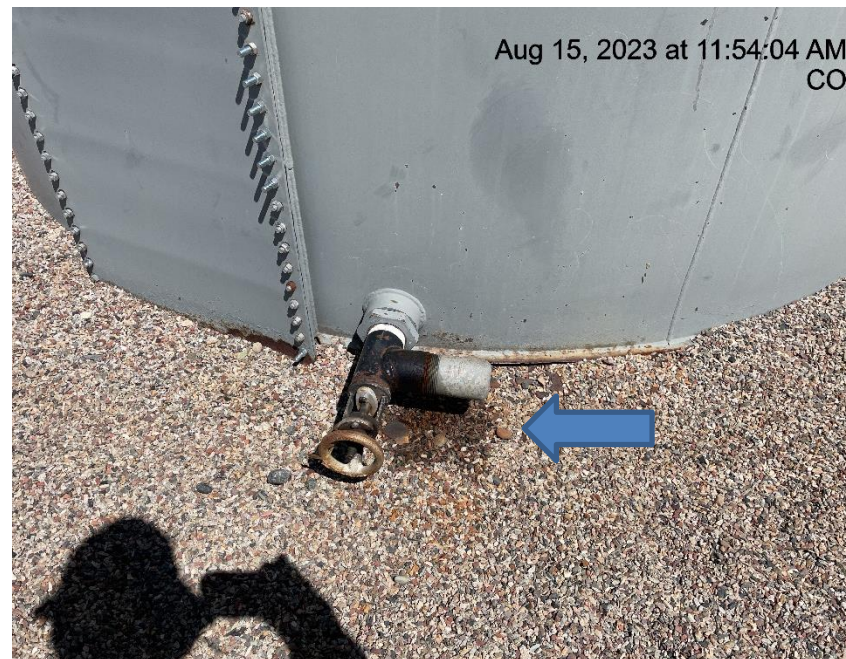
Photo # 5925 Stained gravel in secondary containment

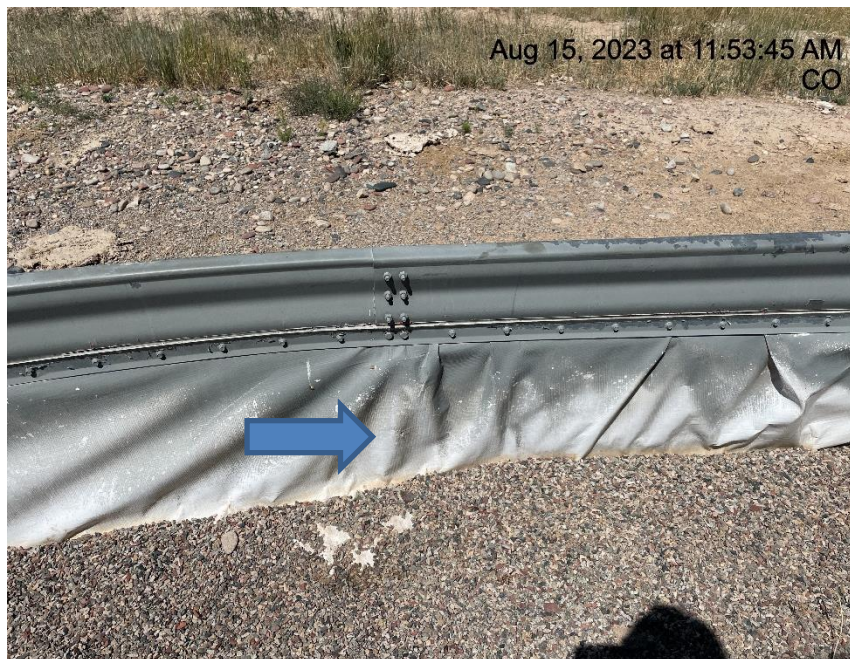
Photo # 5923 Hole in liner/liner needs maintenance

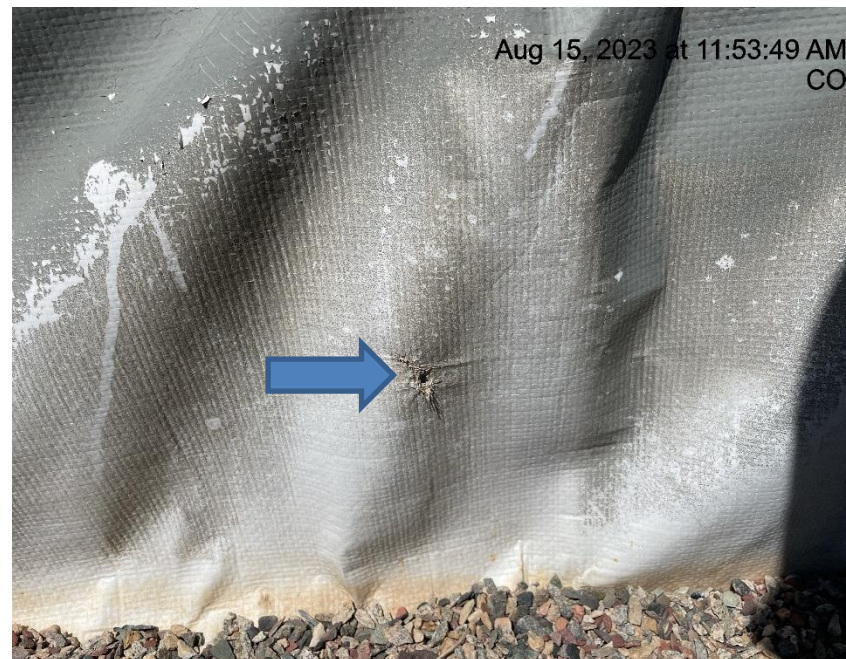
Photo # 5924 Hole in liner/liner needs maintenance

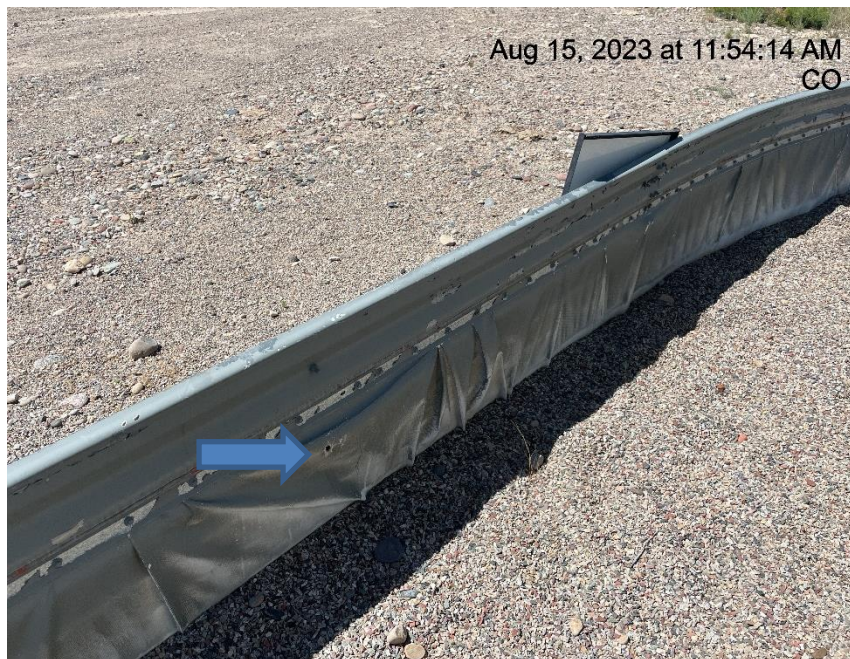
Photo # 5926 Hole in liner/liner needs maintenance

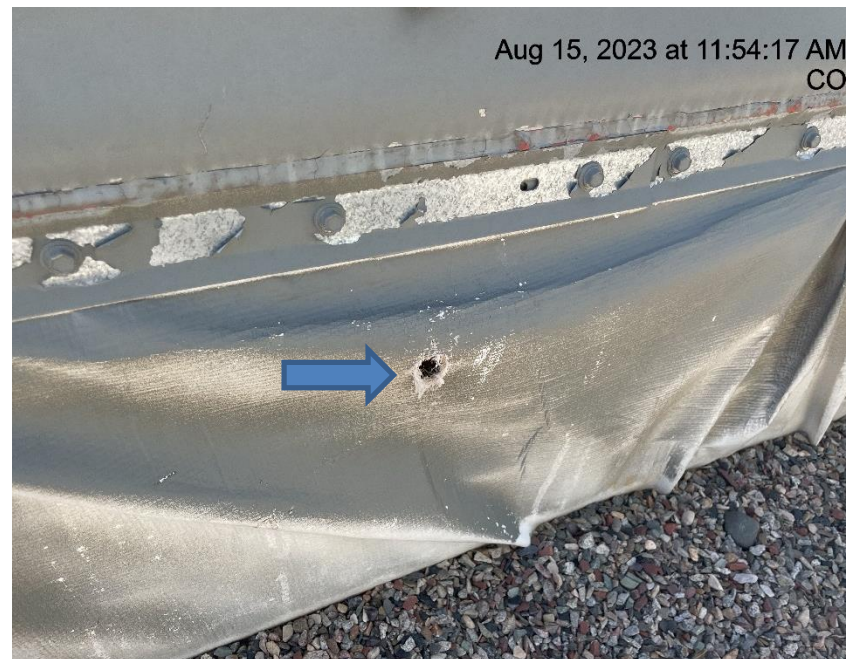
Photo # 5927 Hole in liner/liner needs maintenance

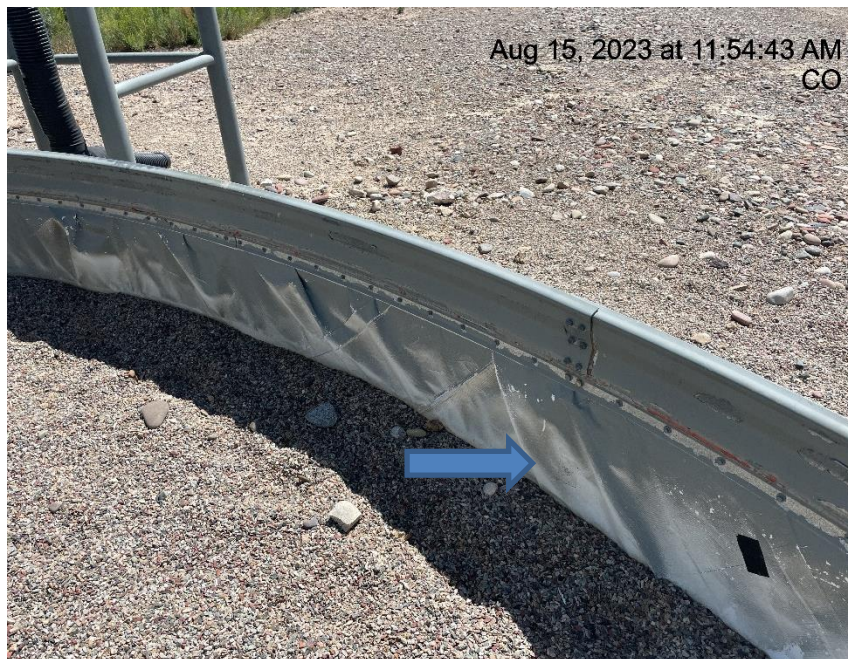
Photo # 5928 Hole in liner/liner needs maintenance

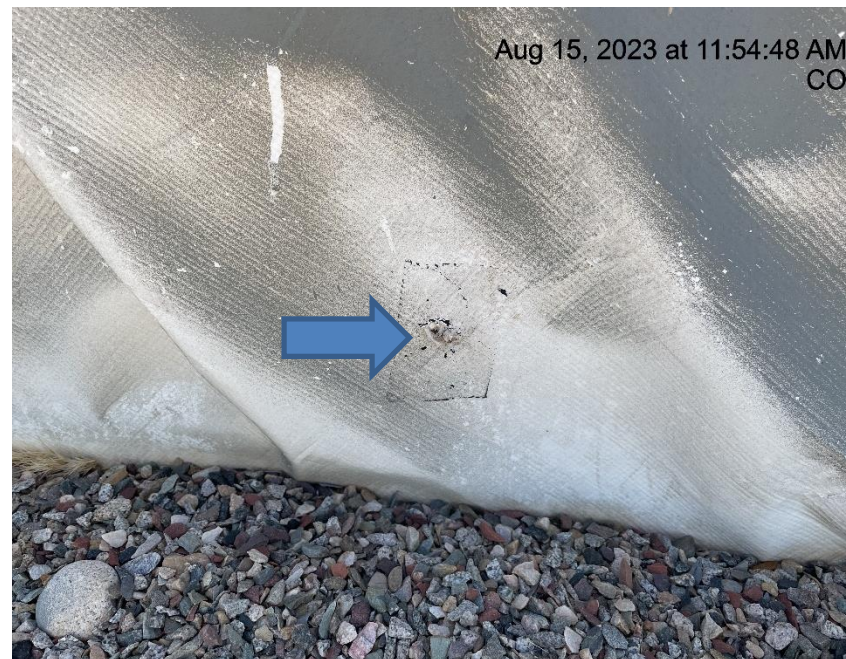
Photo # 5929 Hole in liner/liner needs maintenance
