Inspection Photos

ID: 484359

Operator: DESERT EAGLE OPERATING LLC

Inspection Date: 8/15/2023

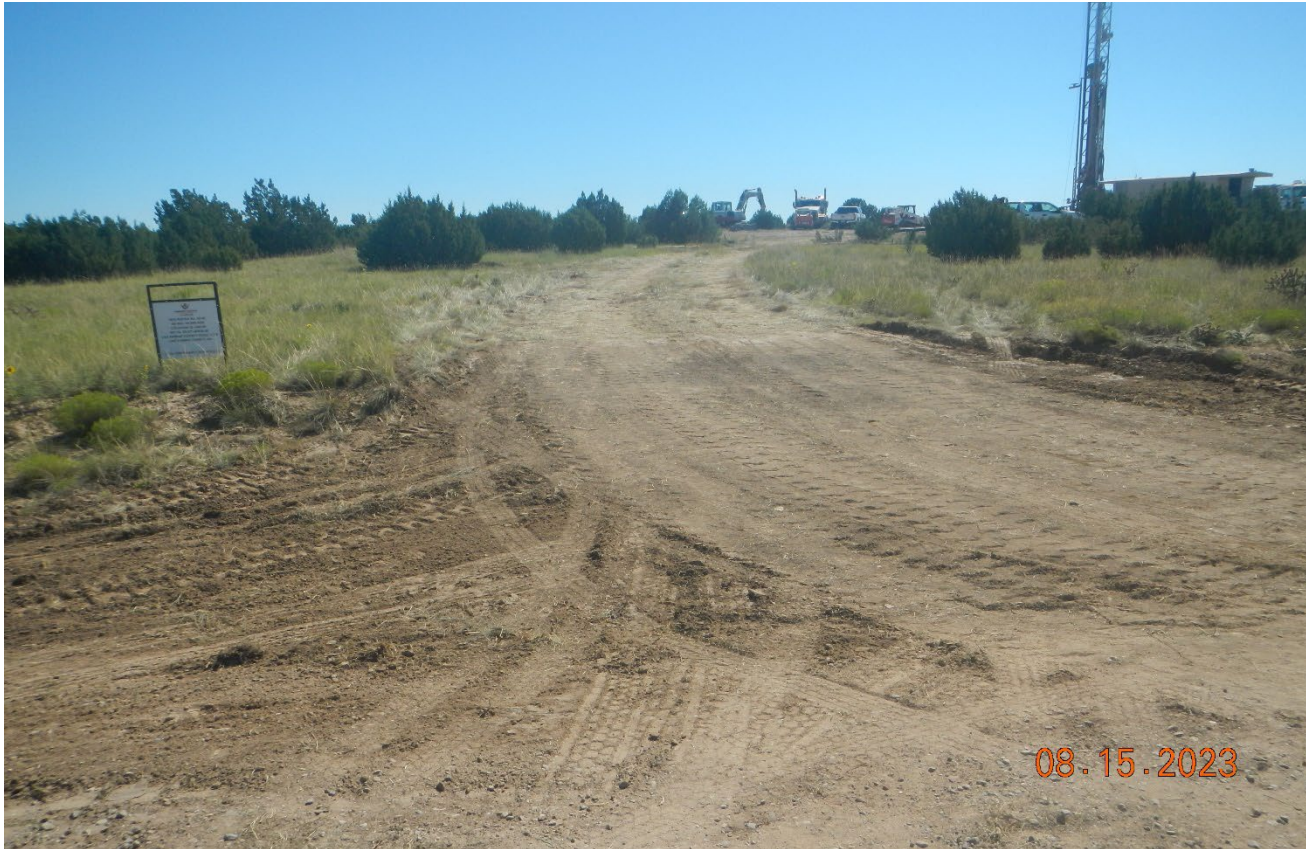
Photo 1. Facing east toward the access road.

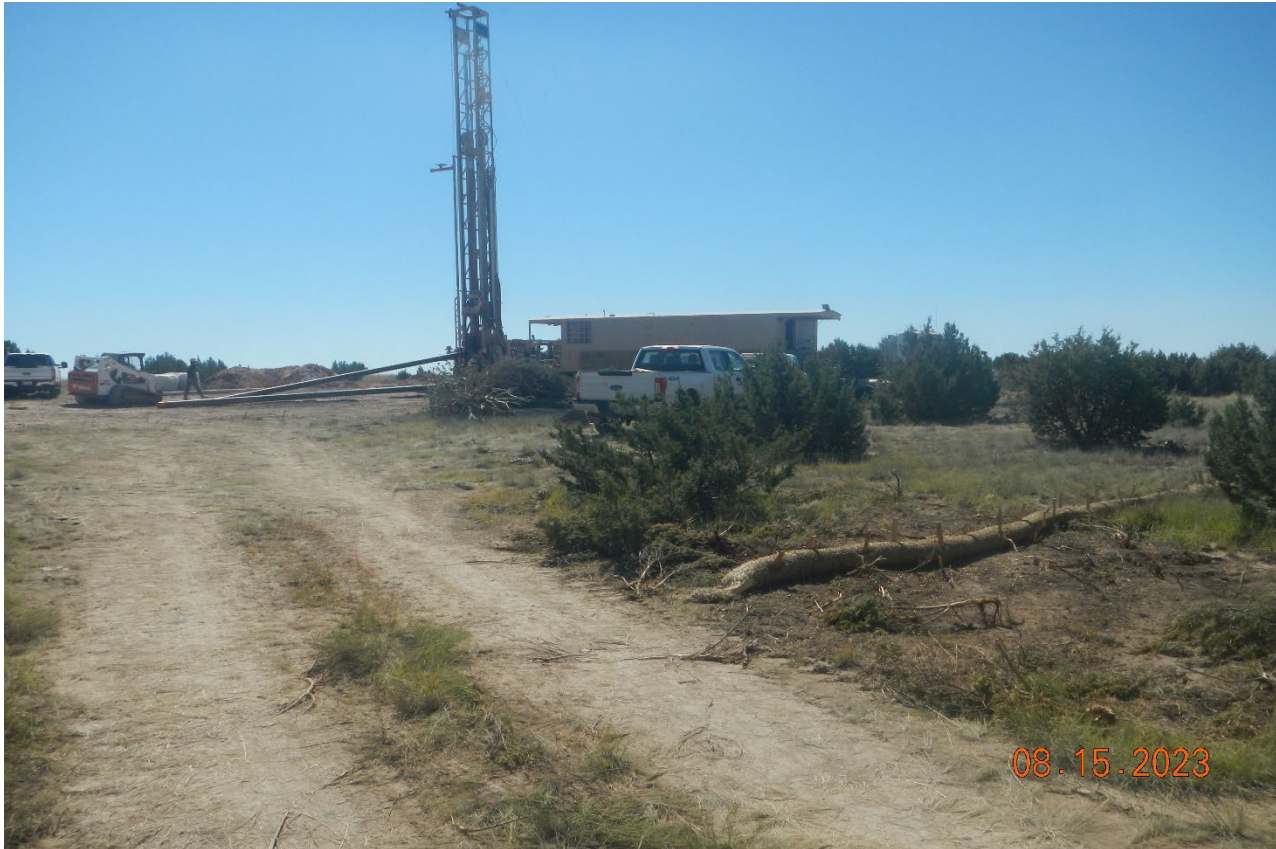
Photo 2. Facing east toward the wellsite. Drilling was in process at the time of inspection.

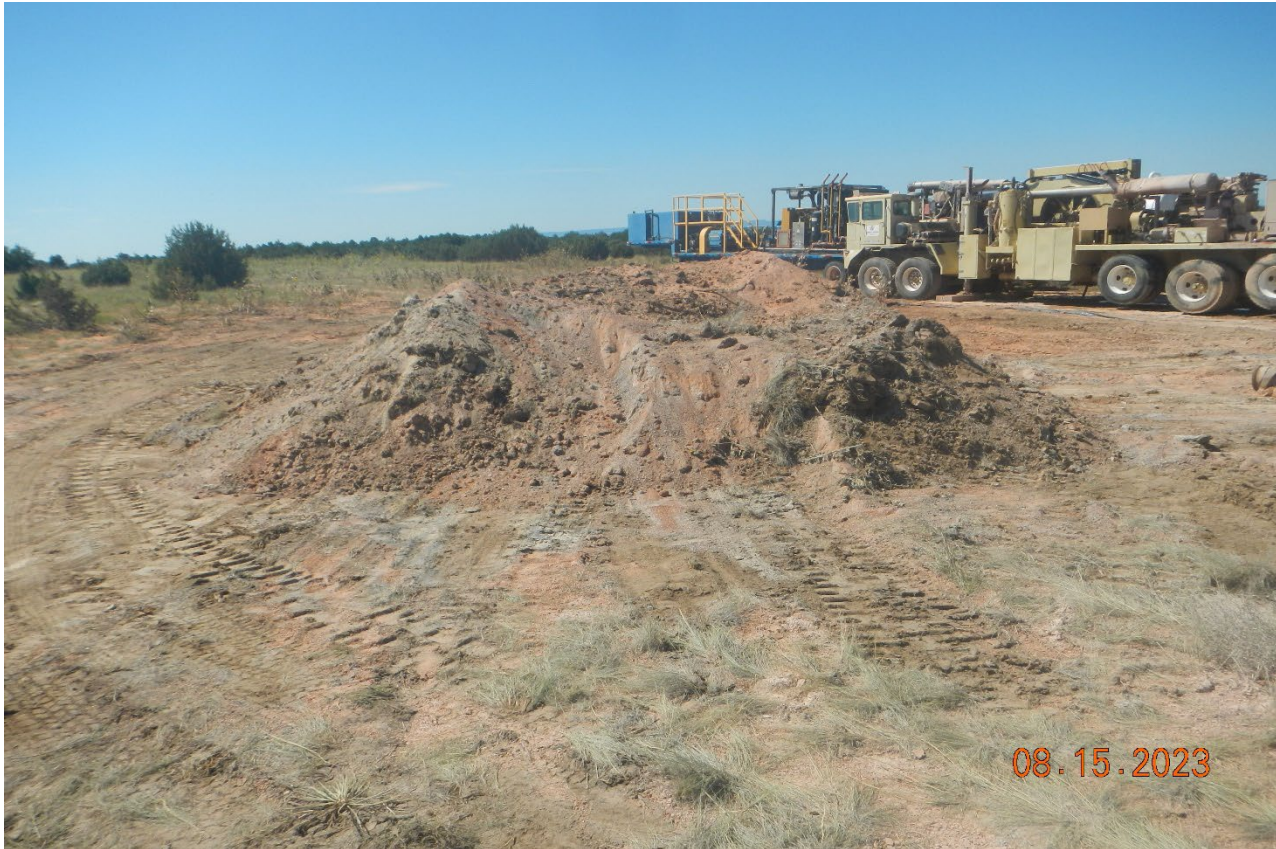
Photo 3. The cuttings pile is not stored with line and berm according to waste mng. Plan.

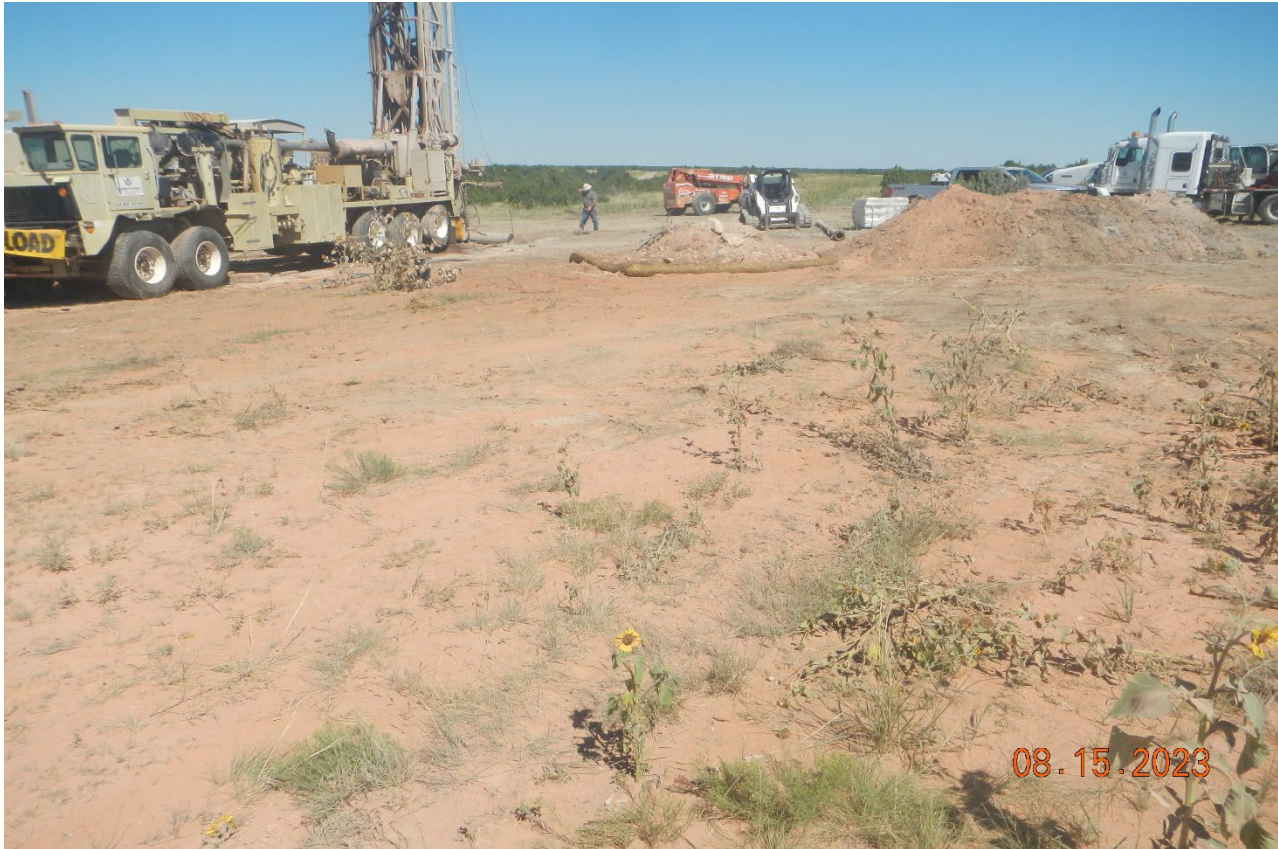
Photo 4. Facing northwest toward the wellsite.

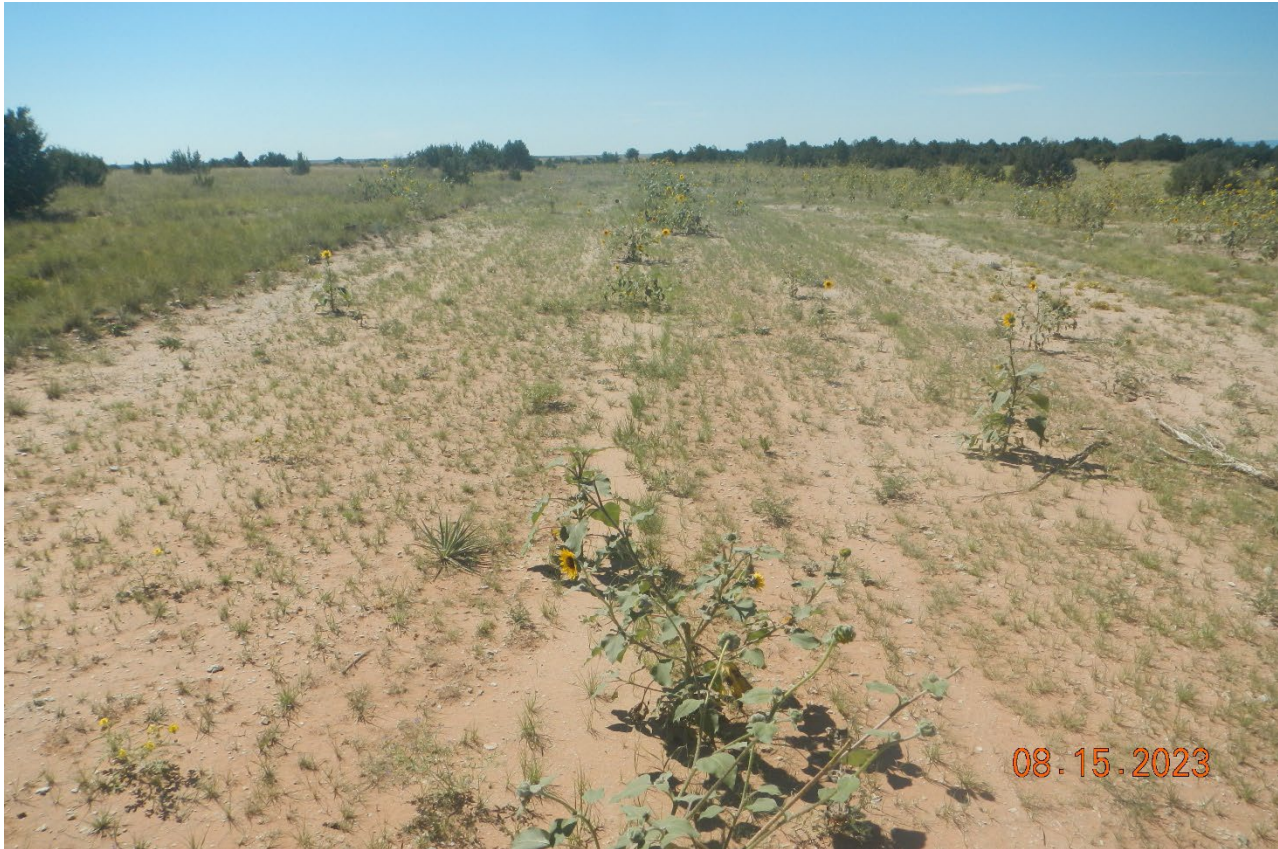
Photo 5. Facing south toward the reclaimed flowline.

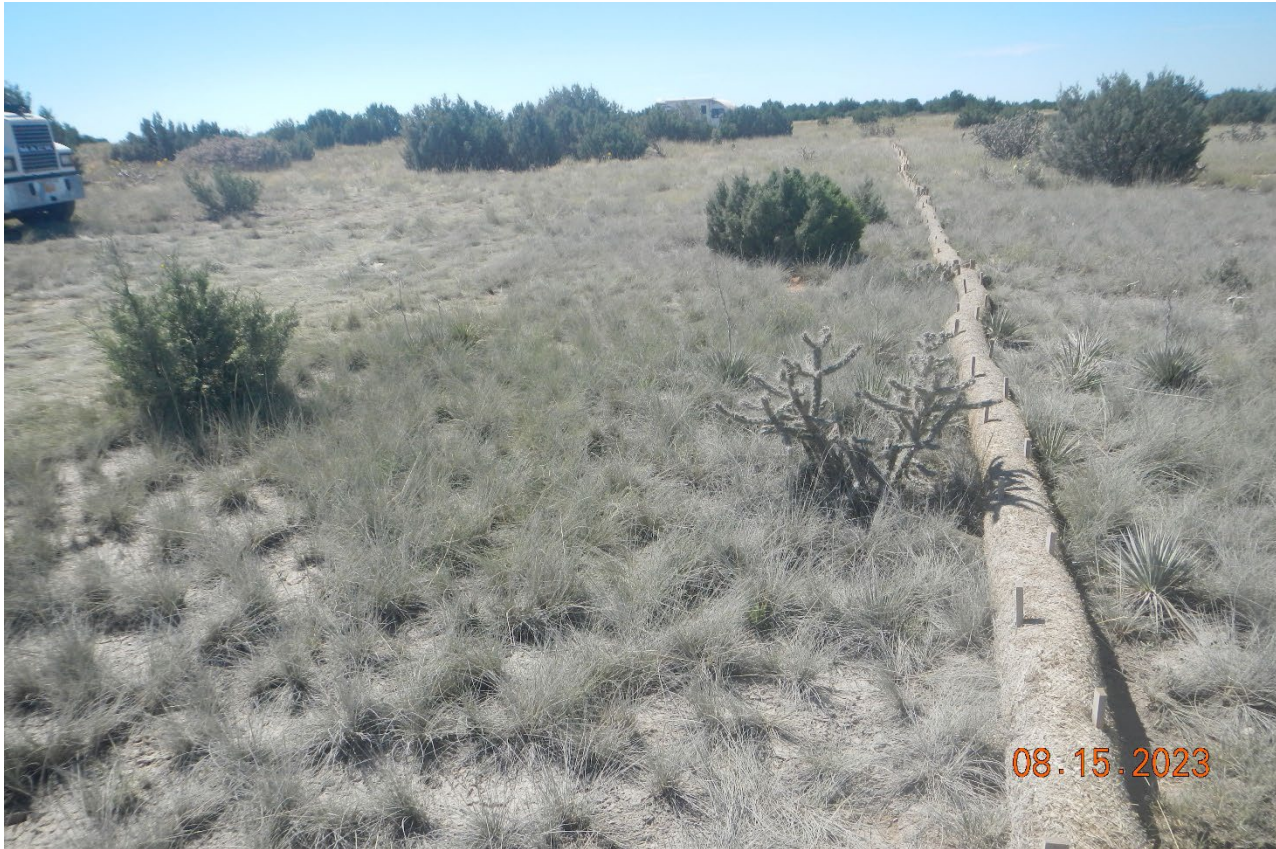
Photo 6. West side of the location facing south. Straw wattles are installed along the up and down gradient side of the location.
