Inspection Photos

API: 071-09549

Operator: EVERGREEN NATURAL RESOURCES

Inspection Date: 8/16/2023

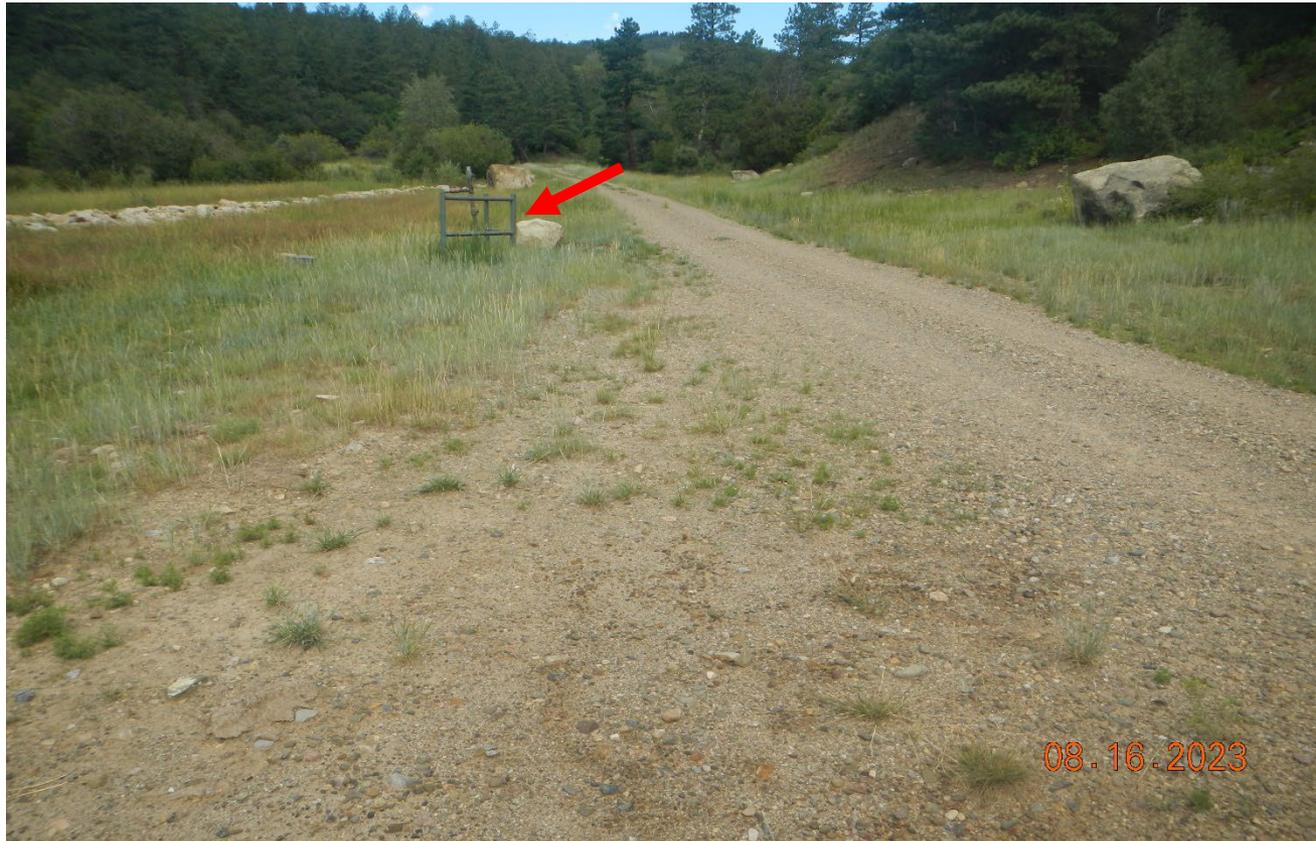
Photo 1. Facing northwest along the main access road. There is an abandoned pipe riser that still remains. No active well sites exist in this area and the riser needs to be removed.

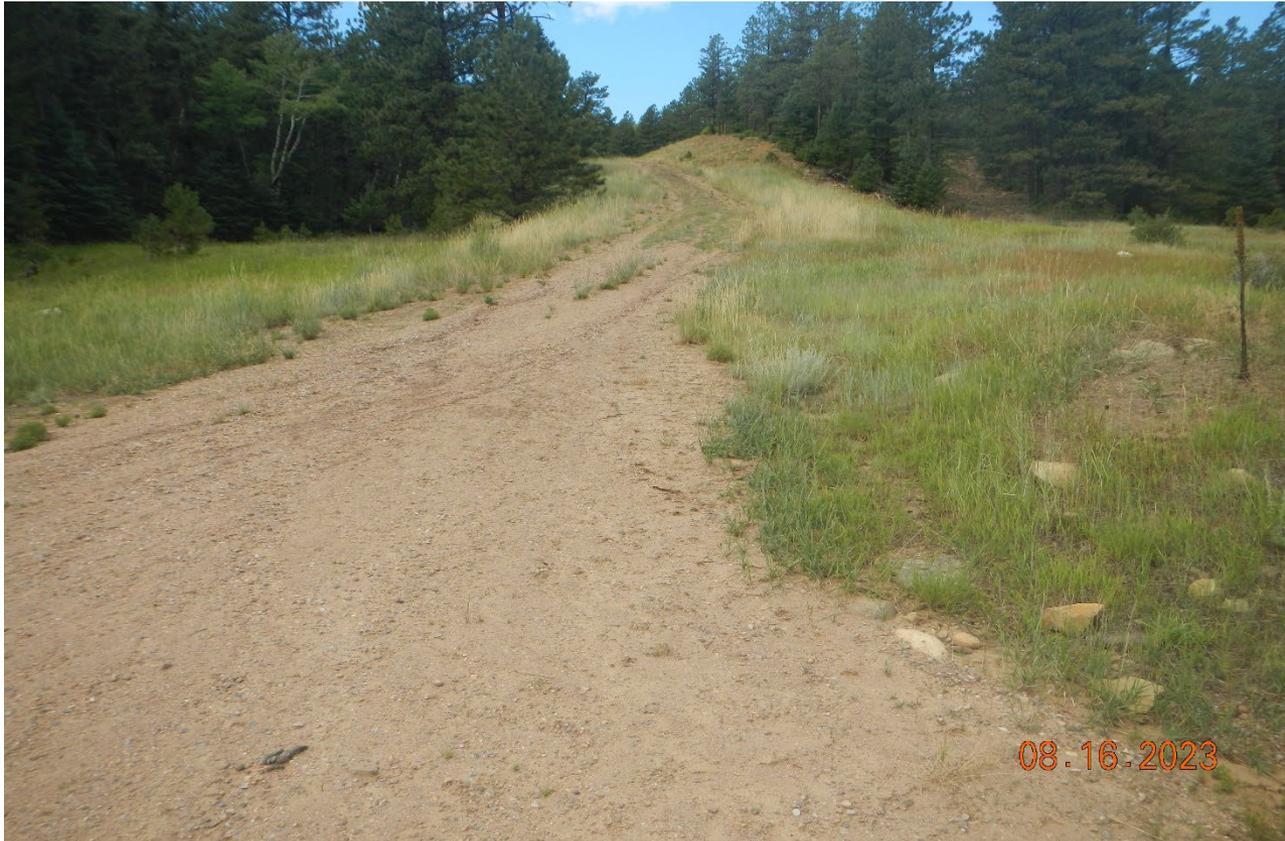
Photo 2. Facing west toward the access road which remains per approved variance.

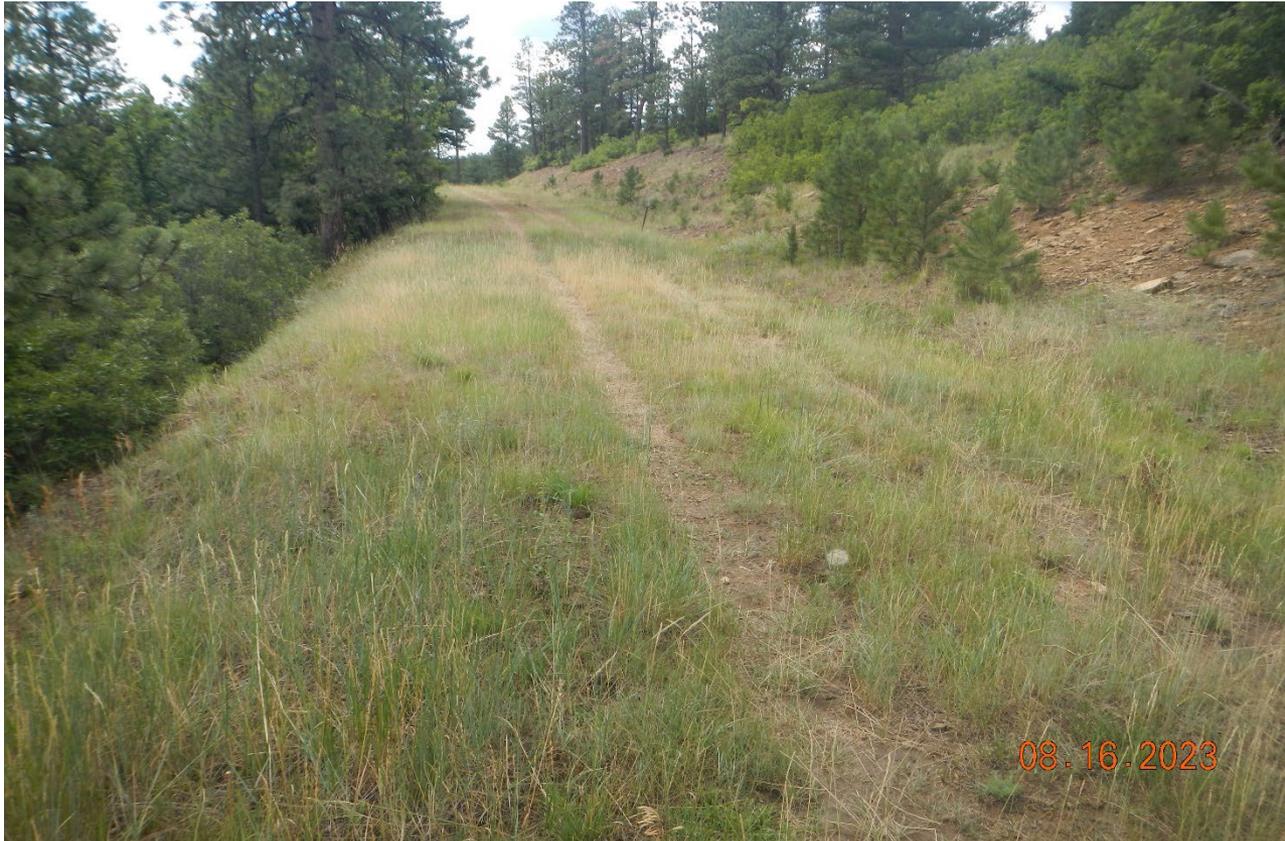
Photo 3. Facing southeast along the access road which remains per approved variance.

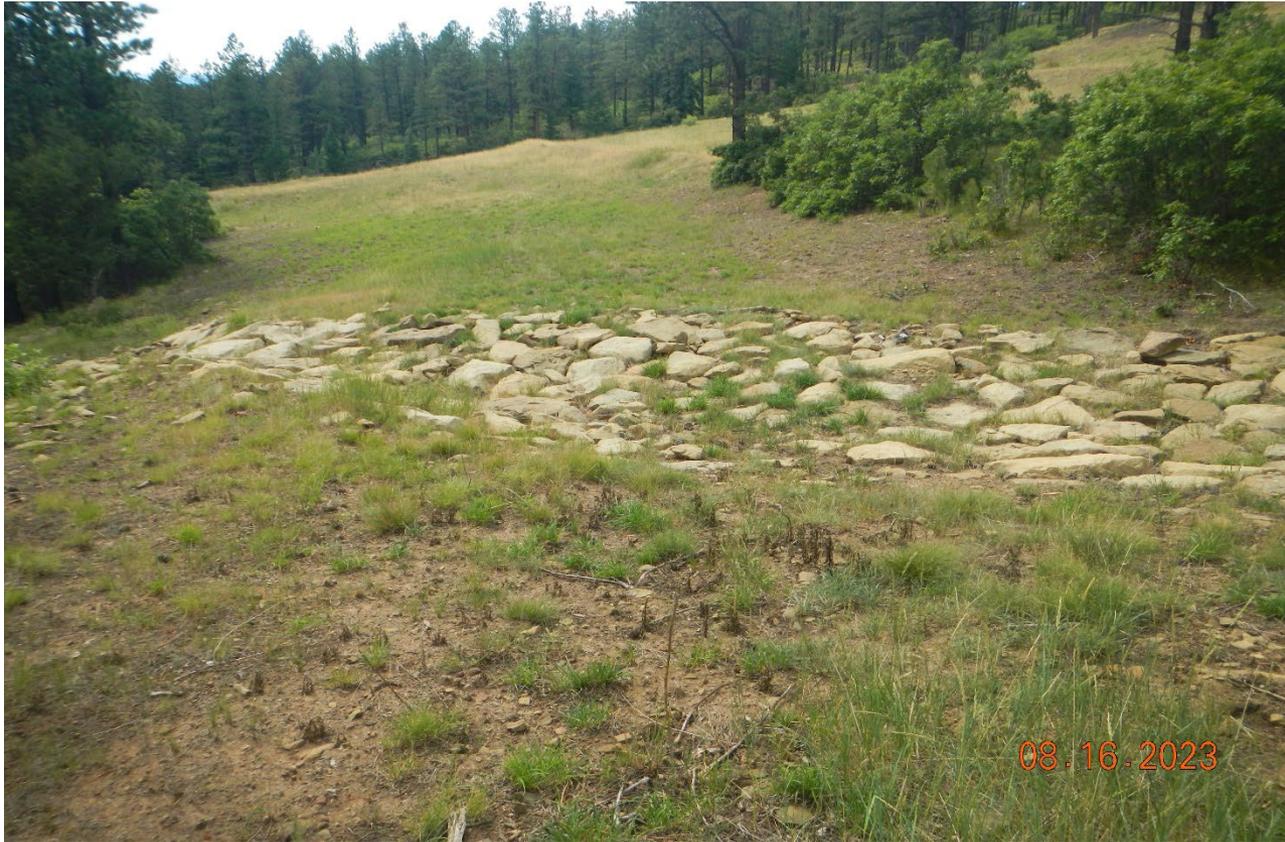
Photo 4. Facing southeast along the portion of the road that was fully reclaimed.

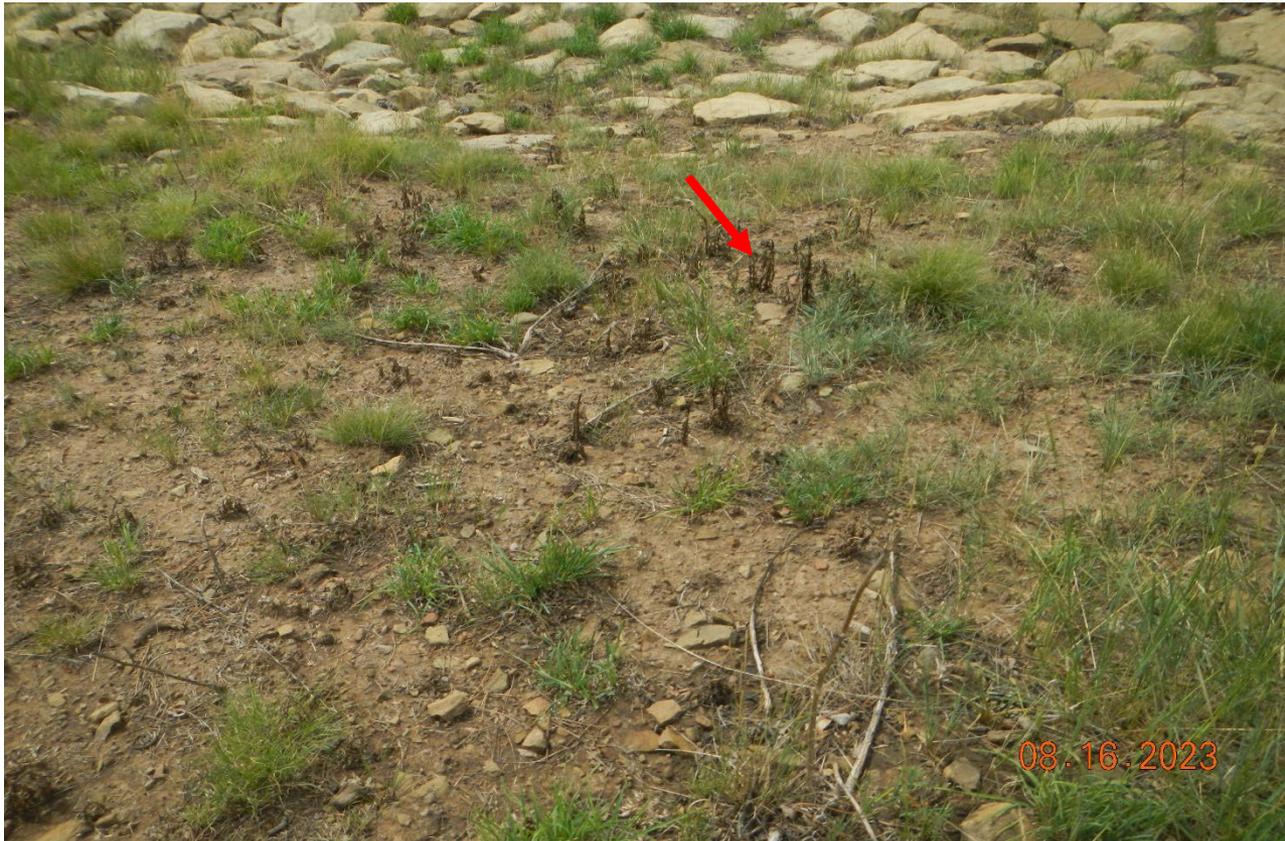
Photo 5. There are noxious weeds at red arrow (Canada thistle) which are wilted from recent weed control.

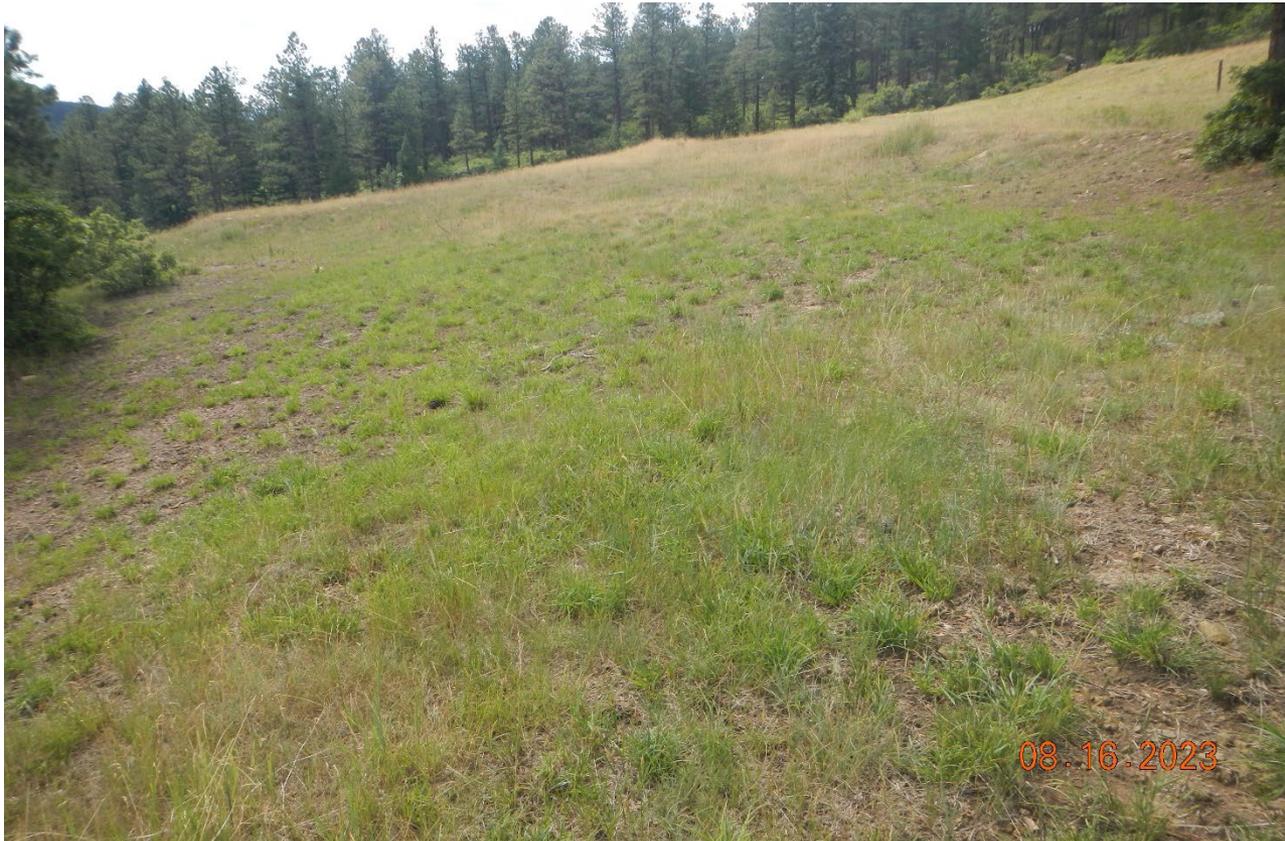
Photo 6. Facing southeast toward the bottom portion of the location. The location is recontoured and vegetation is progressing well..

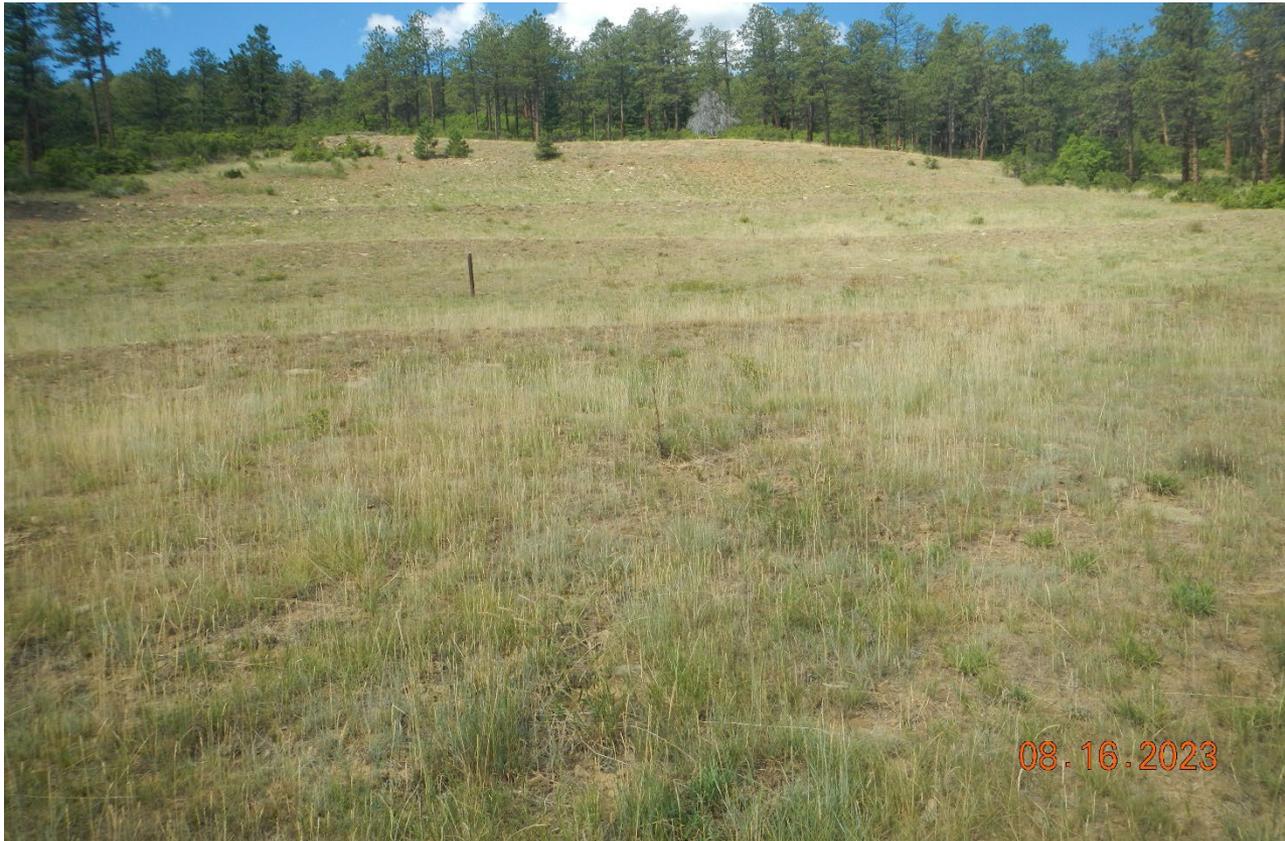
Photo 7. Facing west toward the reclaimed the location. The location is recontoured and vegetation is progressing well.

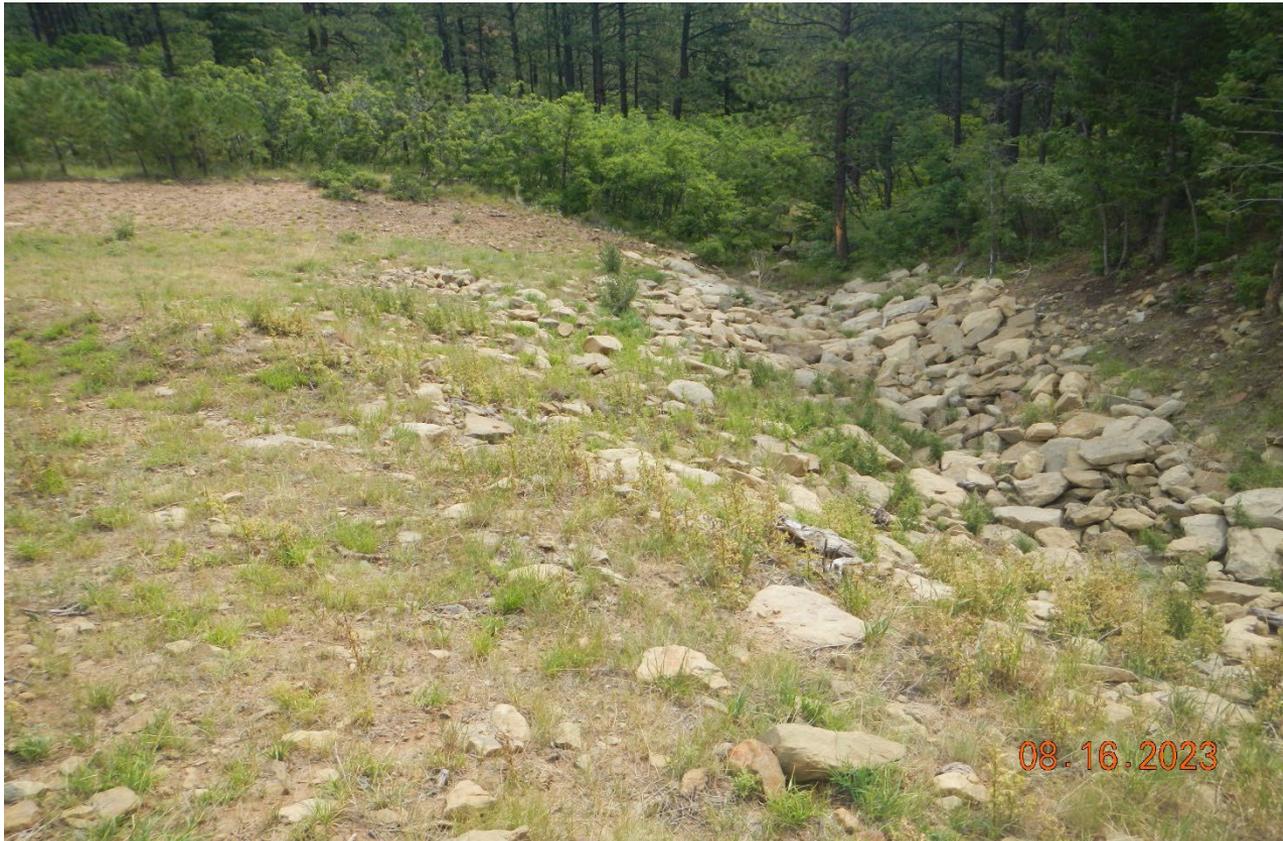
Photo 8. Facing southwest at the location. There are numerous noxious weeds in this area. Some are wilted and controlled but some are not. Follow up weed control will need to be performed.

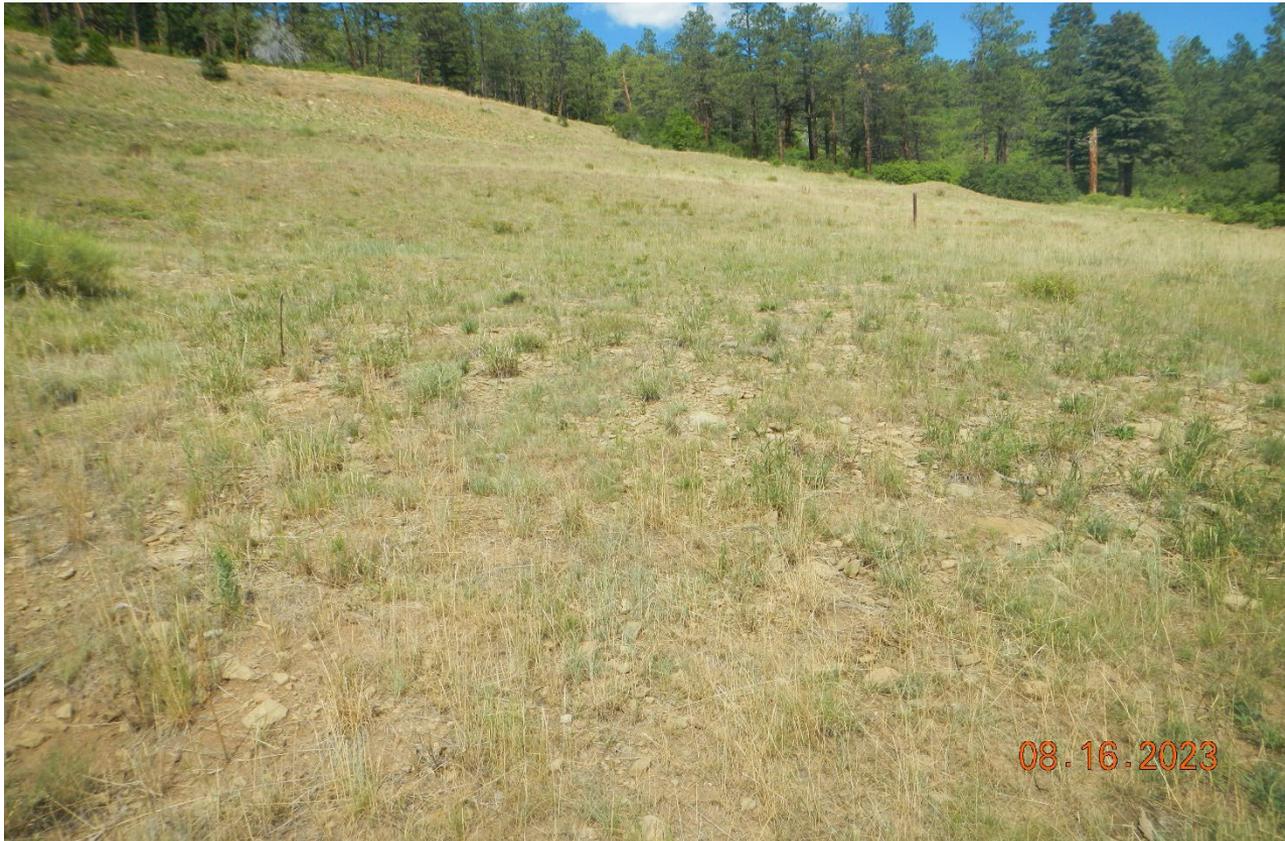
Photo 9. Facing northwest toward the reclaimed the location. The location is recontoured and vegetation is progressing well.

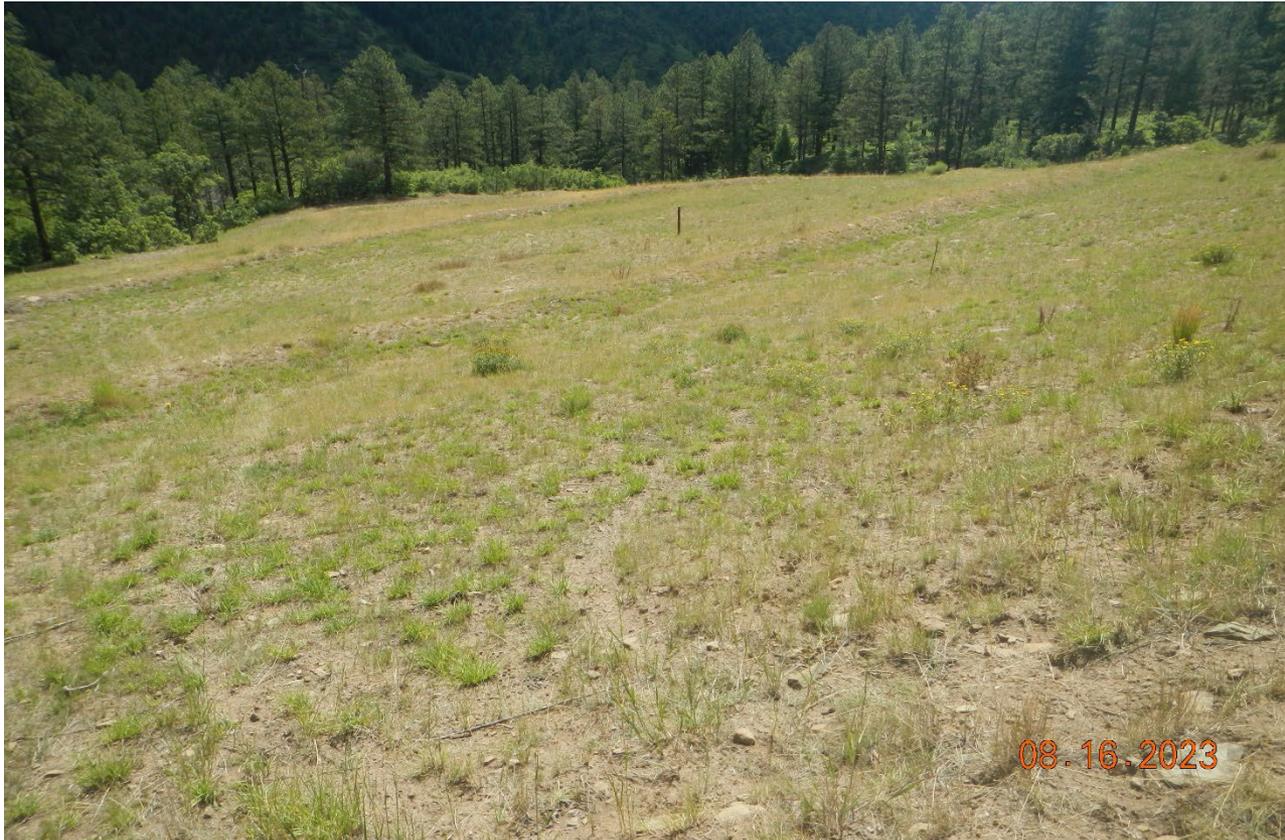
Photo 10. Facing southeast toward the reclaimed the location. The location is recontoured and vegetation is progressing well.

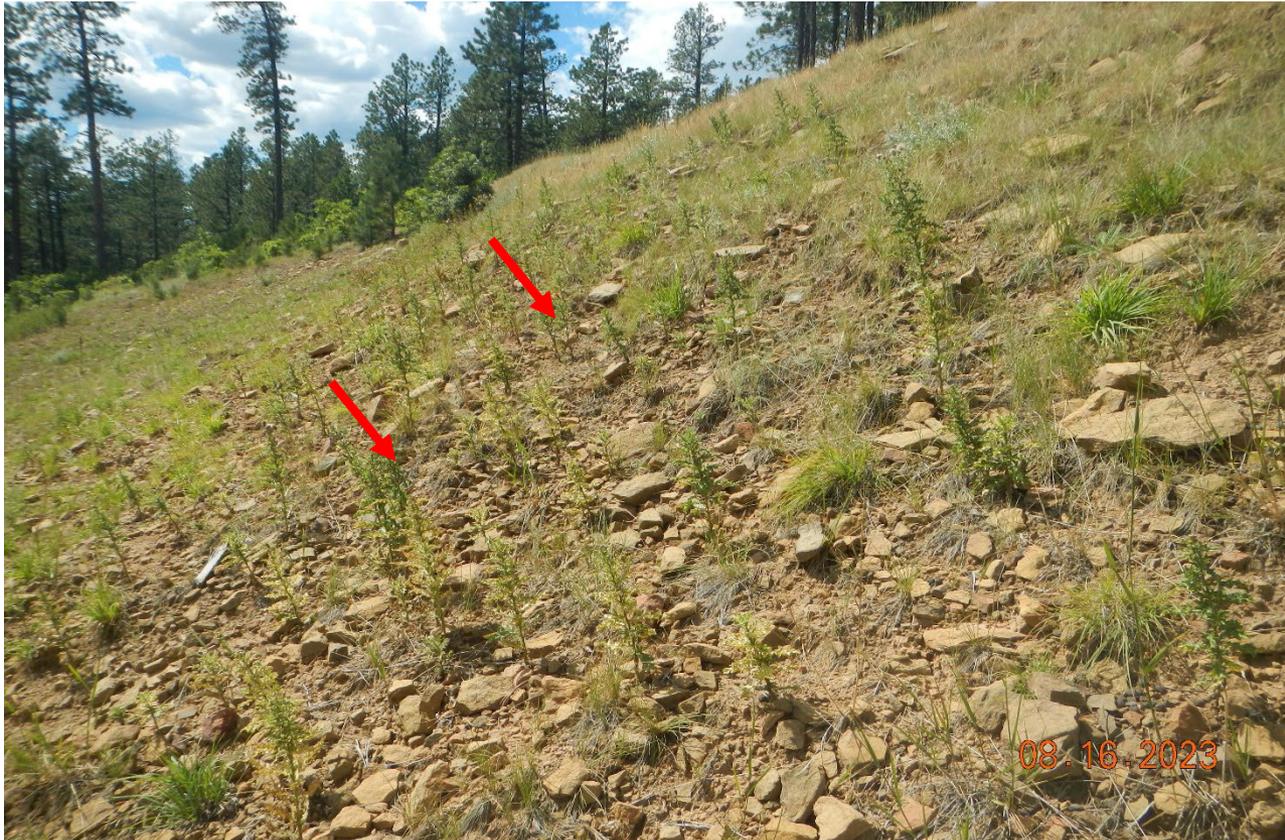
Photo 11. There are noxious weeds at the top portion of the location that have not been controlled. Red arrow points to Canada thistle.
