Inspection Photos  
Maralex Gosney 2A  
API 067-09798

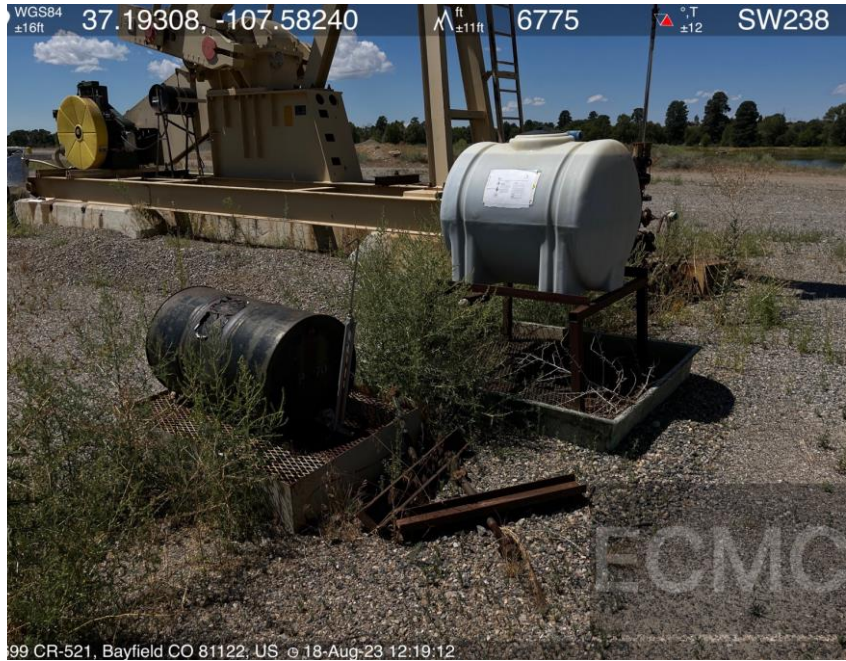
**Photo #1. Disconnected, flammable materials stored near wellhead.**

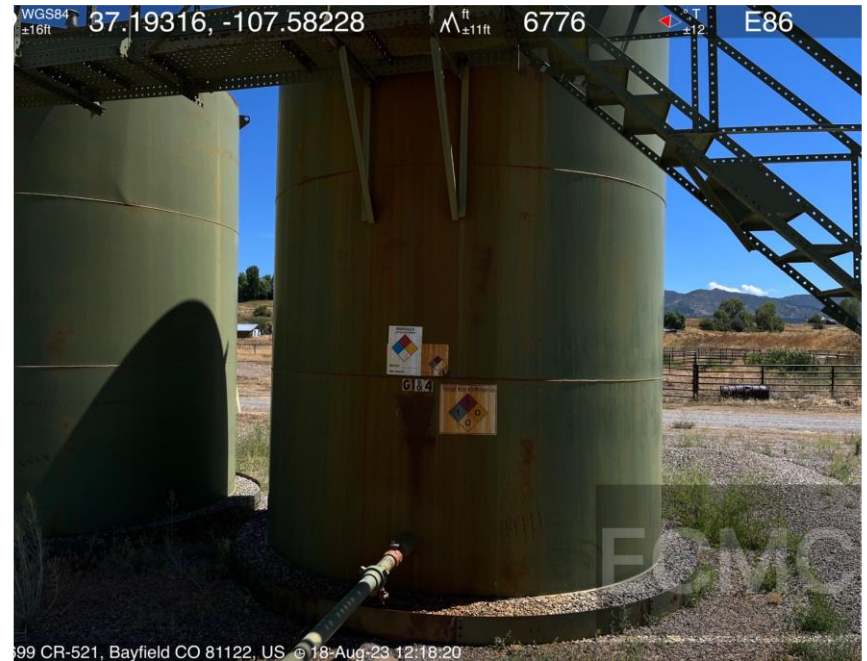
**Photo #2. Produced water tank volume capacity not labeled.**

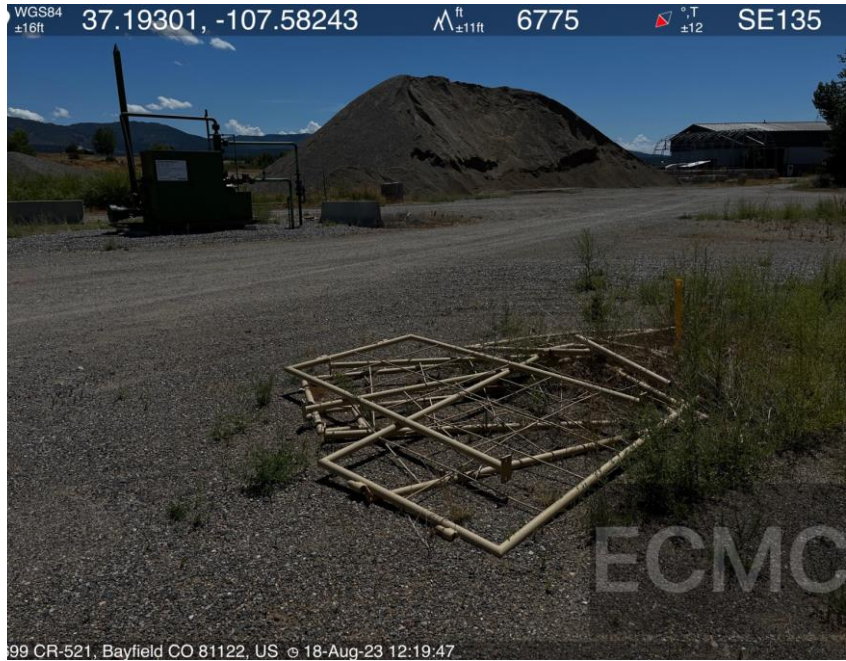
**Photo #3. View of unused equipment stored on ground.**

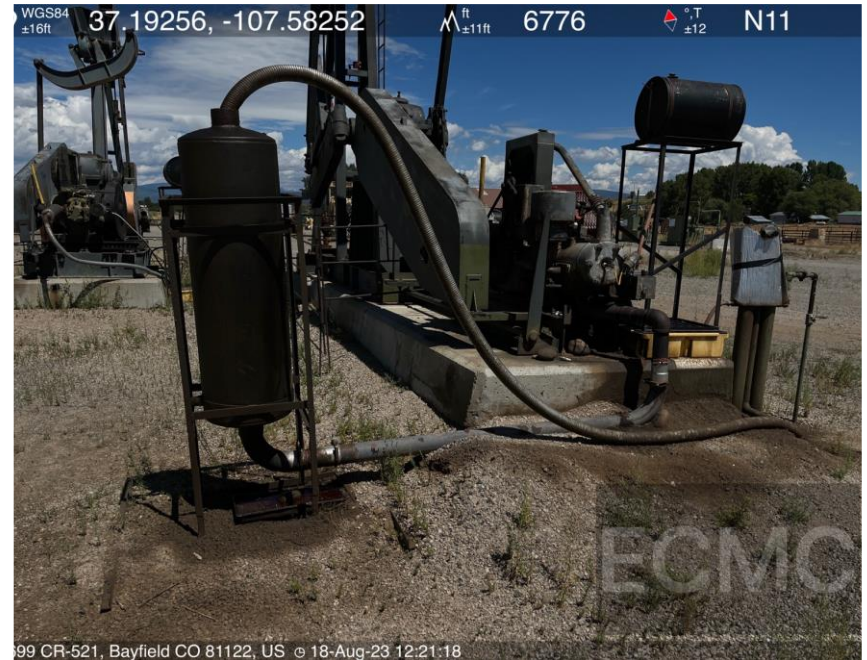
**Photo #4. Impacted material on ground around prime mover.**
