**Inspection Photos**  
**Location Name: CAERUS PICEANCE LLC H36X Pad**  
**Location ID: 335003**

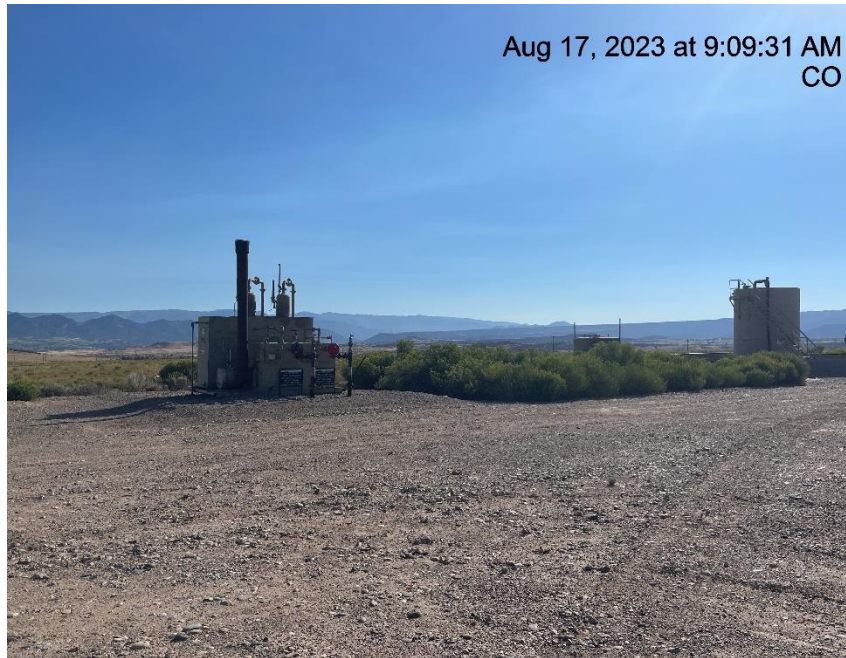
**Photo # 6020 From entrance to location**

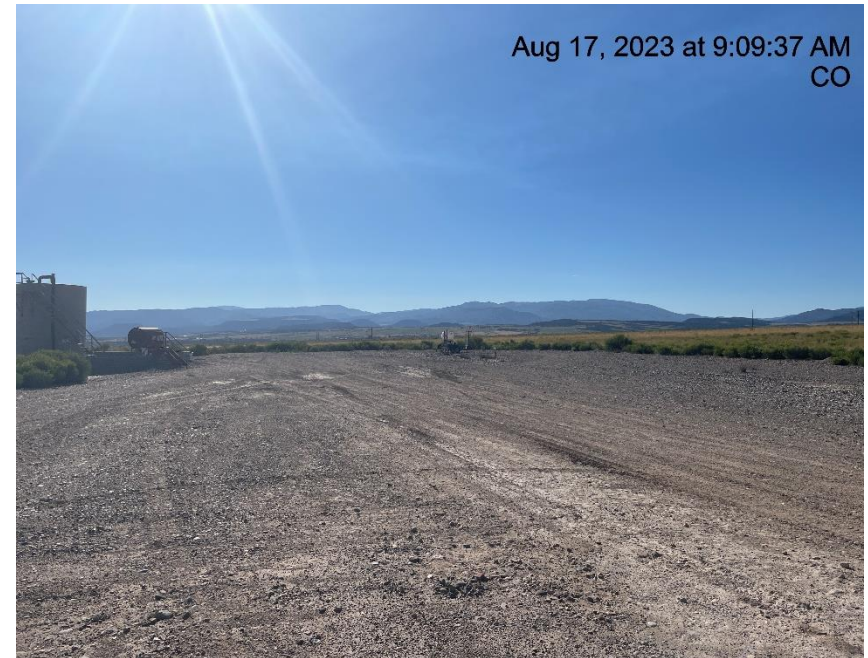
**Photo # 6021 From entrance to location**

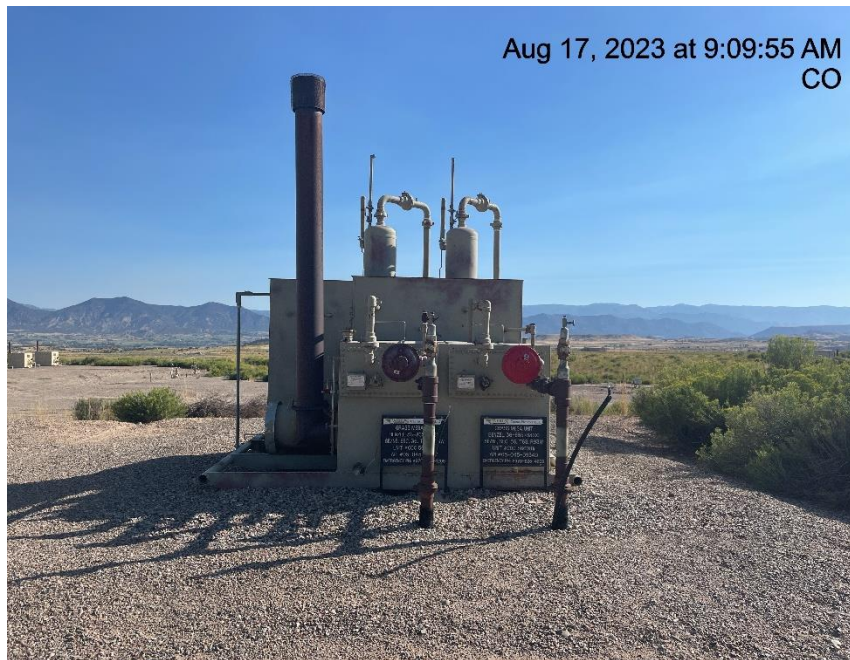
**Photo # 6022 Location**

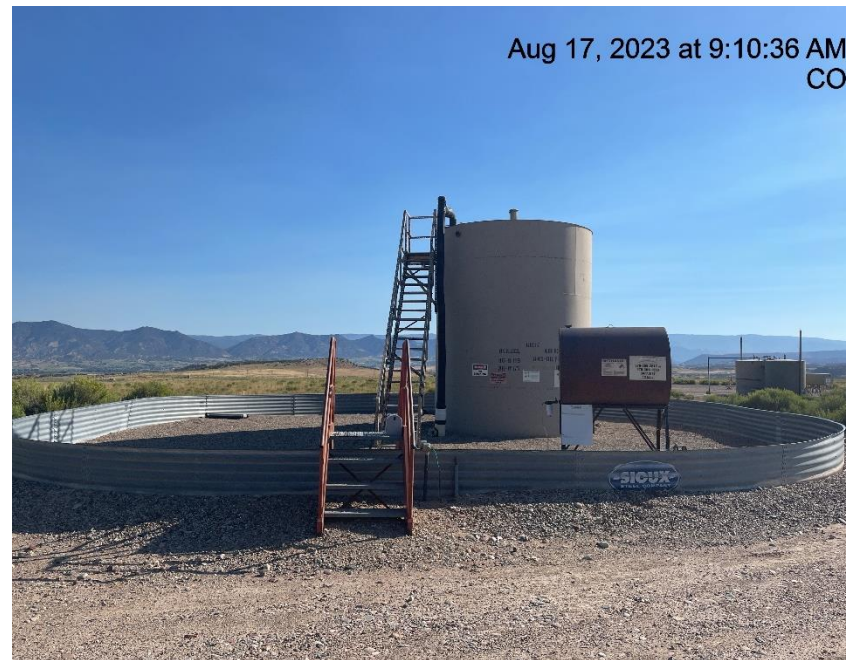
**Photo # 6023 Location**

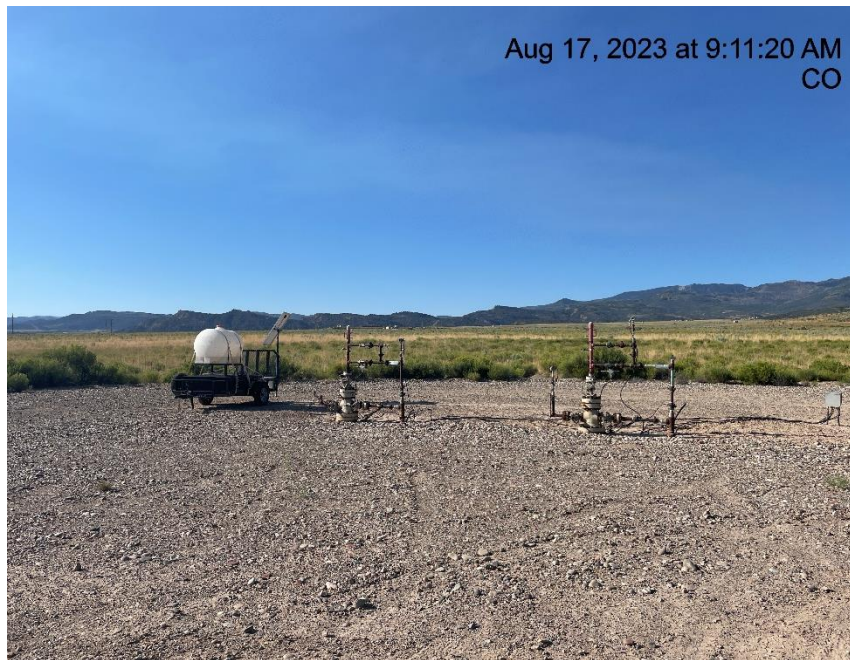
**Photo # 6024 Location**

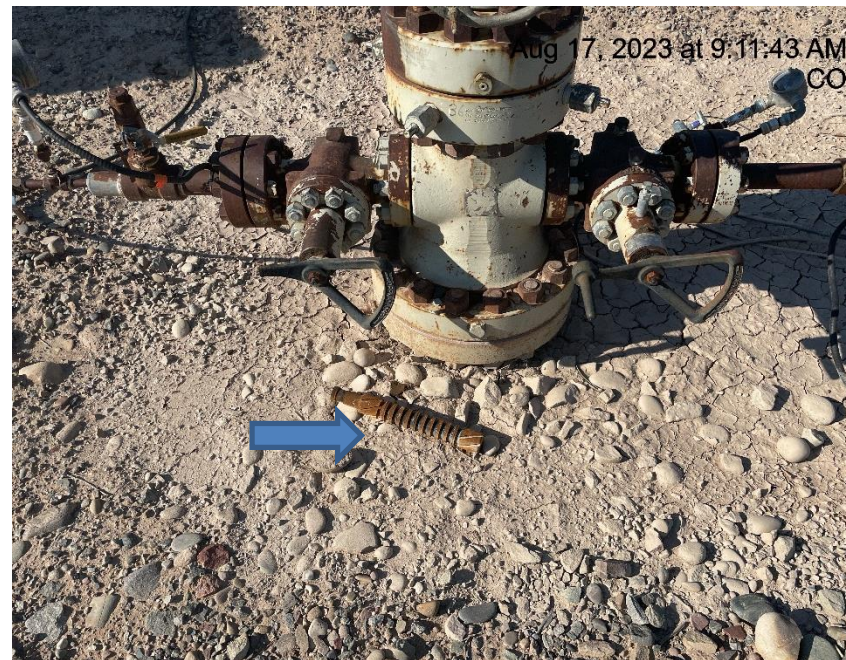
**Photo # 6025 Debris**

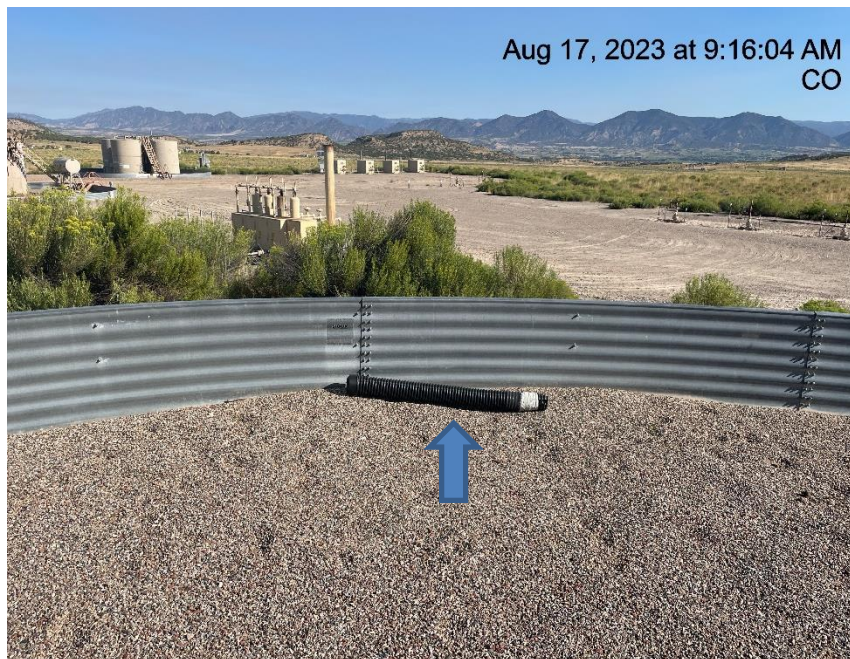
**Photo # 6031 Debris**

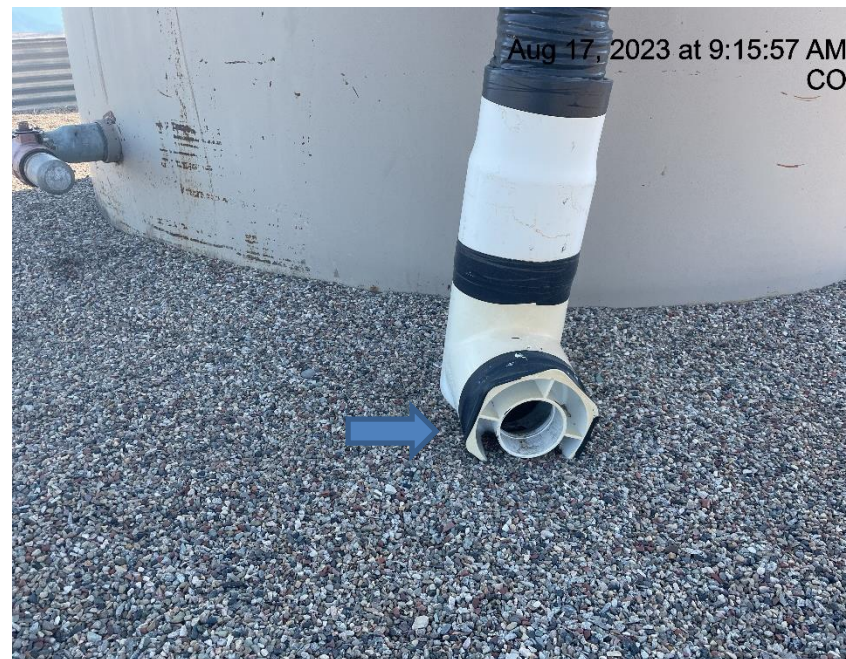
**Photo # 6030 Flowline heating insulation open ended**

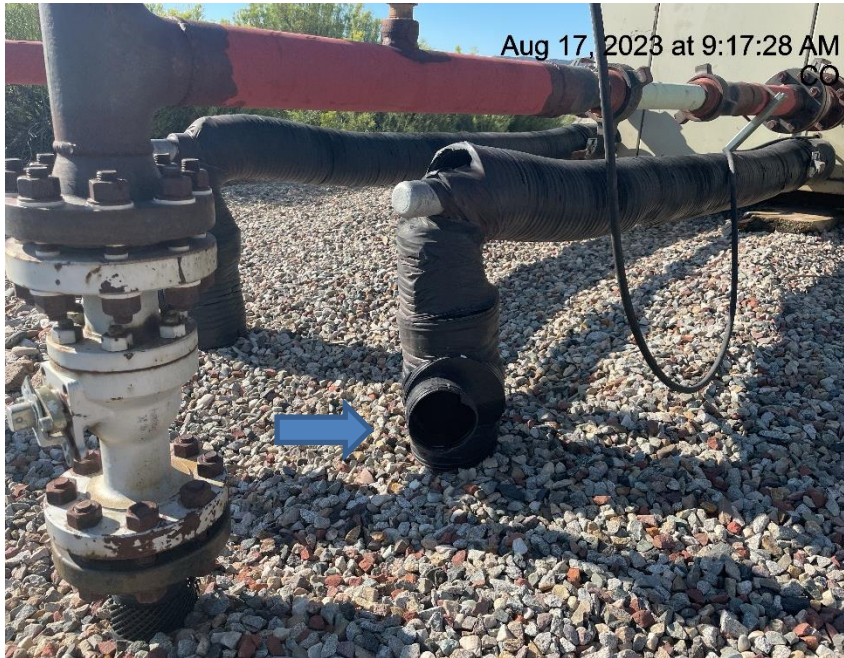
**Photo # 6032 Flowline heating insulation open ended**
