Inspection Photos
Location Name: CAERUS PICEANCE LLC L1 Pad
Location ID: 334961

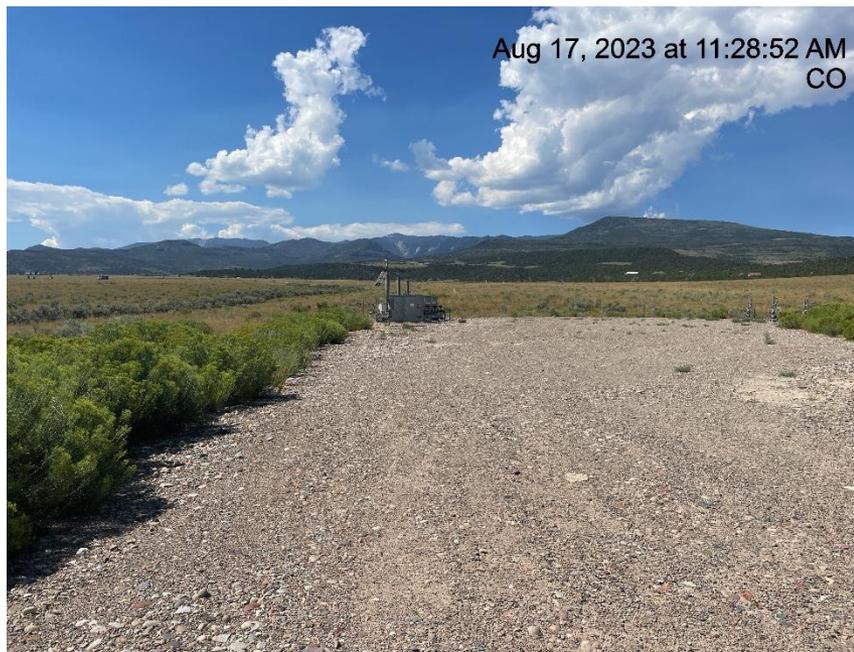
Photo # 6156 From entrance to location

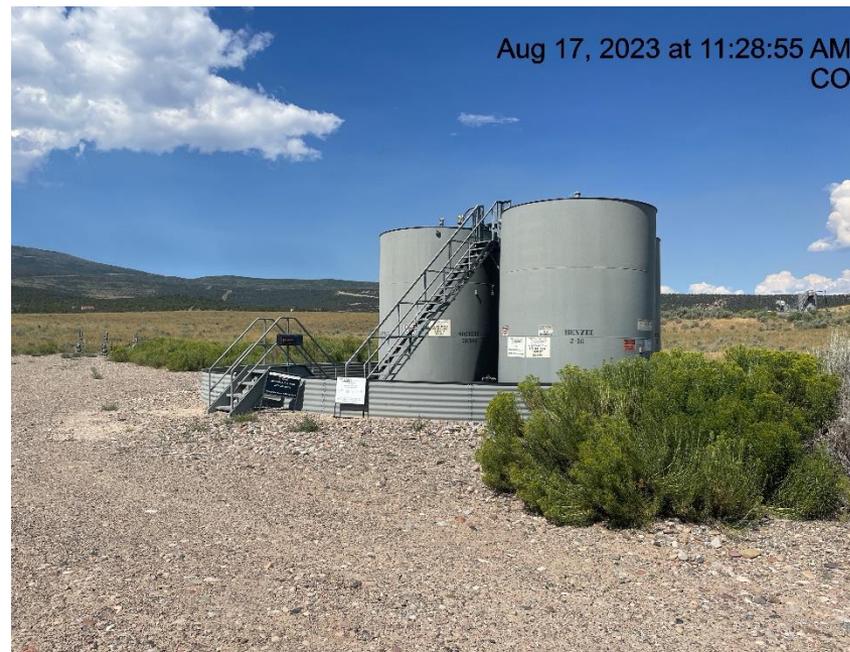
Photo # 6157 From entrance to location

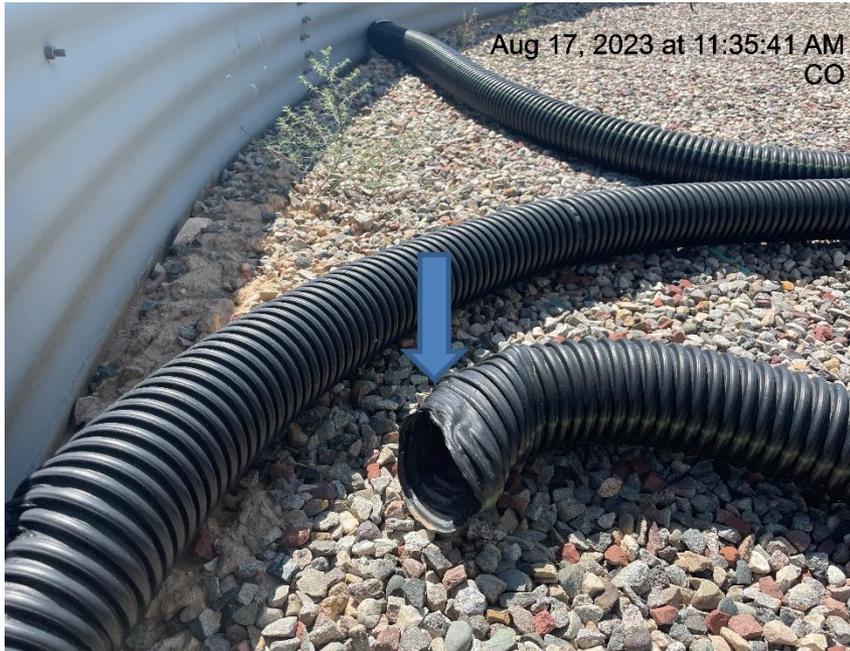
Photo # 6168 Flowline heating insulation open ended

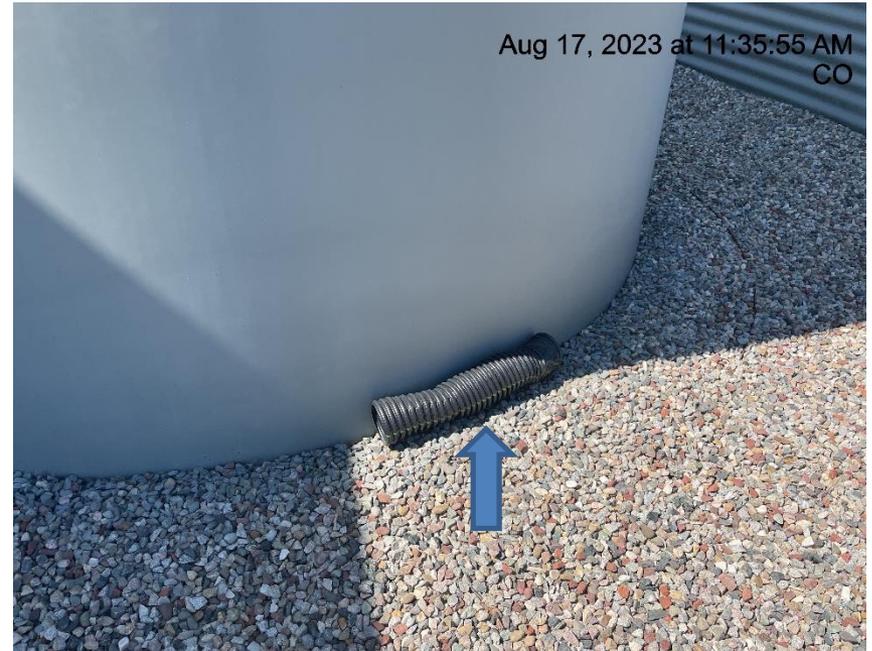
Photo # 6170 Debris

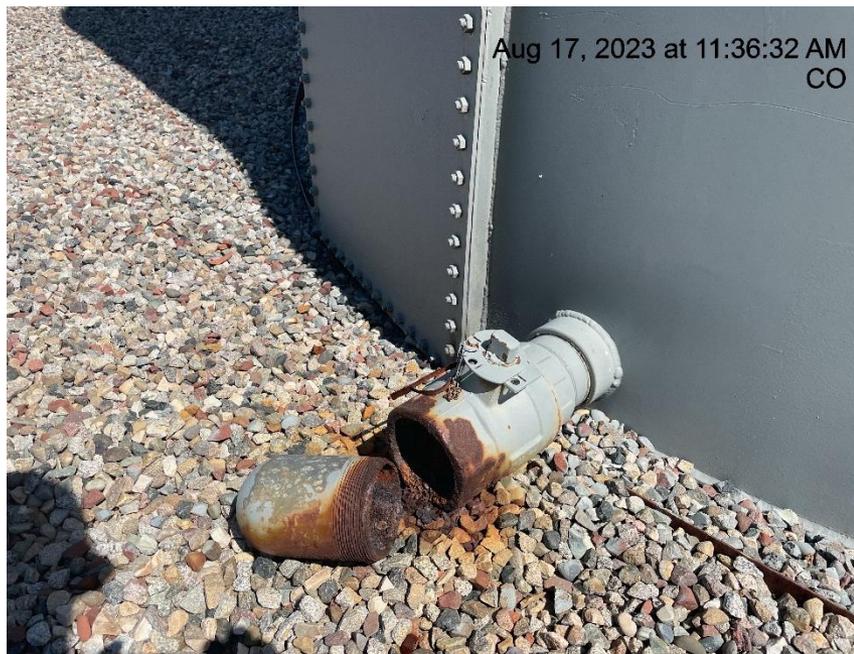
Photo # 6171 Open ended load line

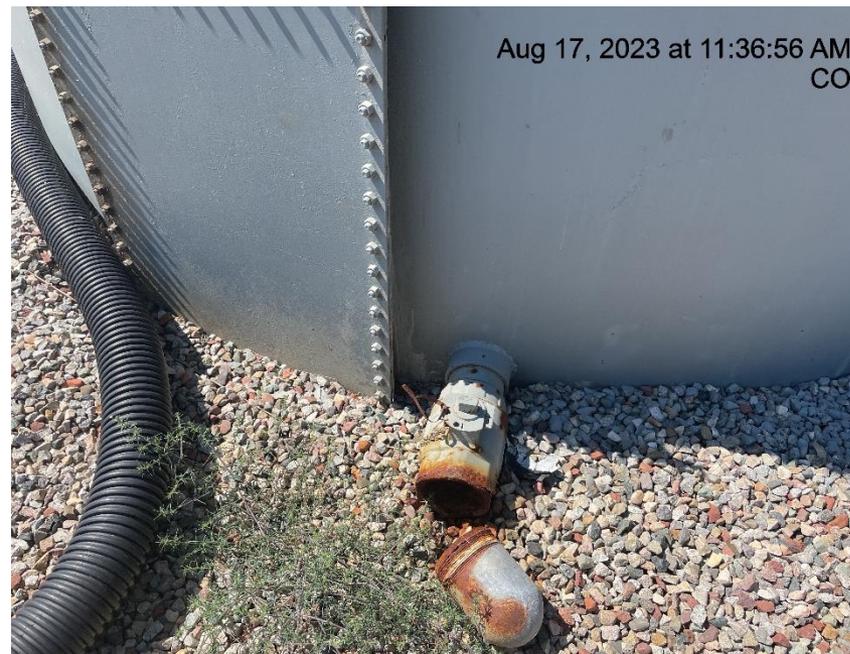
Photo # 6172 Open ended load line
