Inspection Photos
Location Name: CAERUS PICEANCE LLC K36B Pad
Location ID: 334899

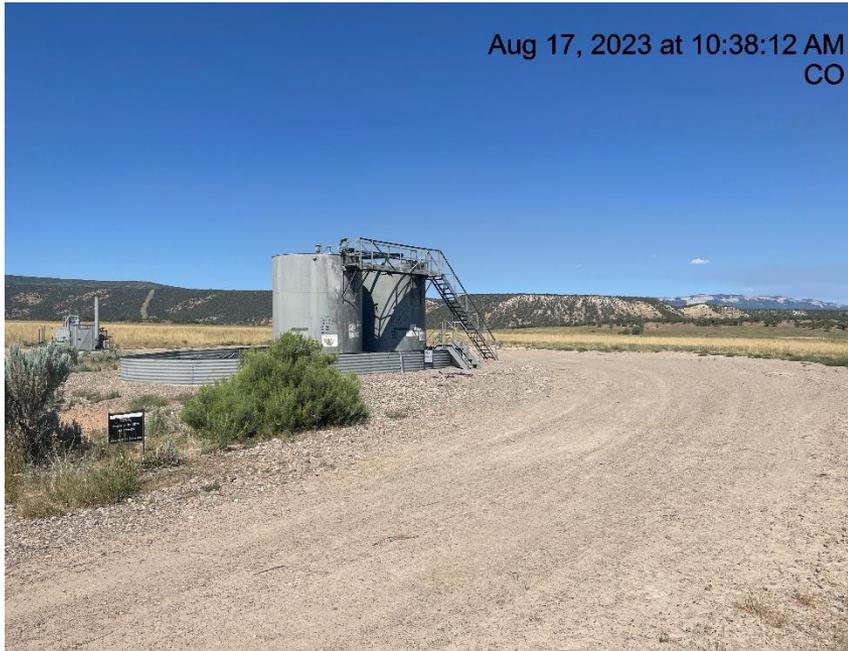
Photo # 6092 From entrance to location

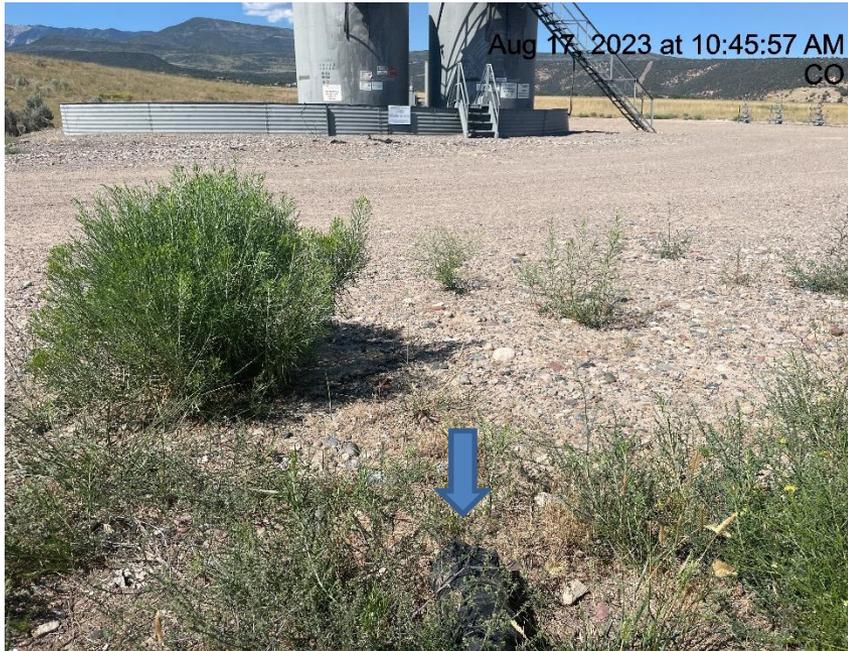
Photo # 6099 Debris

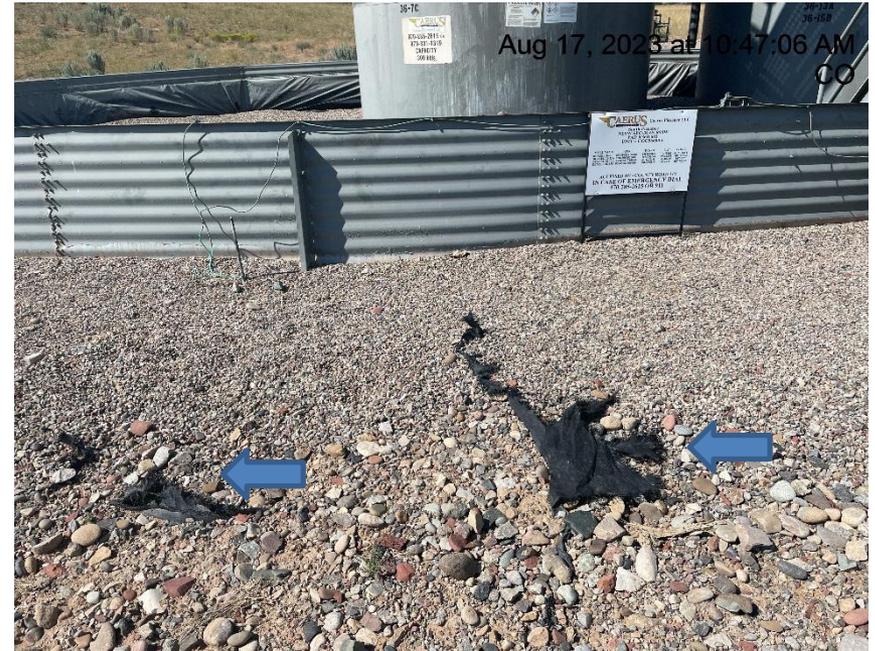
Photo # 6103 Debris

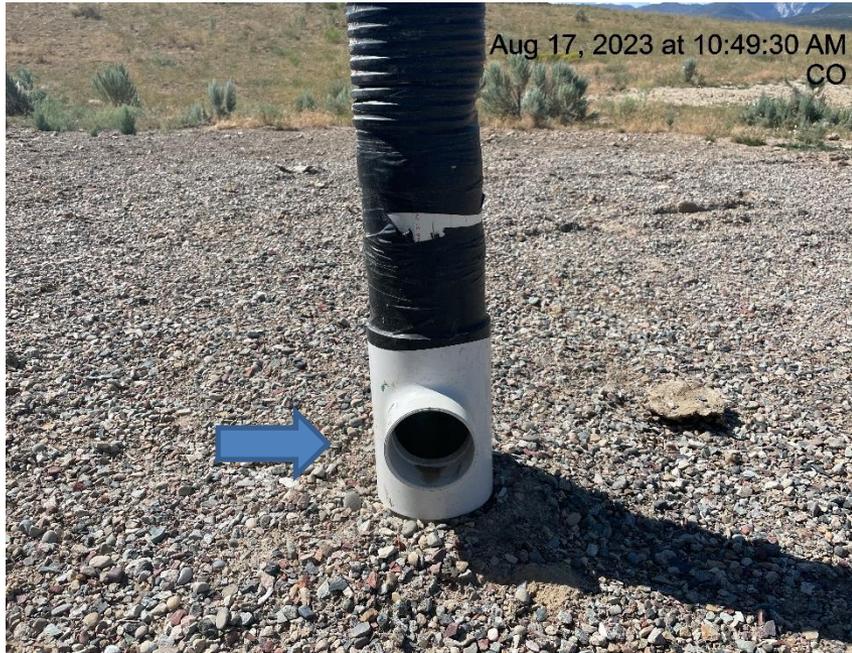
Photo # 6104 Flowline heating insulation open ended
