**Storm Water Management and Erosion control**  
**Location Name: CAERUS PICEANCE LLC FEDERAL 8C Pad**  
**Location ID: 334081**

**Section/Township/Range: 8 8S95W**

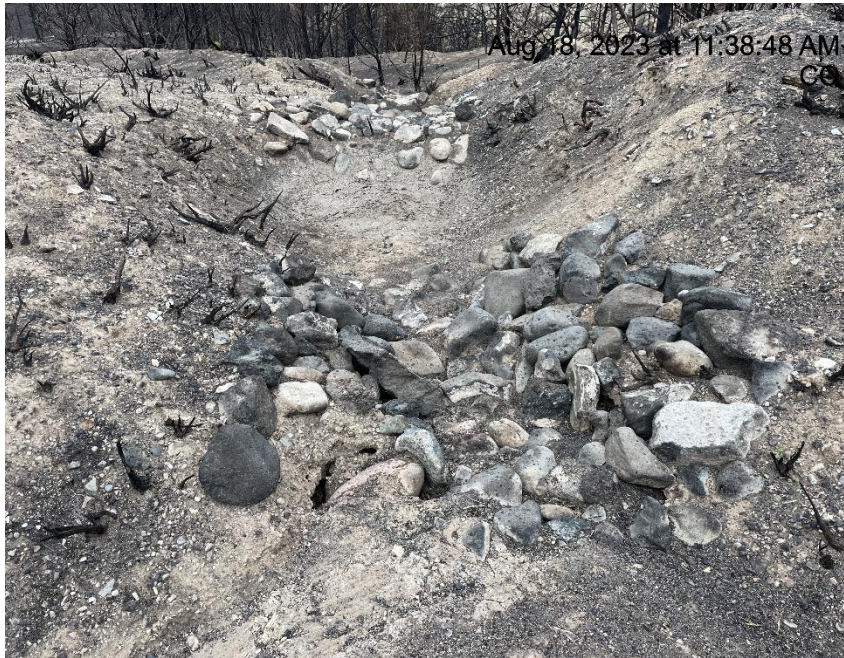
**Photo # 6508 BMP needs maintenance, erosion starting to undercut armoring**

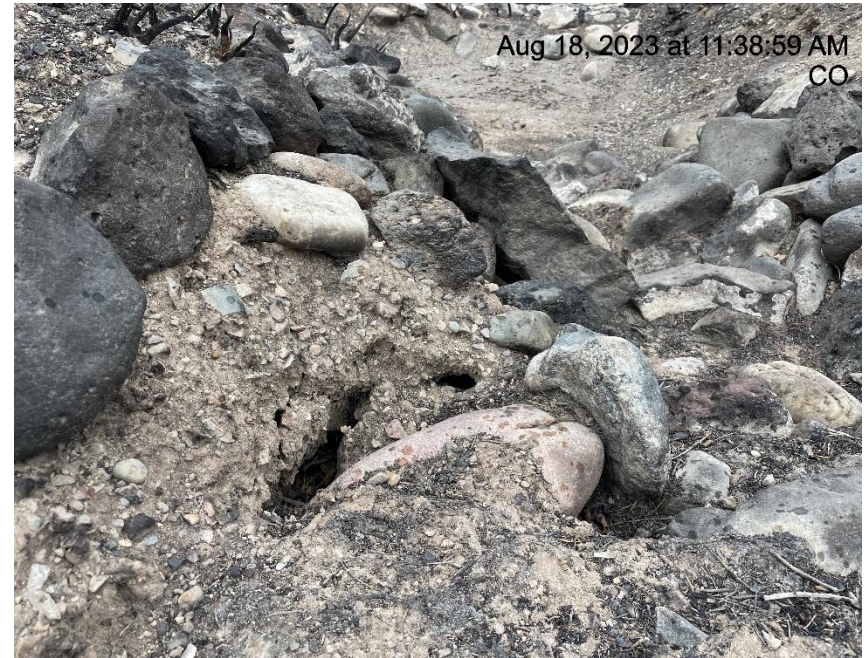
**Photo # 6509 BMP needs maintenance, erosion starting to undercut armoring**

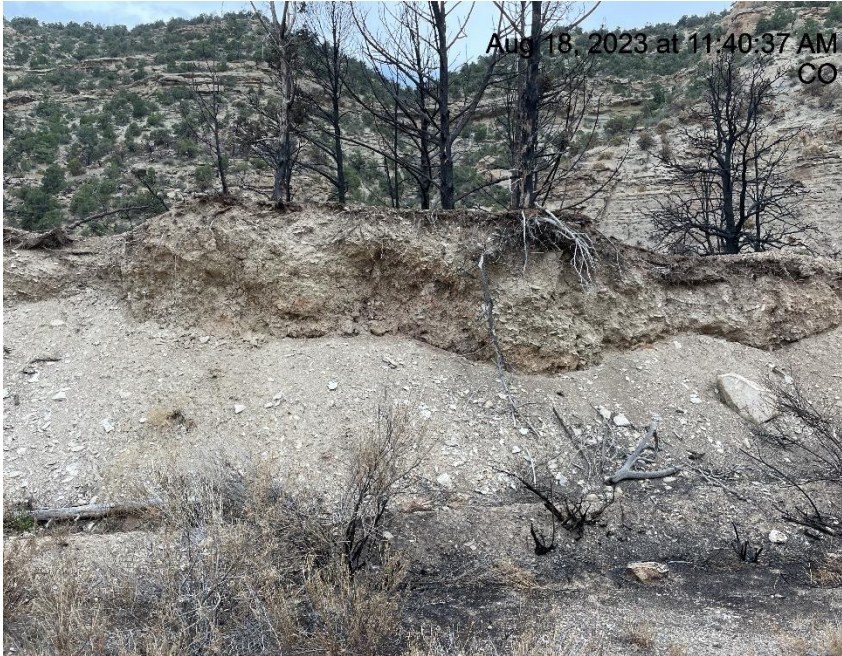
**Photo # 6510 Lack of stabilization on slope/insufficient BMP's**

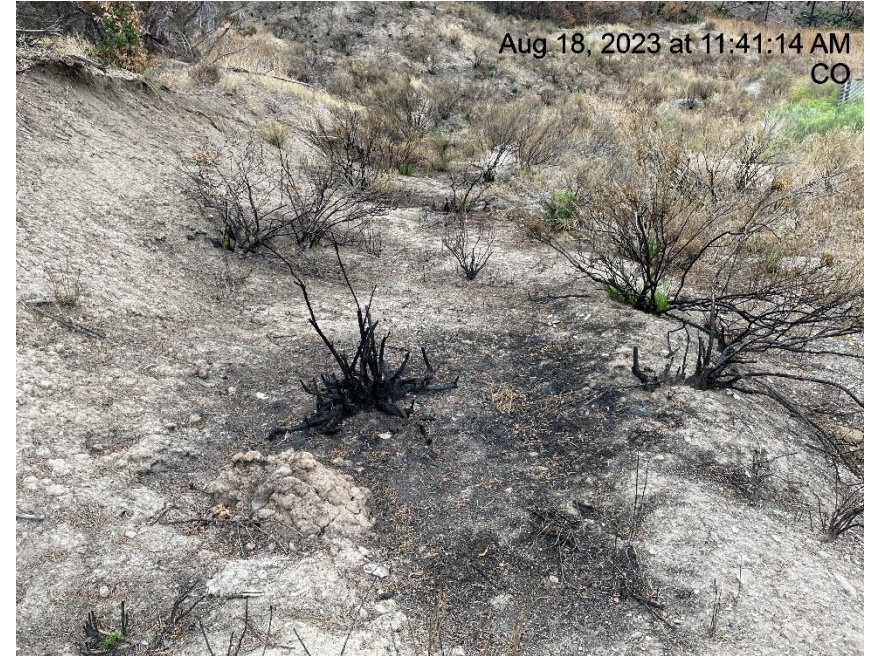
**Photo # 6511 Lack of stabilization on slope/insufficient BMP's/ditch needs maintenance**

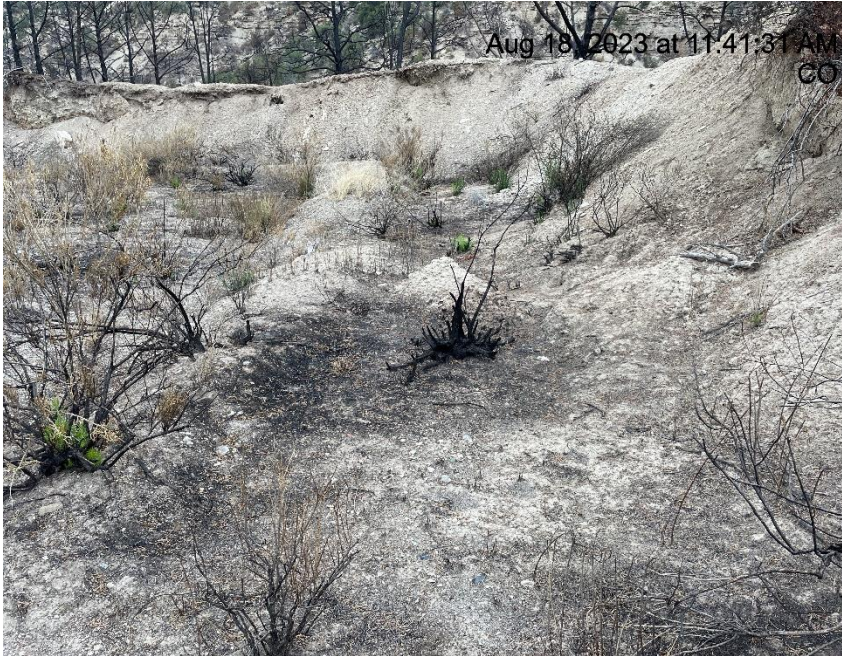
**Photo # 6512 Lack of stabilization on slope/insufficient BMP's/ditch needs maintenance**

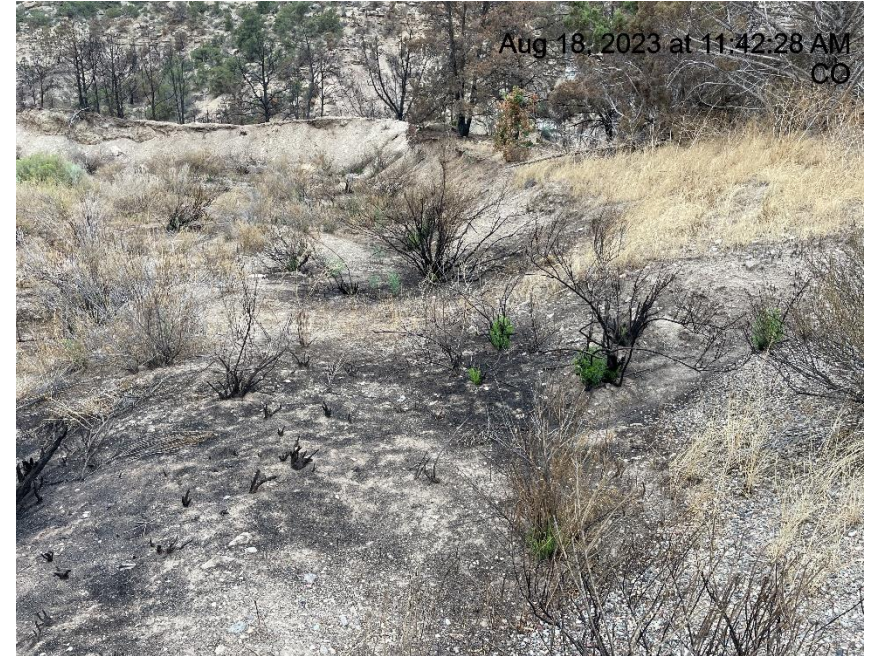
**Photo # 6513 Lack of stabilization on slope/insufficient BMP's/ditch needs maintenance**

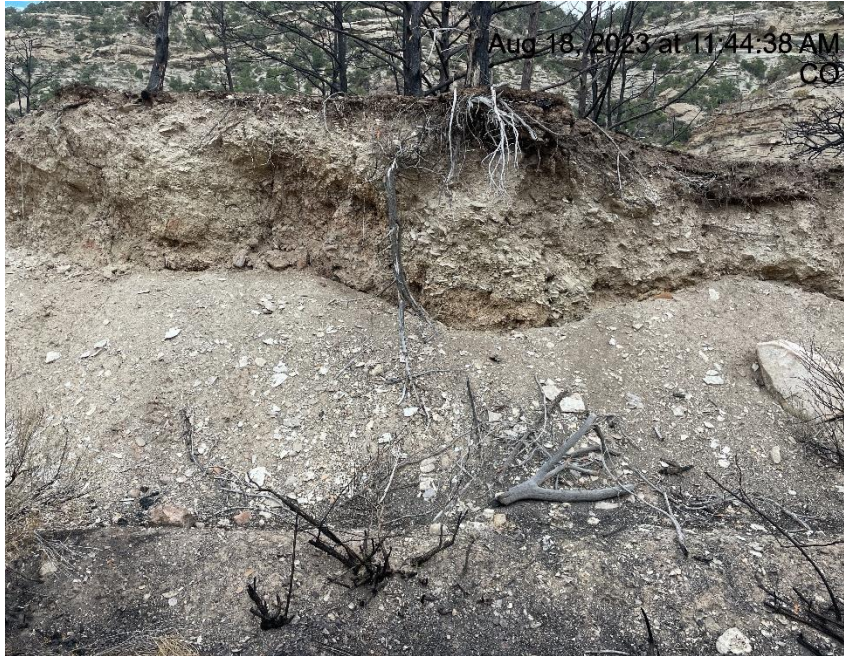
**Photo # 6515 Lack of stabilization on slope/insufficient BMP's**

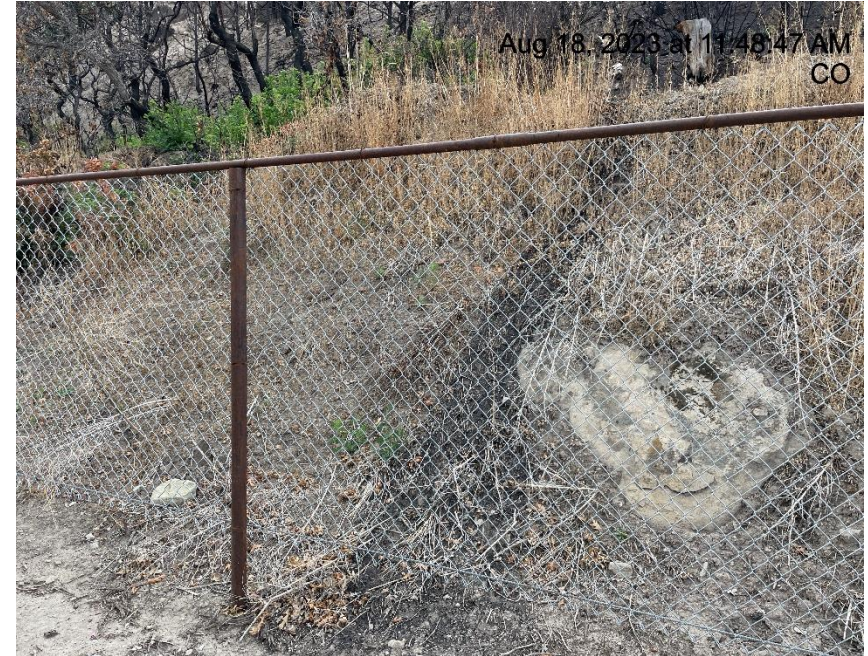
**Photo # 6524 Erosion & transport of sediment onto location/insufficient run on controls/BMP's (near tank battery)**

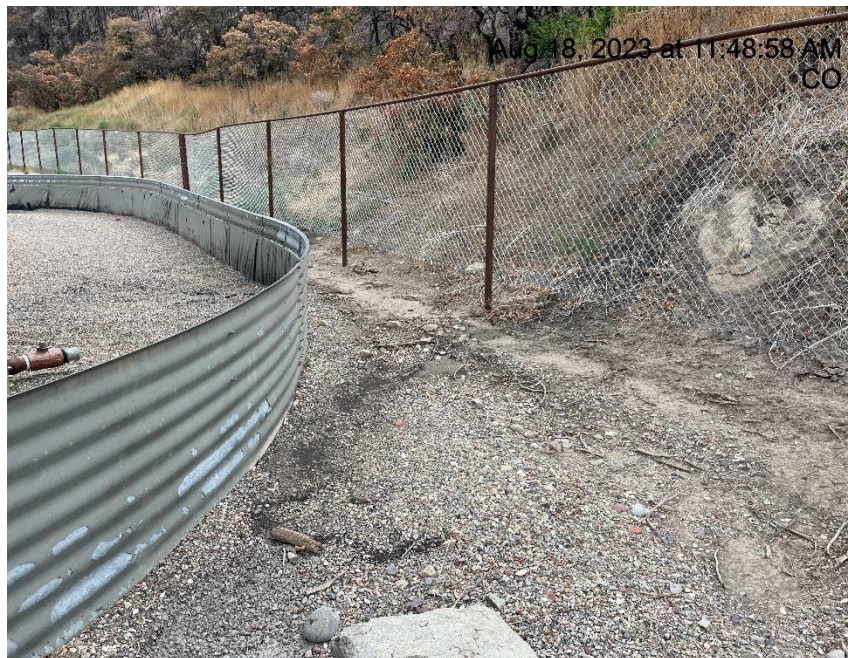
**Photo # 6525 Erosion & transport of sediment onto location/insufficient run on controls/BMP's (near tank battery)**

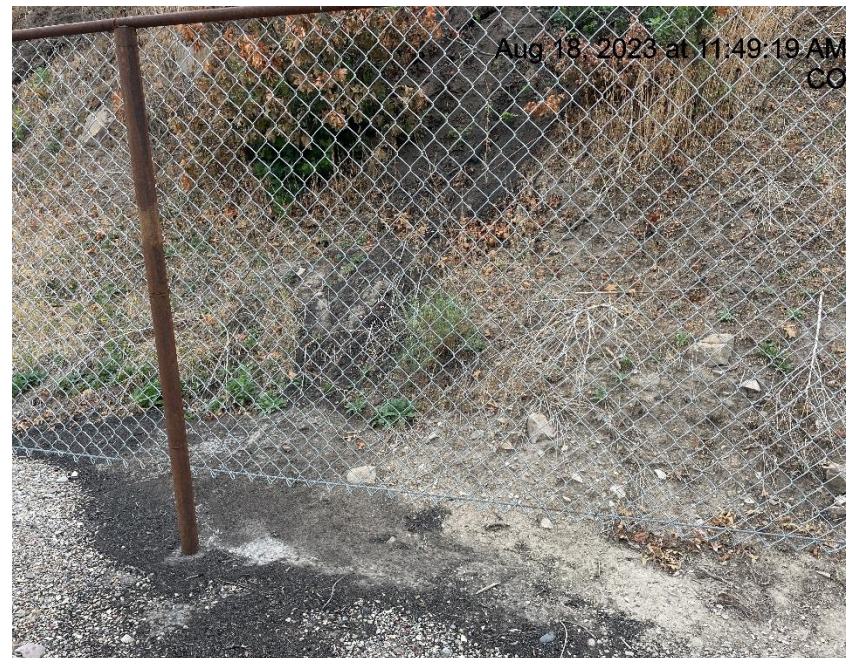
**Photo # 6526 Erosion & transport of sediment onto location/insufficient run on controls/BMP's (near tank battery)**

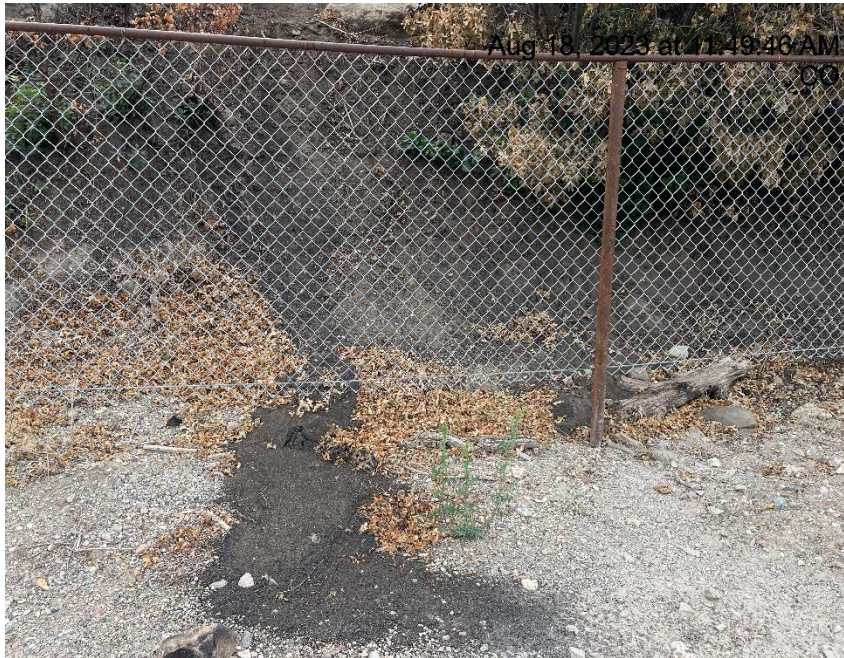
**Photo # 6527 Erosion & transport of sediment onto location/lack of stabilization on slope/insufficient run on controls/BMP's (near tank battery)**

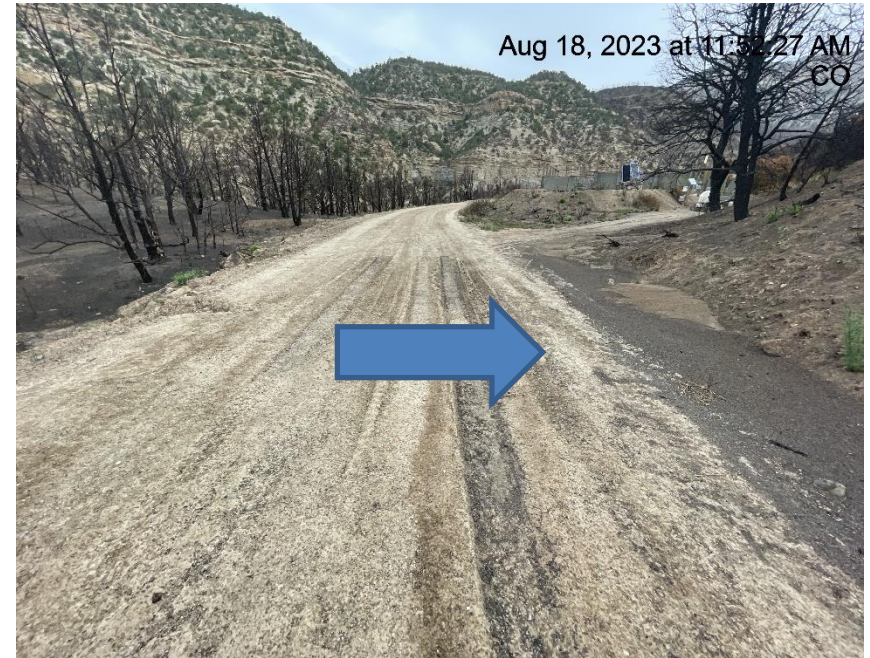
**Photo # 6531 Lack of stabilization on slope/erosion & transport of sediment/ditch needs maintenance**

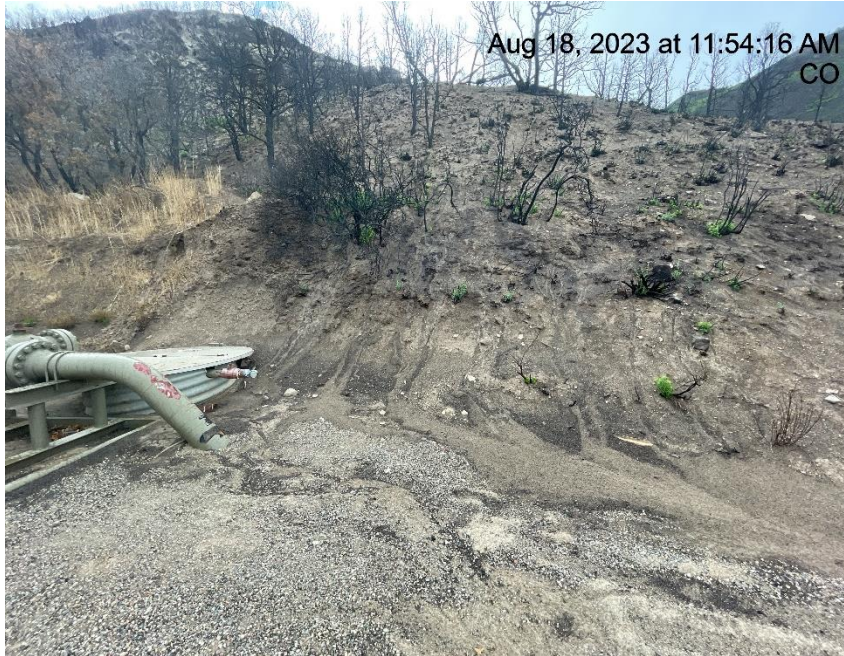
**Photo # 6535 Lack of stabilization on slope/erosion & transport of sediment/insufficient run on controls/BMP's**

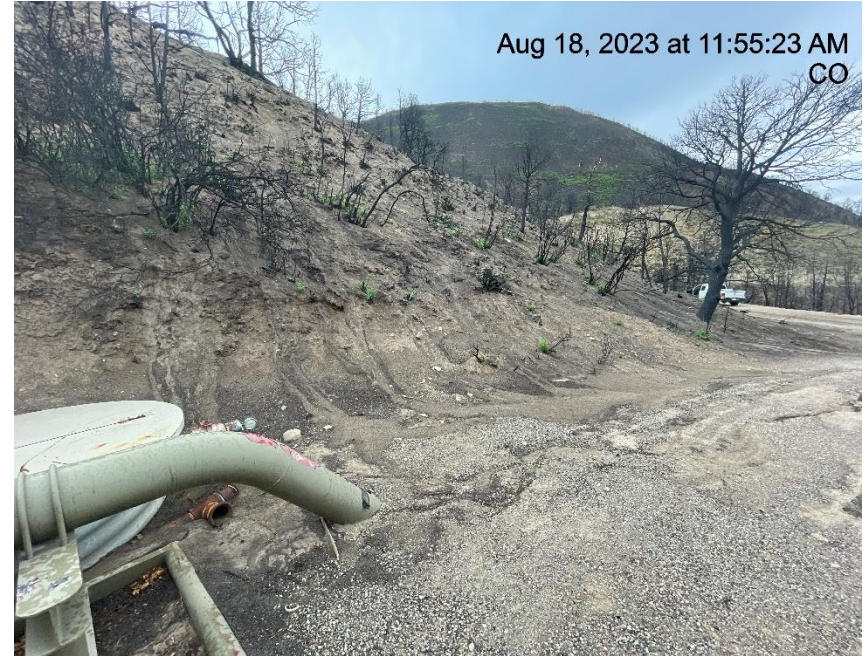
**Photo # 6539 Lack of stabilization on slope/erosion & transport of sediment/insufficient run on controls/BMP's**

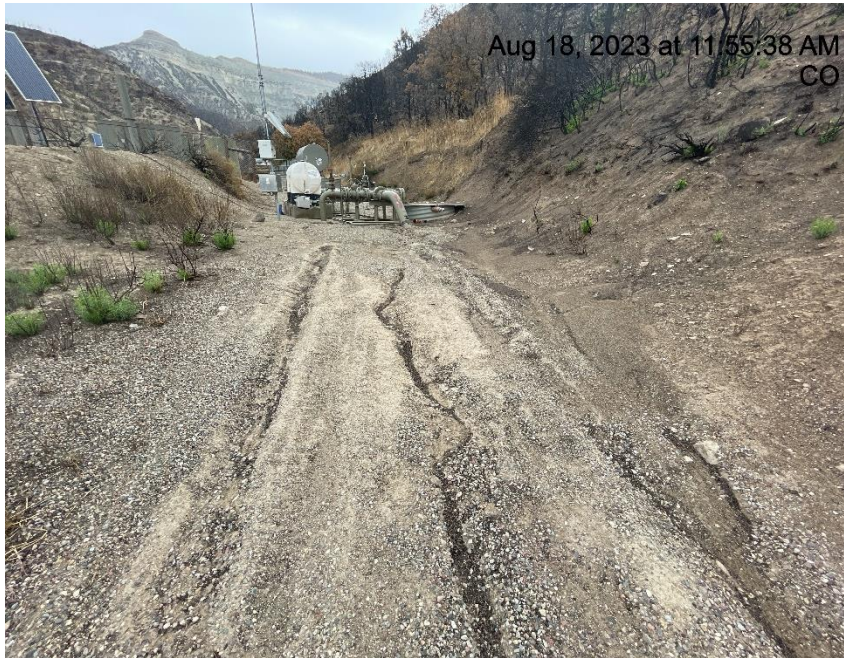
**Photo # 6540 Erosion & transport of sediment**

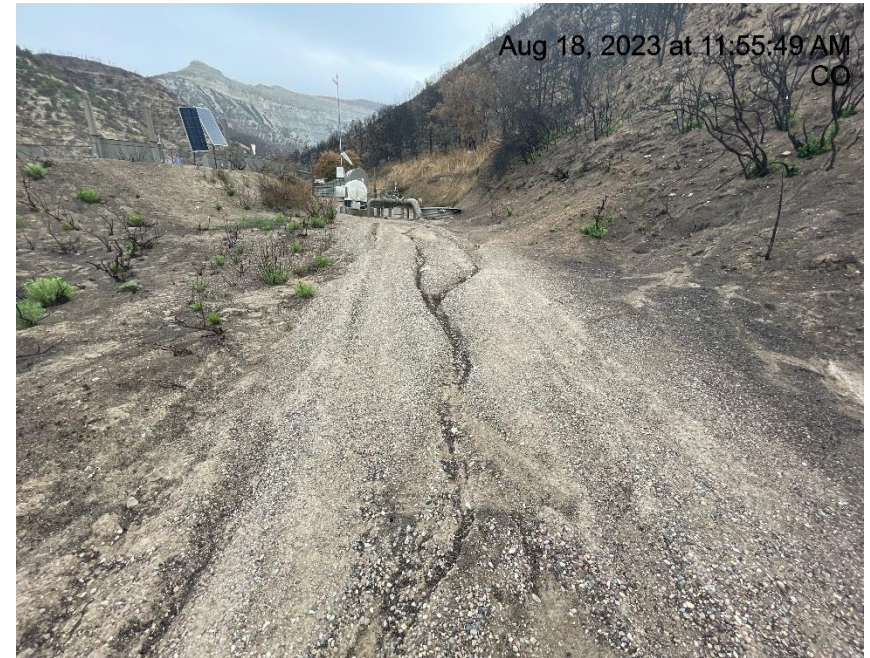
**Photo # 6541 Erosion & transport of sediment**

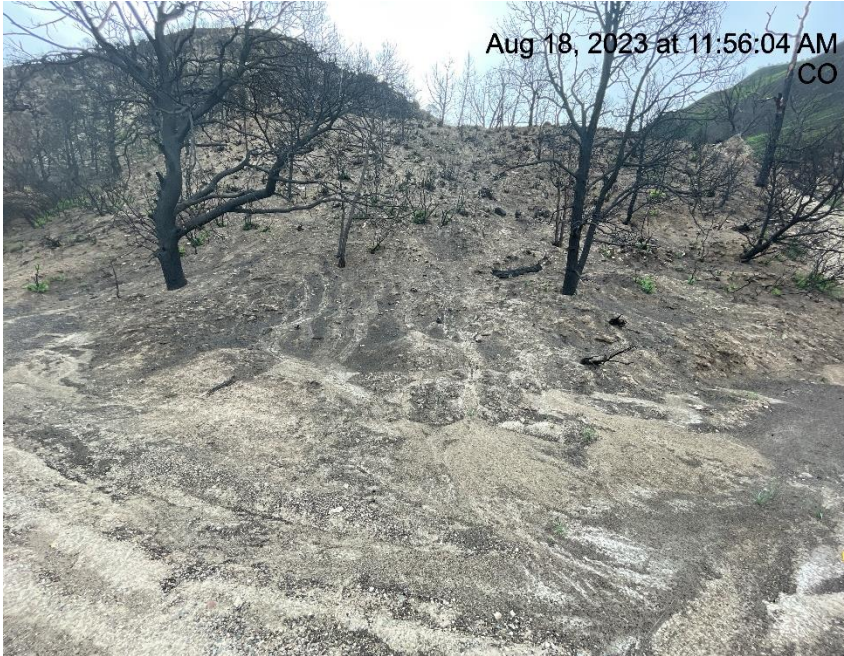
**Photo # 6542 Lack of stabilization on slope/erosion & transport of sediment/insufficient run on controls/BMP's (on lease road near pig station)**

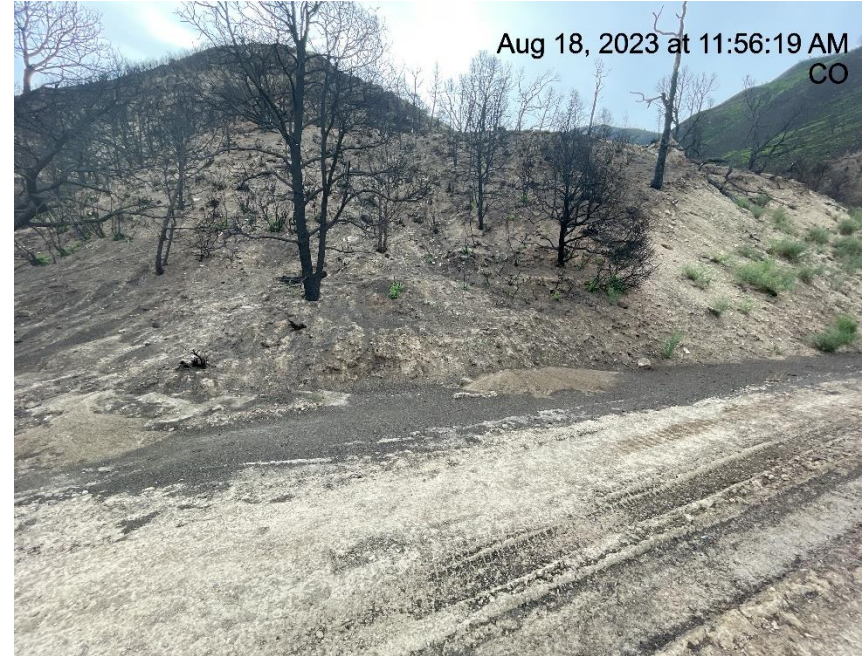
**Photo # 6544 Lack of stabilization on slope/erosion & transport of sediment/insufficient run on controls/BMP's (on lease road near pig station)**

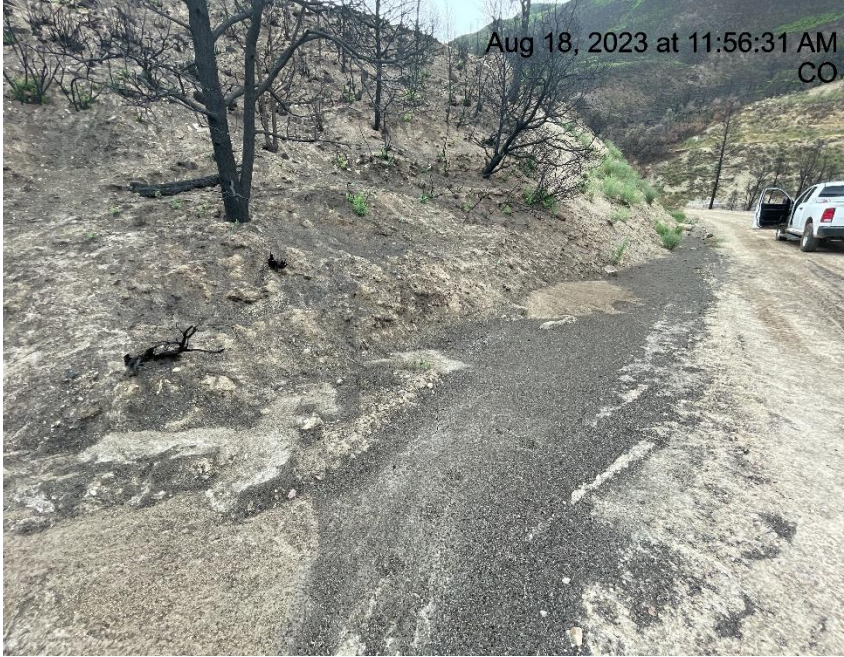
**Photo # 6545 Lack of stabilization on slope/erosion & transport of sediment/insufficient run on controls/BMP's (on lease road near pig station)**

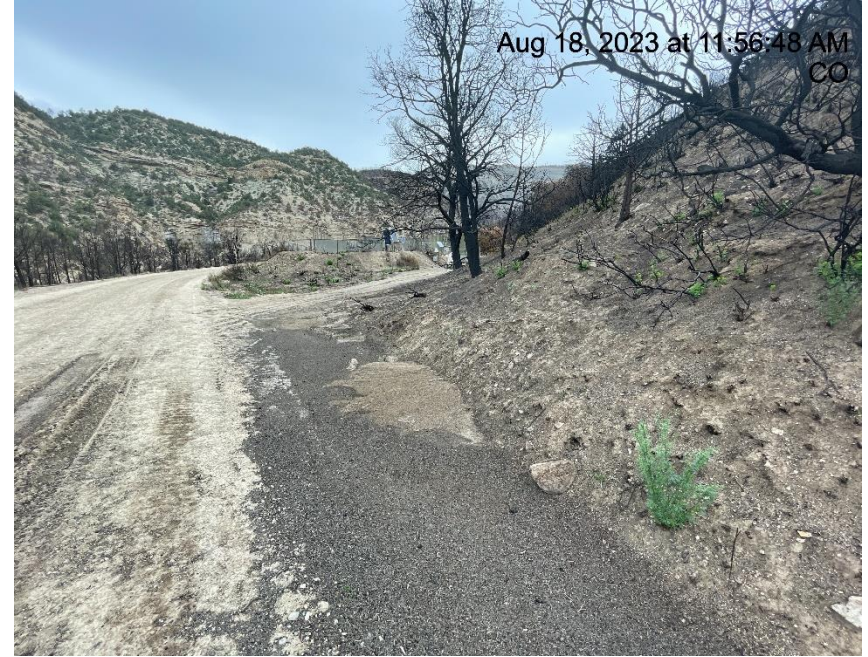
**Photo # 6546 Lack of stabilization on slope/erosion & transport of sediment/insufficient run on controls/BMP's (on lease road near pig station)**

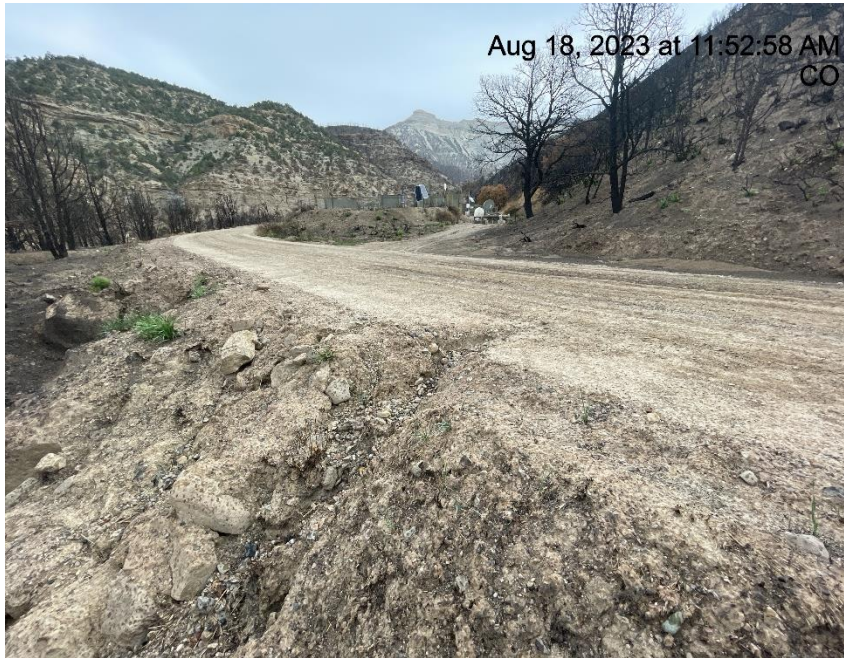
**Photo # 6532 Erosion & transport of sediment off lease road  
(on lease road near pig station)**

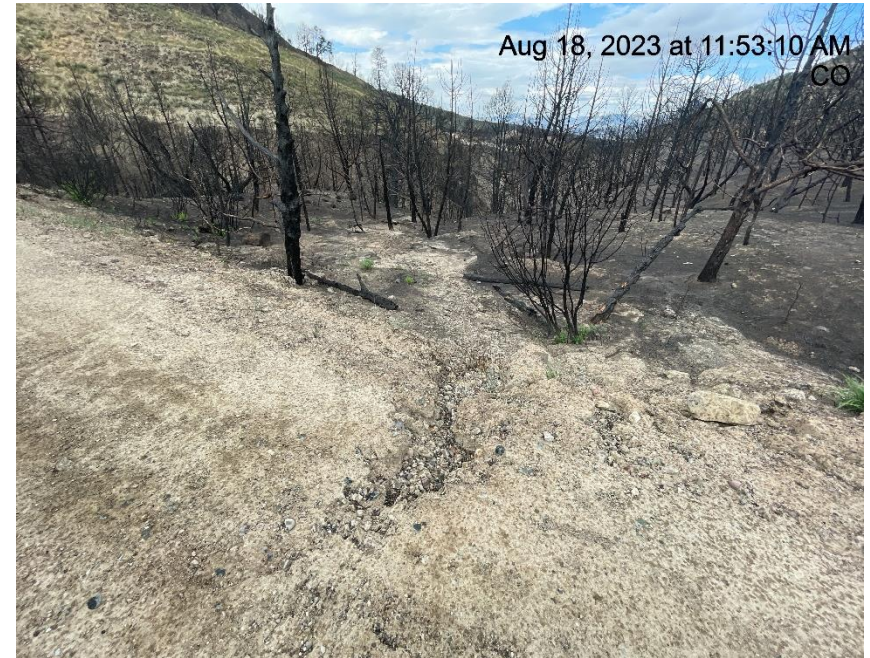
**Photo # 6533 Erosion & transport of sediment off lease road  
(on lease road near pig station)**

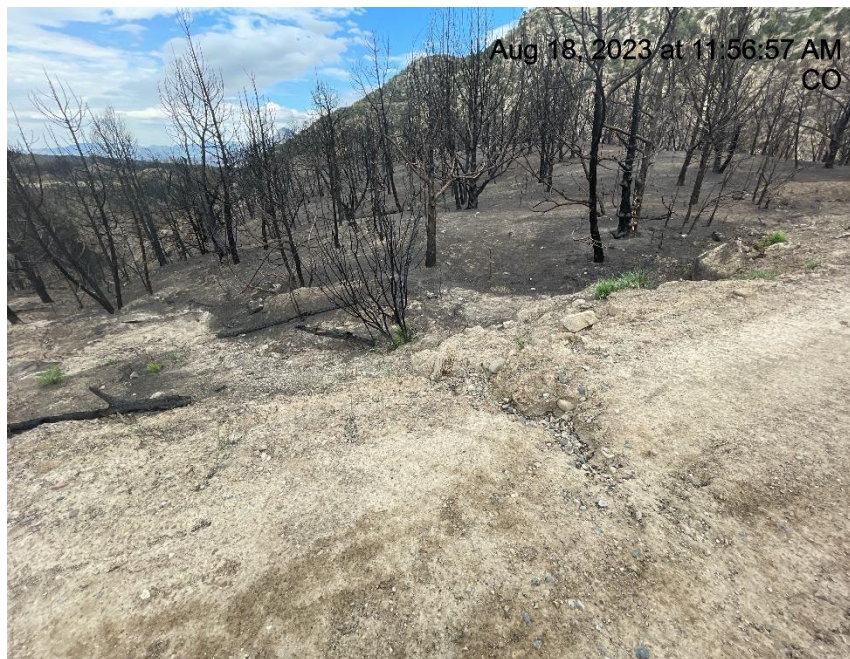
**Photo # 6547 Erosion & transport of sediment off lease road  
(on lease road near pig station)**

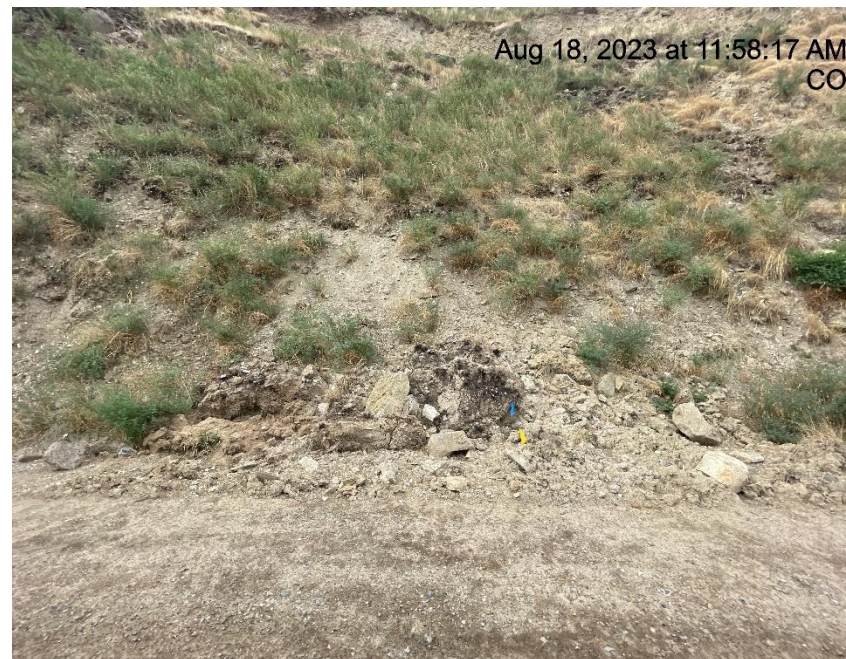
**Photo # 6549 Lack of stabilization on slope/transport of  
sediment onto edge of lease road (approximately 1/10<sup>th</sup> of a  
mile from location)**

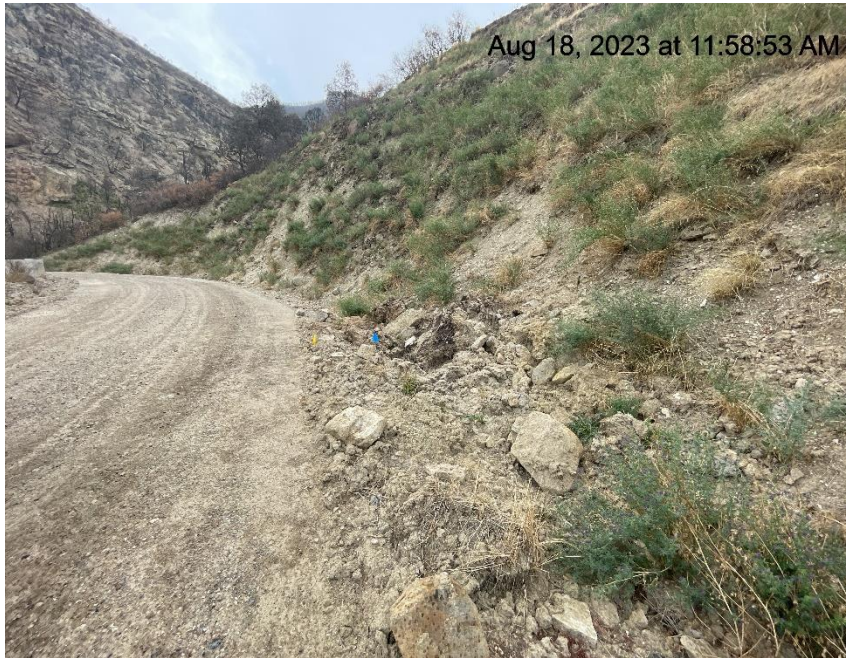
**Photo # 6551 Lack of stabilization on slope/transport of sediment onto edge of lease road (approximately 1/10<sup>th</sup> of a mile from location)**

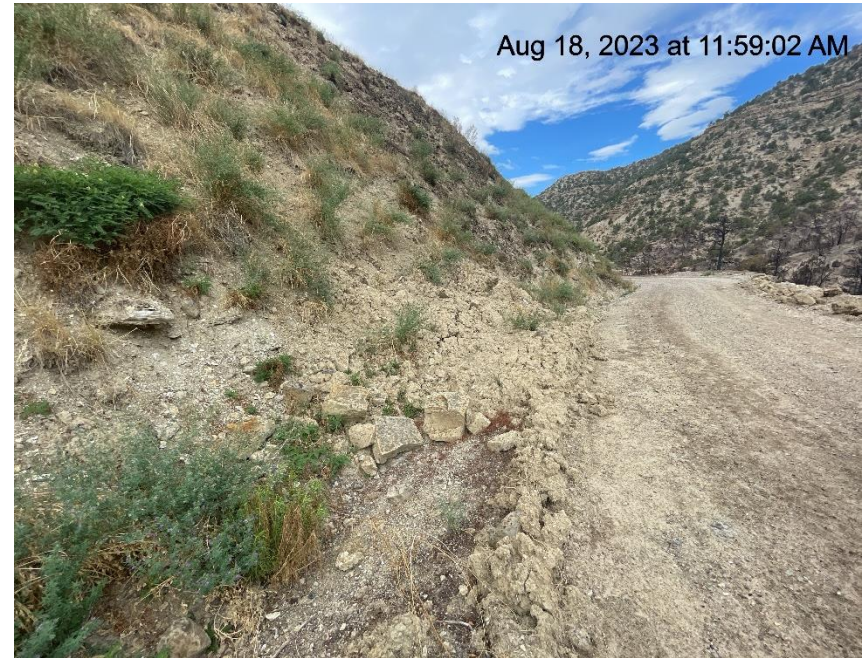
**Photo # 6552 Lack of stabilization on slope/transport of sediment onto edge of lease road (approximately 1/10<sup>th</sup> of a mile from location)**

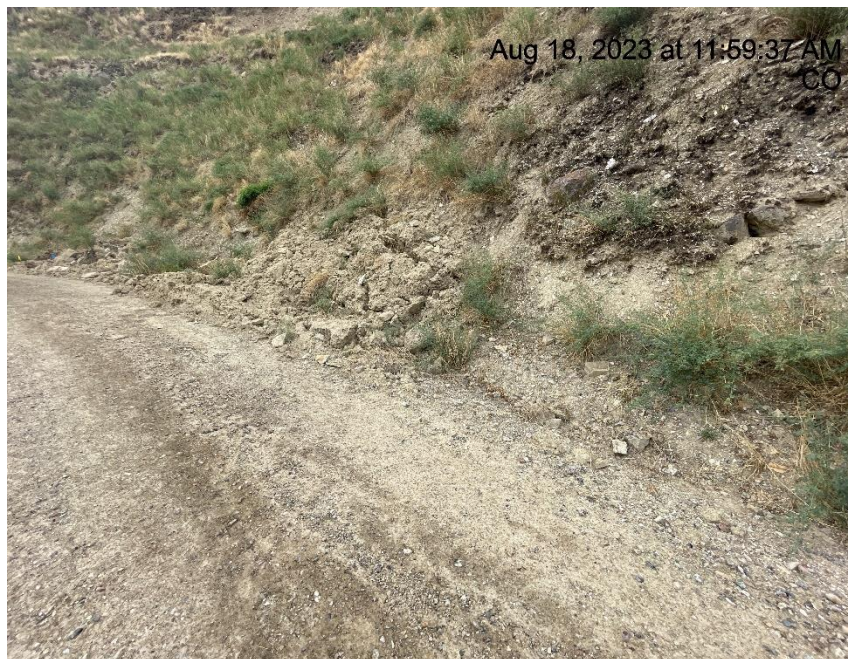
**Photo # 6555 Lack of stabilization on slope/transport of sediment onto edge of lease road (approximately 1/10<sup>th</sup> of a mile from location)**

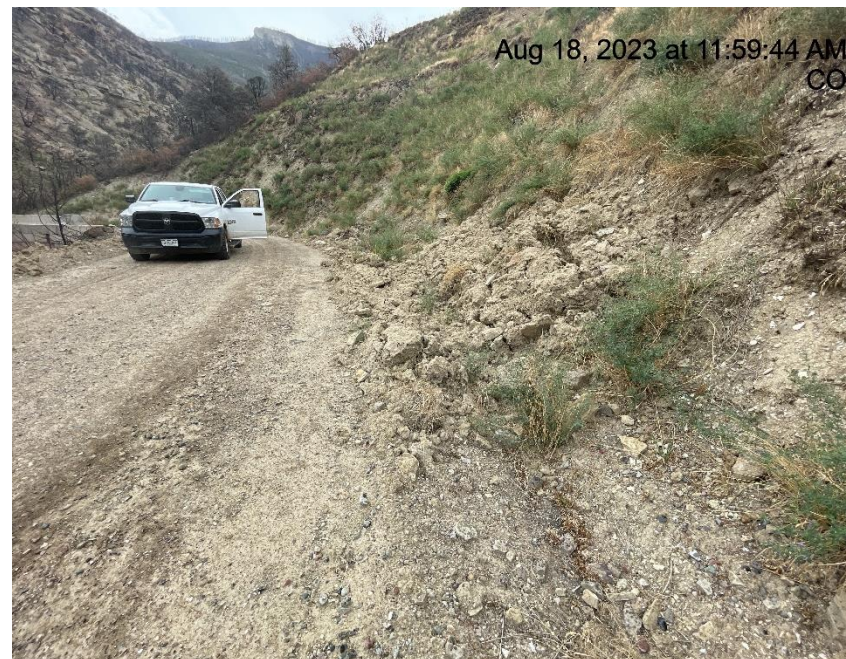
**Photo # 6556 Lack of stabilization on slope/transport of sediment onto edge of lease road (approximately 1/10<sup>th</sup> of a mile from location)**

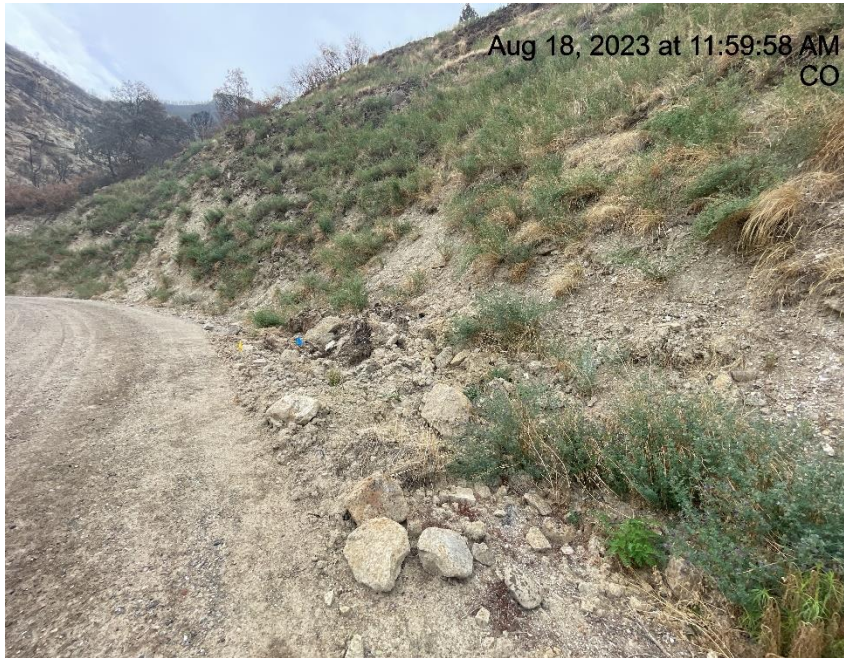
**Photo # 6557 Lack of stabilization on slope/transport of sediment onto edge of lease road (approximately 1/10<sup>th</sup> of a mile from location)**

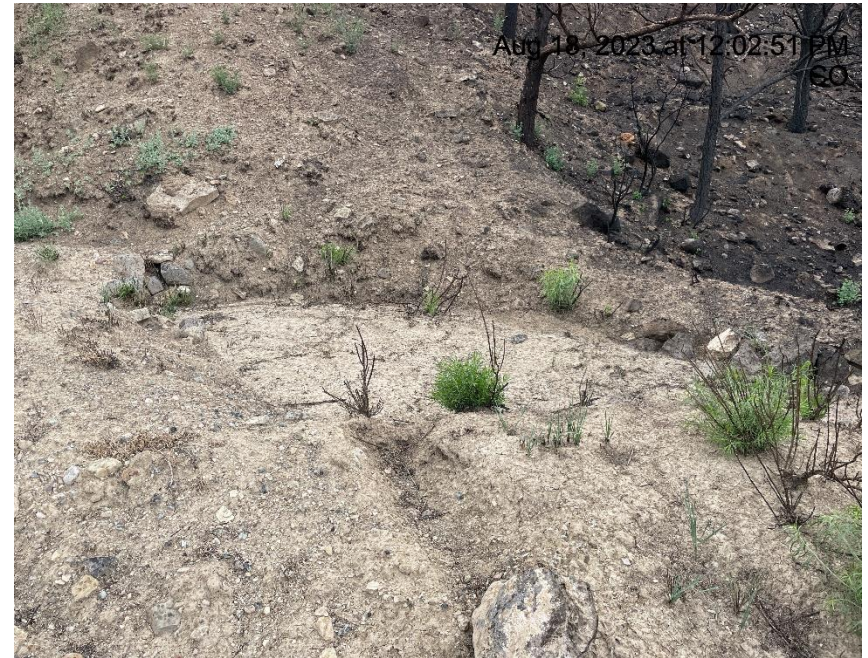
**Photo # 6561 Sediment trap needs maintenance (on lease road just after the Federal 8D pad location # 415673)**

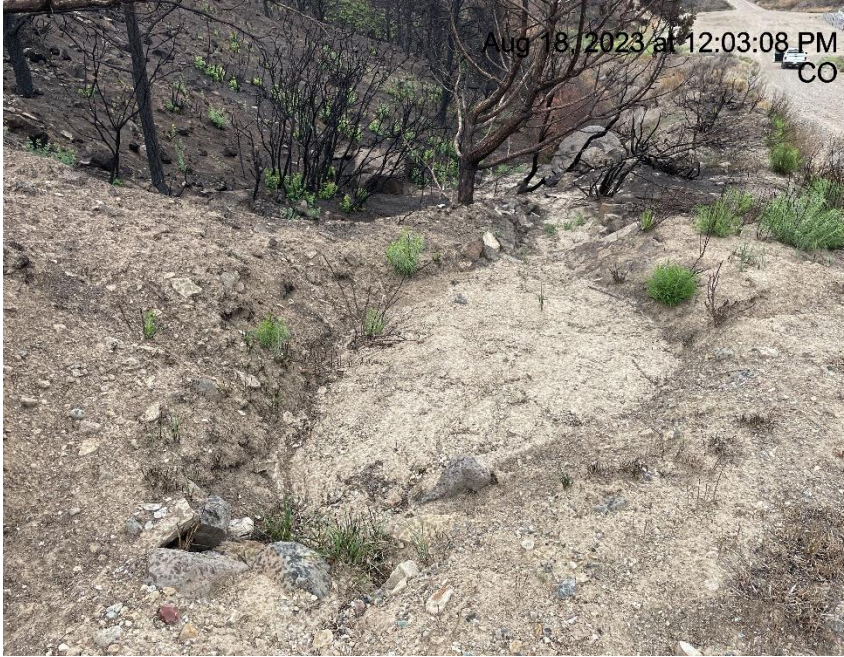
**Photo # 6562 Sediment trap needs maintenance (on lease road just after the Federal 8D pad location # 415673)**

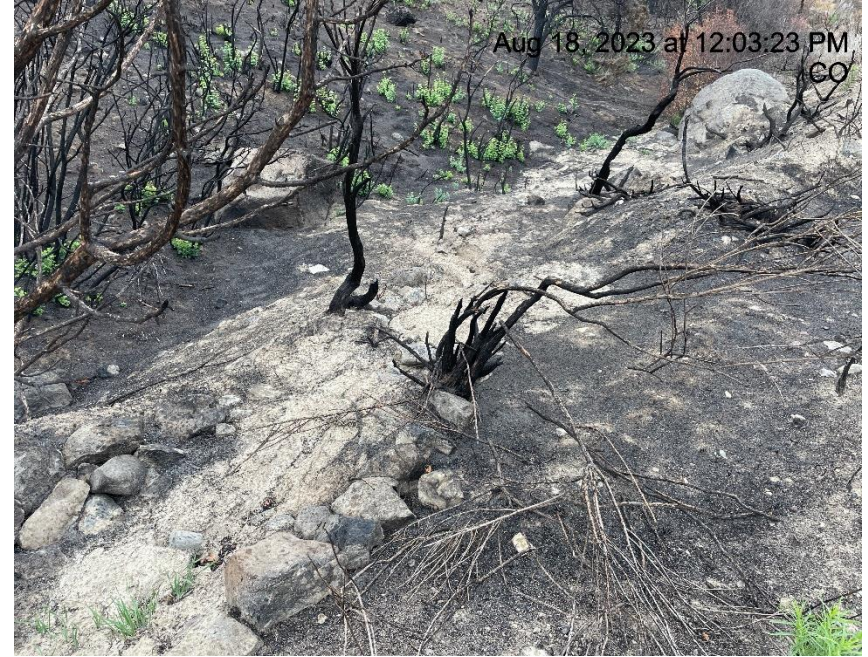
**Photo # 6563 Sediment trap needs maintenance/BMP's need maintenance/erosion & transport of sediment (on lease road just after the Federal 8D pad location # 415673)**

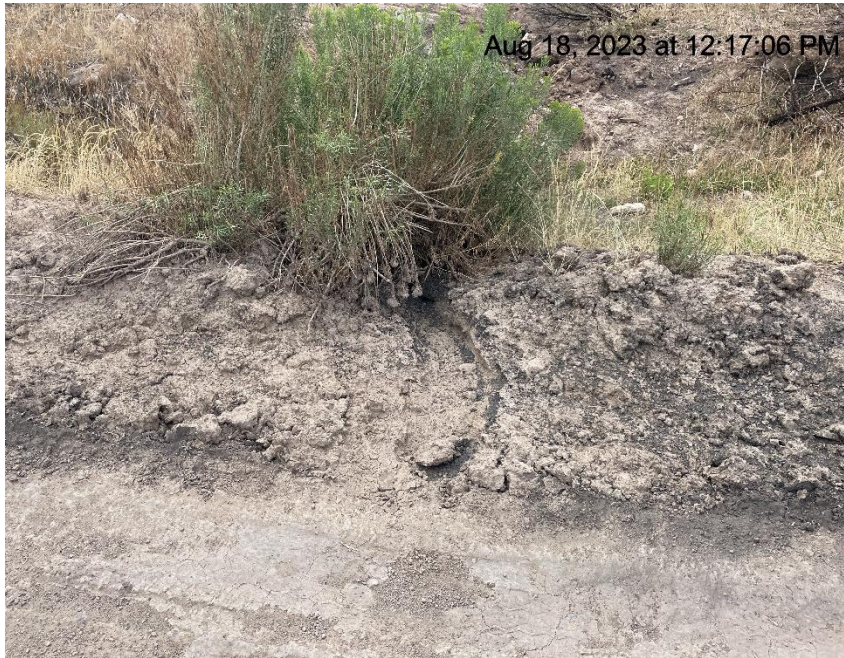
**Photo # 6573 Erosion & transport of sediment off lease road  
(approximately 2 miles from location)**

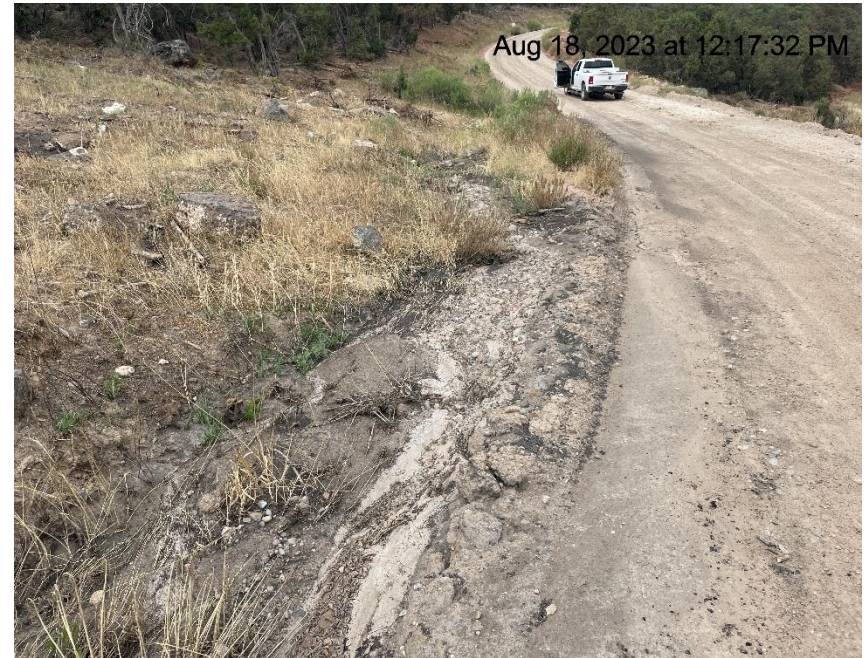
**Photo # 6574 Erosion & transport of sediment  
(approximately 2 miles from location)**

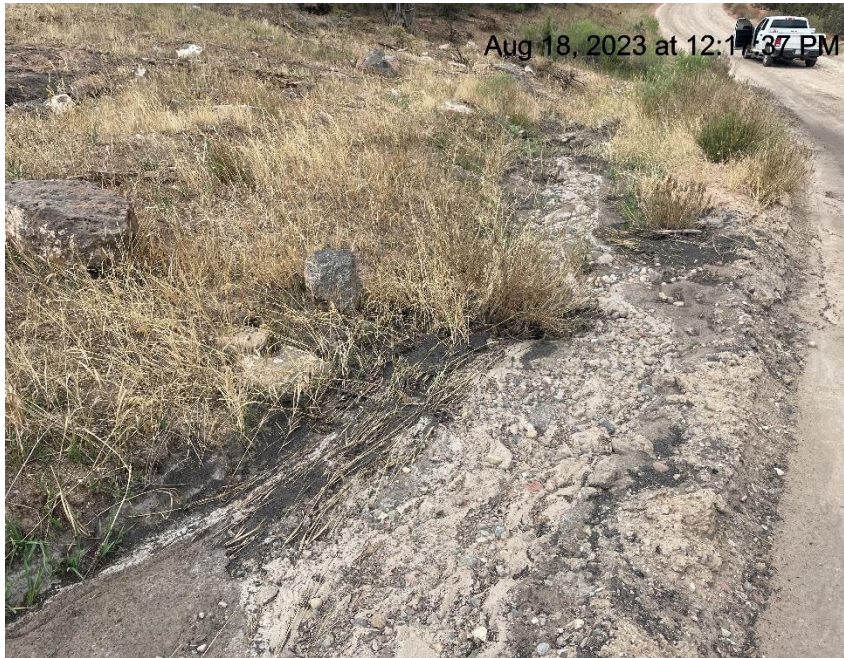
**Photo # 6575 Erosion & transport of sediment/BMP's need maintenance (approximately 2 miles from location)**

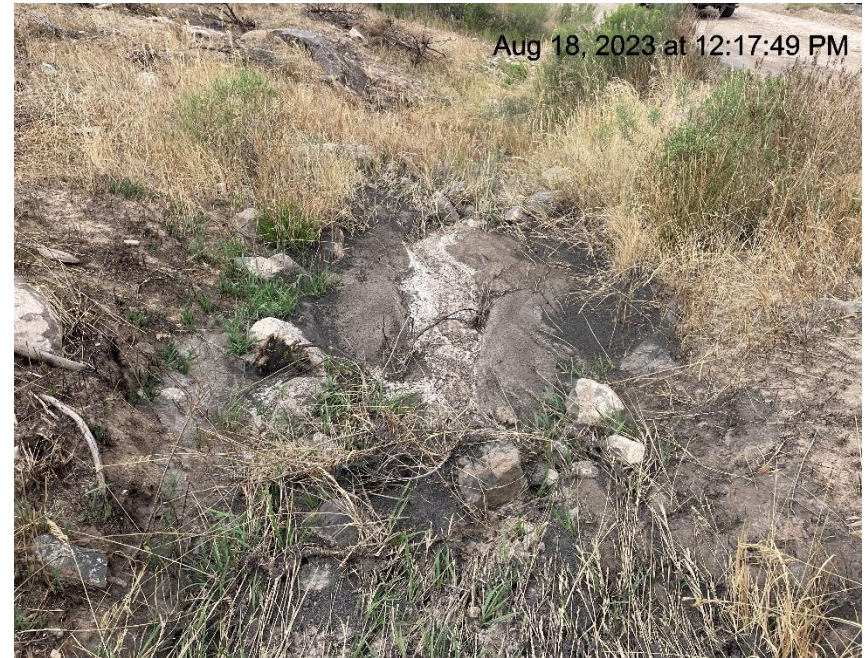
**Photo # 6576 Sediment trap need maintenance (approximately 2 miles from location)**

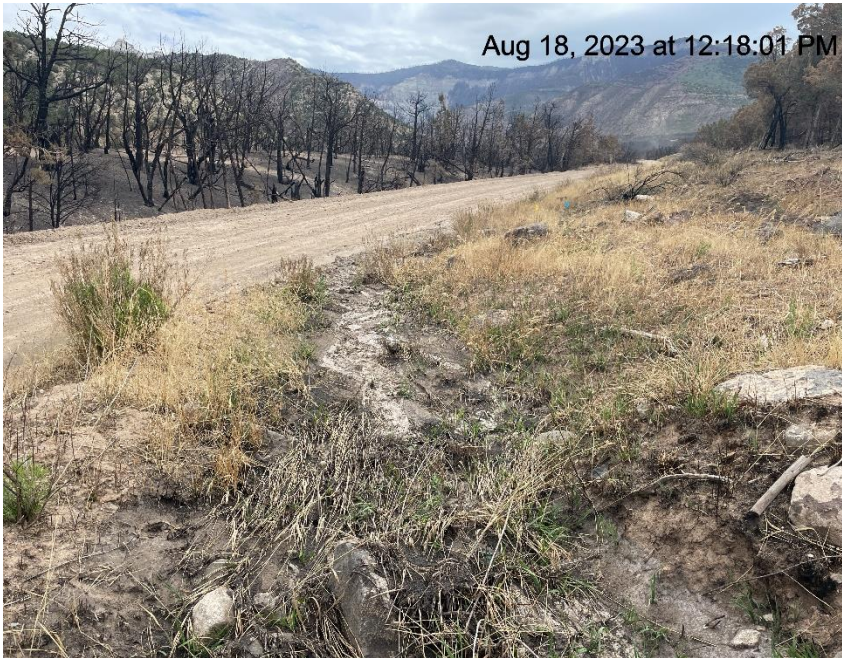
**Photo # 6577 Erosion & transport of sediment/BMP's need maintenance (approximately 2 miles from location)**

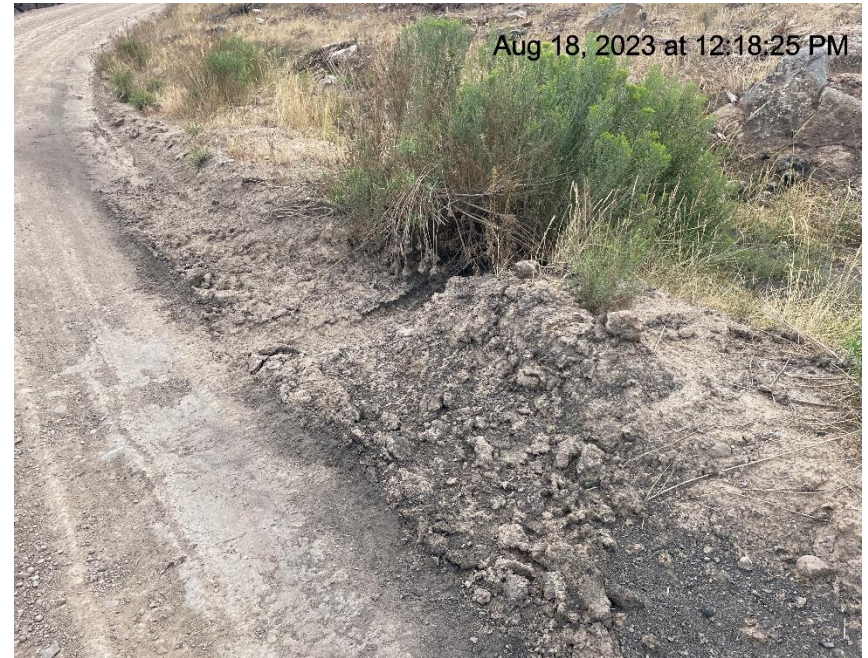
**Photo # 6578 Erosion & transport of sediment off lease road (approximately 2 miles from location)**
