Storm Water Management and Erosion control
Location Name: CAERUS PICEANCE LLC SGV FEDERAL 8D Pad
Location ID: 415673

**Location Overview: Location is approximately 86 yards from
Pete & Bill creek. Location is within High Priority/Black
Bear/NSO Habitat areas.**

Section/Township/Range: 8 8S95W

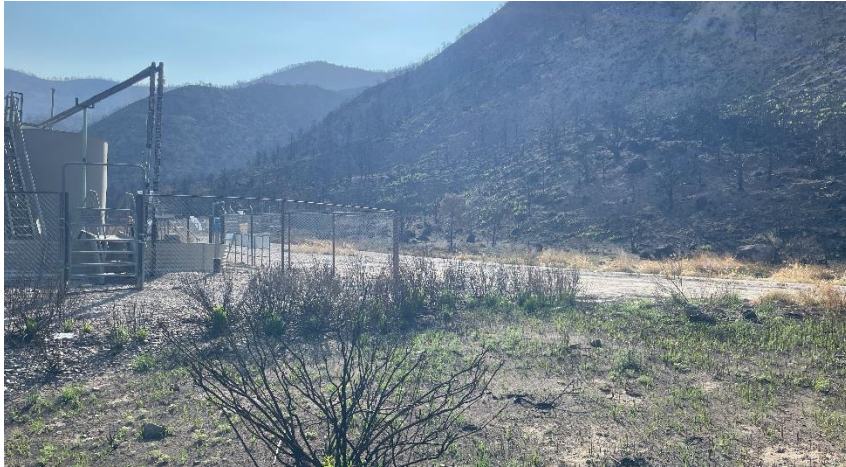
North West corner of location.

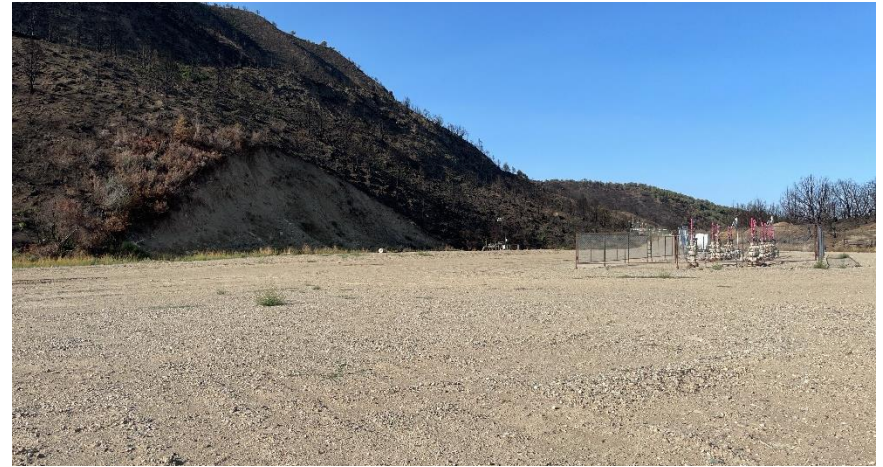
North East corner of location.

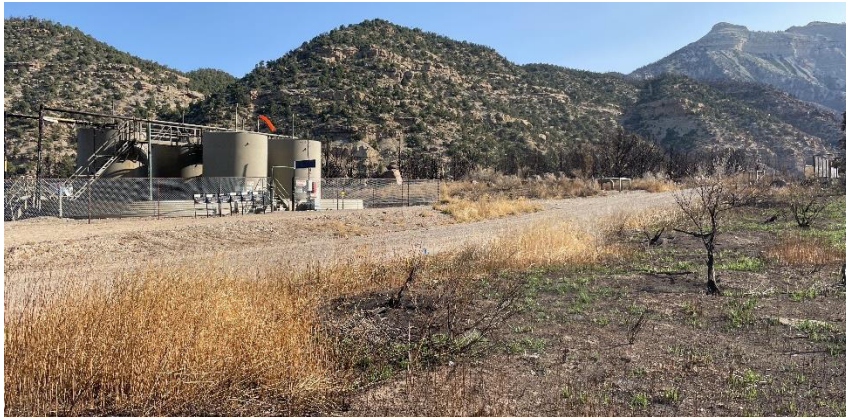
South West corner of location.

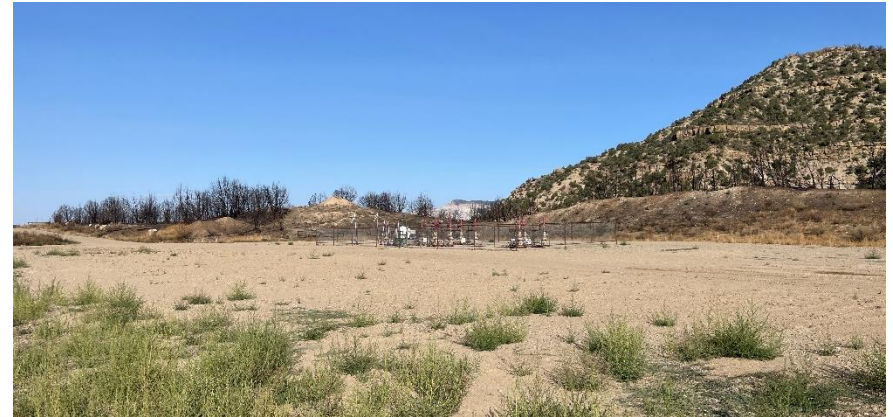
South East corner of location.

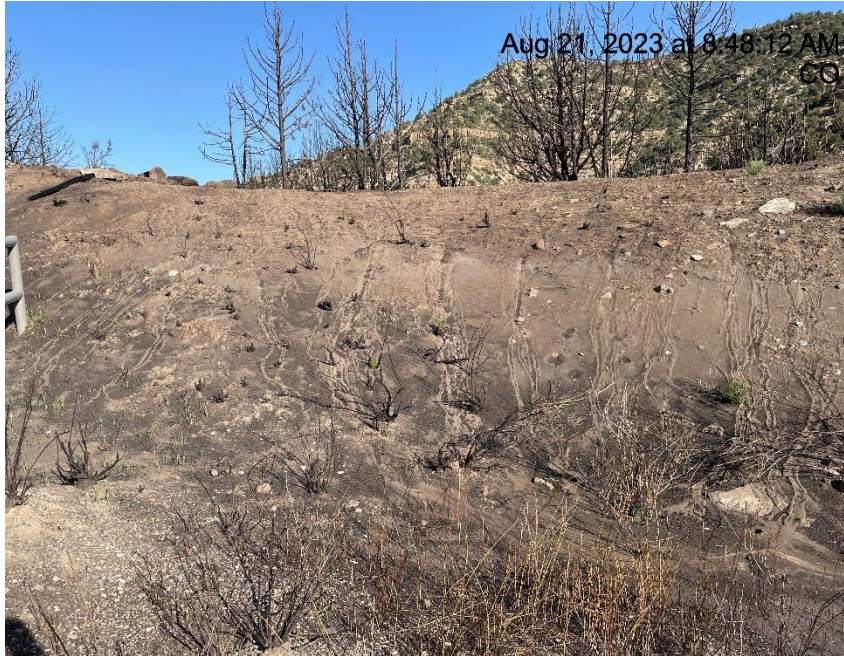
Photo # 6621 Erosion & transport of sediment (N/NE area of location on slope near wellheads)

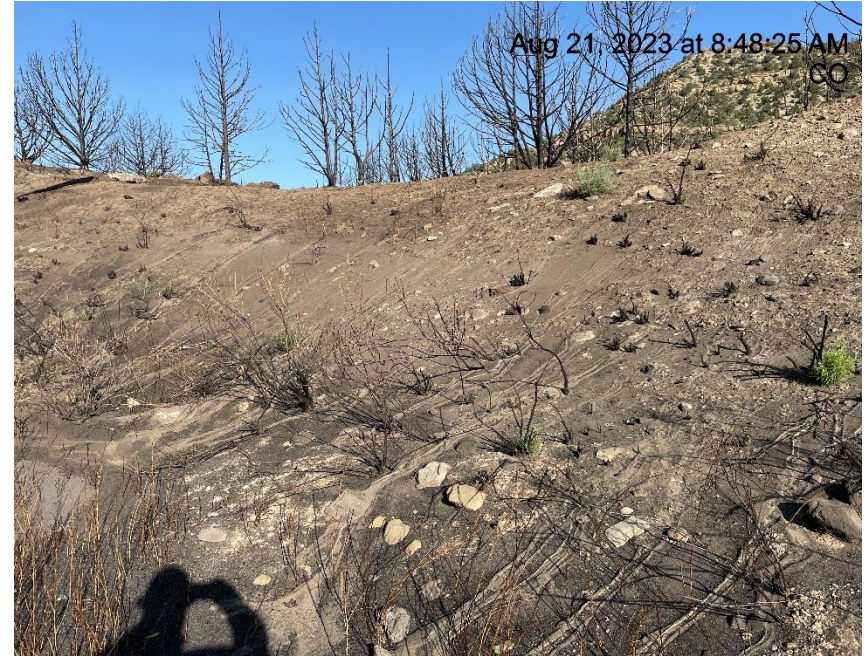
Photo # 6622 Erosion & transport of sediment (N/NE area of location on slope near wellheads)

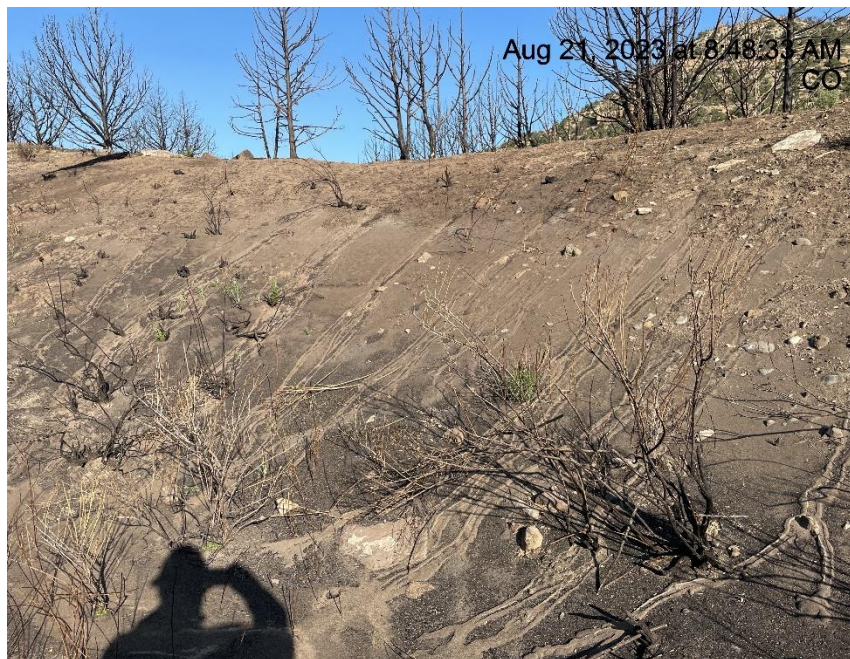
Photo # 6623 Erosion & transport of sediment (N/NE area of location on slope near wellheads)

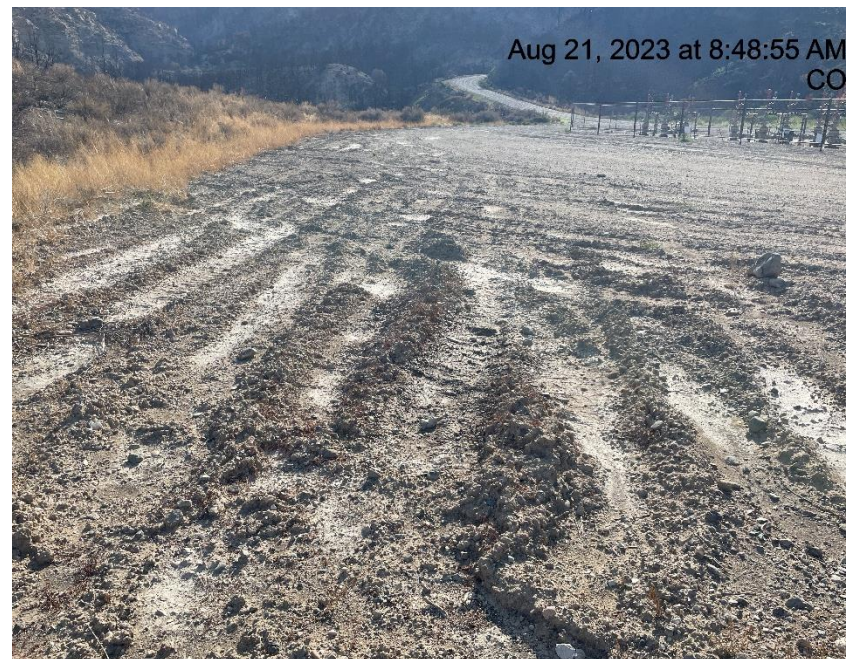
Photo # 6624 Lack of stabilization/compaction

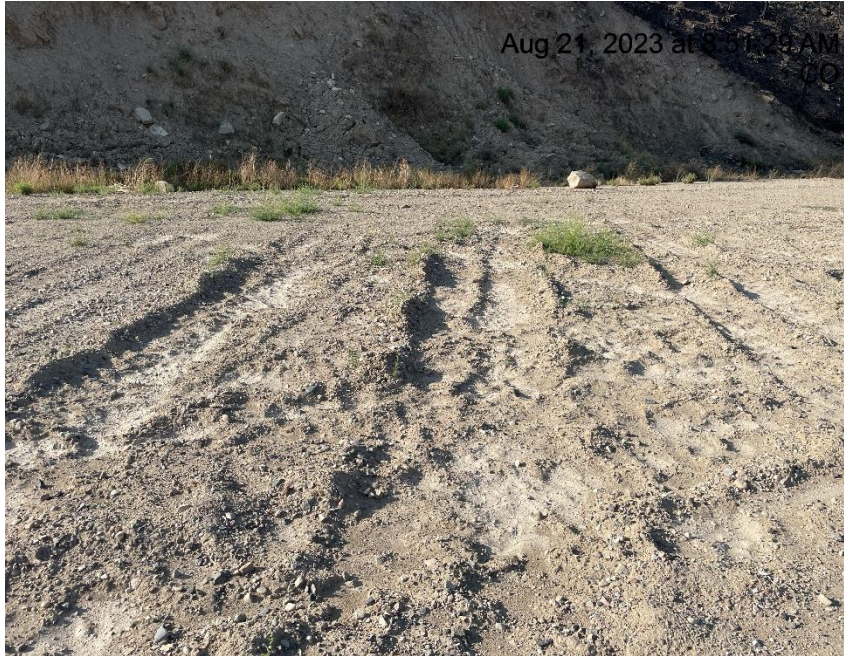
Photo # 6631 Lack of stabilization/compaction

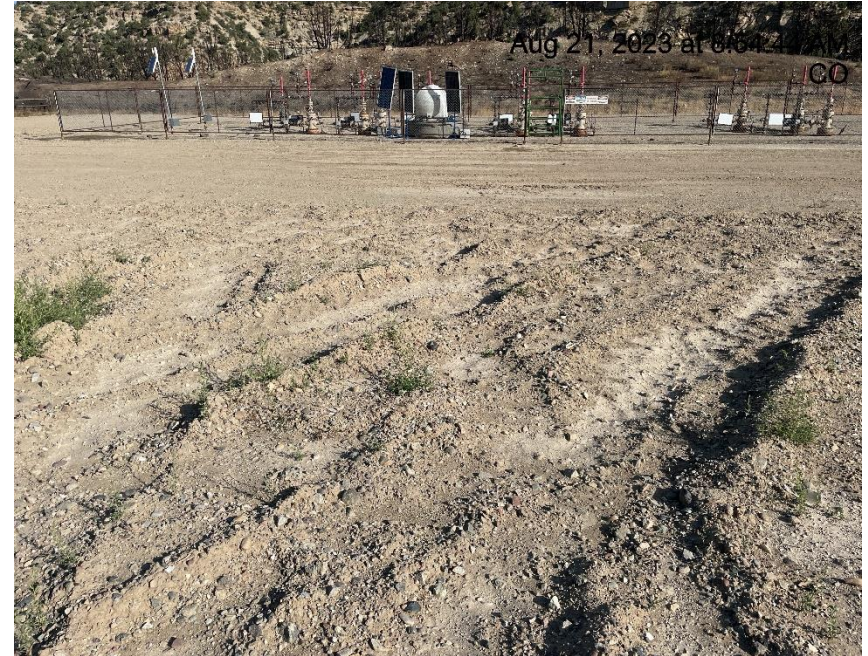
Photo # 6636 Lack of stabilization/compaction

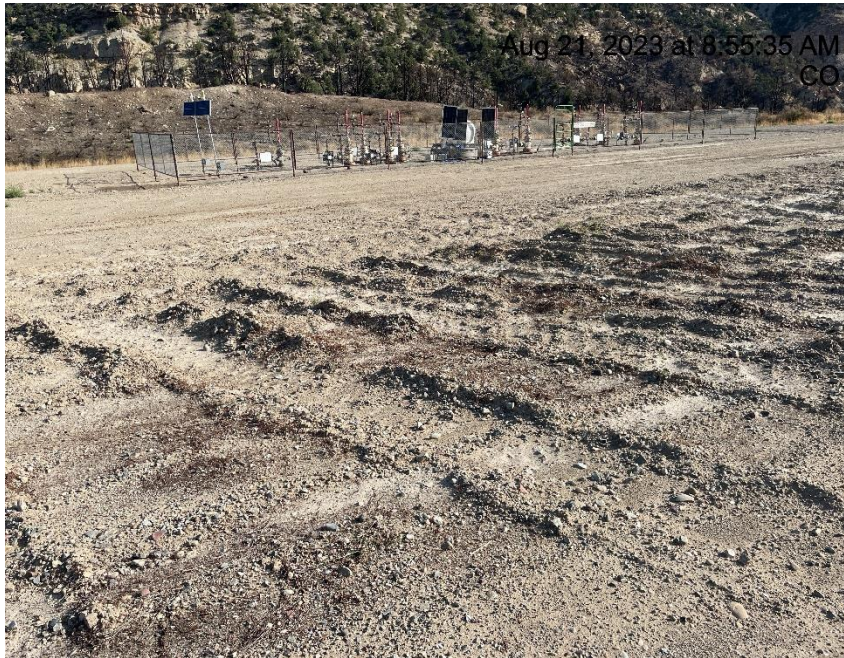
Photo # 6642 Lack of stabilization/compaction

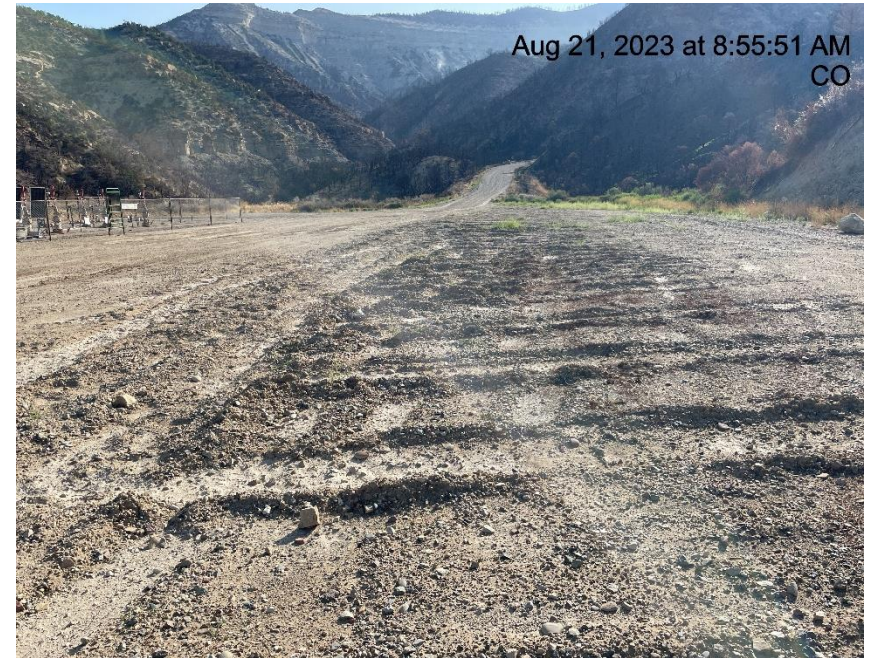
Photo # 6644 Lack of stabilization/compaction

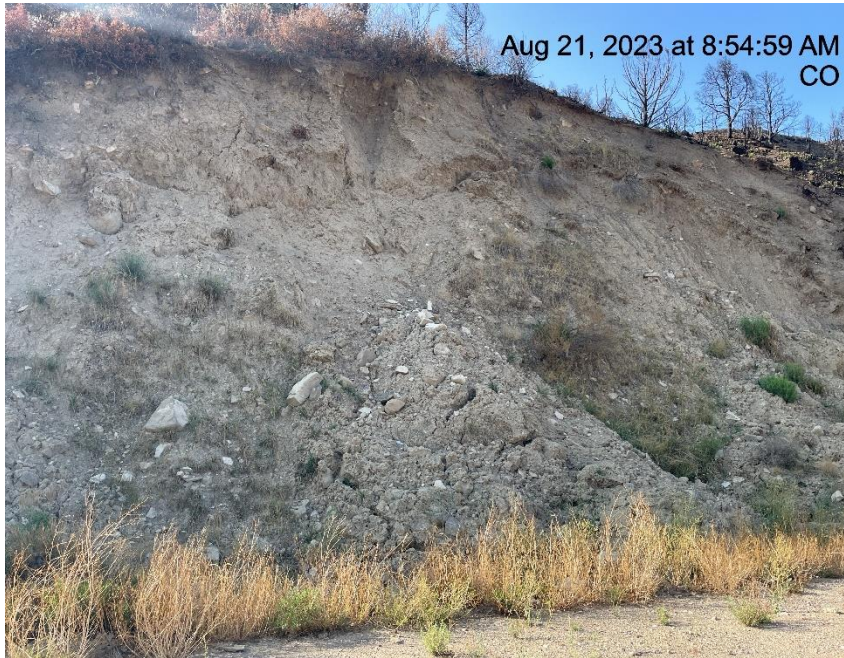
Photo # 6637 Lack of stabilization on cut slope (S/SE area of location)

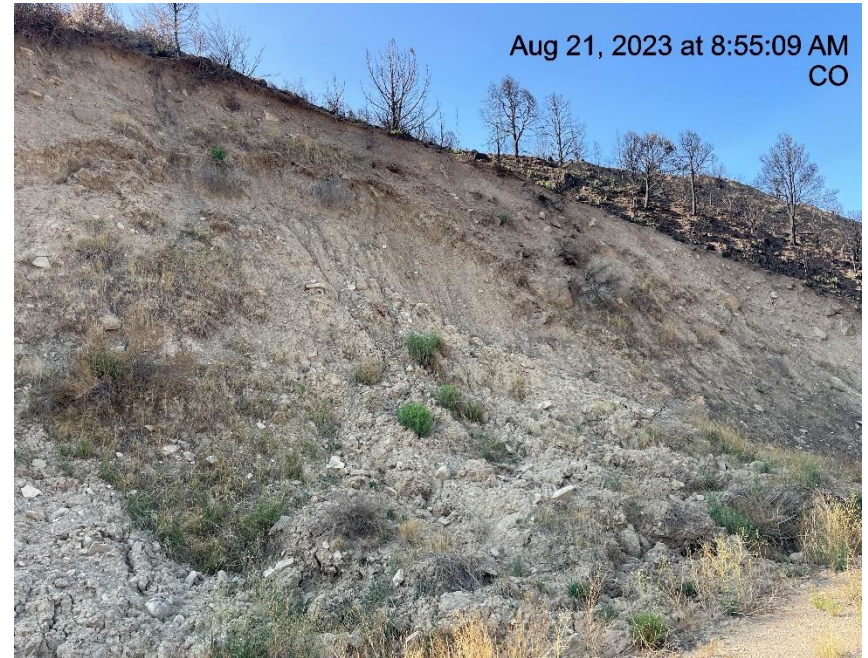
Photo # 6638 Lack of stabilization on cut slope (S/SE area of location)

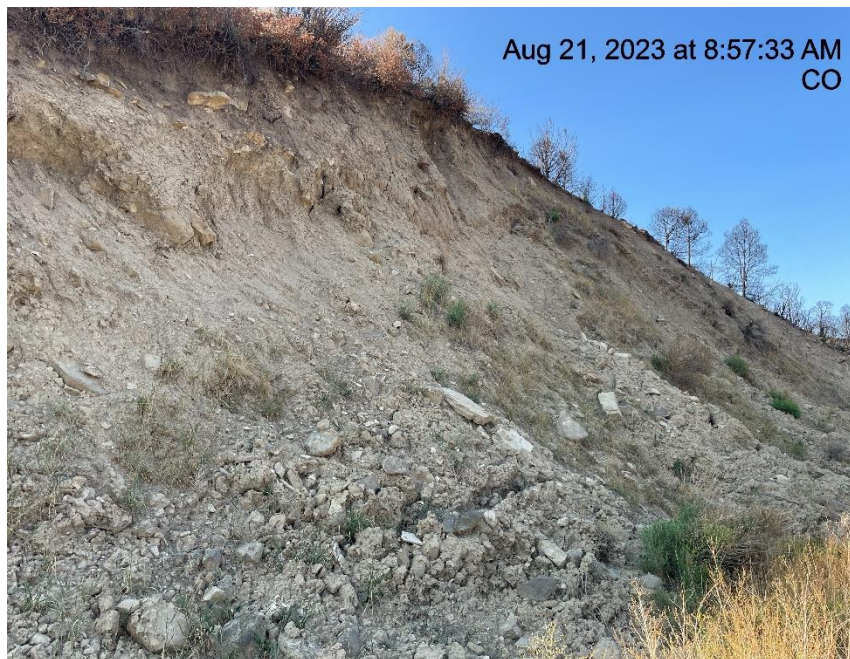
Photo # 6647 Lack of stabilization on cut slope (S/SE area of location)

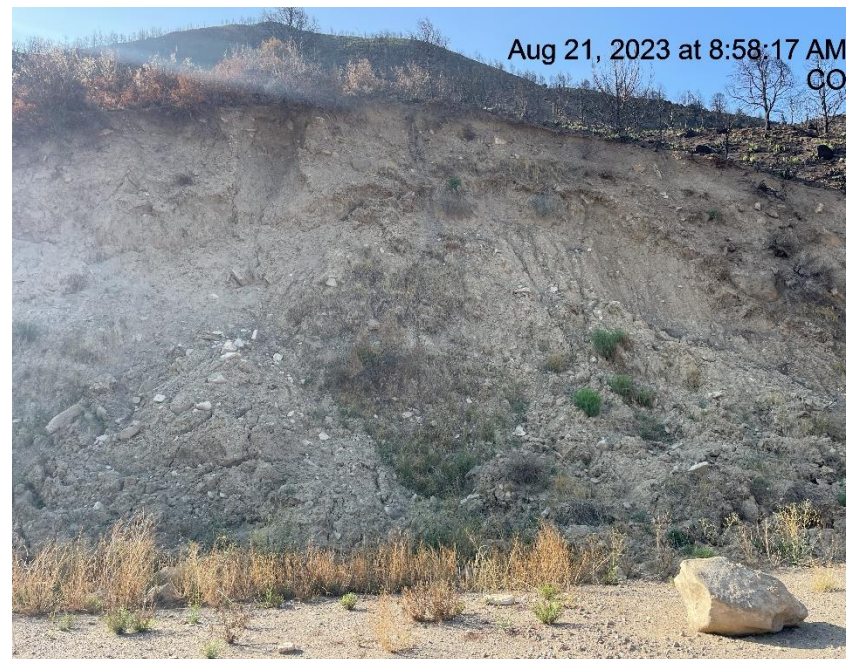
Photo # 6652 Lack of stabilization on cut slope (S/SE area of location)

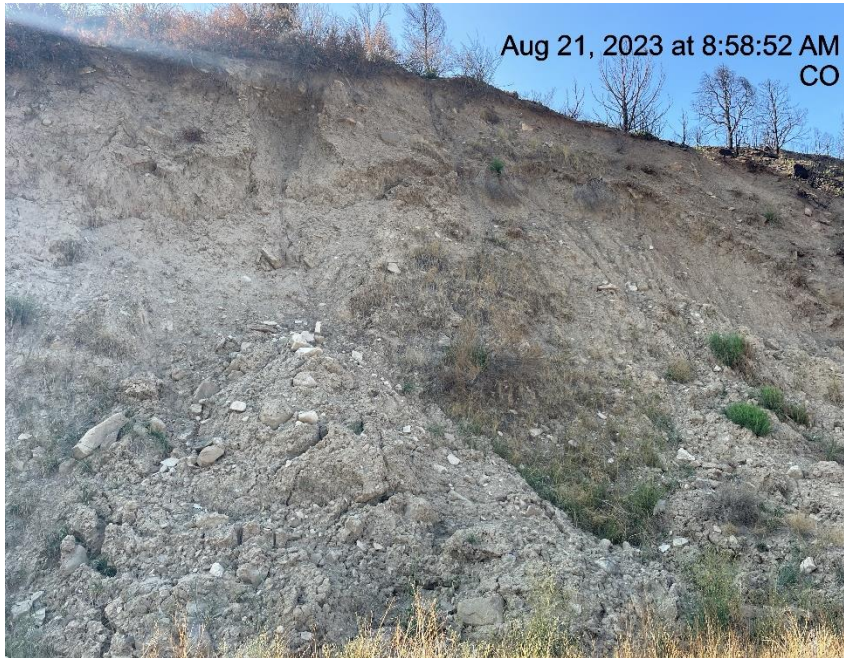
Photo # 6654 Lack of stabilization on cut slope (S/SE area of location)

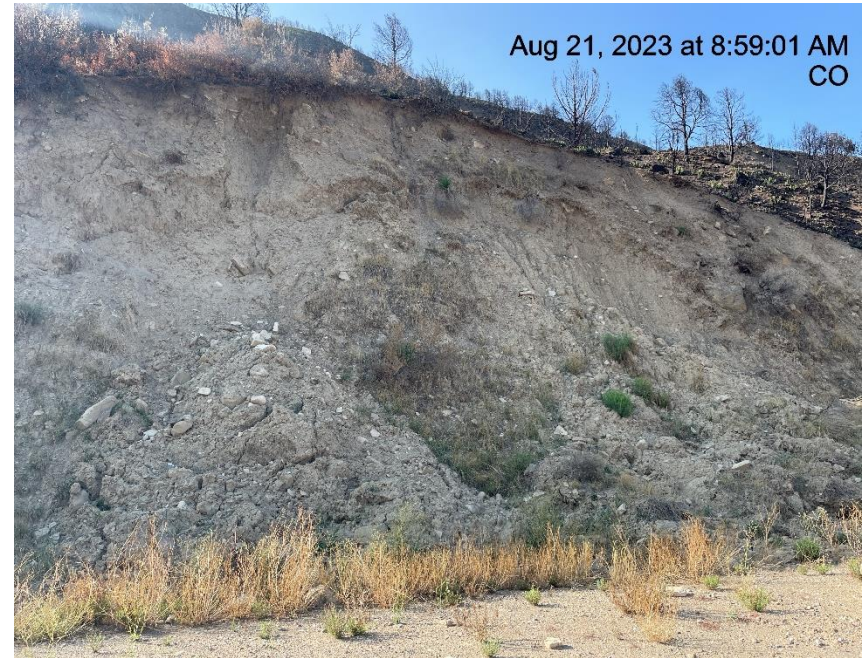
Photo # 6656 Lack of stabilization on cut slope (S/SE area of location)

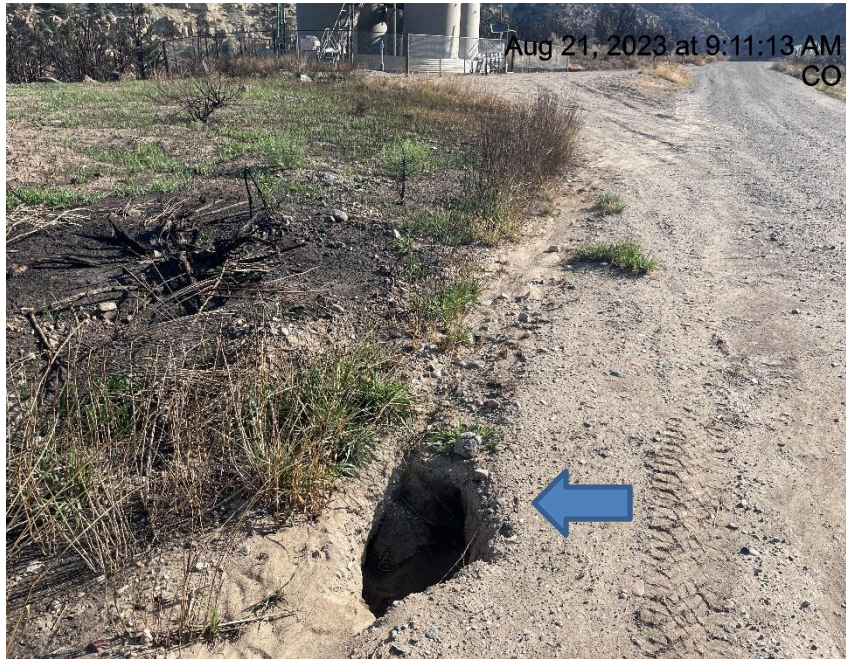
Photo # 6690 Tunnel erosion/sink hole (near entrance to location)
