Inspection Photos

Location Name: CAERUS PICEANCE LLC SGV 7K Pad

Location ID: 334366

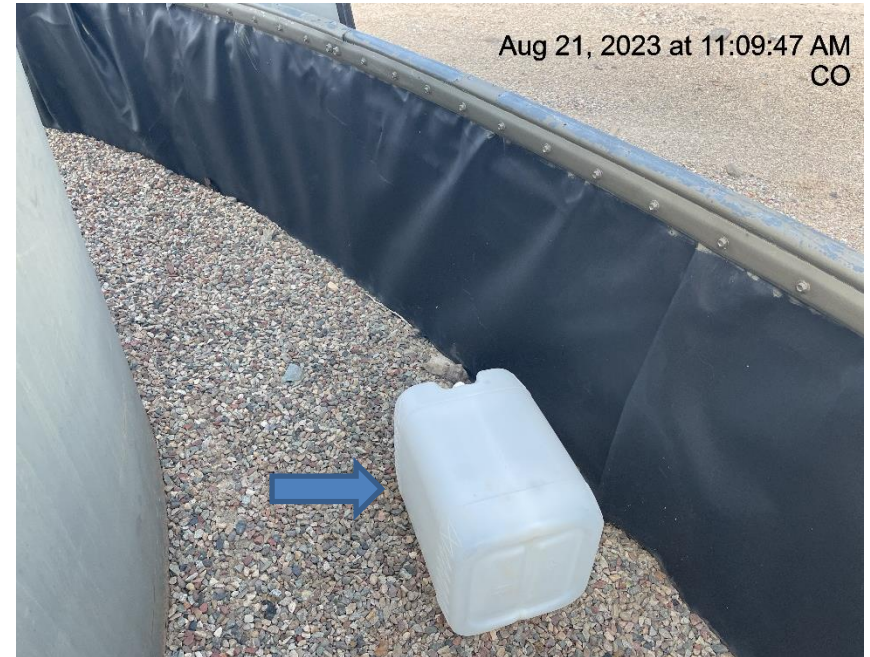
Photo # 6871 Debris

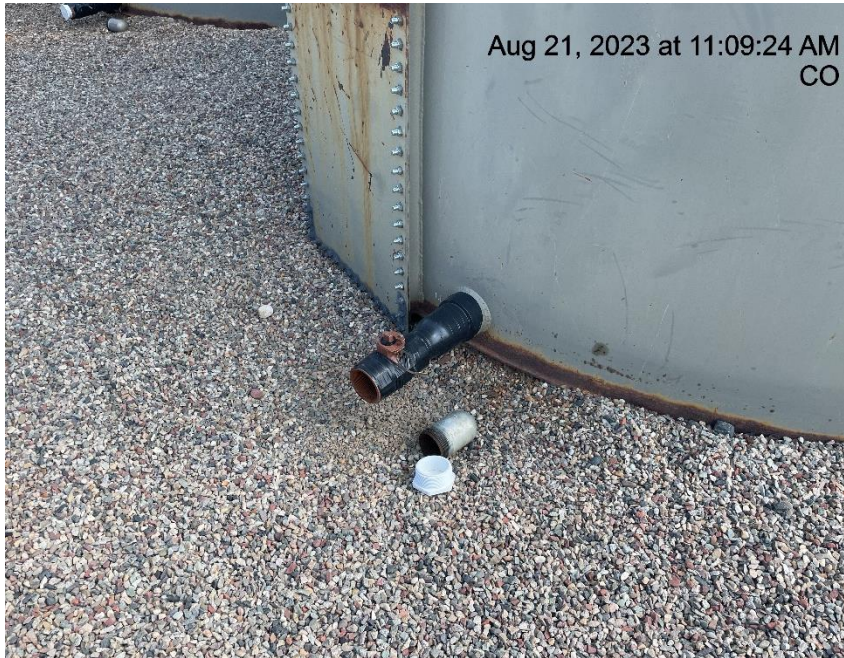
Photo # 6870 Open ended load line

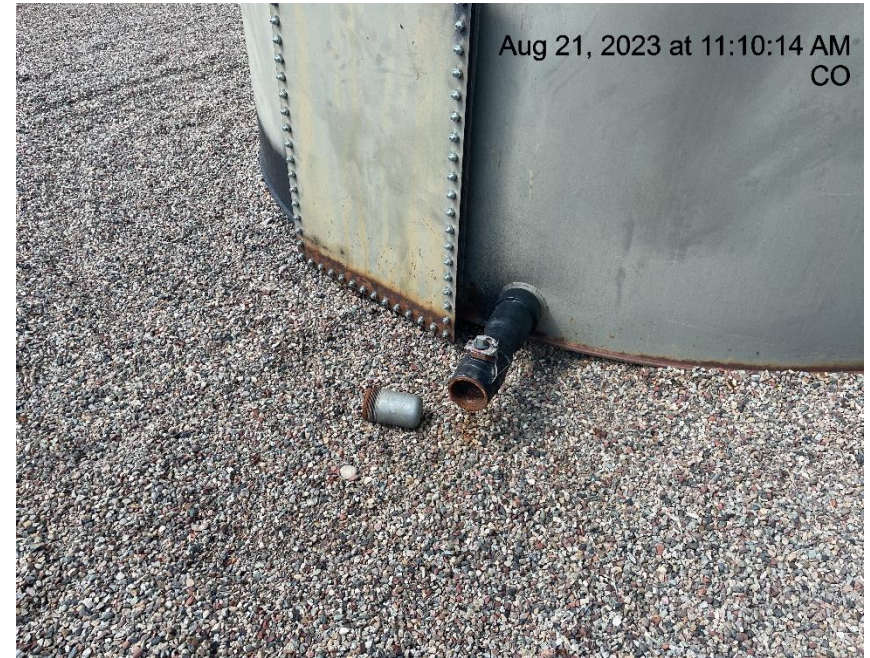
Photo # 6872 Open ended load line

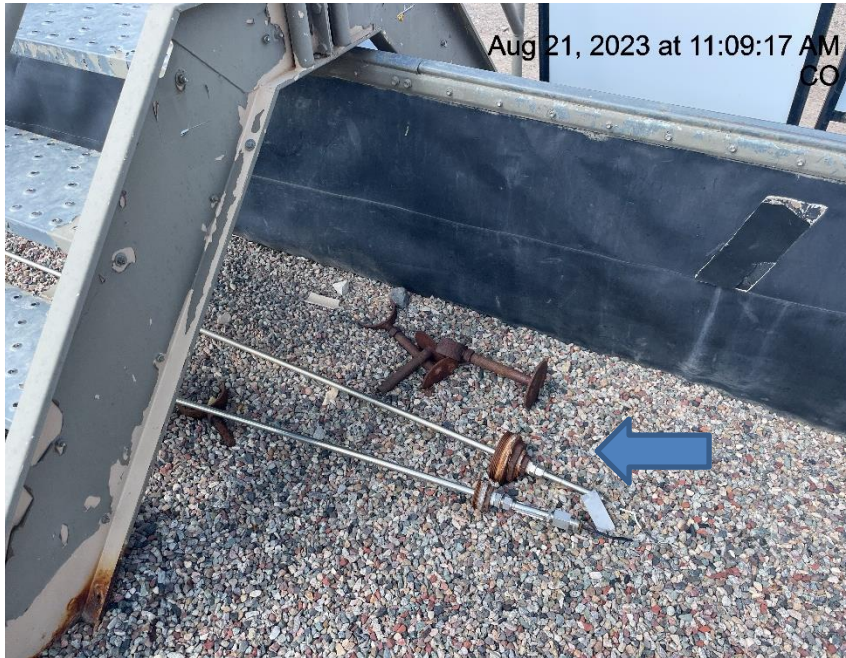
Photo # 6869 Debris
