## Inspection Photos

Location Name: TEP ROCKY MOUNTAIN LLC Johnson 5-07 Pad

Location ID: 334388

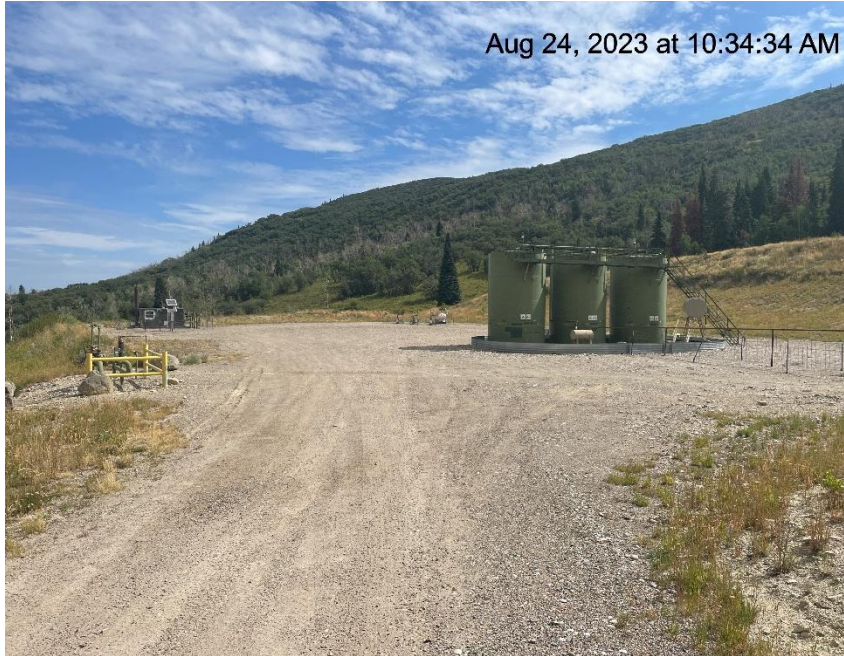
**Photo # 7088 From entrance to location**

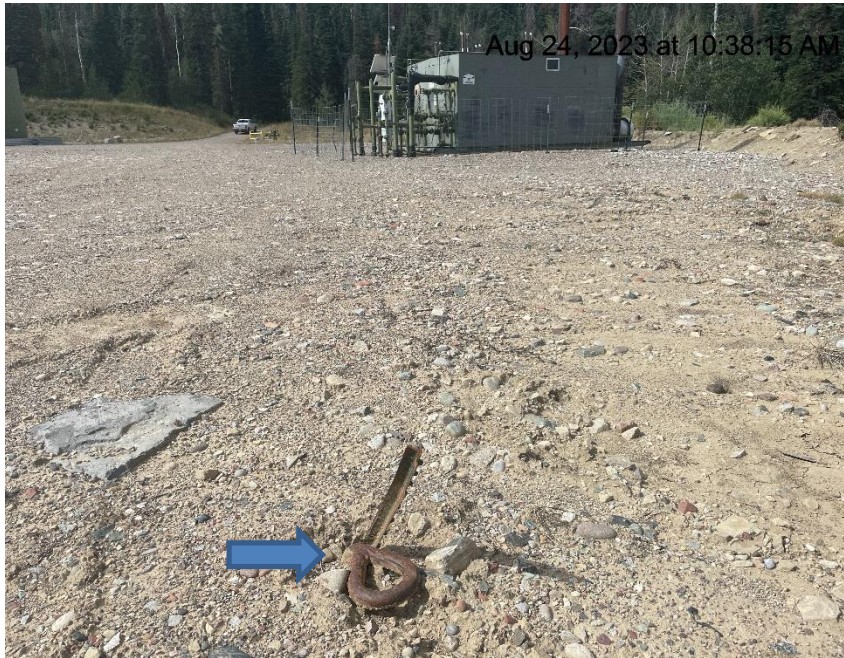
**Photo # 7096 Improperly marked deadman**

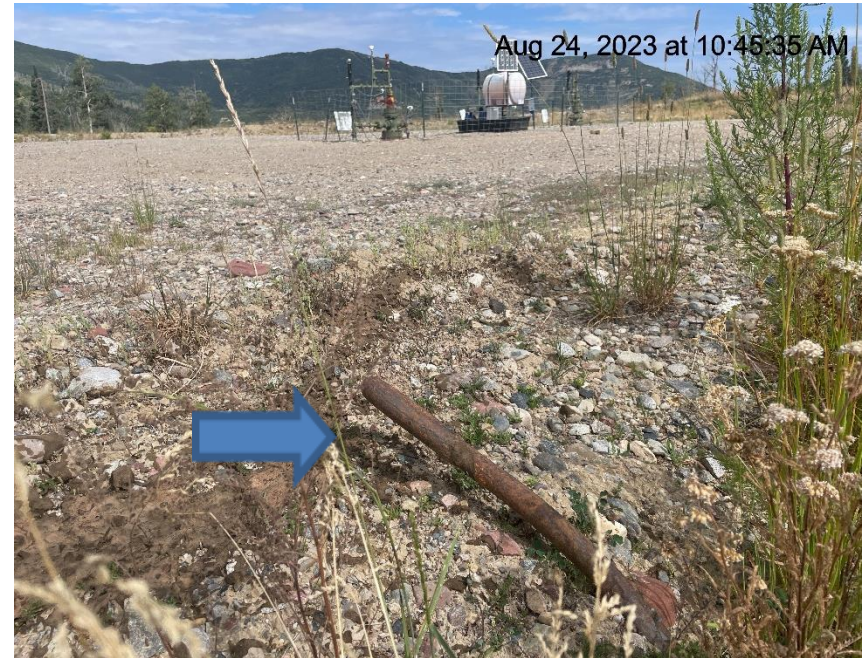
**Photo # 7107 Unmarked deadman**

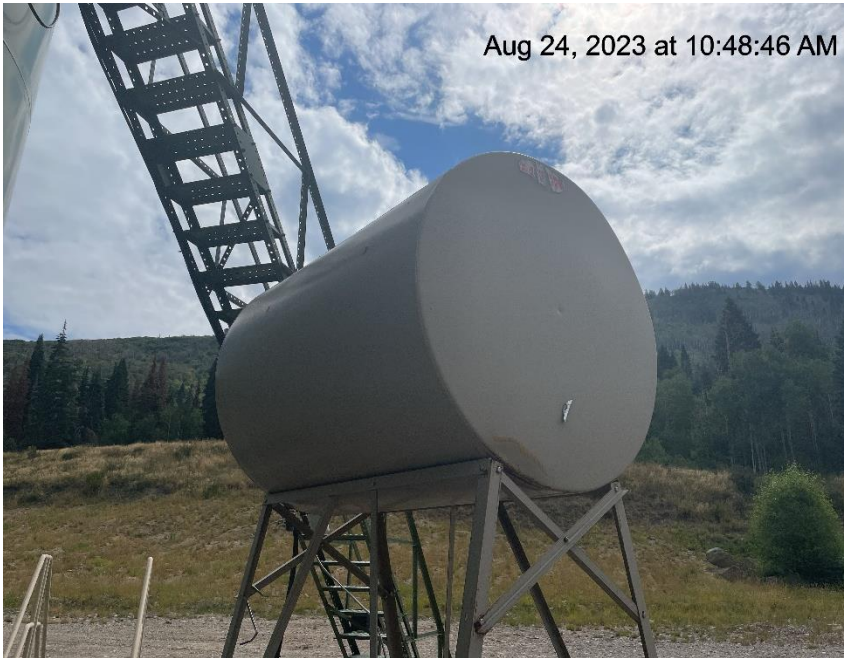
**Photo # 7111 Methanol tank lacks required information**

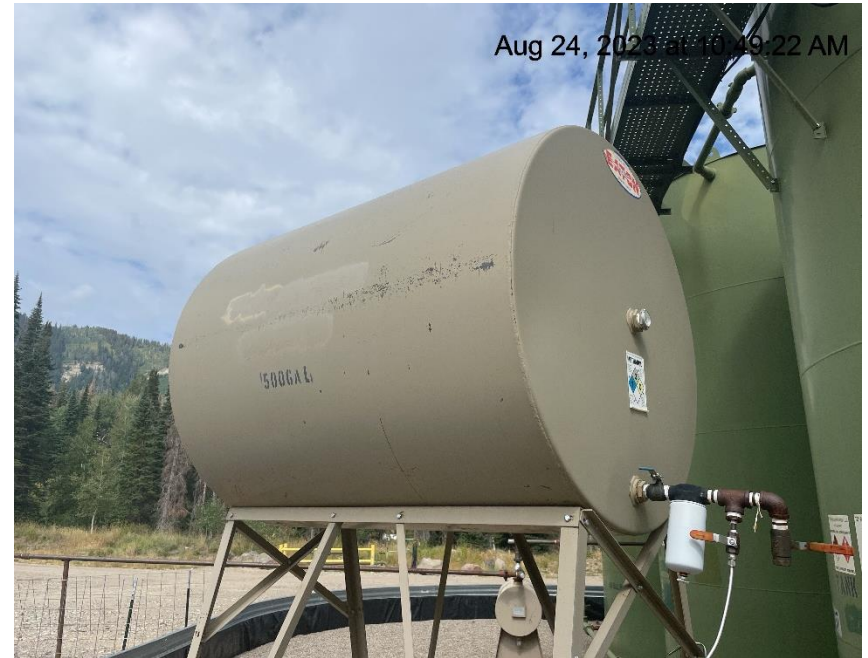
**Photo # 7112 Methanol tank lacks required information**

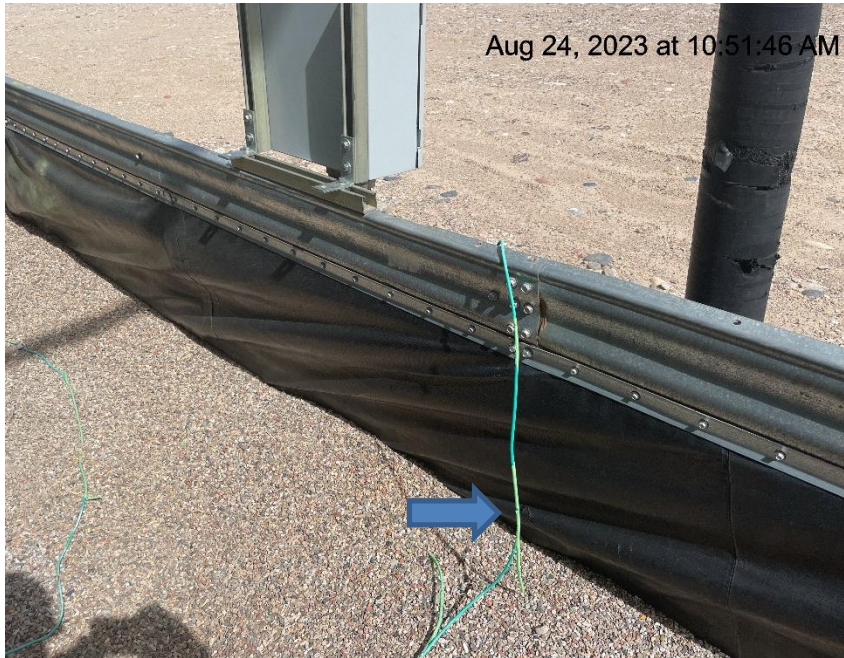
**Photo # 7115 Hole in liner/liner needs maintenance**

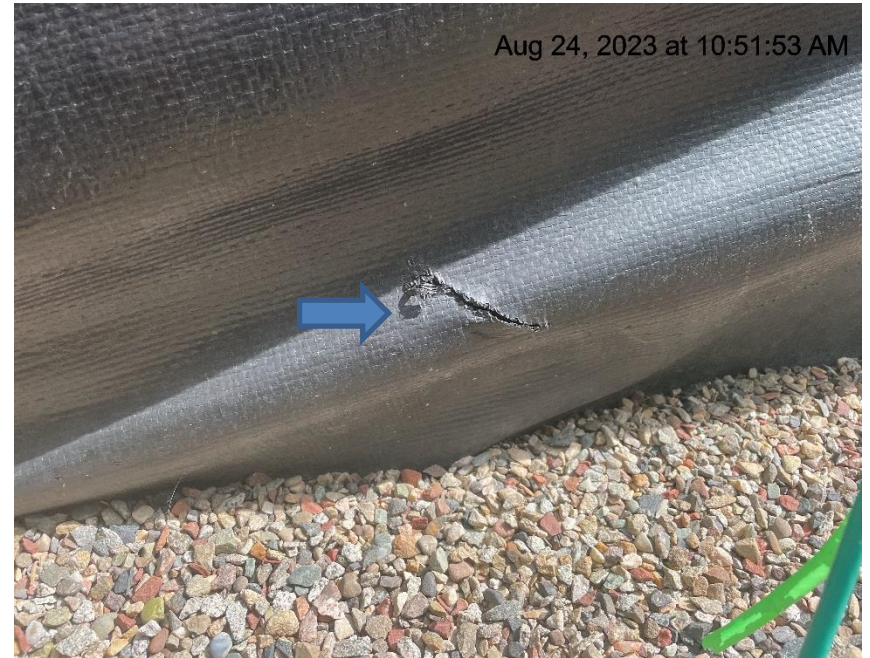
**Photo # 7116 Hole in liner/liner needs maintenance**

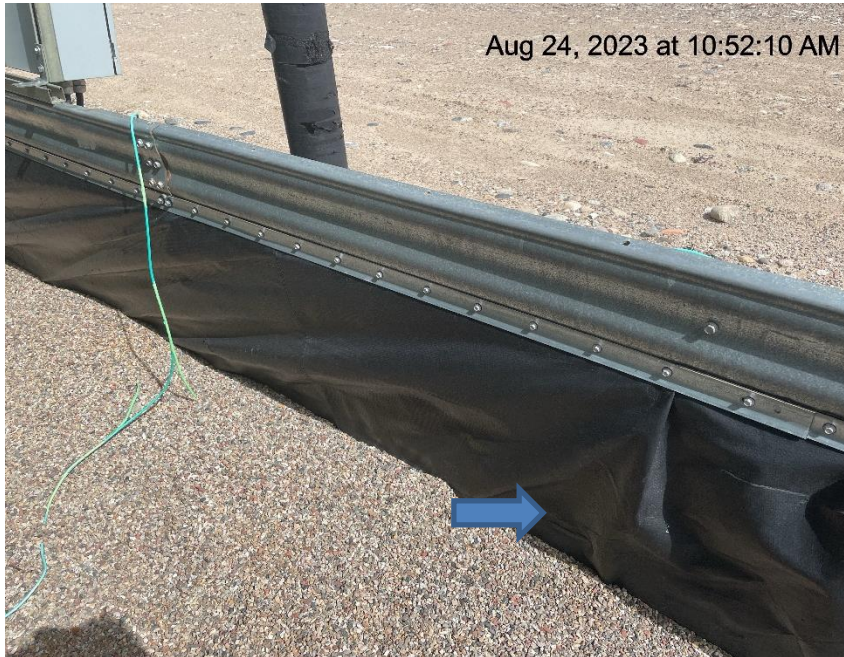
**Photo # 7118 Hole in liner/liner needs maintenance**

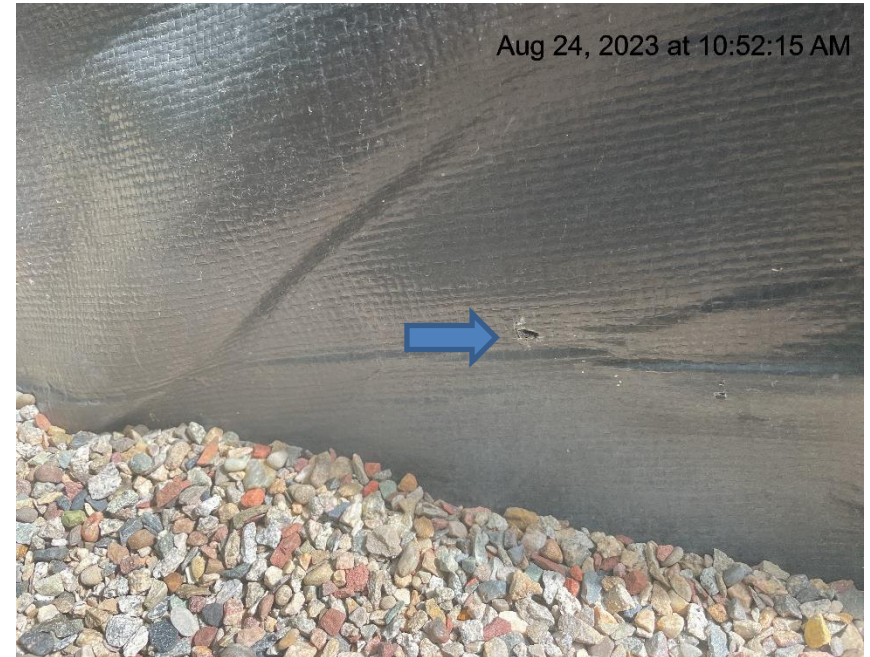
**Photo # 7119 Hole in liner/liner needs maintenance**

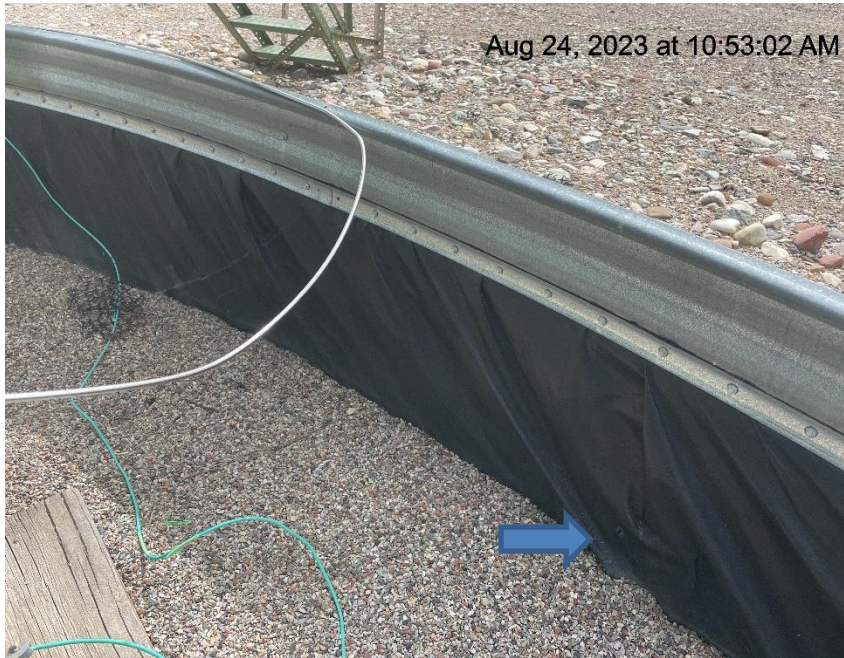
**Photo # 7121 Hole in liner/liner needs maintenance**

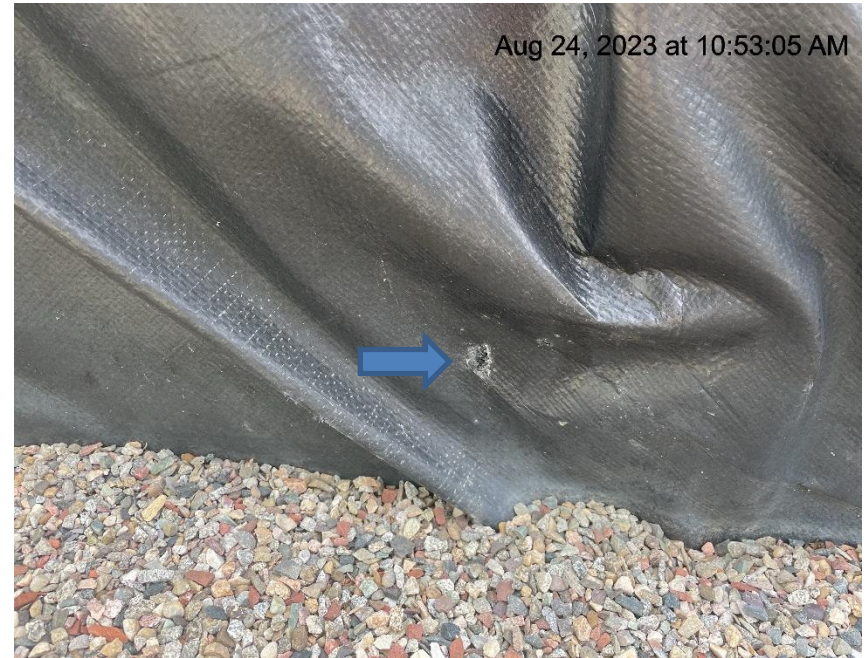
**Photo # 7122 Hole in liner/liner needs maintenance**

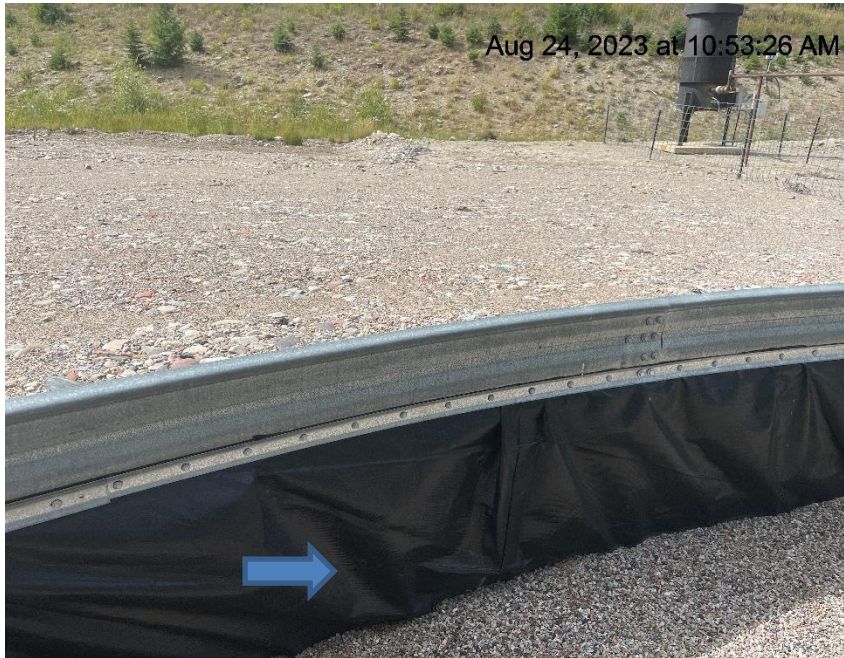
**Photo # 7124 Hole in liner/liner needs maintenance**

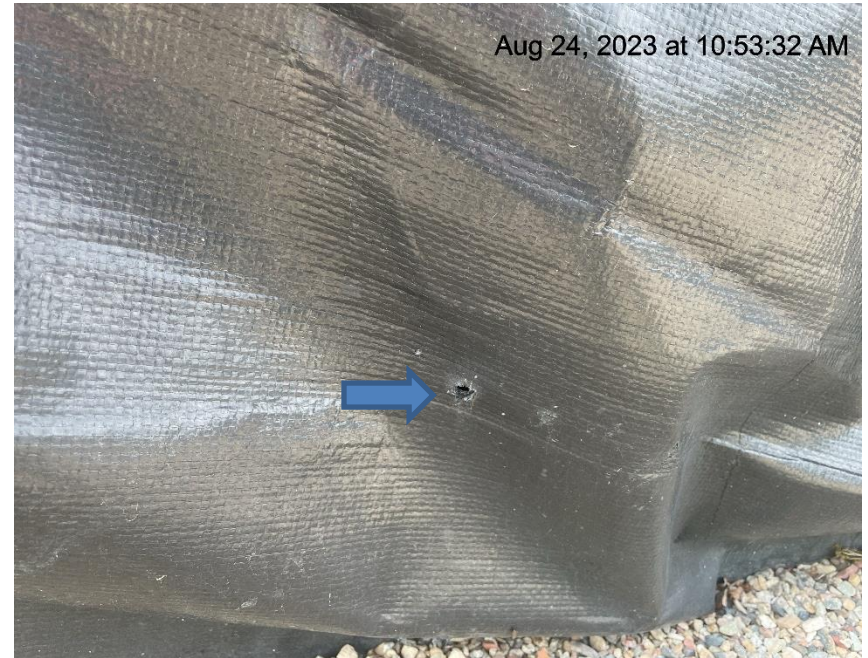
**Photo # 7125 Hole in liner/liner needs maintenance**

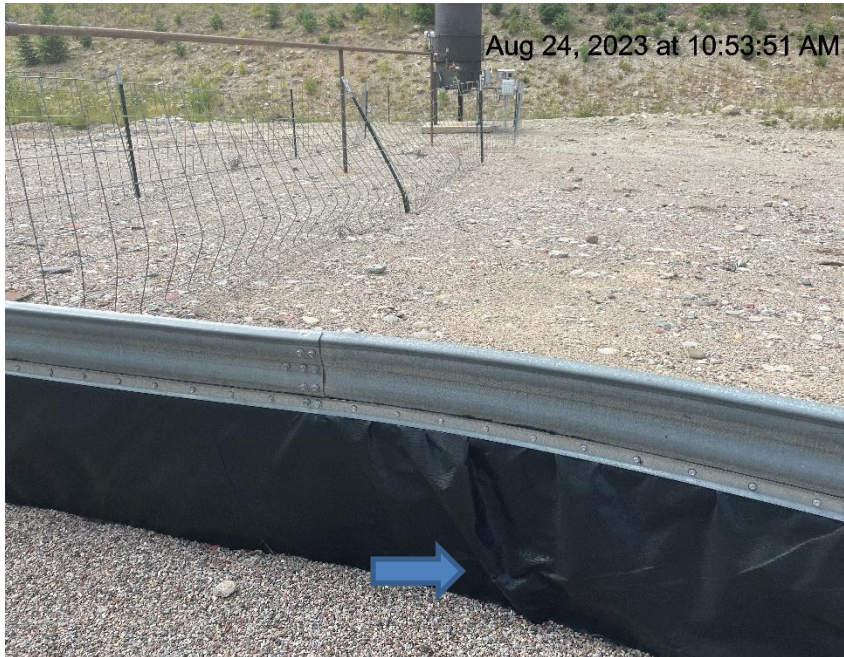
**Photo # 7126 Hole in liner/liner needs maintenance**

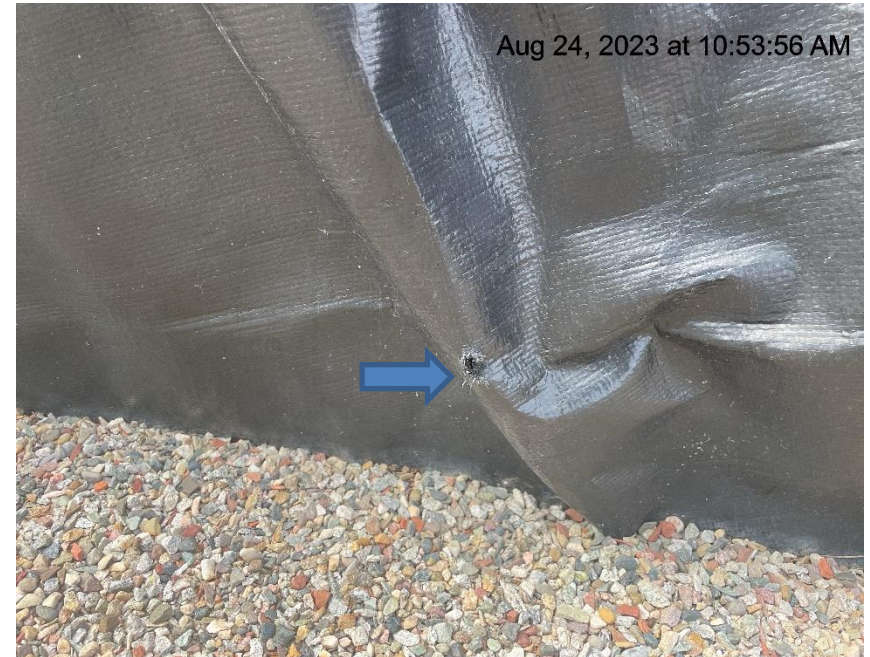
**Photo # 7127 Hole in liner/liner needs maintenance**

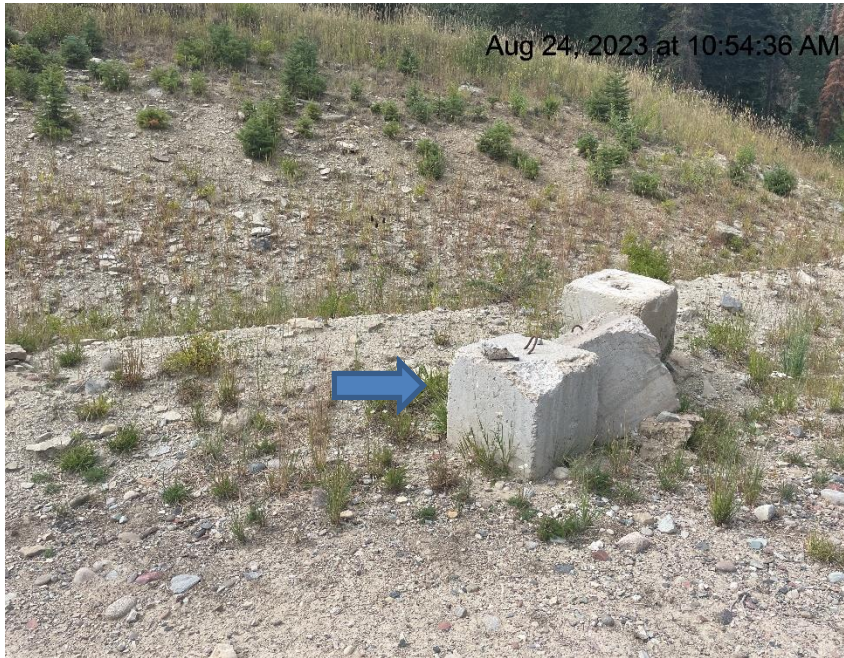
Photo # 7128 Debris

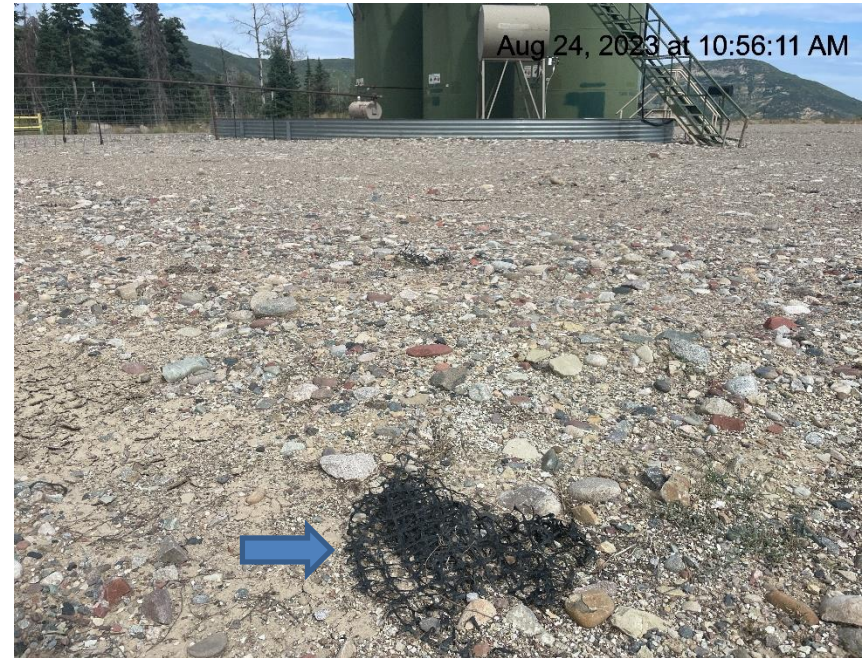
Photo # 7131 Debris

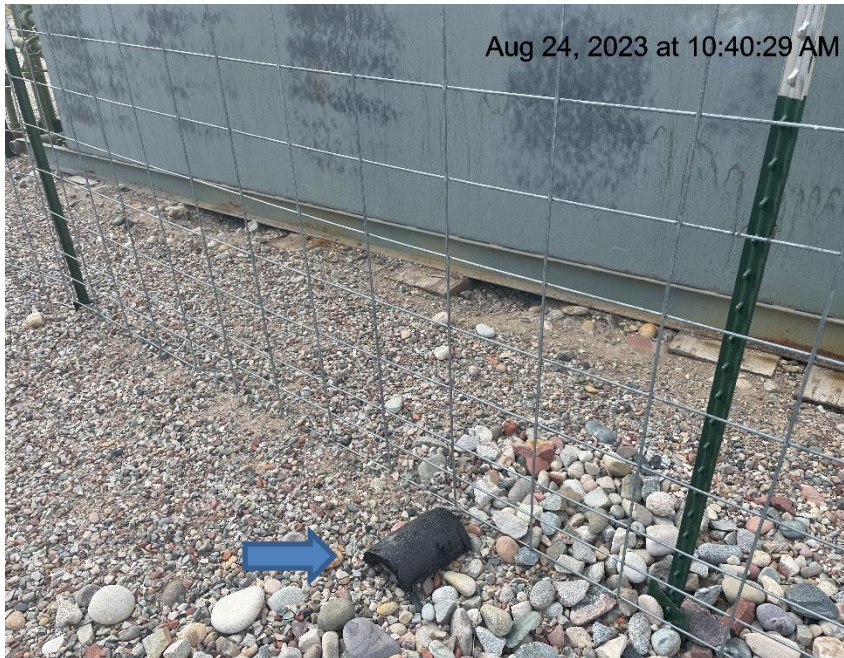
Photo # 7098 Debris

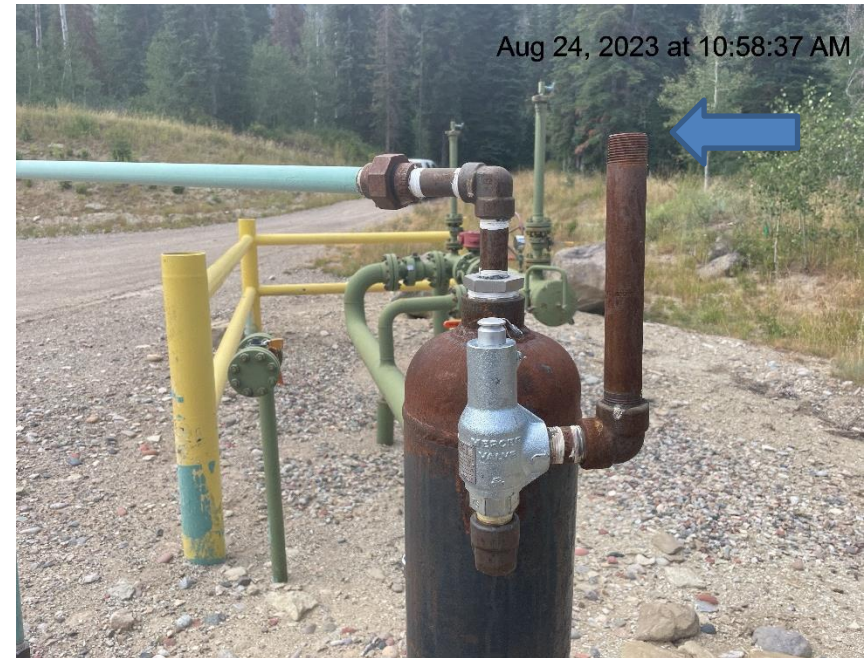
Photo # 7136 PRV vent lacks cap
