Inspection Photos
Location Name: CAERUS PICEANCE LLC I18 Pad
Location #: 334866

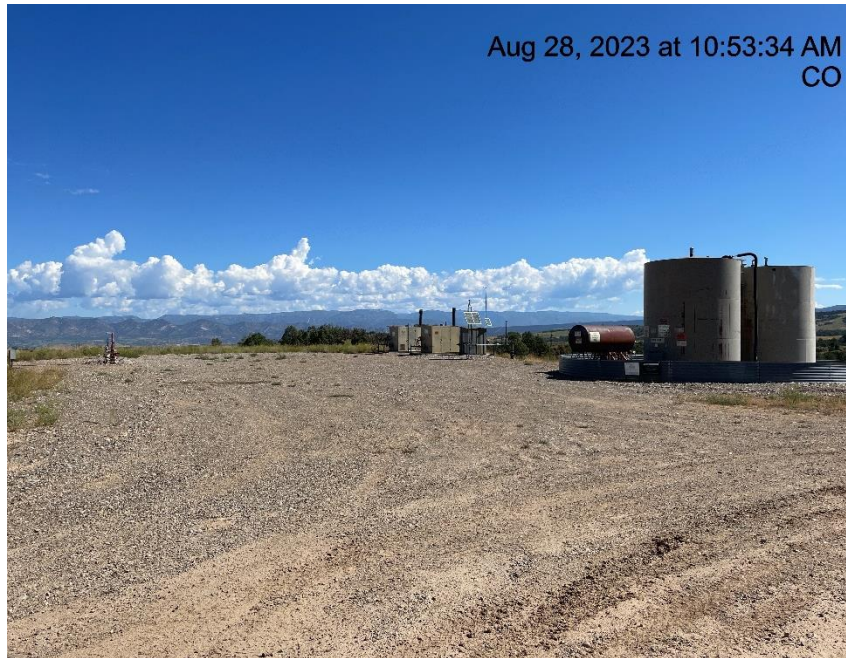
Photo # 7435 From entrance to location

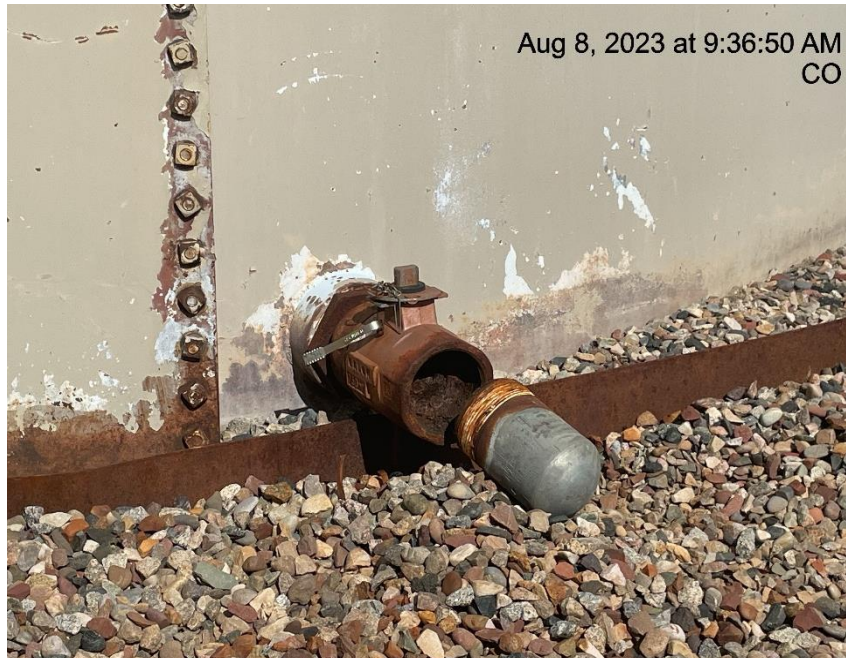
Photo # 5161 From inspection 708901316 conducted on 08/08/2023 Open ended load line

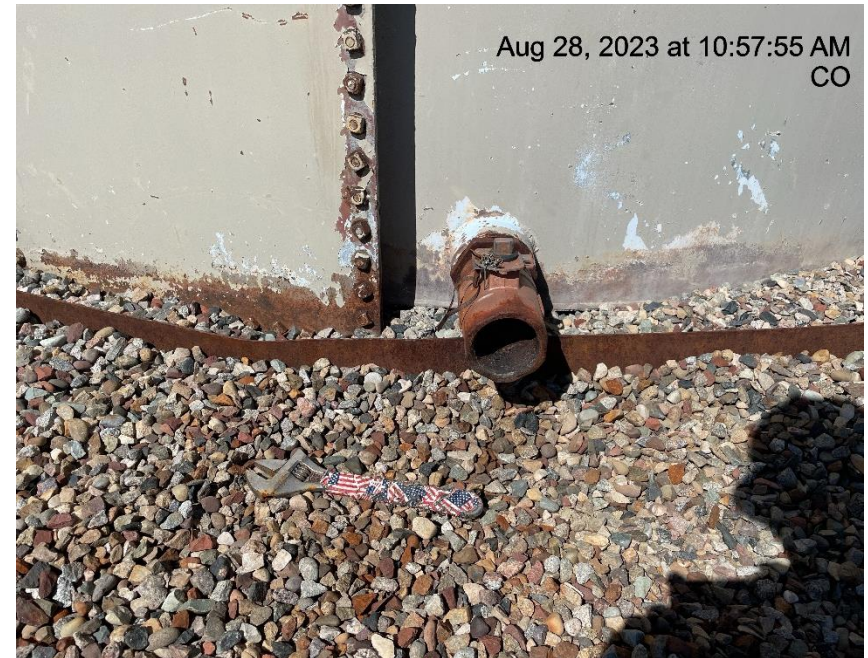
Photo # 7445 Open ended load line

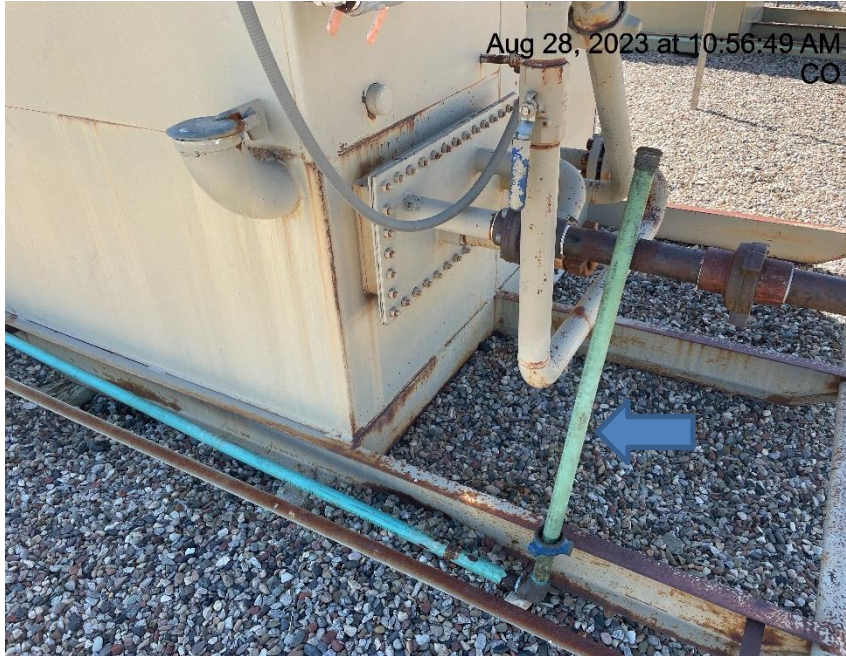
Photo # 7444 Debris
