Final Reclamation and Stormwater Inspection

Location ID: 313914

Inspection Document #: 708200515

Inspection Photos
Location Name: Muir 13A
Location ID: 313914

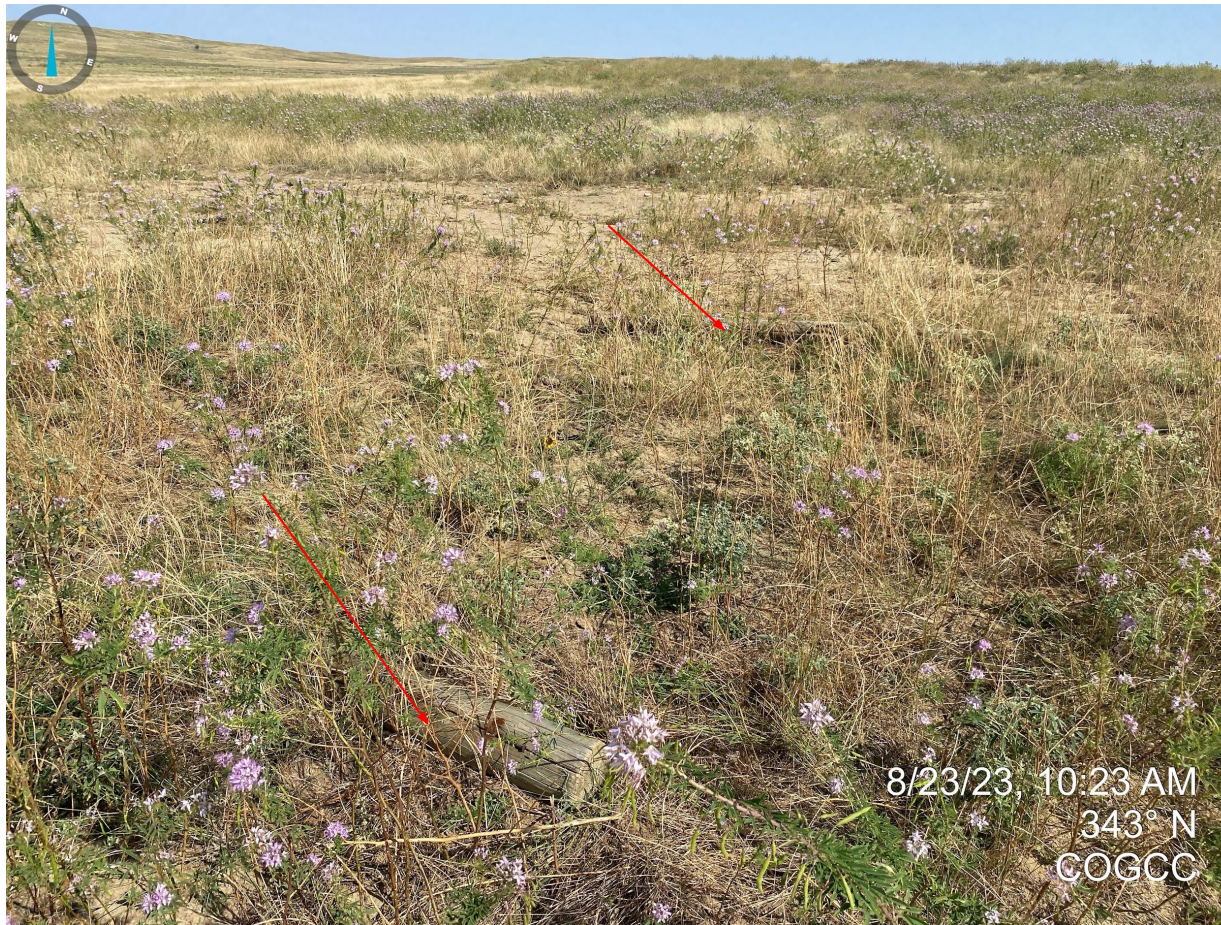
Photo 1. Taken near the former well location. Debris (fence posts) remain on location and there is evidence of non-uniform vegetation cover resulting in bare/exposed soils. Additional reclamation activities are required in order to comply with Rule 1004.

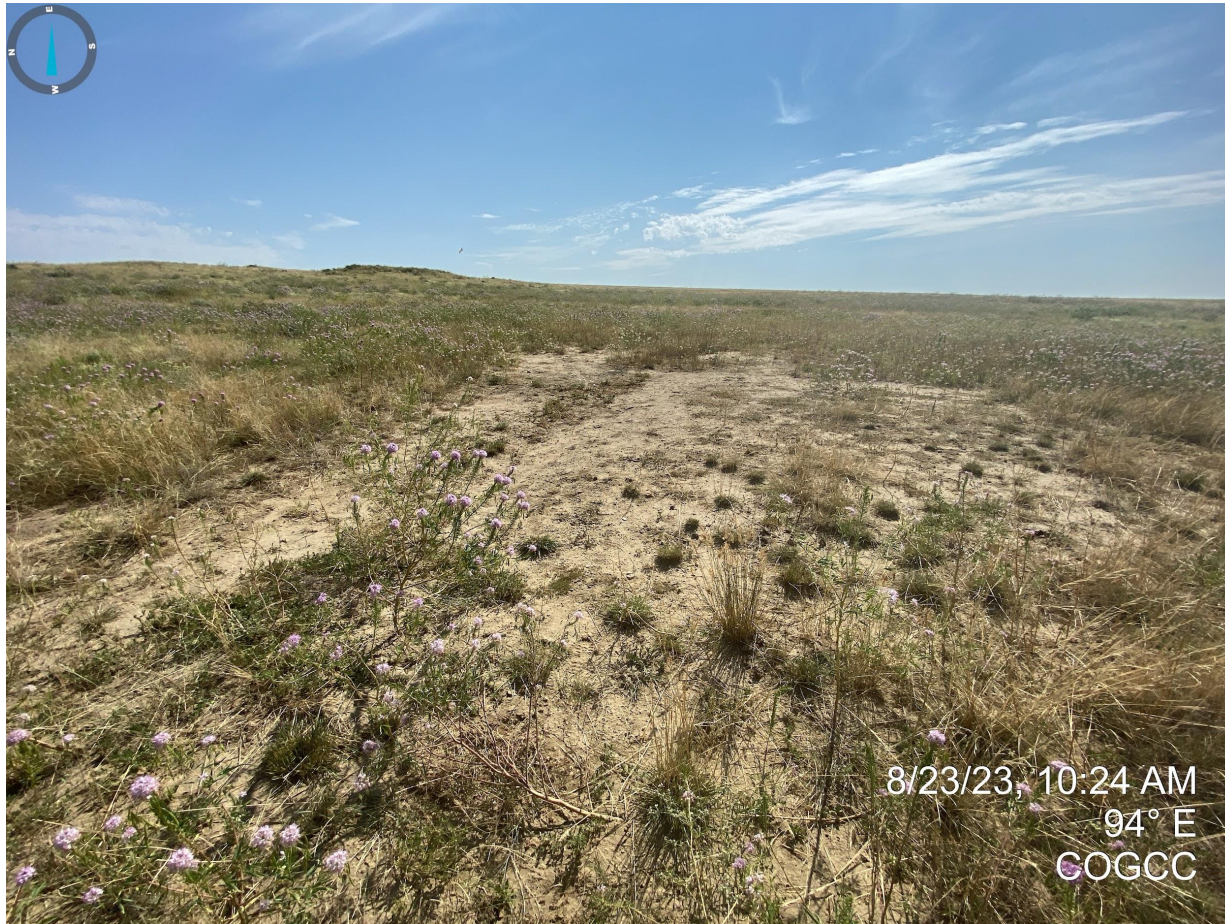
Photo 2. Taken from the western portion of the well location; see comments in Photo 1.

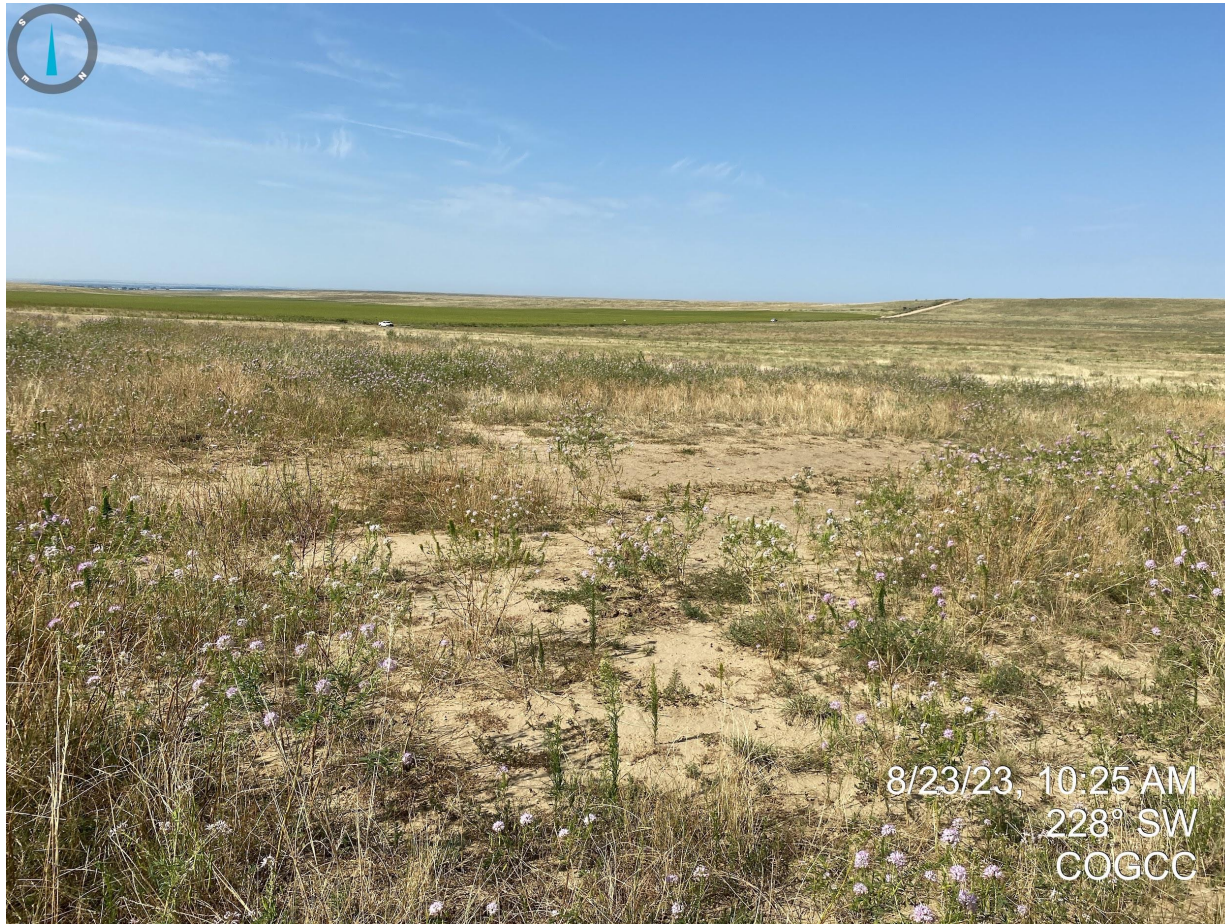
Photo 3. Taken from the eastern portion of the location; see comments in Photo 1.

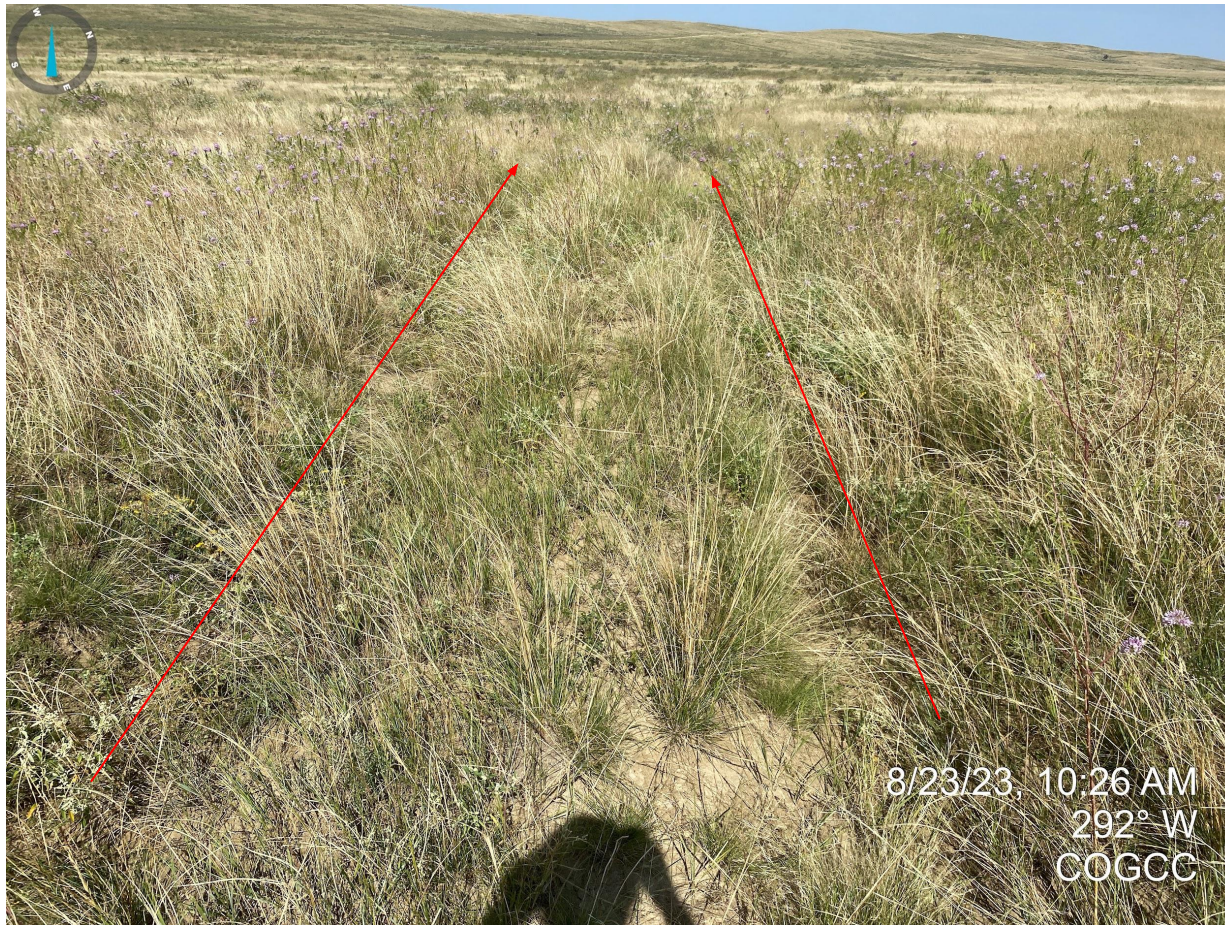
Photo 4. Taken on the east-west lease road. Heavy rutting on the former access road (obscured by vegetation) will require additional reclamation activities in order to comply with Rule 1004.

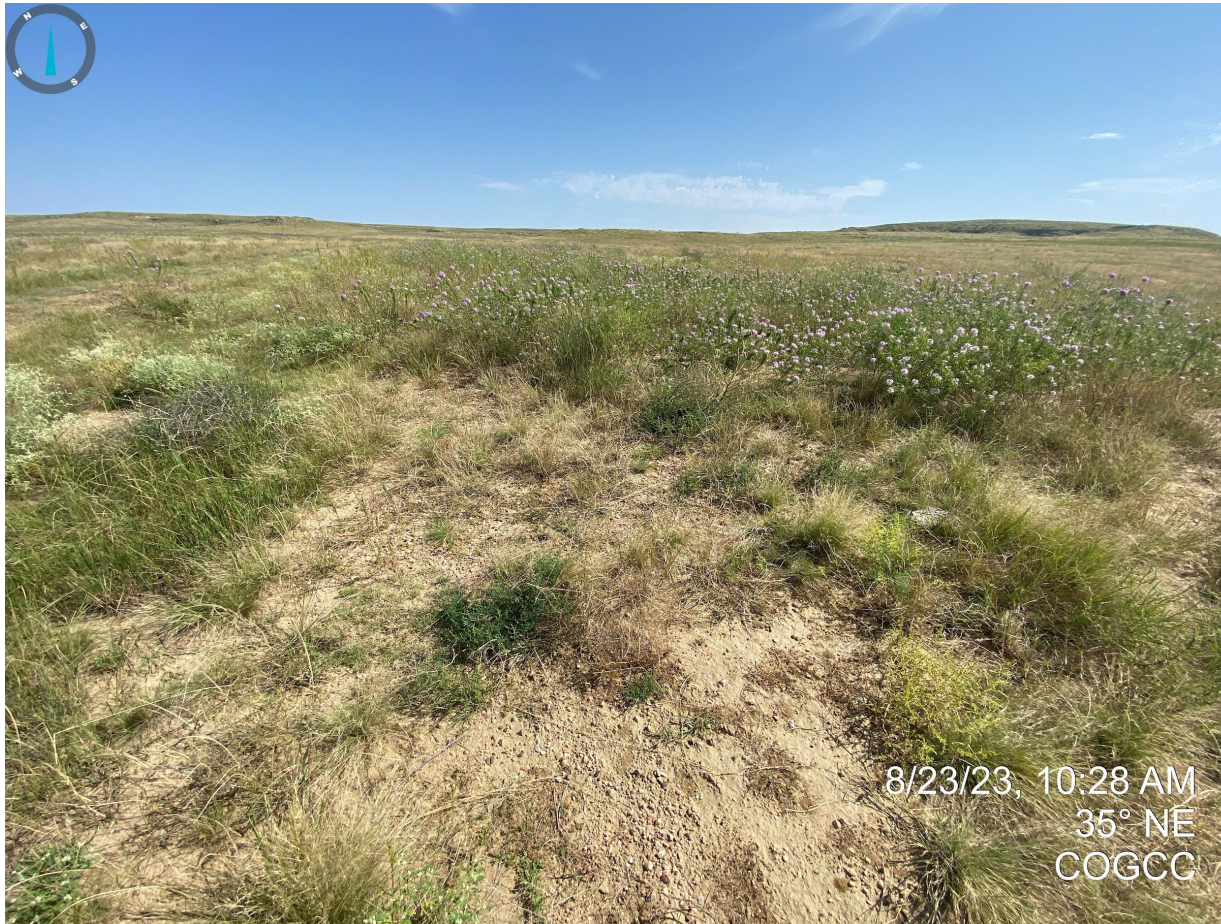
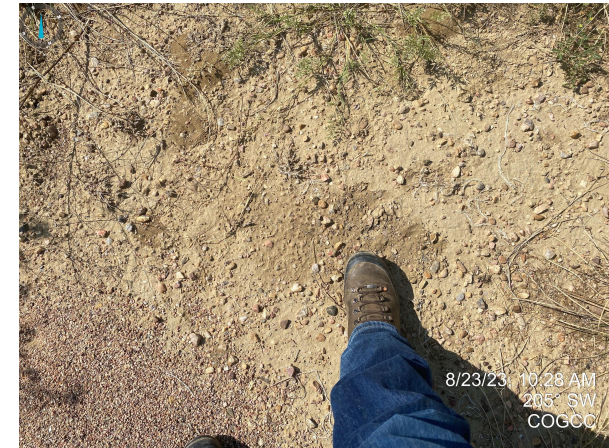
Photo 5. Taken near the former separator location. Gravel and road base material remain on the location and requires removal to comply with Rule 1004.

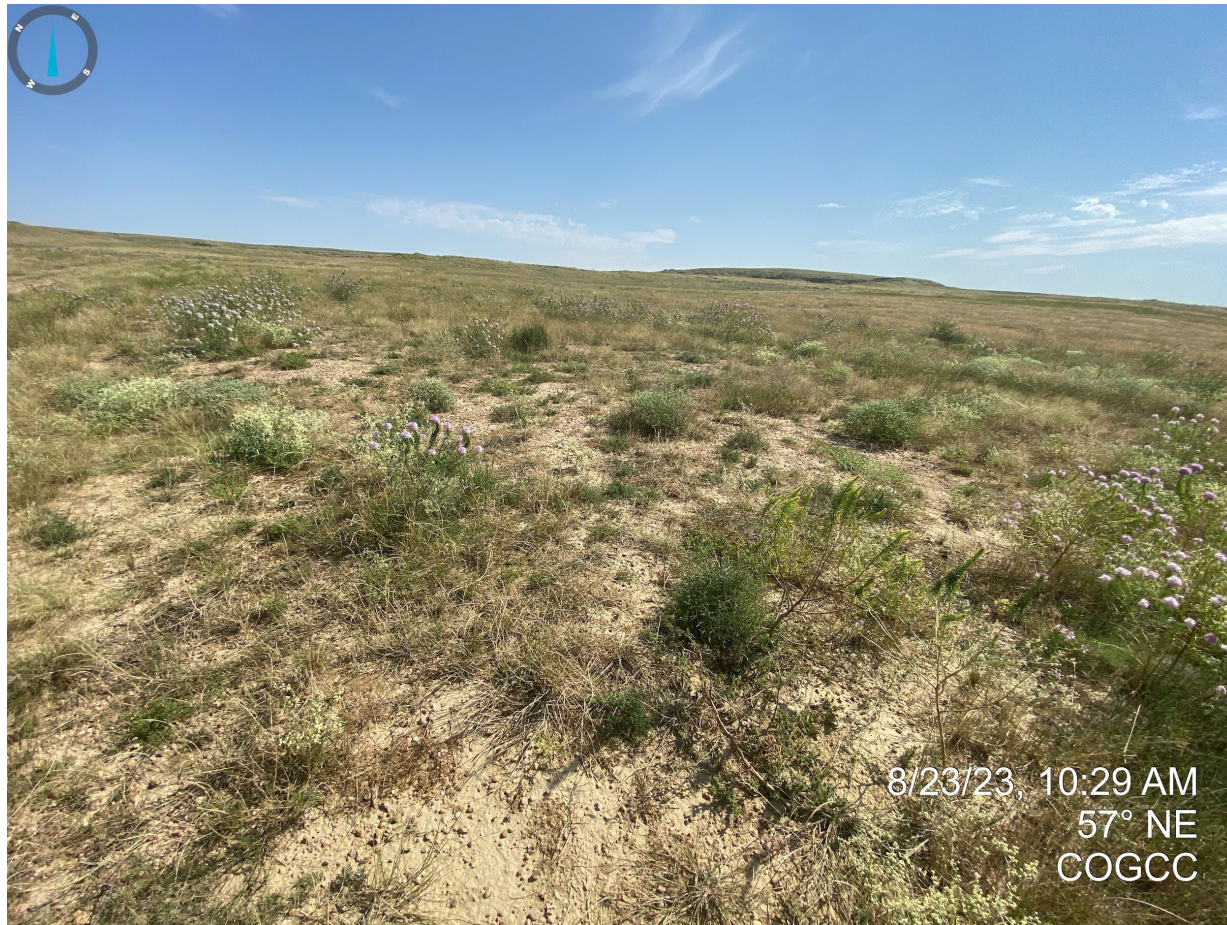
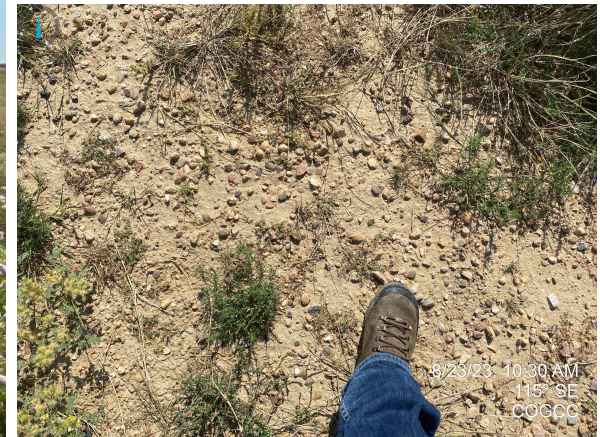
Photo 6. Taken near the former tank battery location; Gravel and road base material remain on the location and requires removal to comply with Rule 1004.

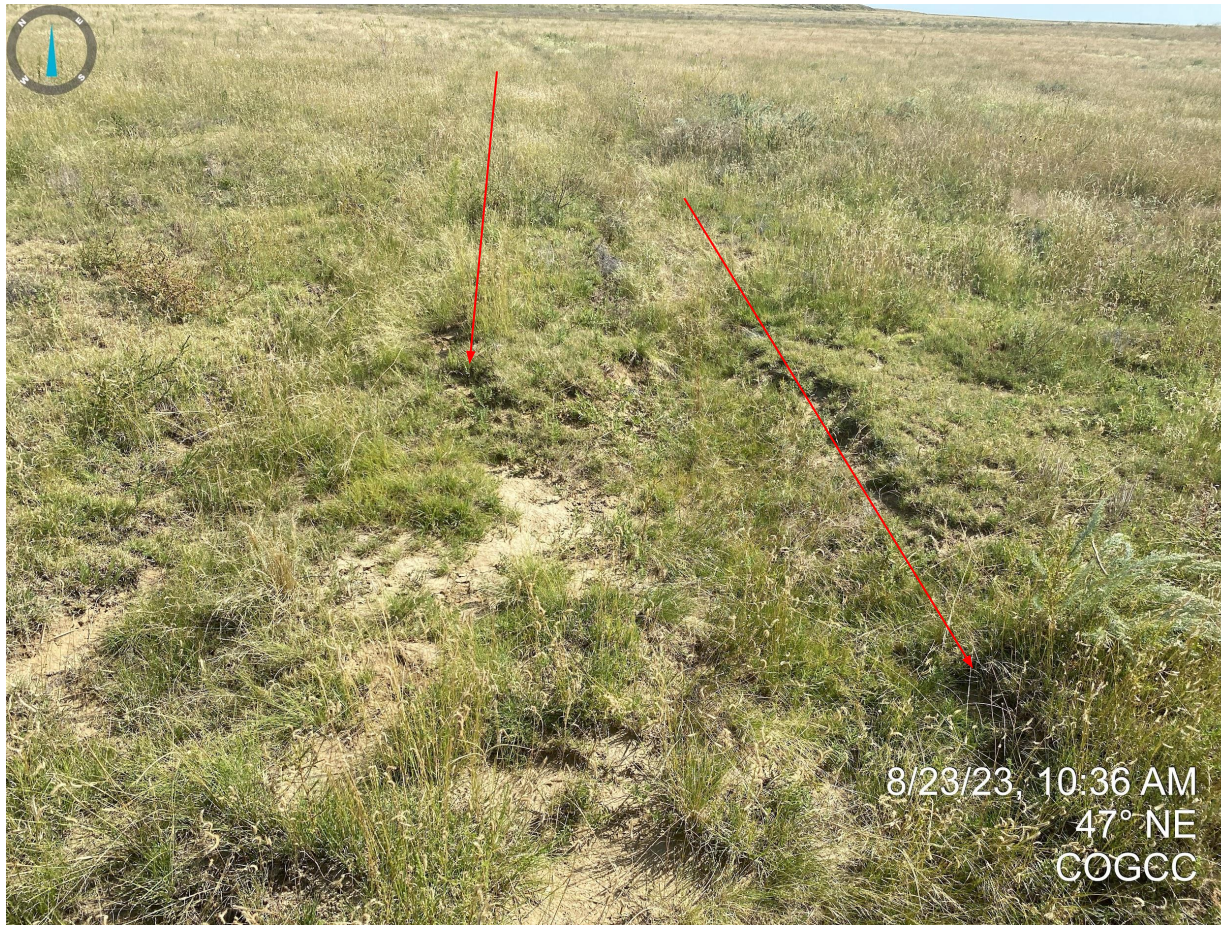
Photo 7. Taken from the north-south access road. Heavy rutting on the former access road (obscured by vegetation) will require additional reclamation activities in order to comply with Rule 1004.

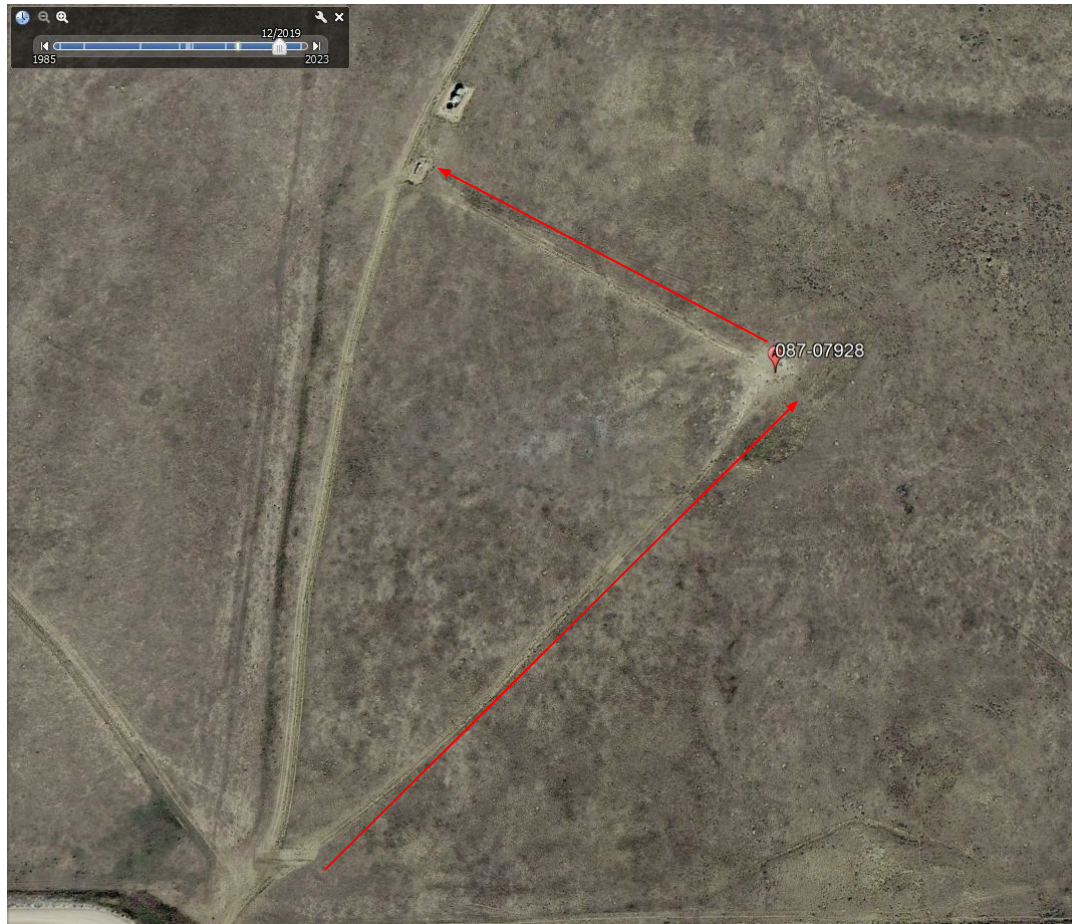
Photo 8. Google Earth aerial imagery taken circa 12/2019. Photo illustrates the access roads that require additional reclamation activities to comply with Rule 1004. During this inspection, Staff walked both access roads and observed that re-grading and contouring is required as heavy rutting (as deep as 1') was evident.
