**APEX Oil Ventures Inc
Gillam-Trigood-Gov't 14
Loc ID: 314769**

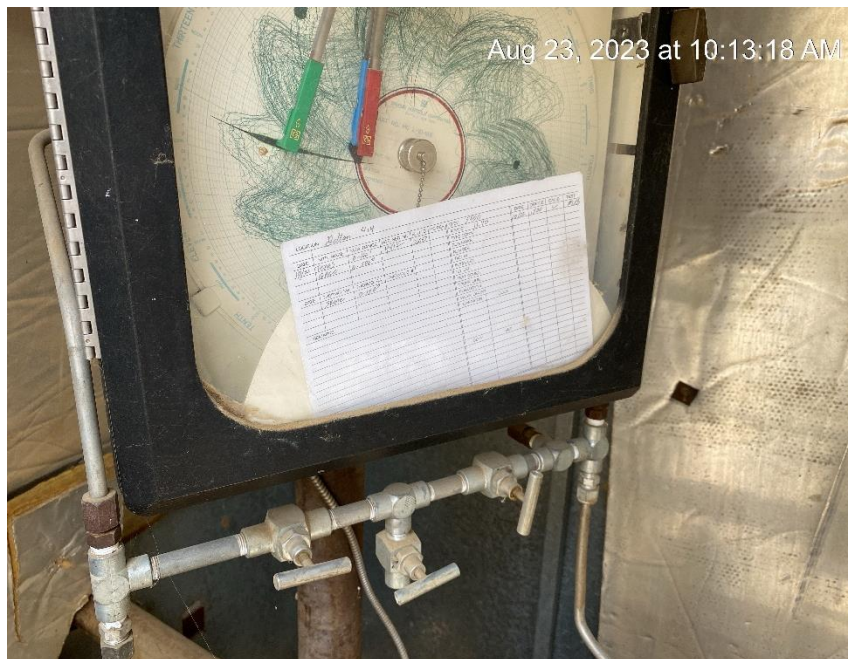
No gas sales. All gas being flared.

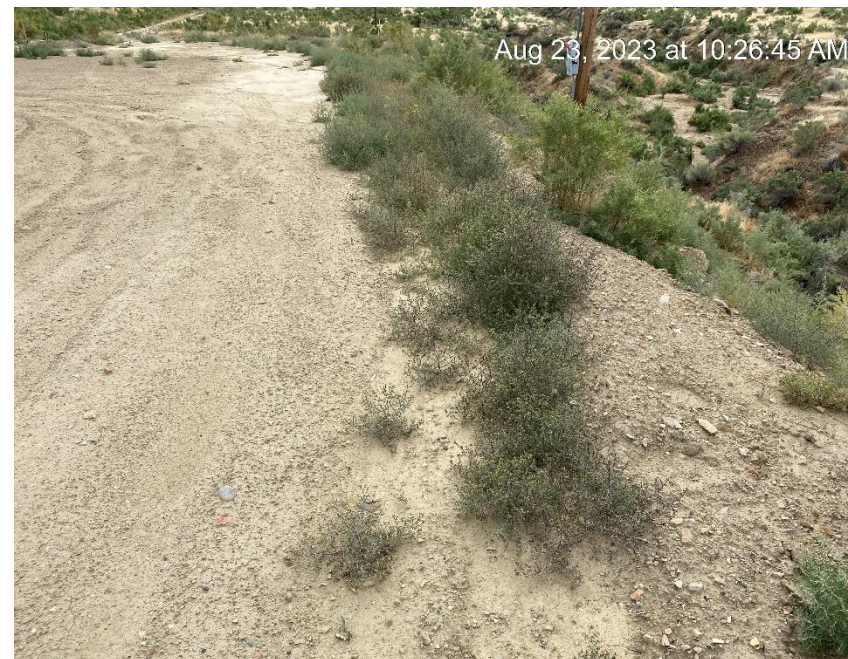
Weeds

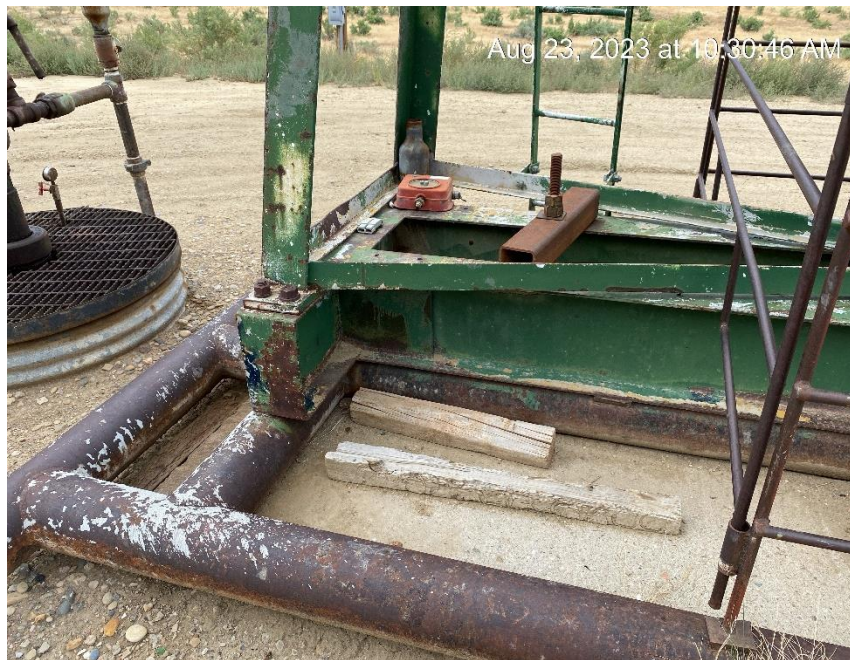
Random debris

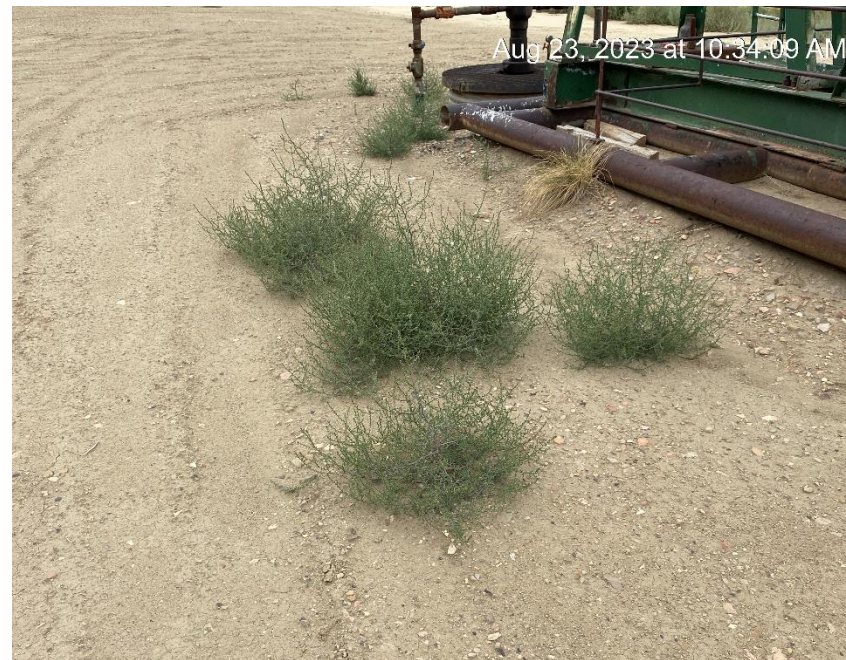
Weeds

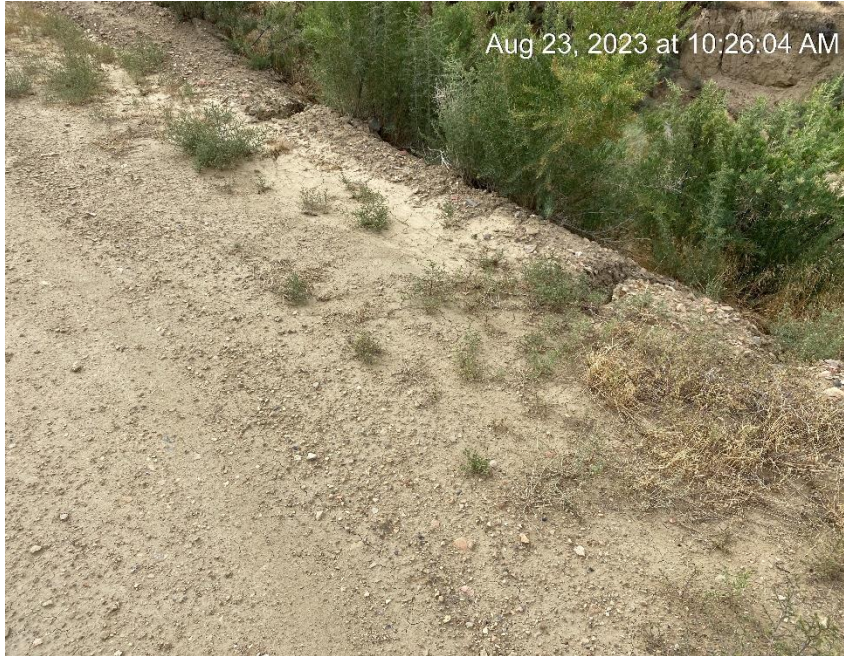
Stormwater BMPs need implementation and maintenance.

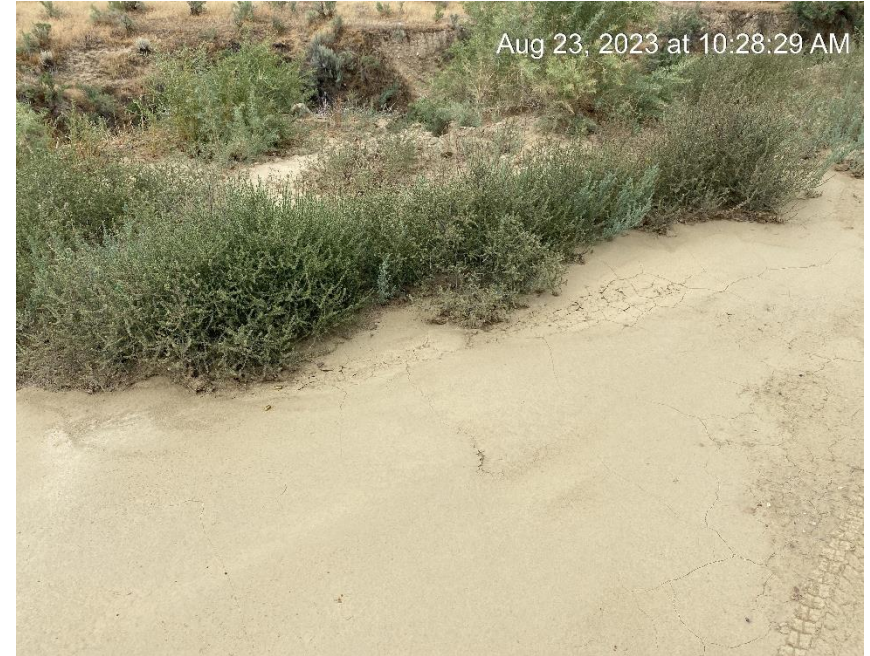
Weeds. Sediment migration. Stormwater BMP not maintained.

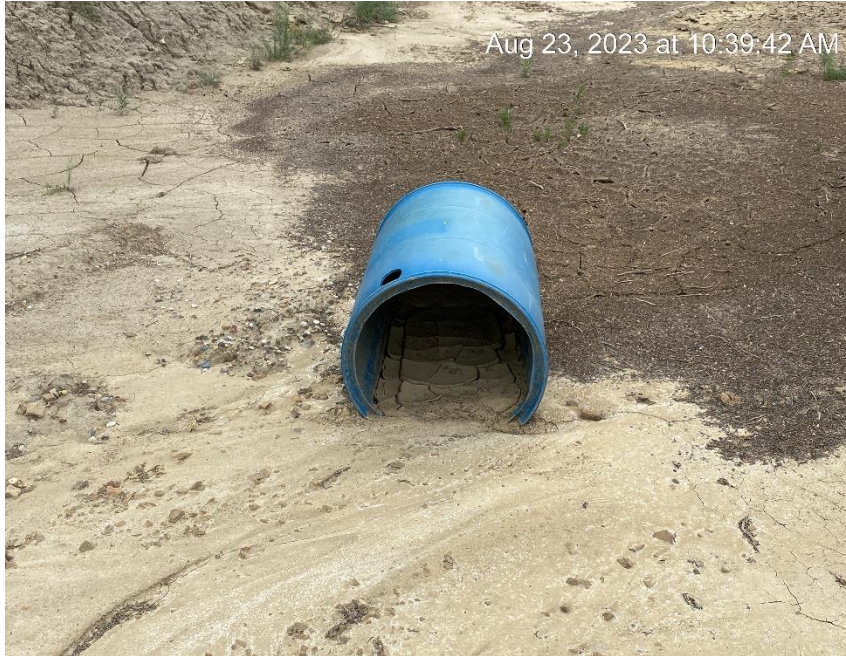
Debris. Lack of Stormwater BMPs

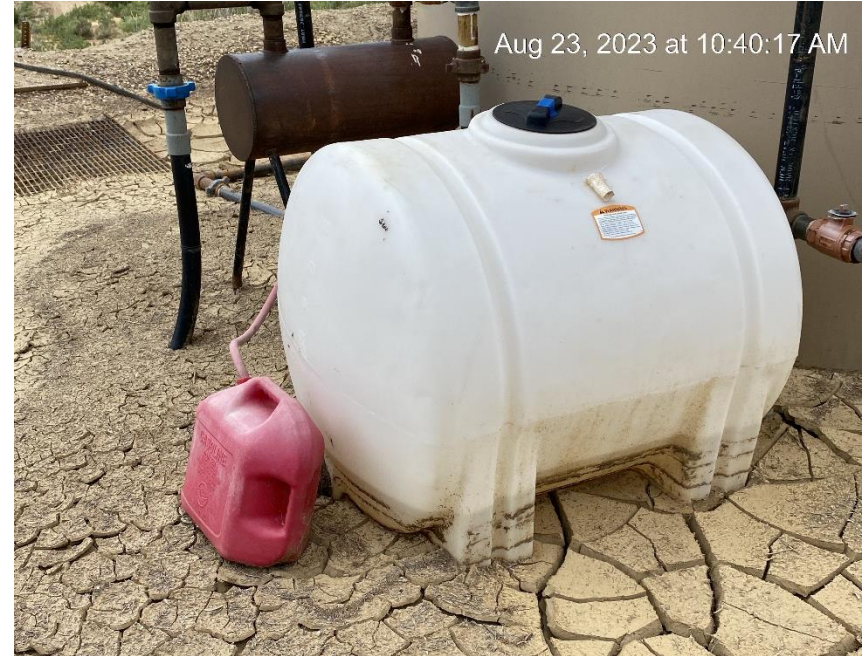
Debris

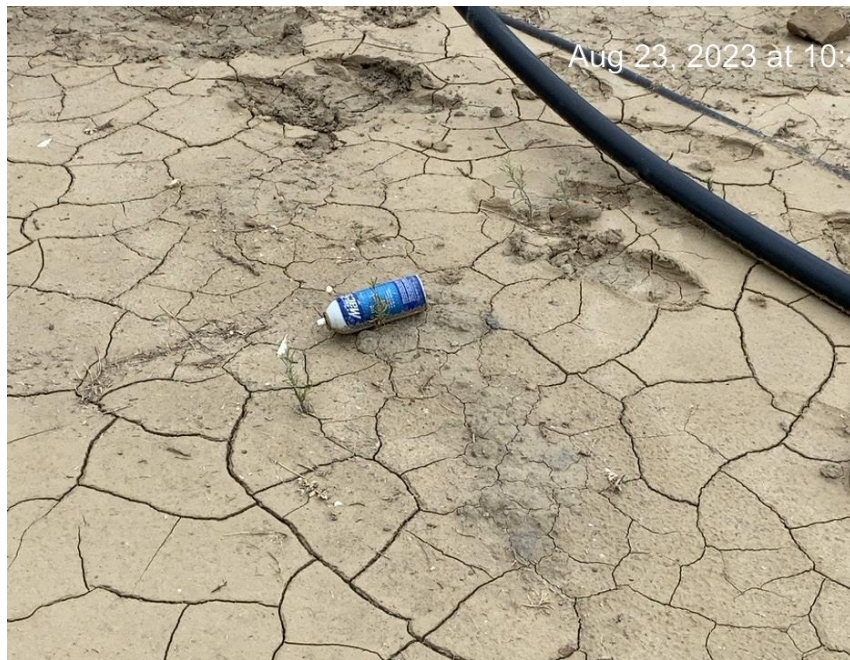
Debris

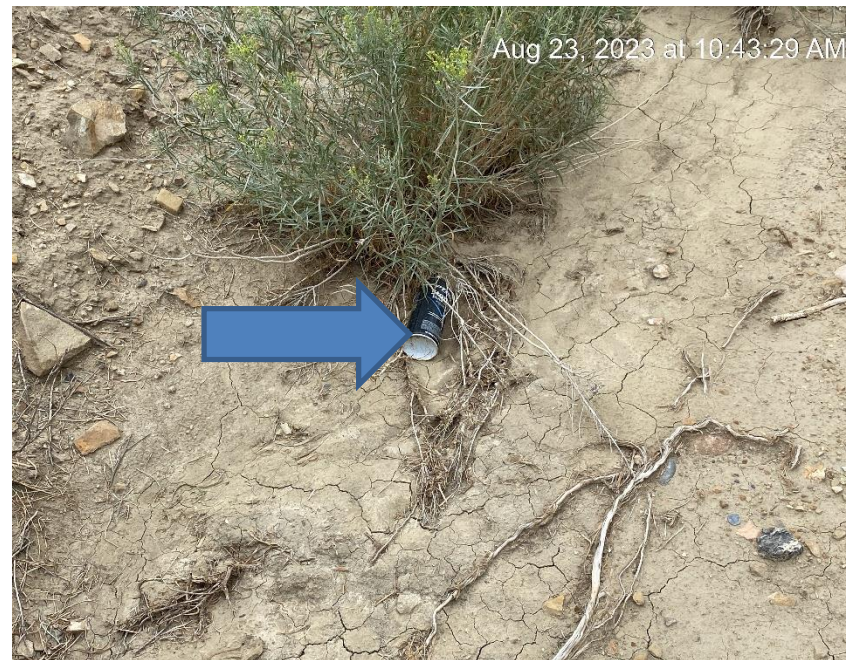
Debris

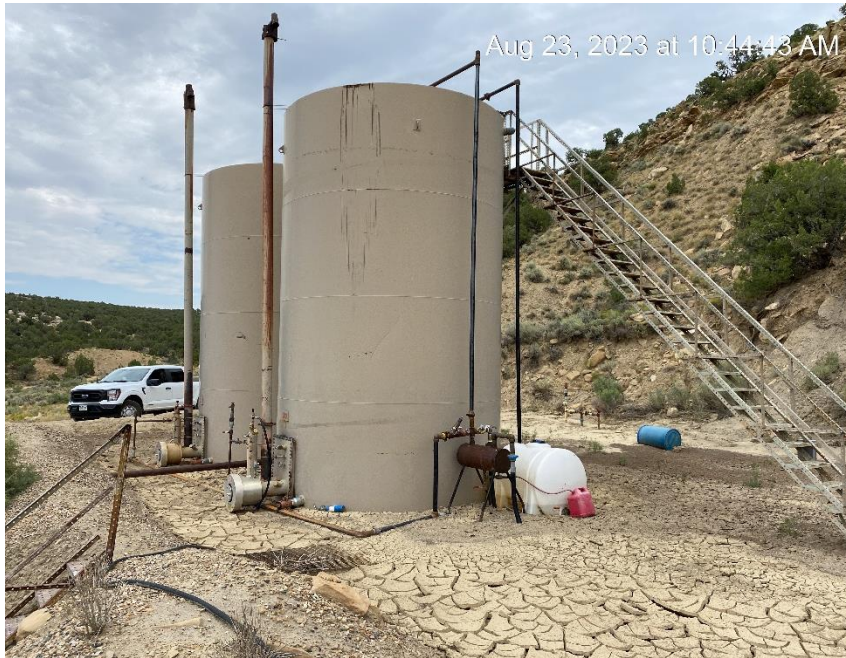
Tank battery. Stormwater BMPs not in place.

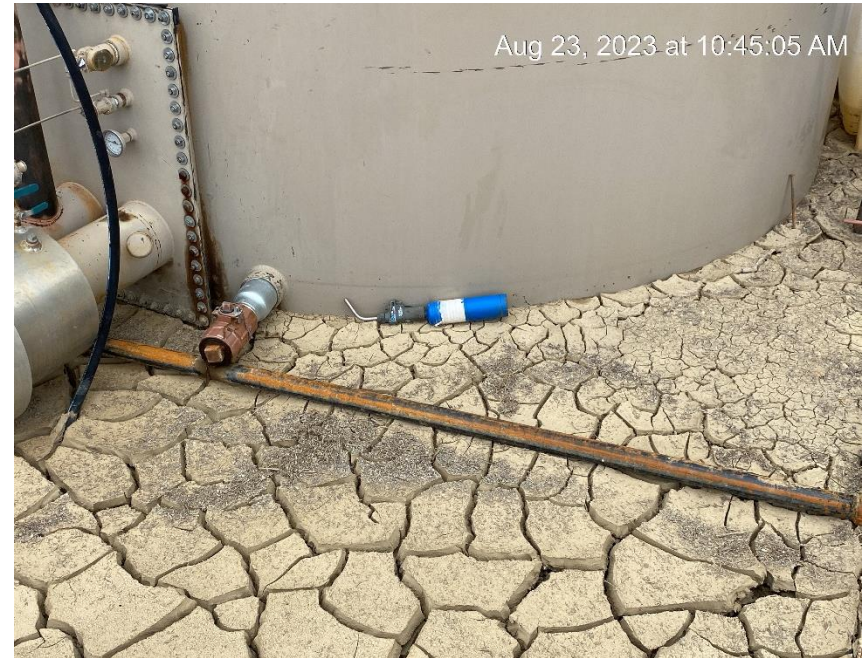
Debris

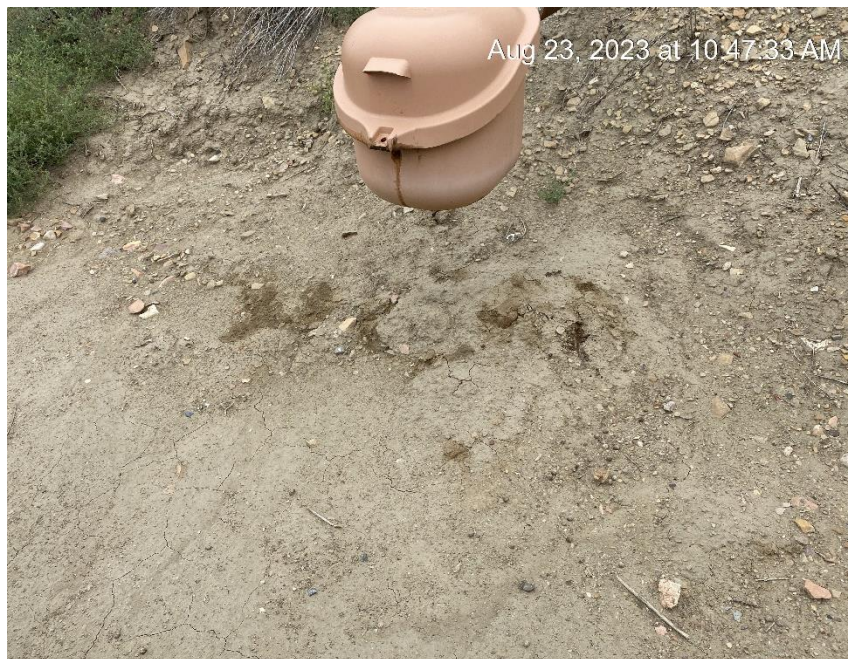
Stained soil at loadout.

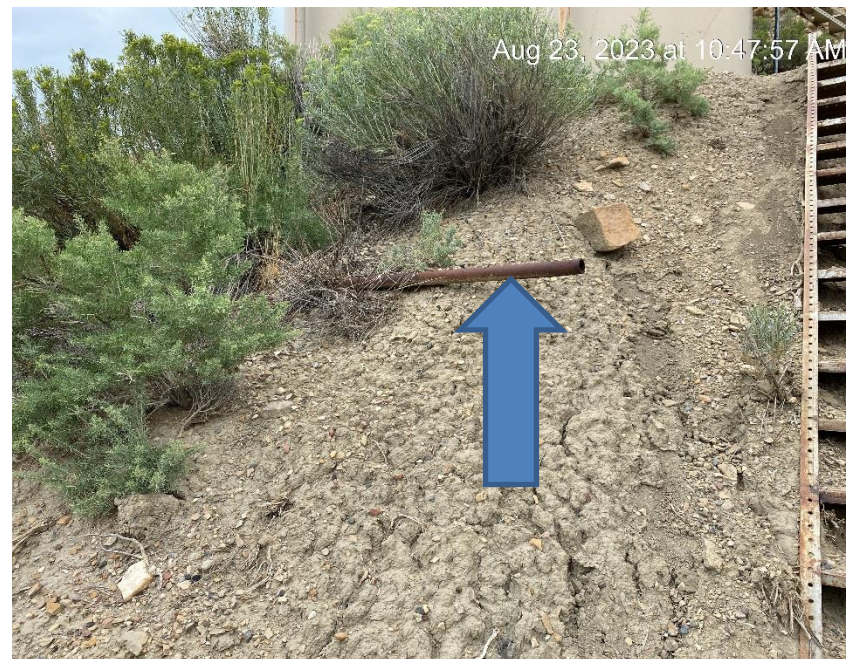
Debris
