Inspection Photos

API: 041-06051

Operator: ETOCO LP

Inspection Date: 8/23/2023

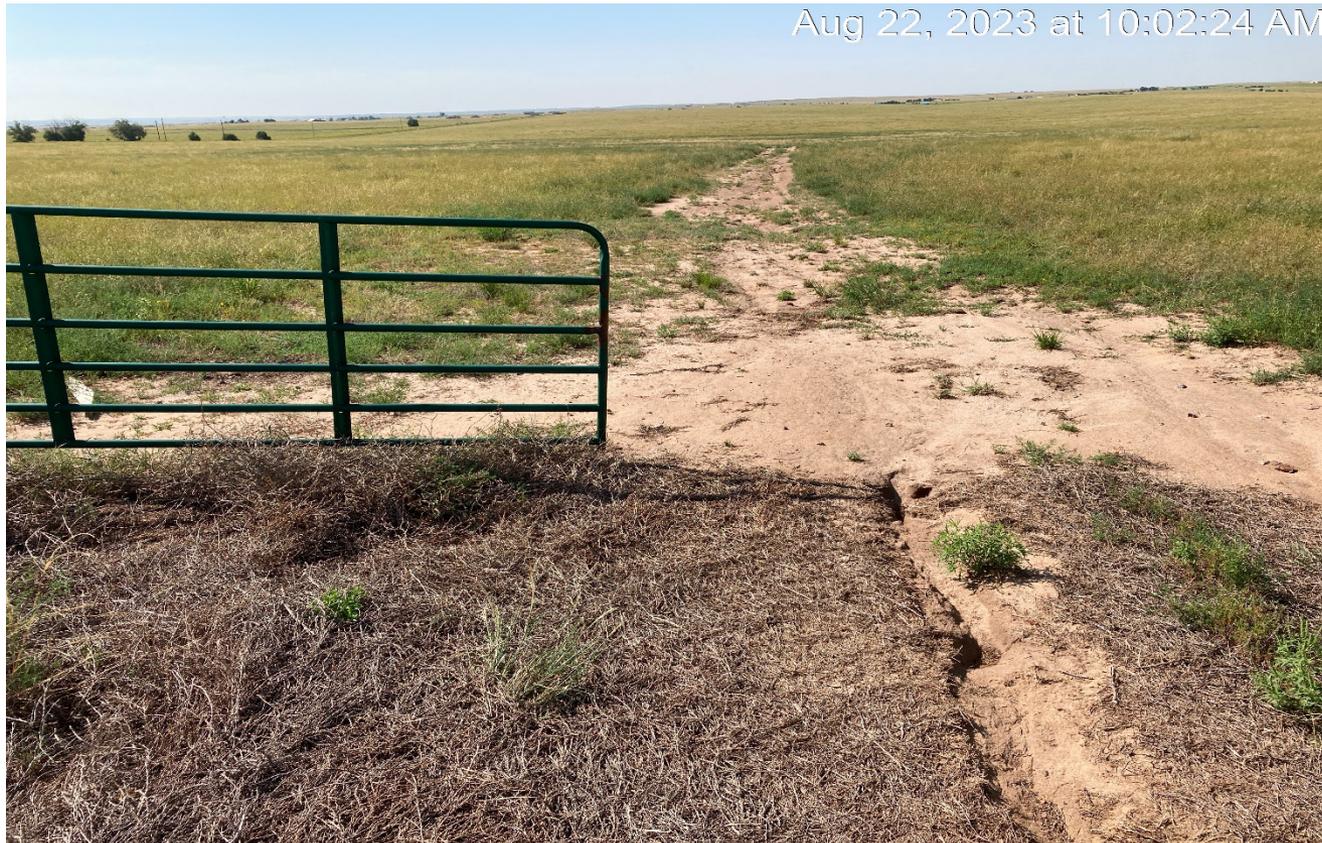
Photo 1. Facing south along the former access road which has not established vegetation. There are some signs of erosion along the road.

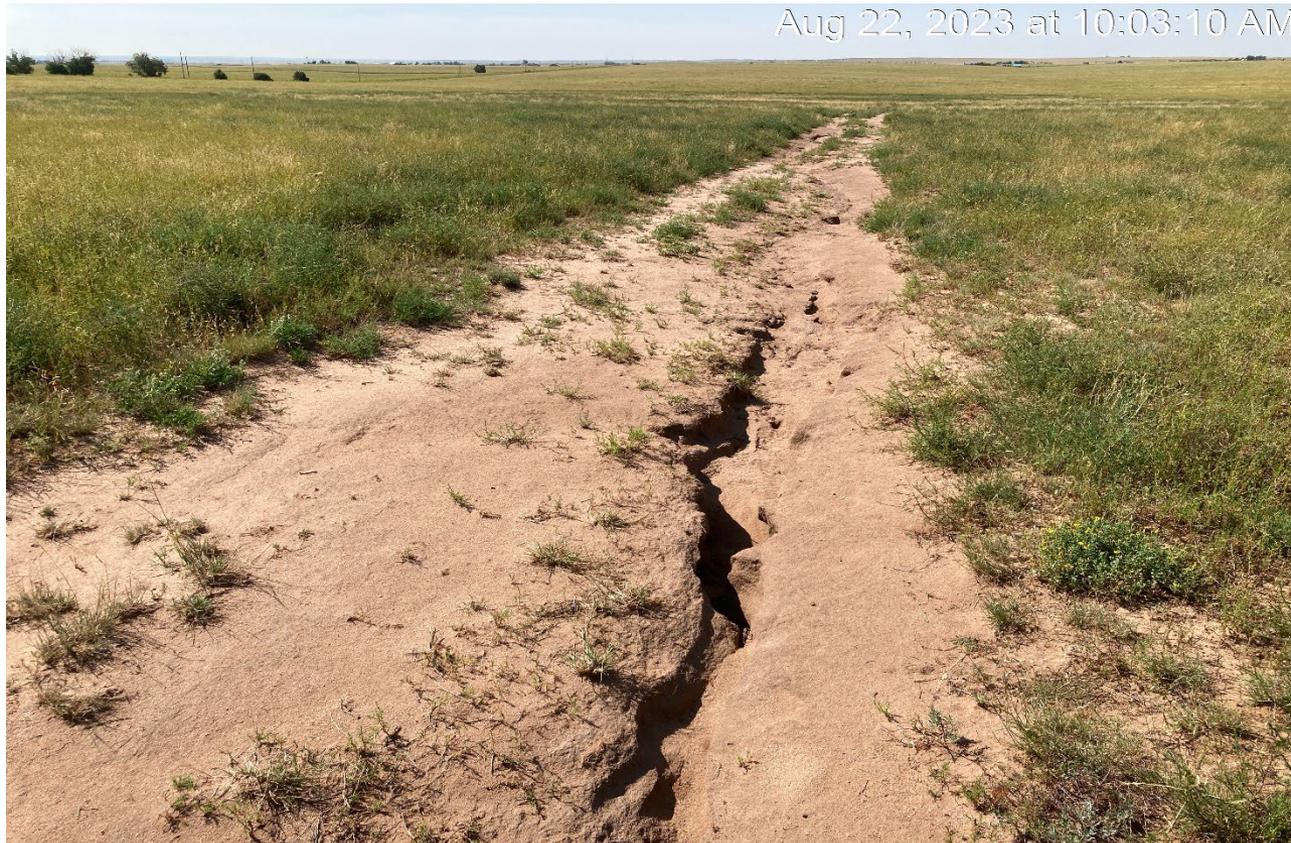
Photo 2. Facing south along the former access road which has not established vegetation. There are some signs of erosion along the road.

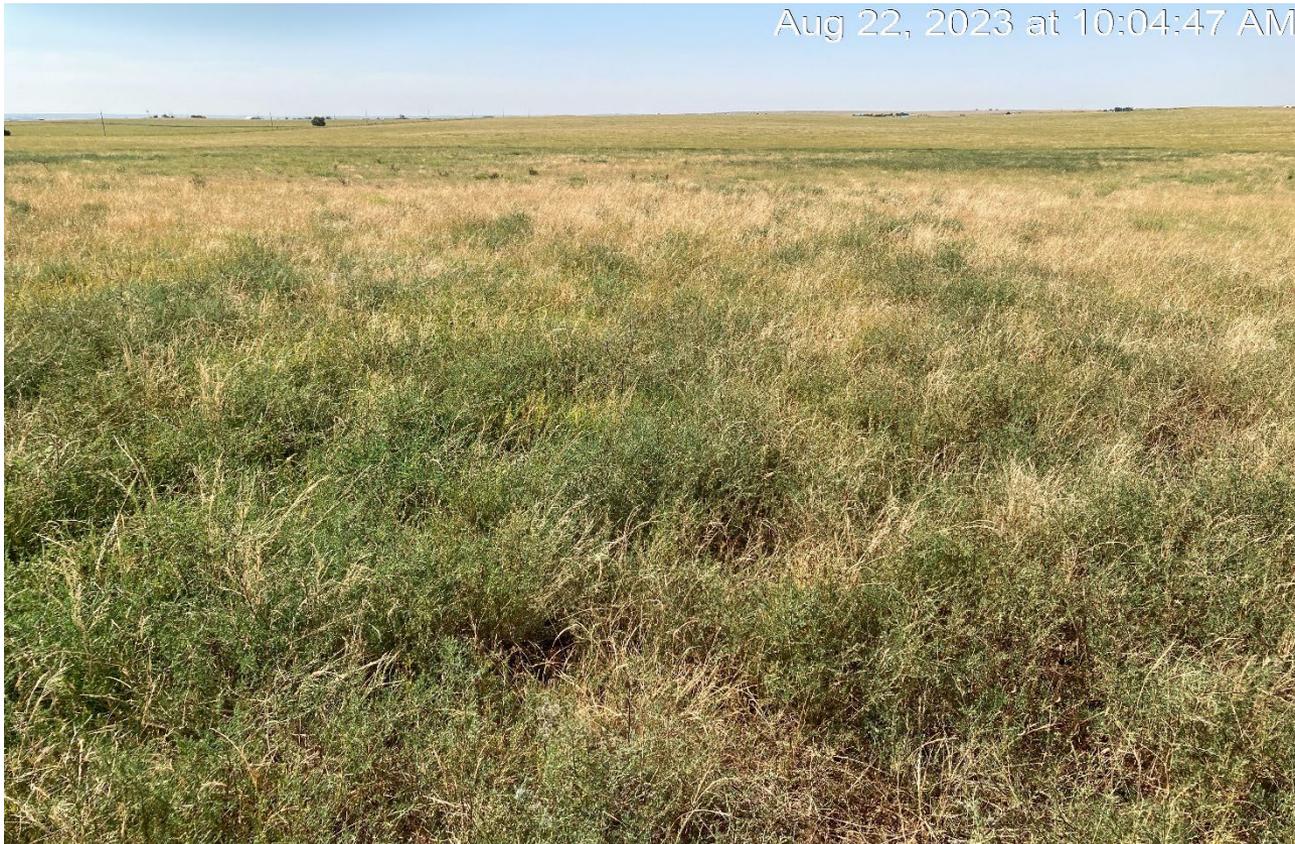
Photo 3. Center of the location facing south.

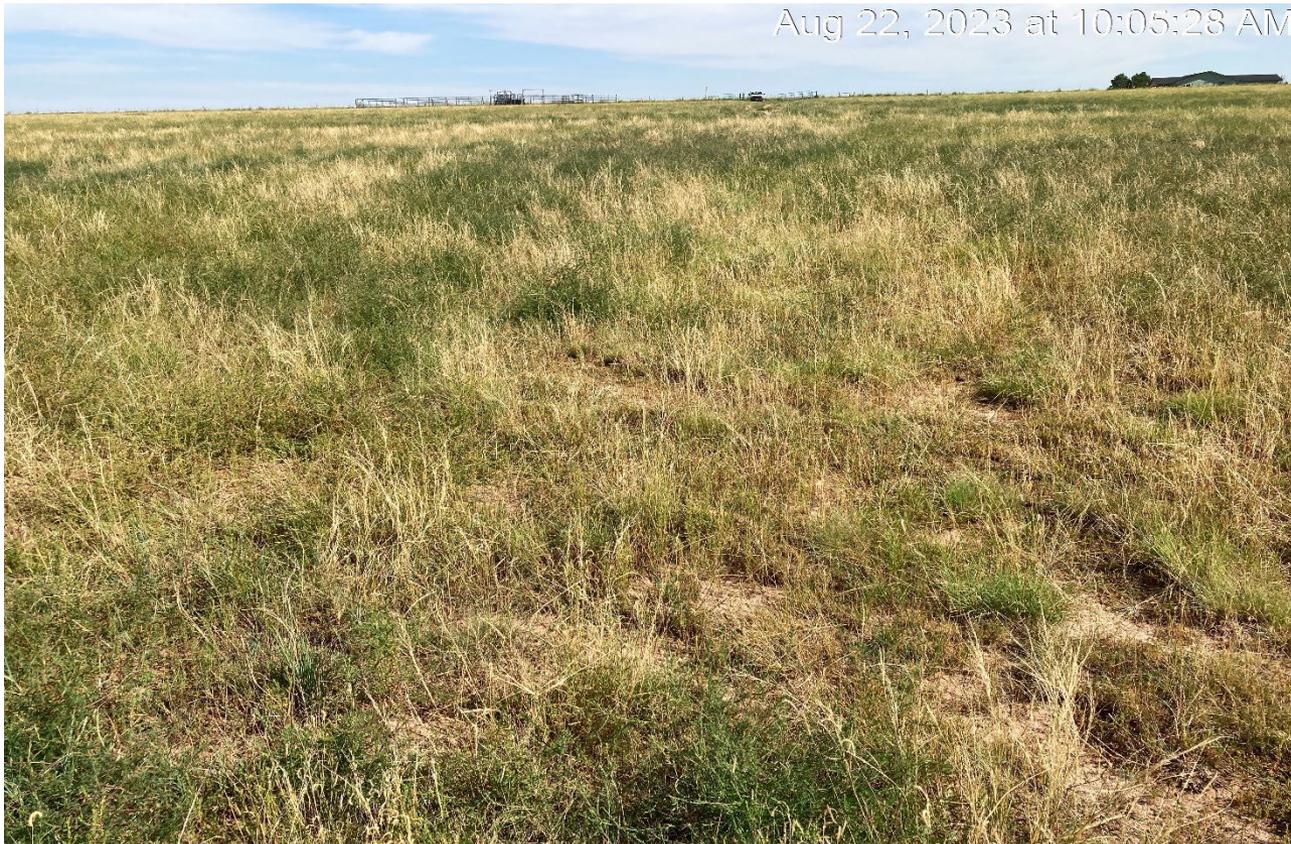
Photo 4. Center of the location facing north.

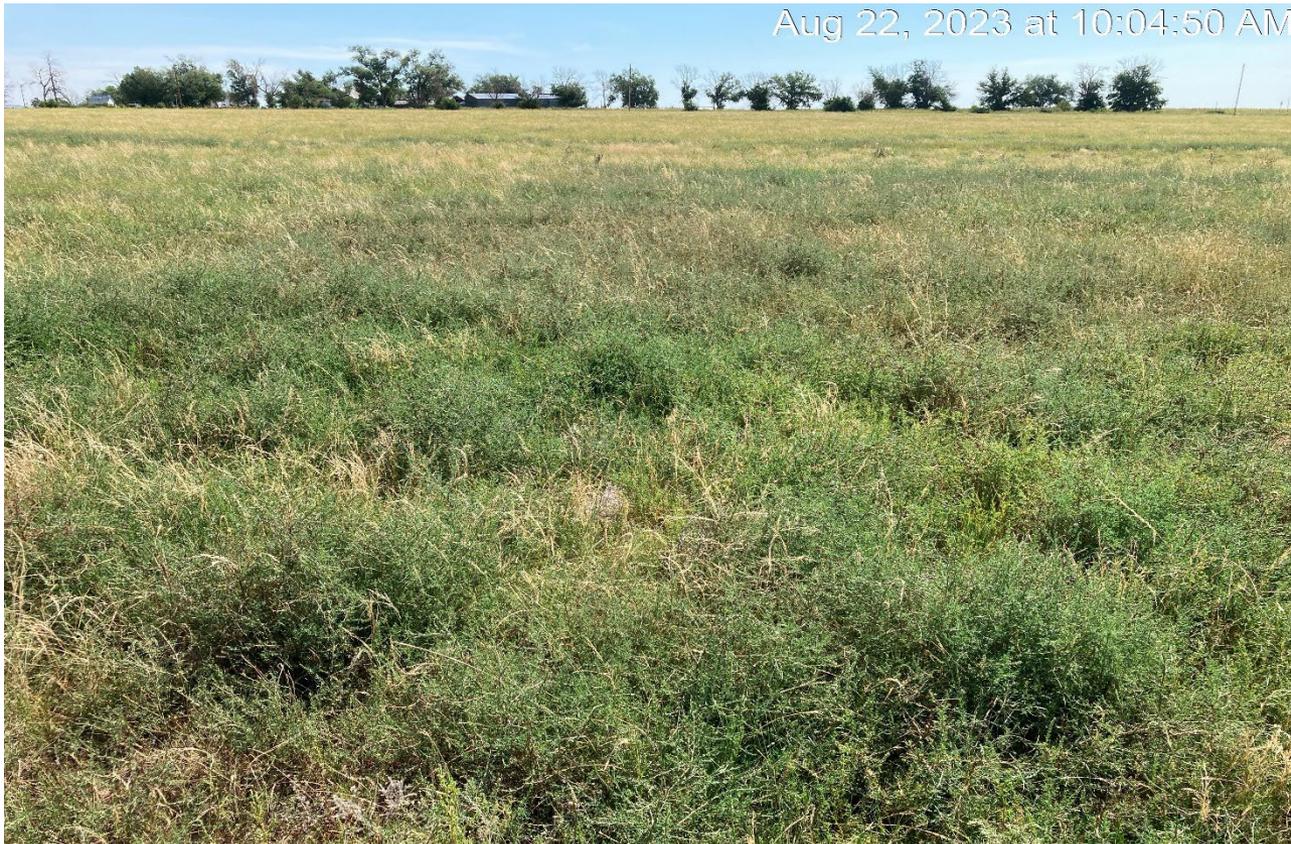
Photo 5. Center of the location facing east.

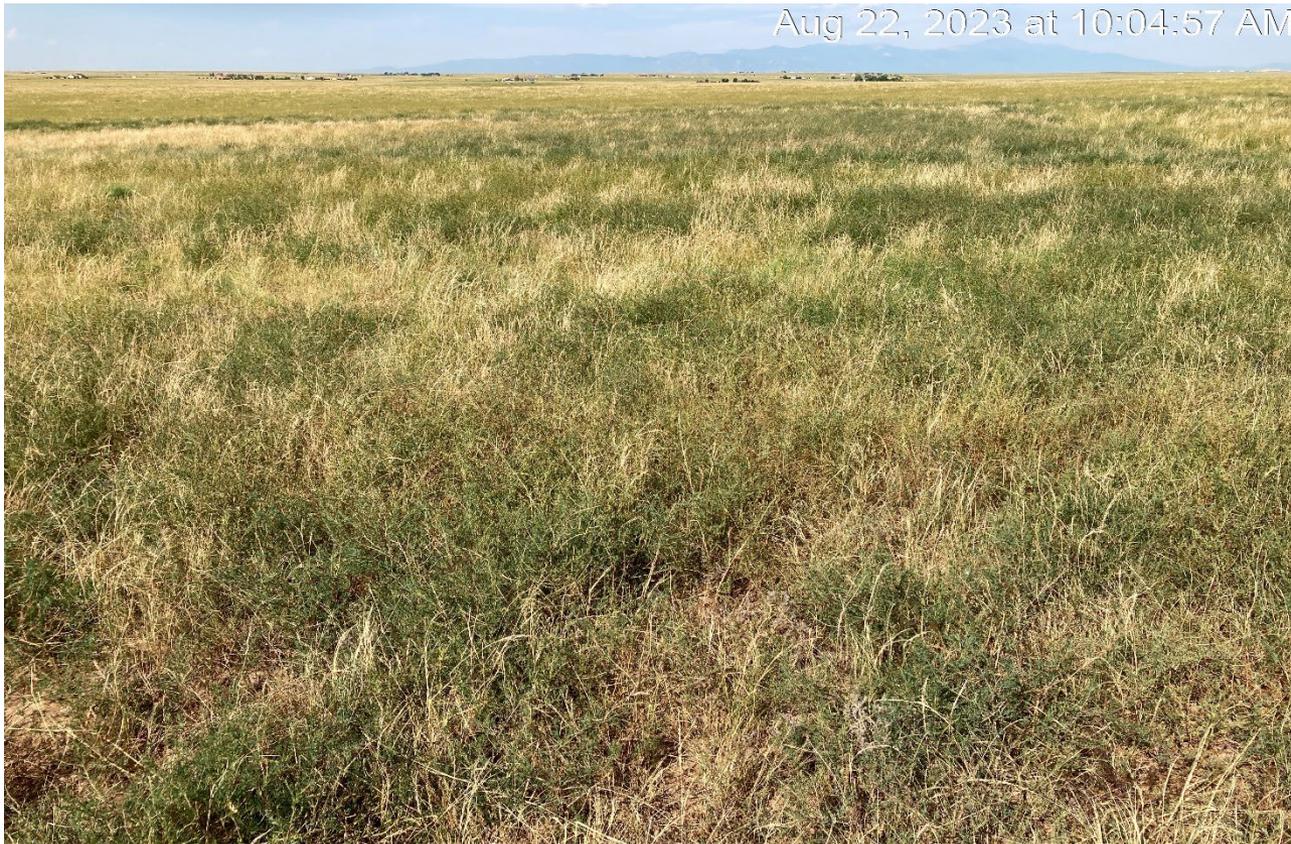
Photo 6. Center of the location facing west.
