Inspection Photos
well 057-06139
Inspection
Date:8/18/2023

COLORADO
Oil & Gas Conservation
Commission
Department of Natural Resources

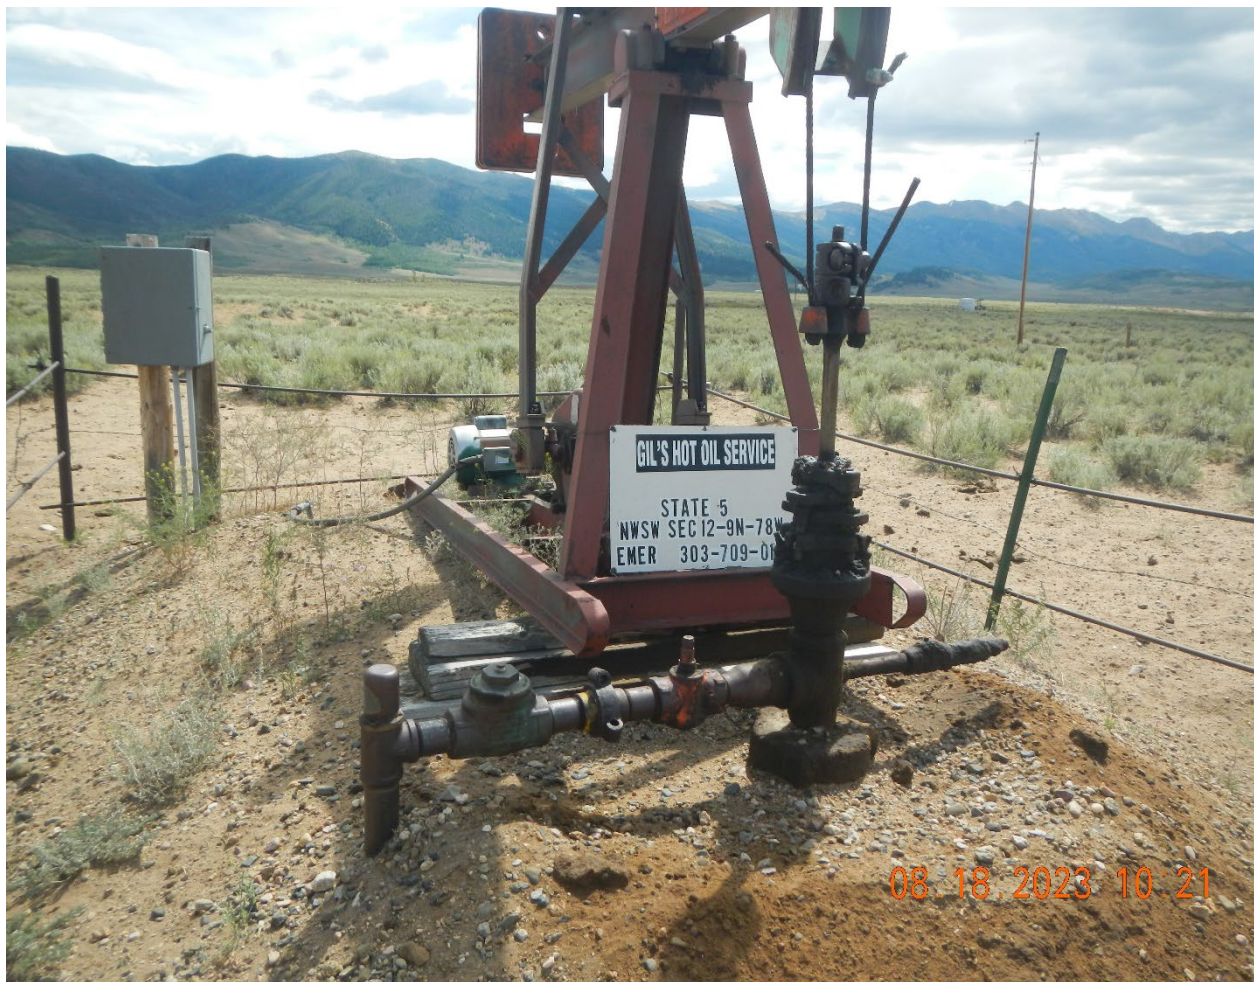
Photo #1 wellhead was fenced with pump rods.

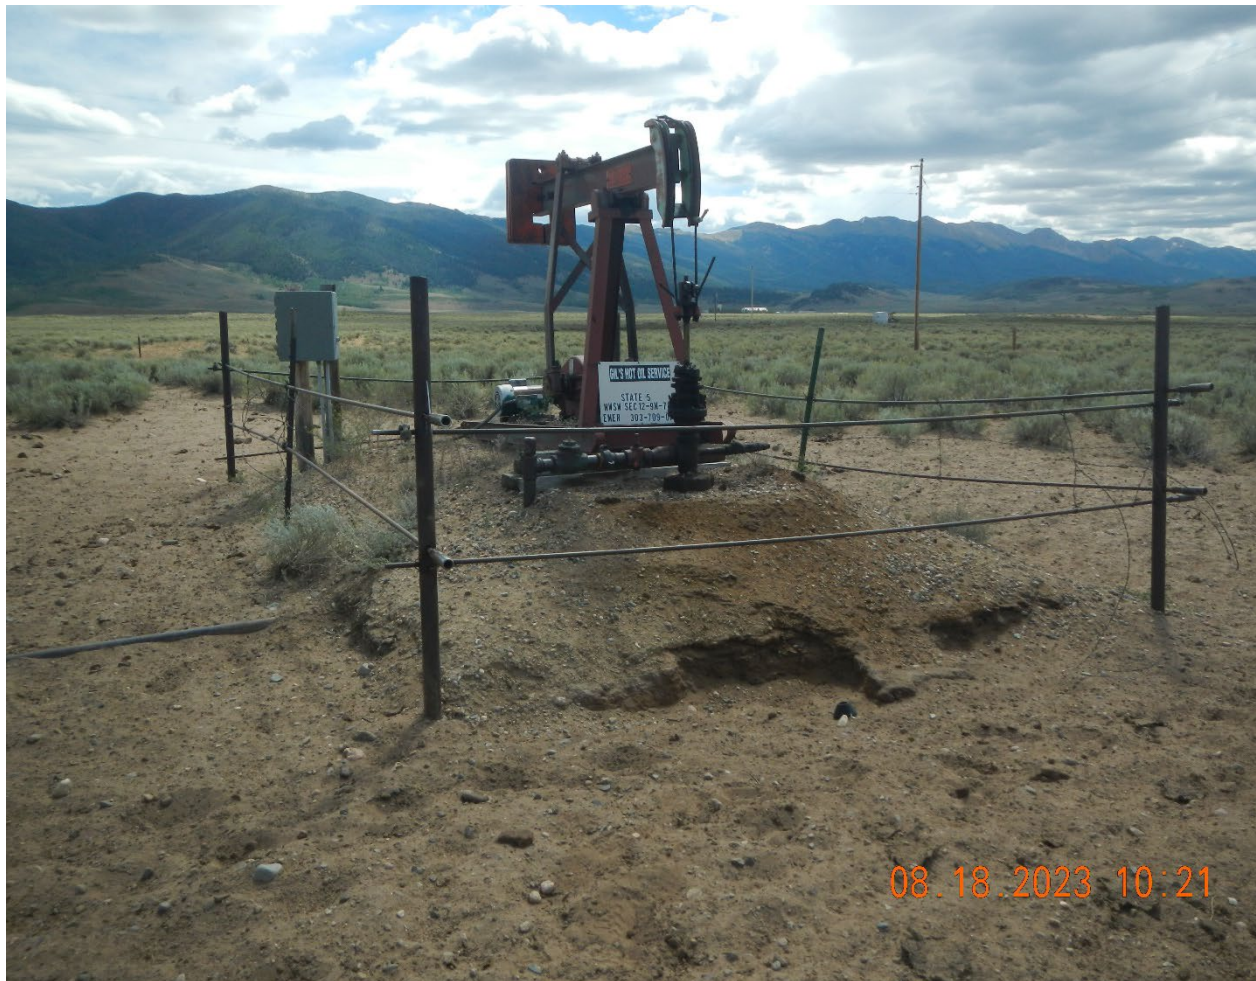
Photo #2 flowline on ground. Soil built up at wellhead had oil staining.

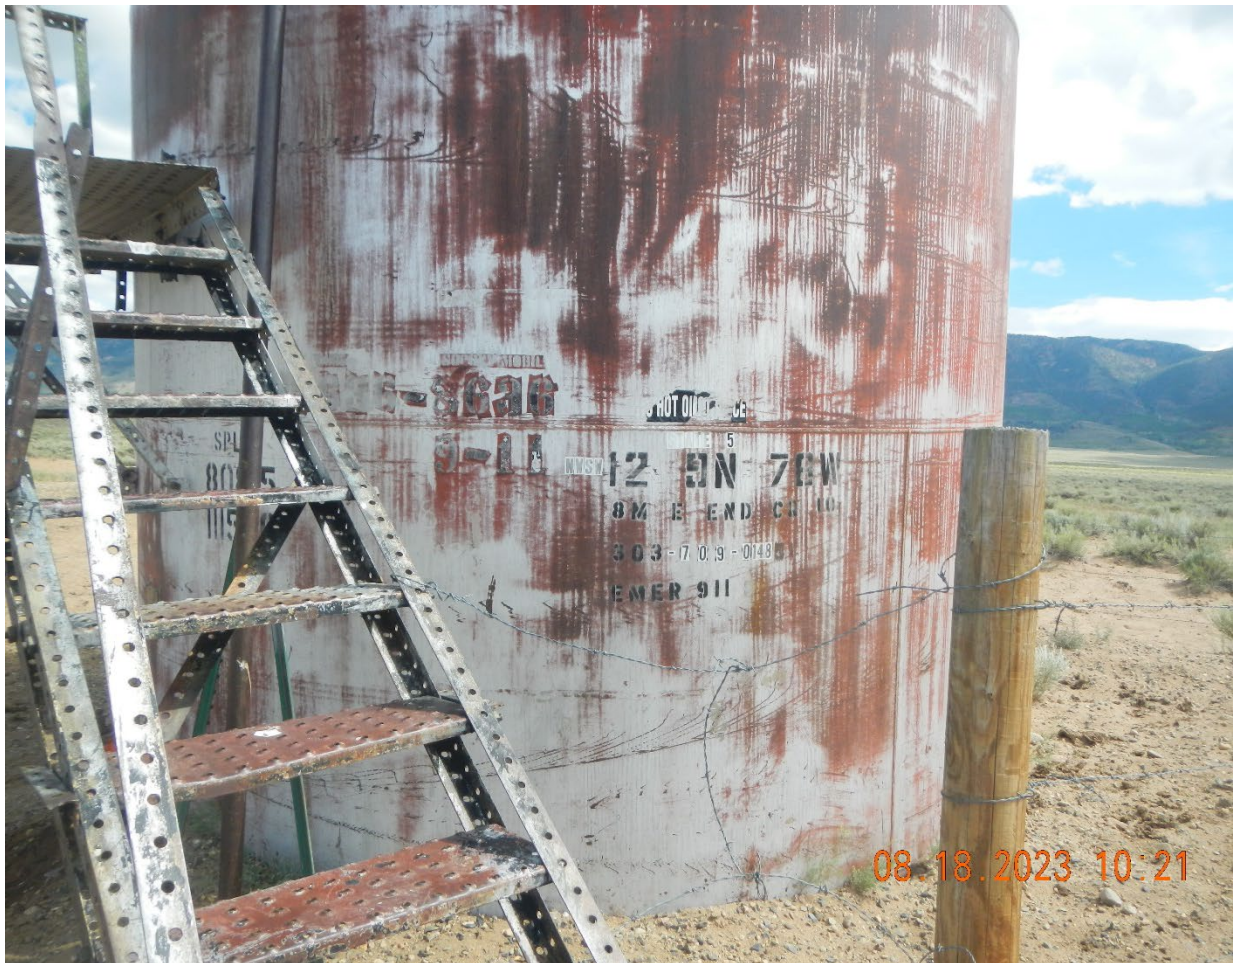
Photo #3 Tank near well. Tank was fenced.

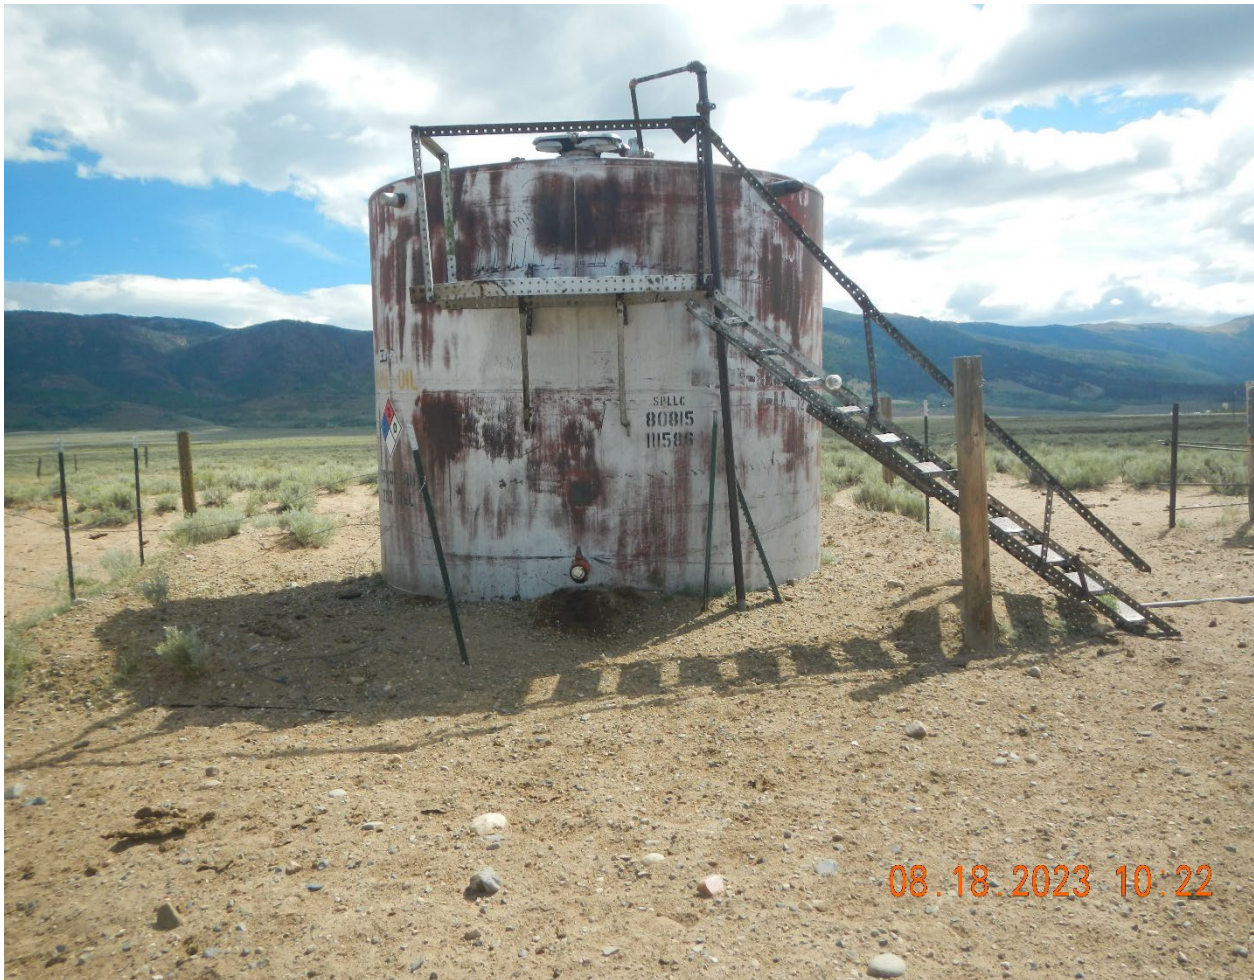
Photo #4 overview of Tank. Tank did not have adequate secondary containment. Soil type at tank is Sand.

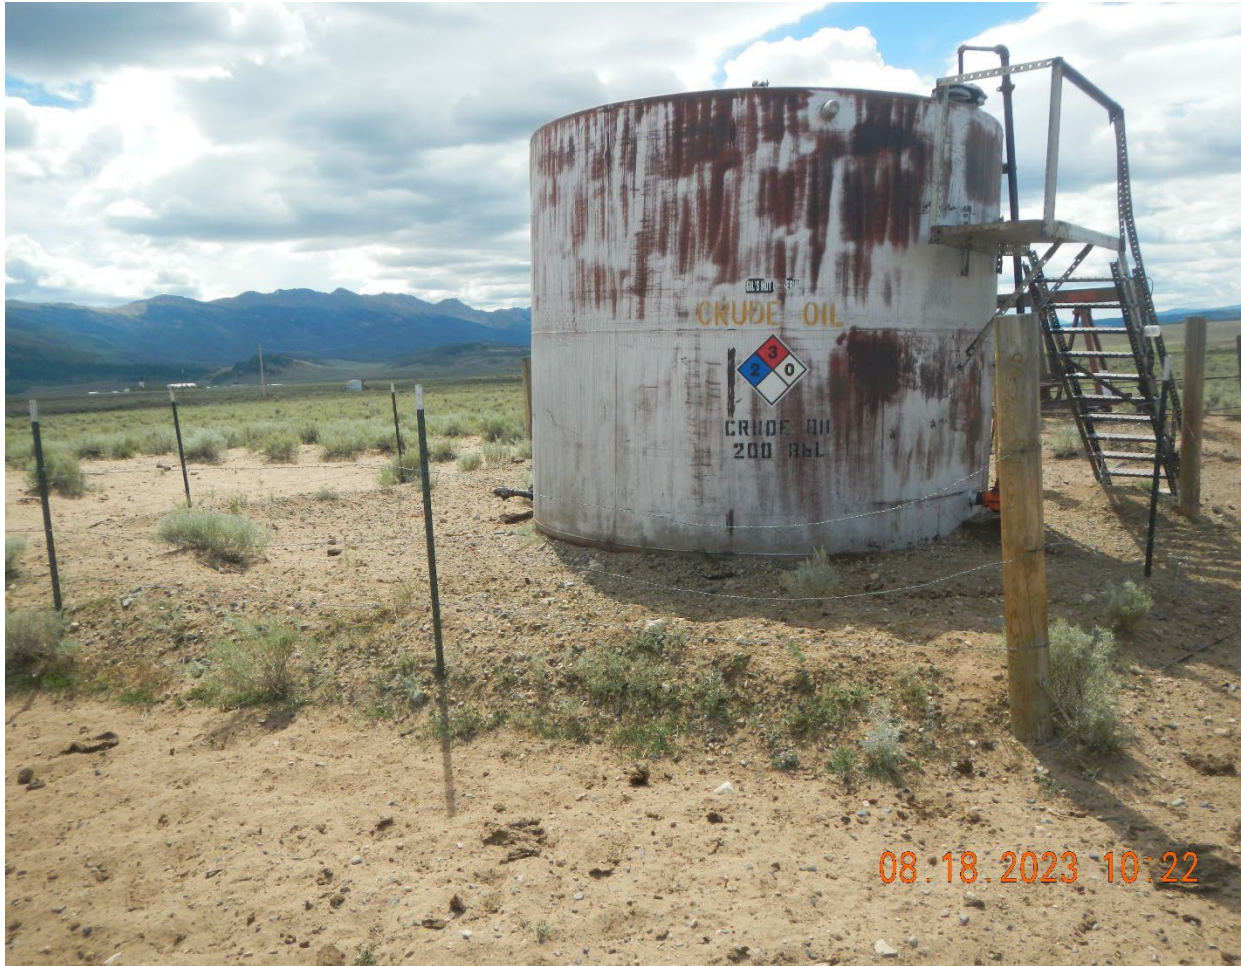
Photo #5 overview of Tank. Tank did not have adequate secondary containment. Soil type at tank is Sand.

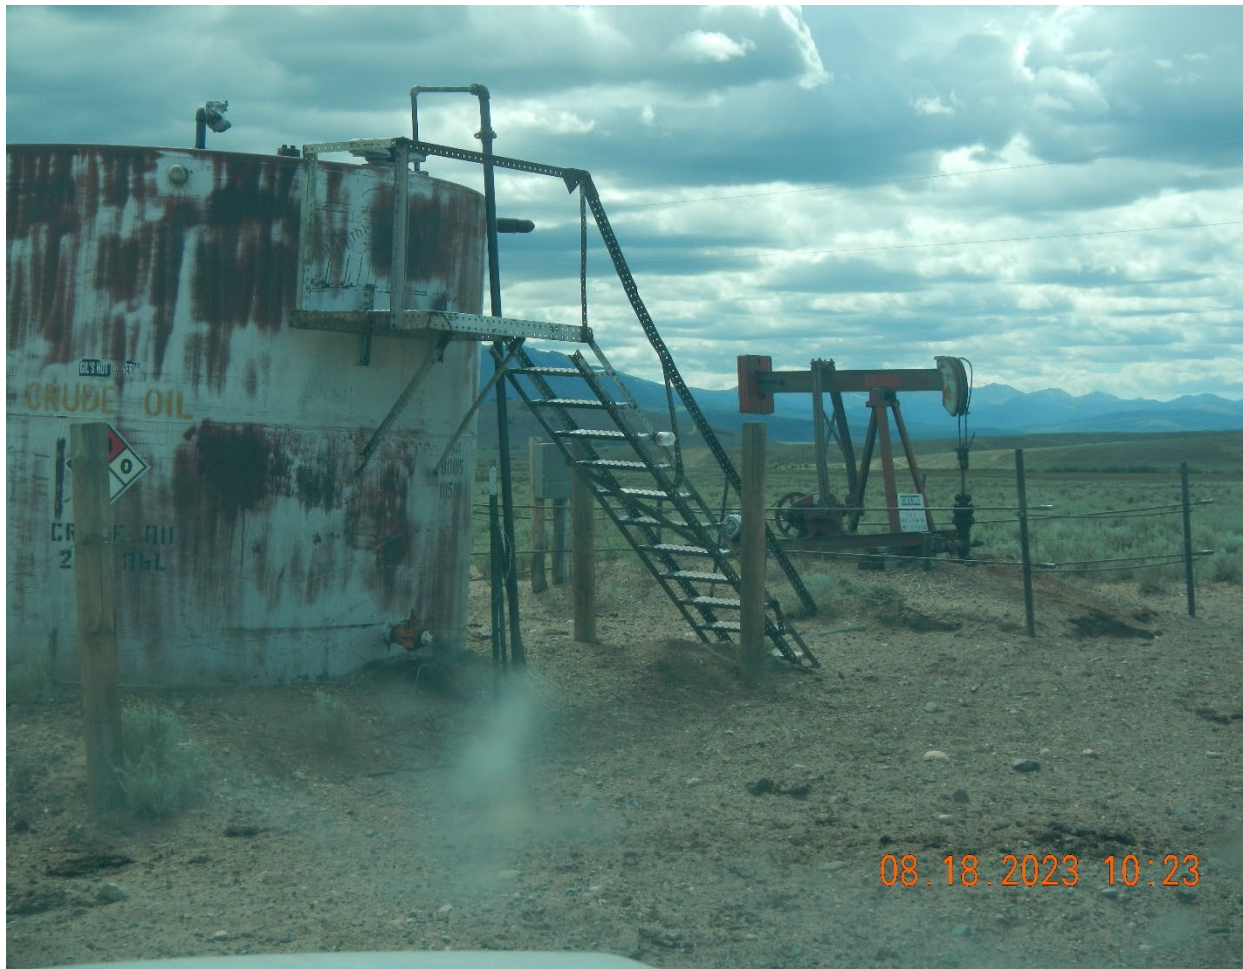
Photo #6 photo showing proximity of tank to well. .
