Inspection Photos
well 057-06376

Inspection
Date:8/18/2023

All Photos taken
by Kris Neidel

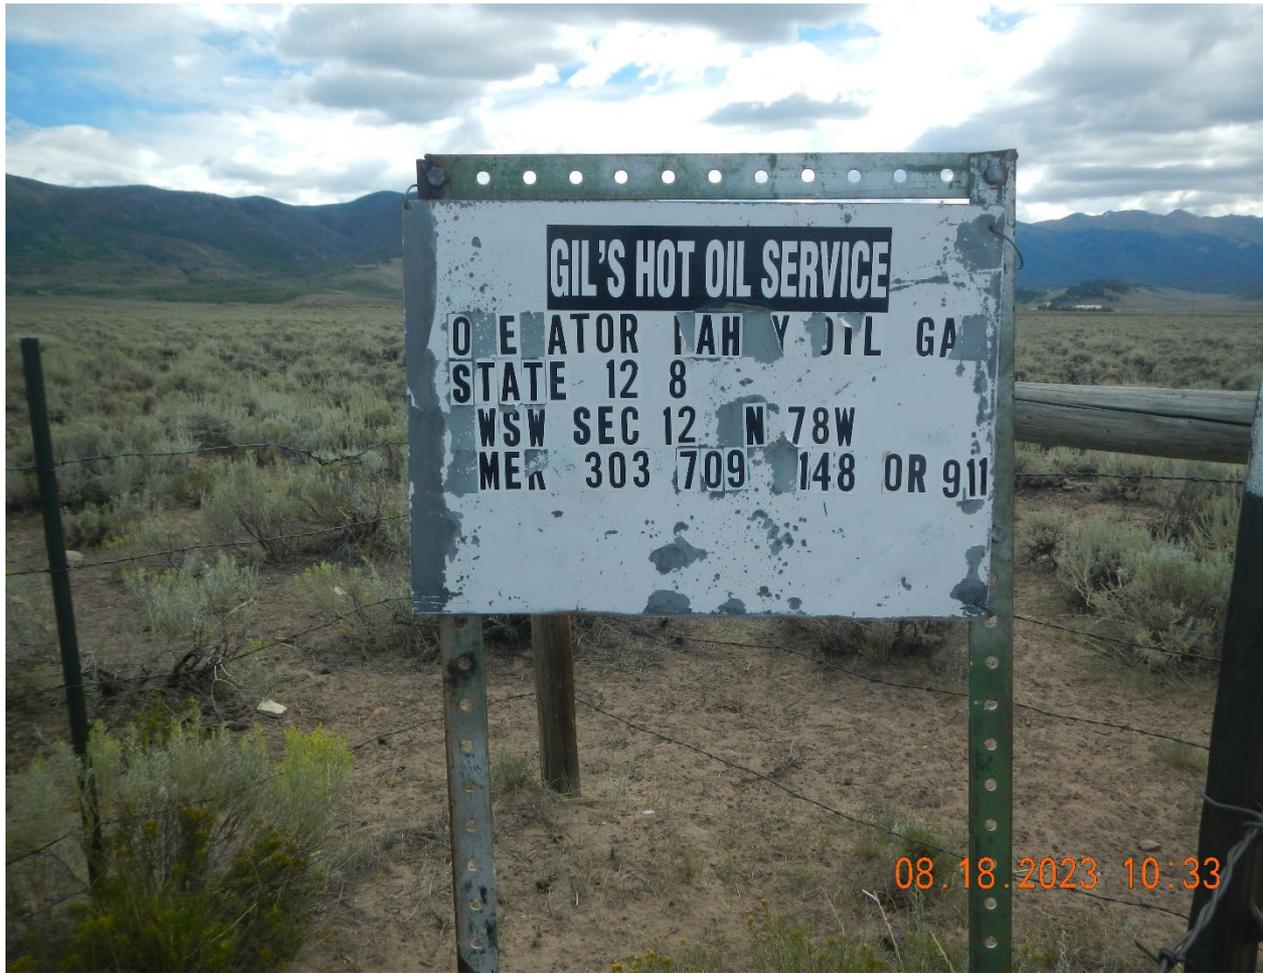
Photo #1 Sign at wellhead.

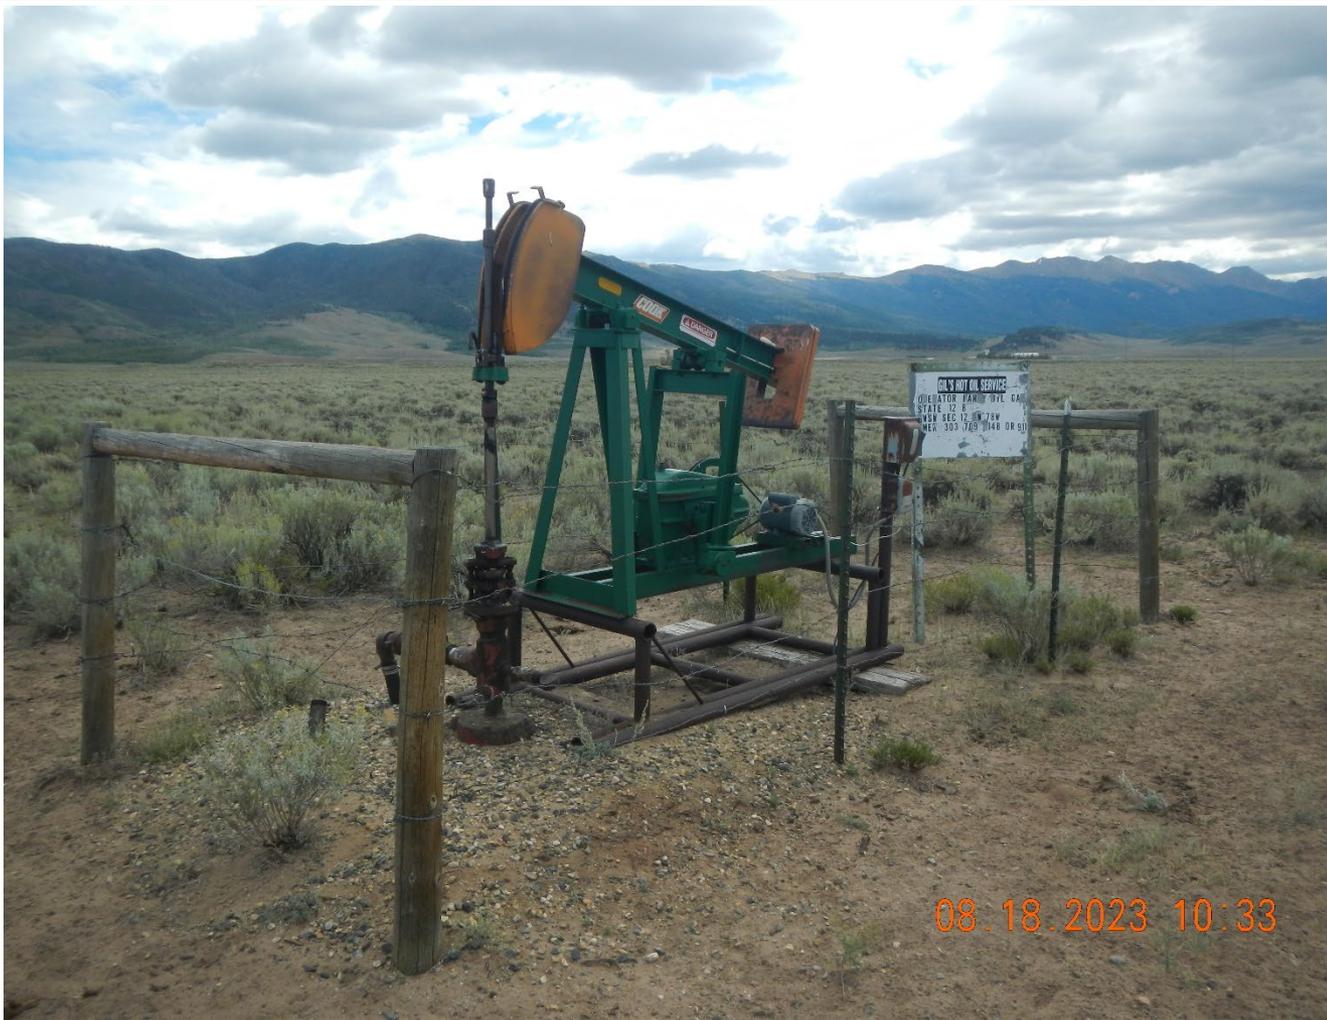
Photo #2 Well fenced.

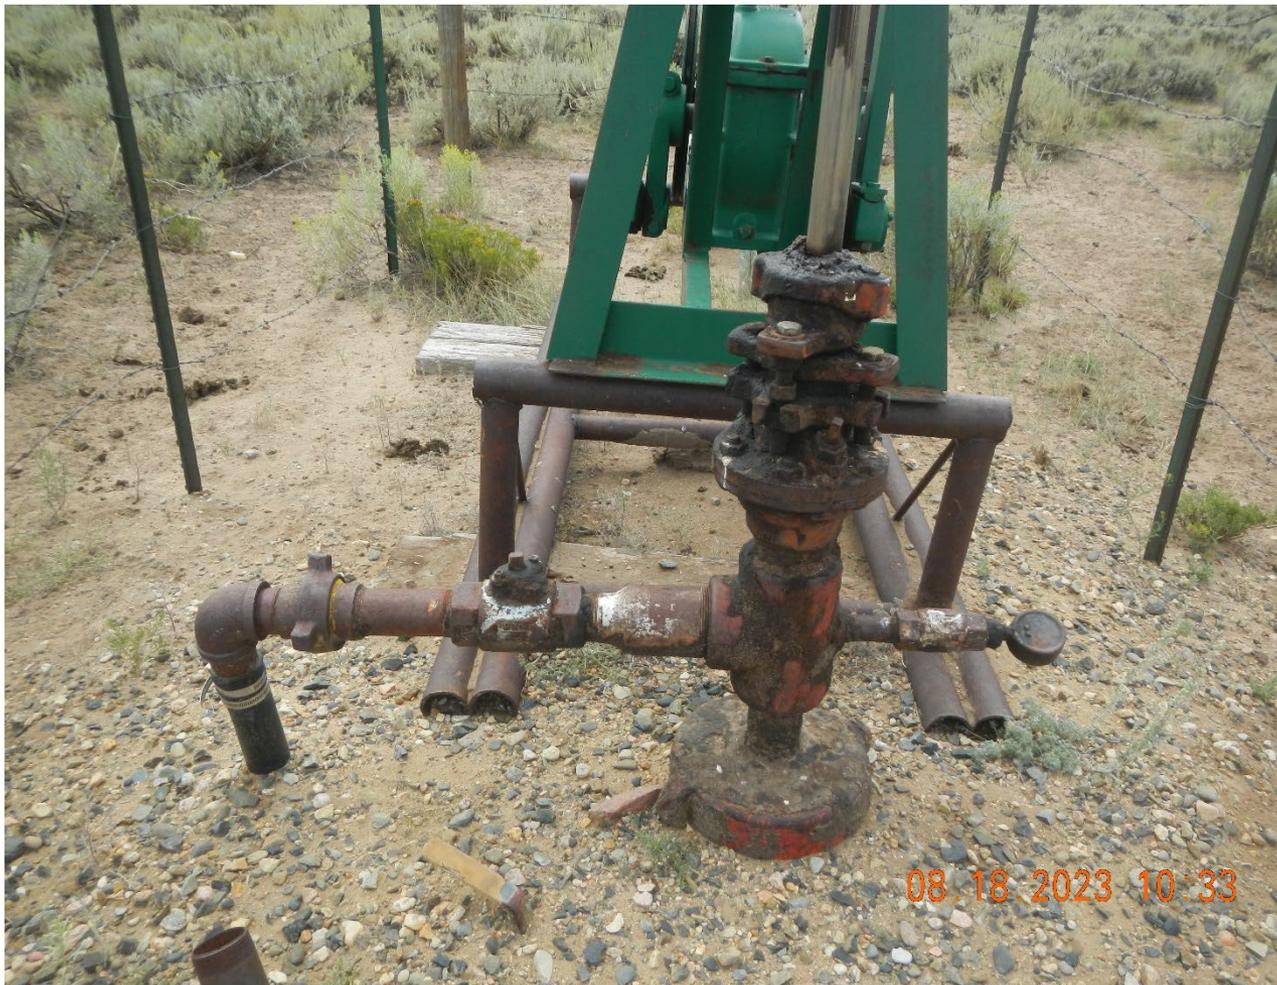
Photo #3 condition of wellhead.

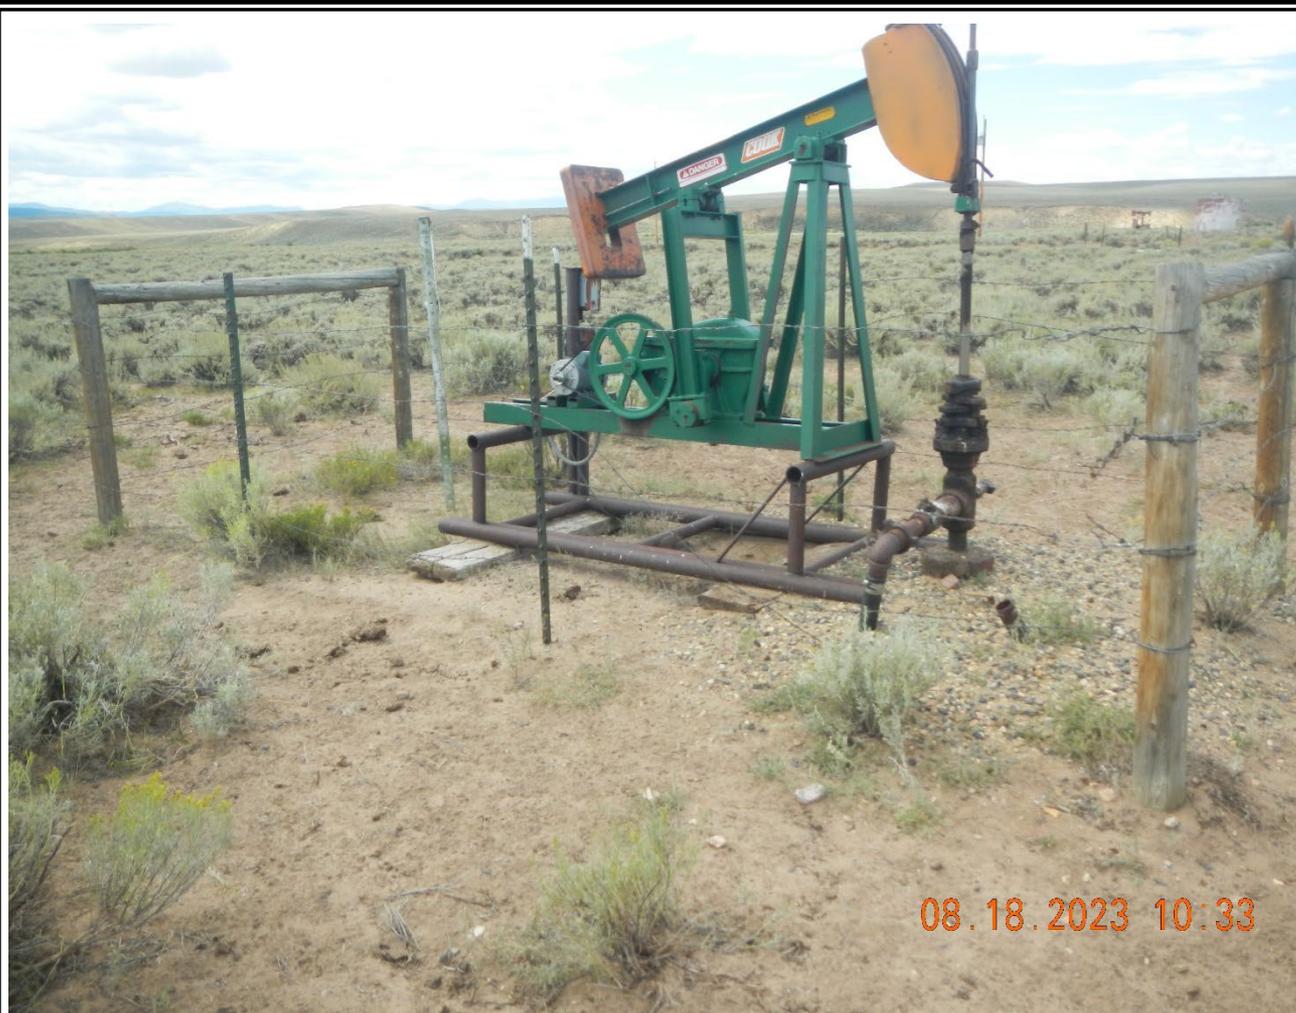
Photo #4 Another view of well.

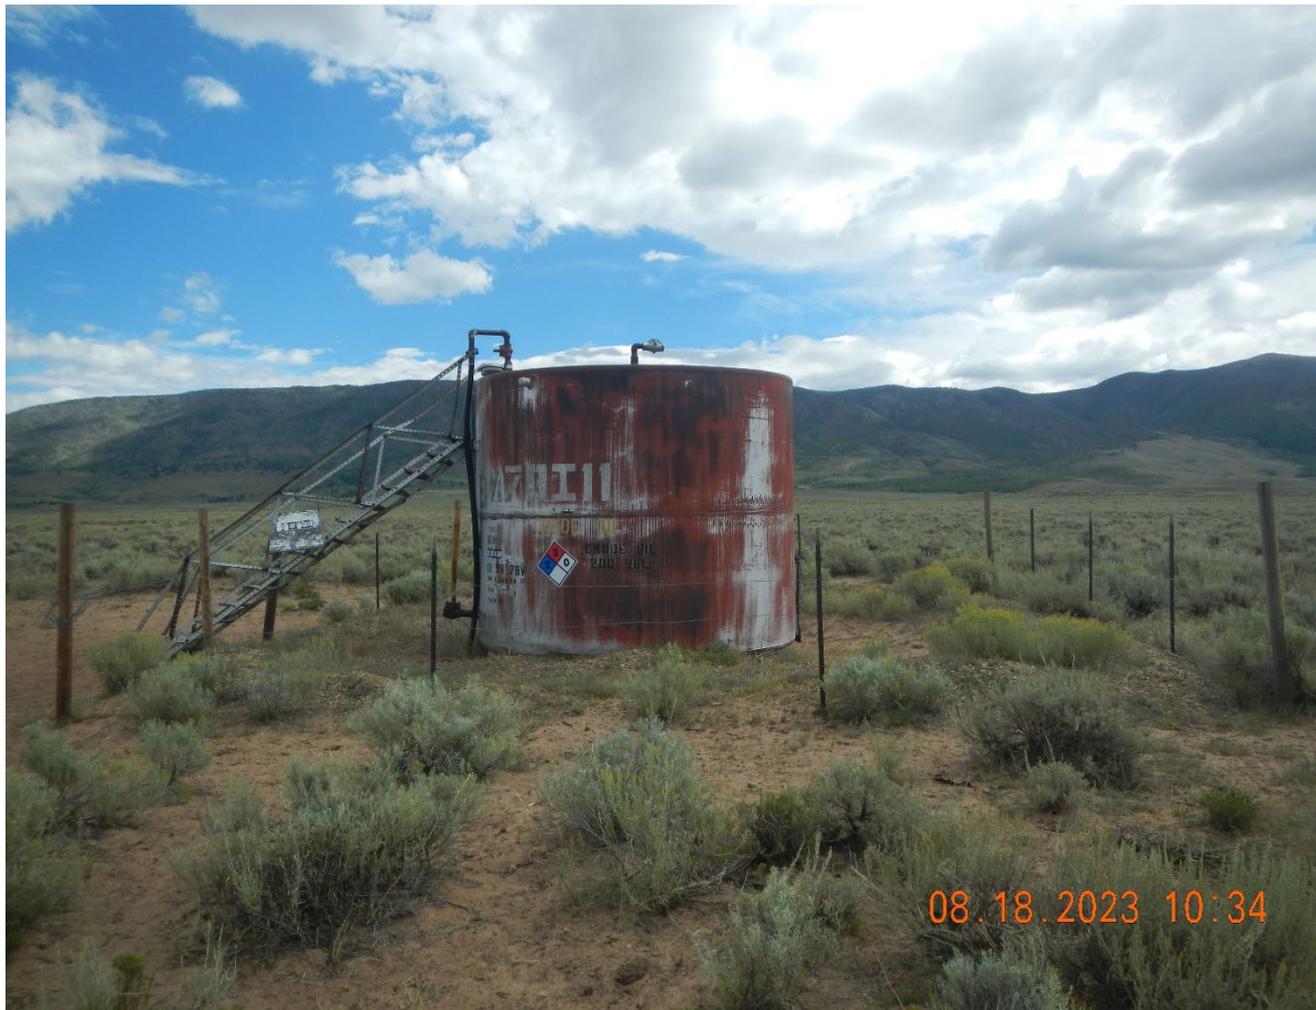
Photo #5 Tank Battery near well. Tank is fenced. It was not obvious that this tank has adequate secondary containment.

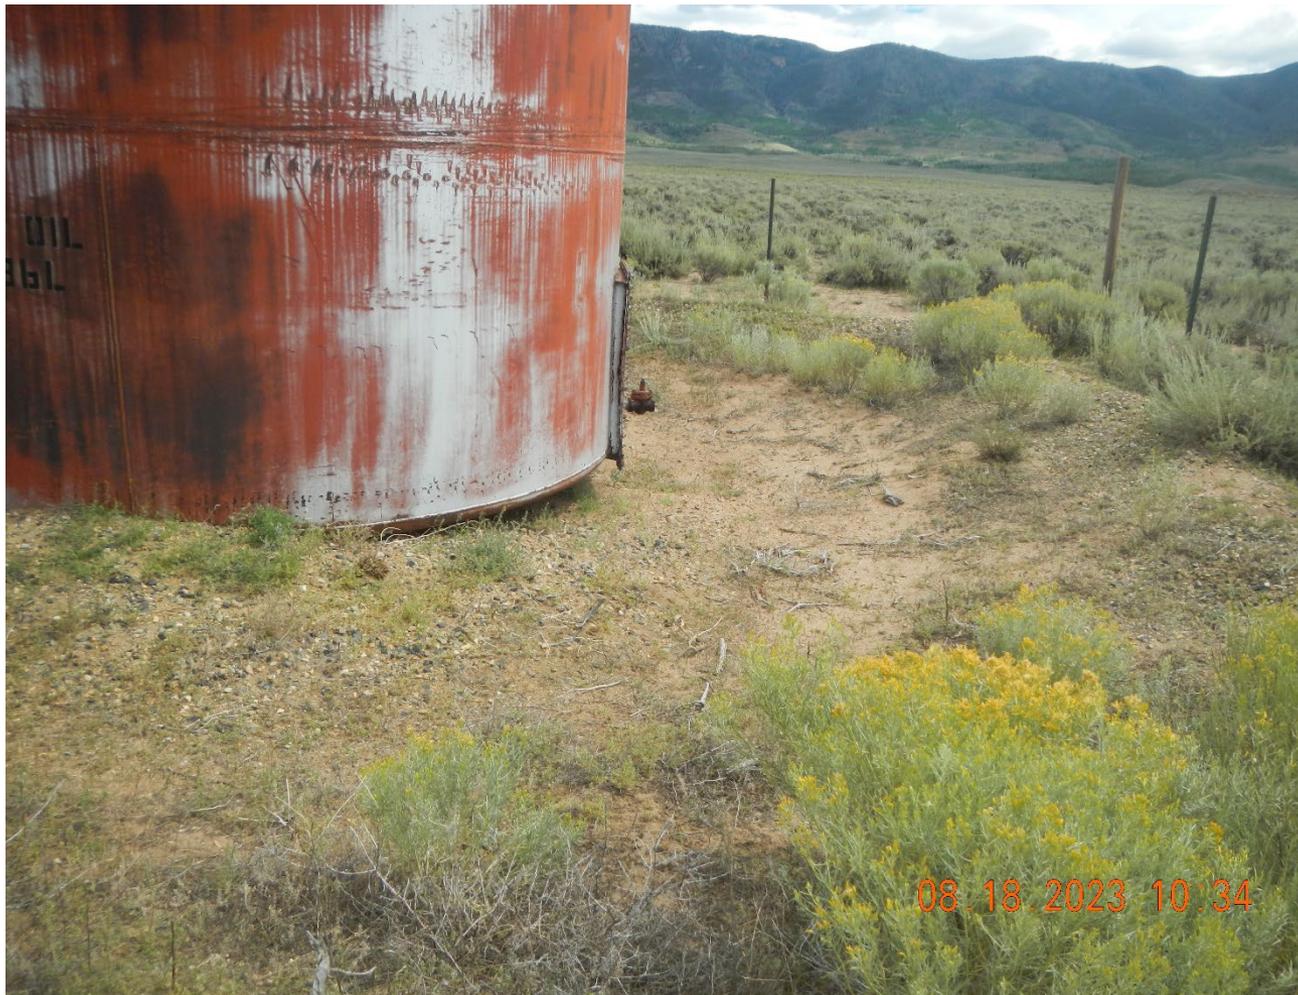
Photo #6 erosion under tank.

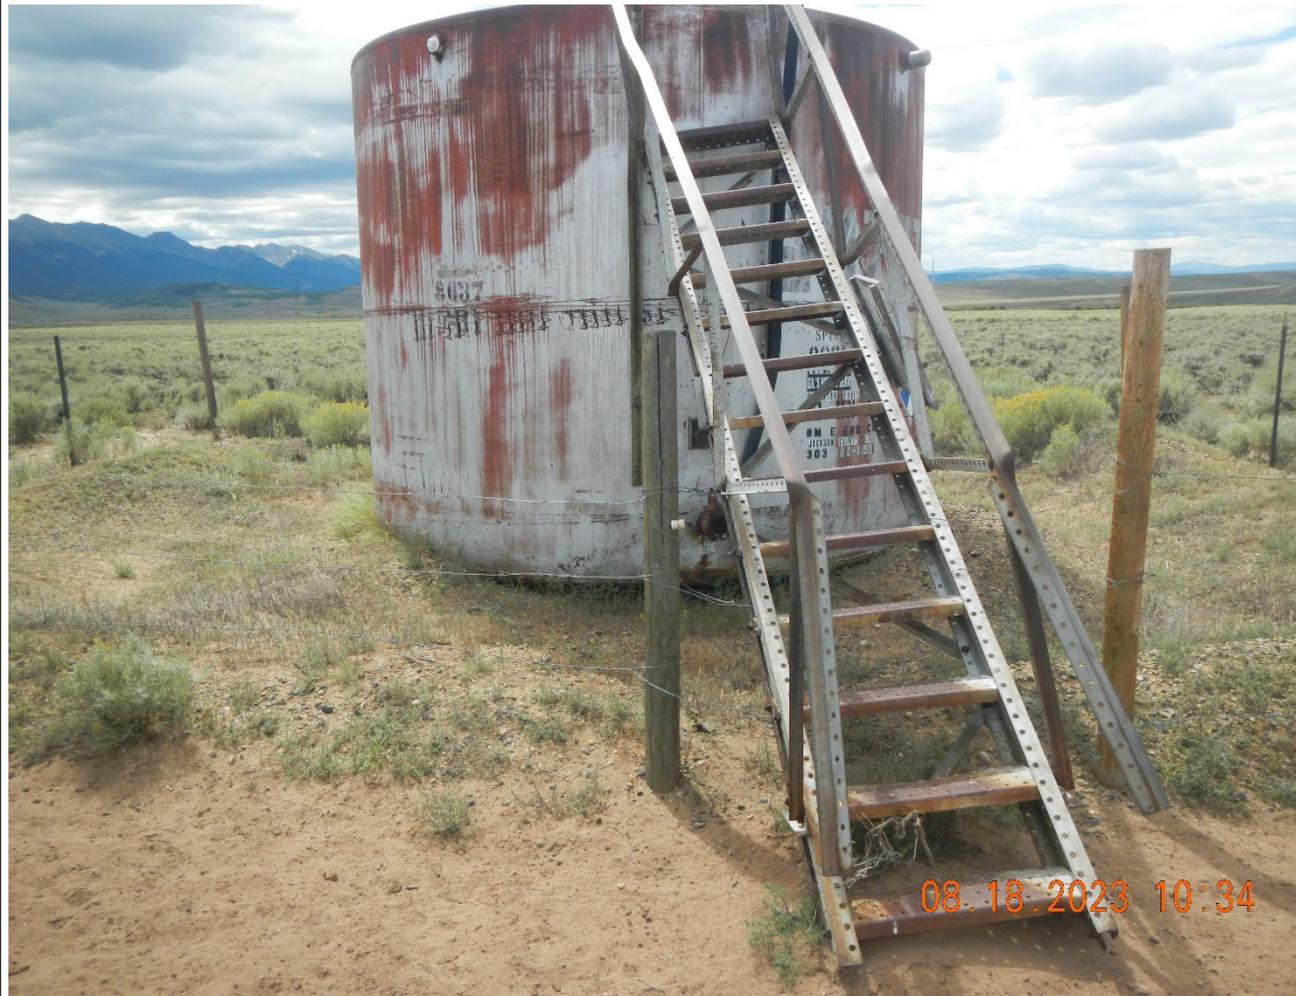
Photo #7 Tank.

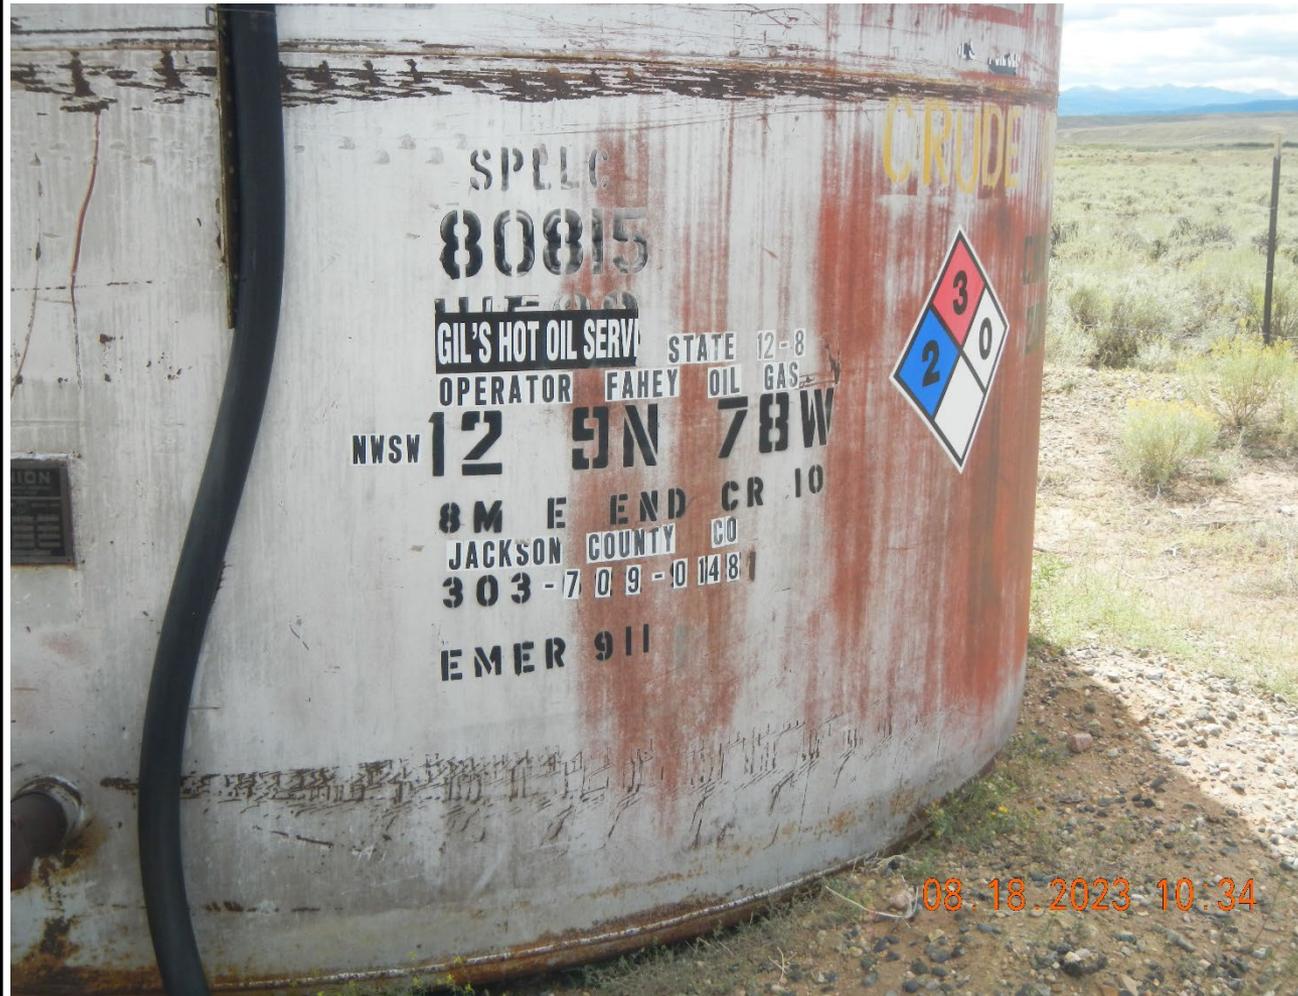
Photo #8 Plaquire on Tank.
