# Inspection Photos

8/28/2023

Operator: TEP ROCKY MOUNTAIN LLC #96850

Location Number: 334745

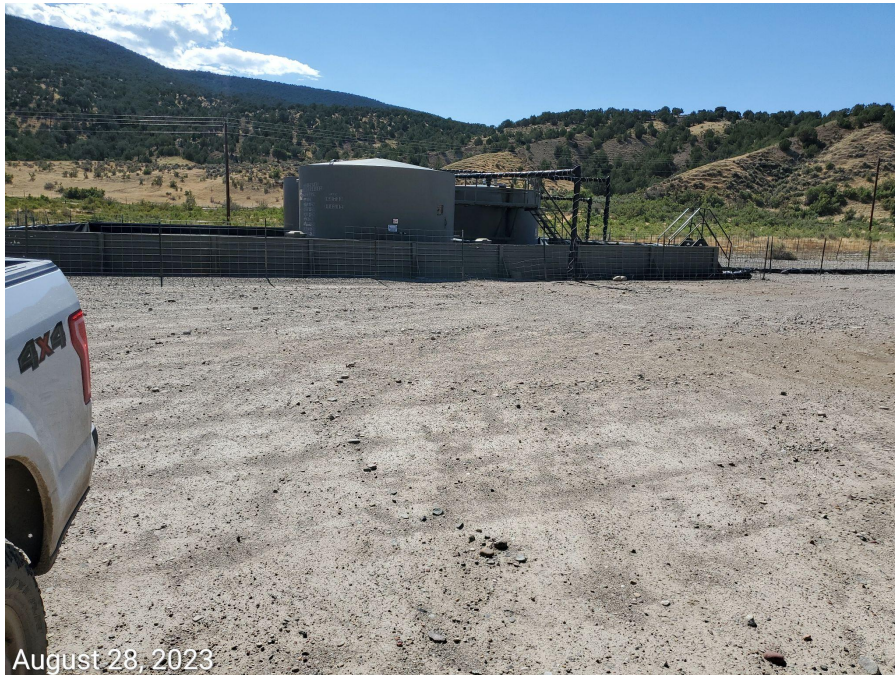
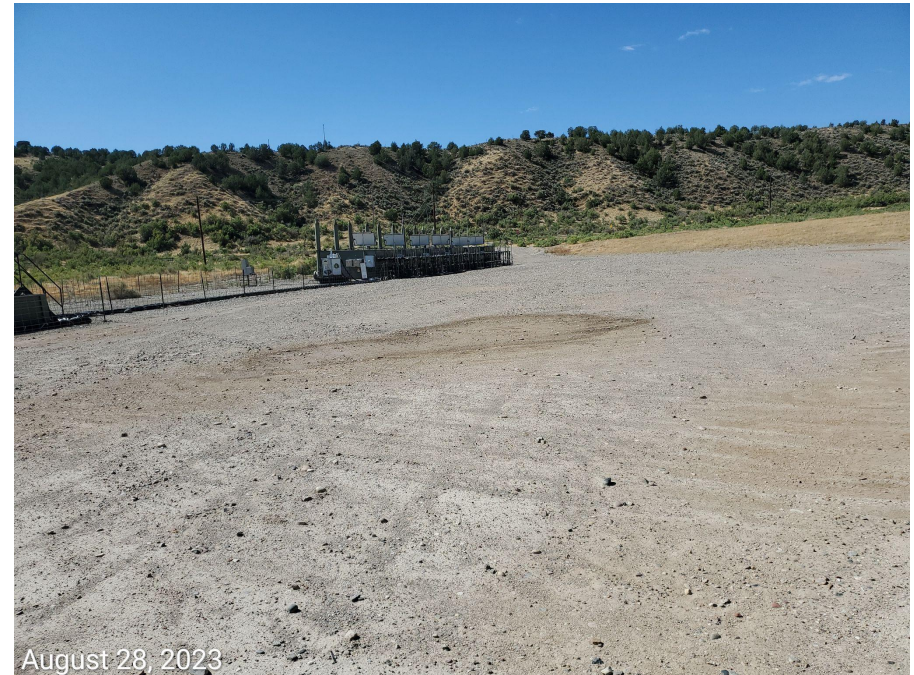
**Photo 1:** Photos 1-2 provide an overview of the working pad surface, from east, southeast, southwest to west.

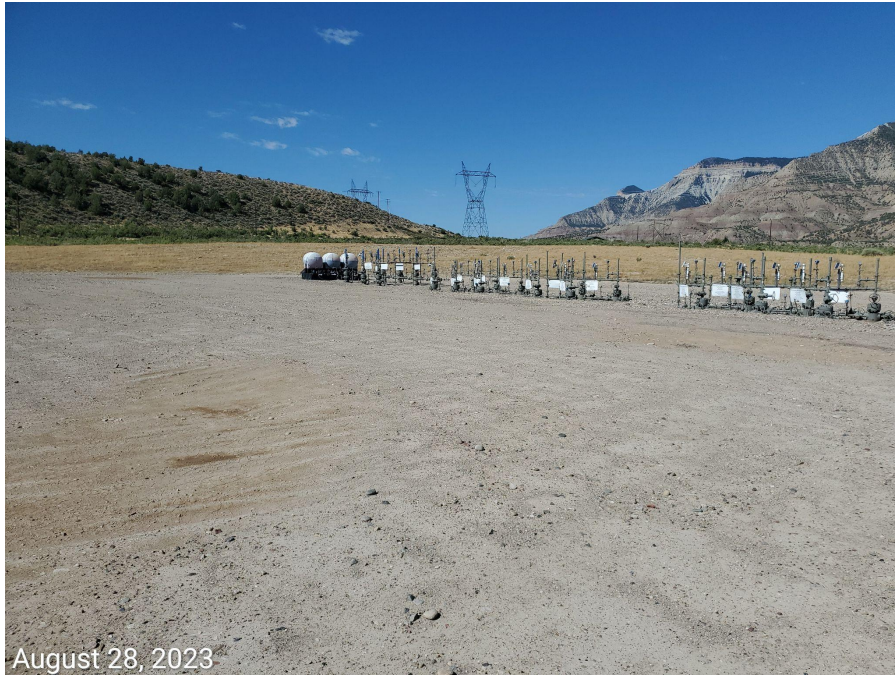
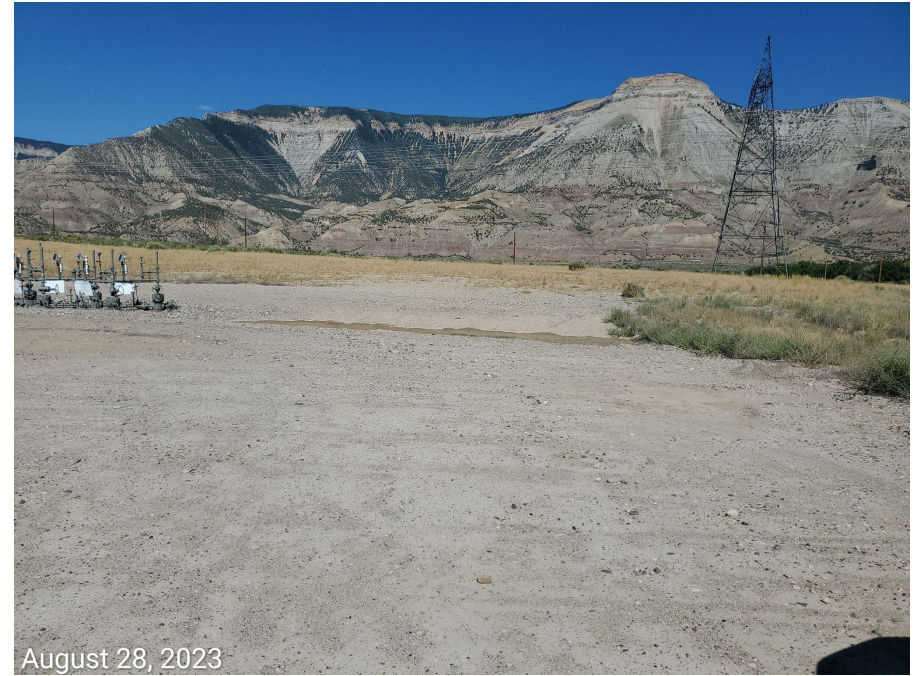
**Photo 2:** See comments under photo 1.

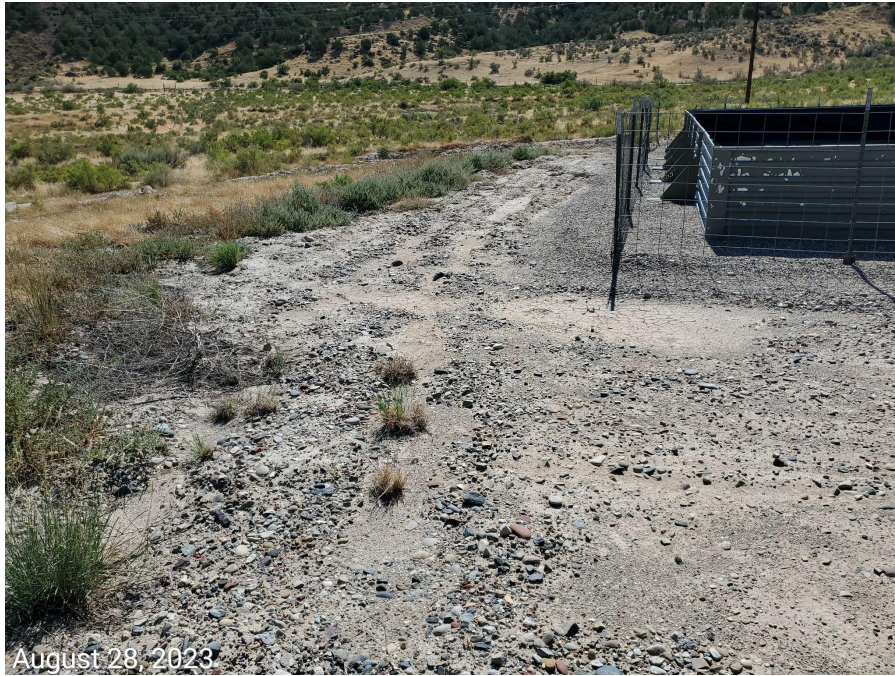
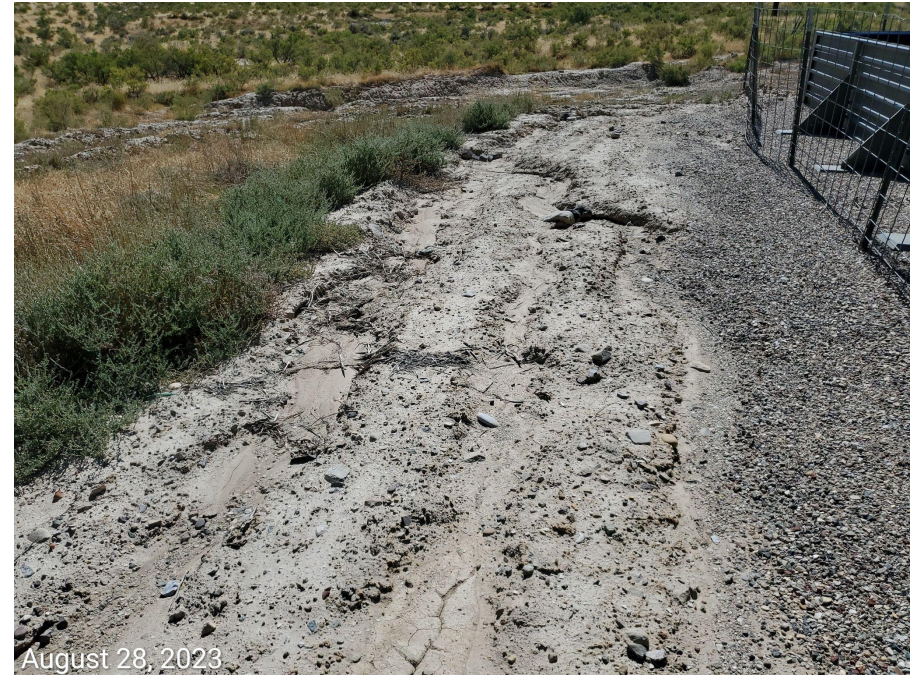
**Photo 3:** Photo taken from the northeast corner of the working pad surface. Photo shows control measures to allow for proper stormwater discharge remain missing or insufficient; erosion degradation has persisted.

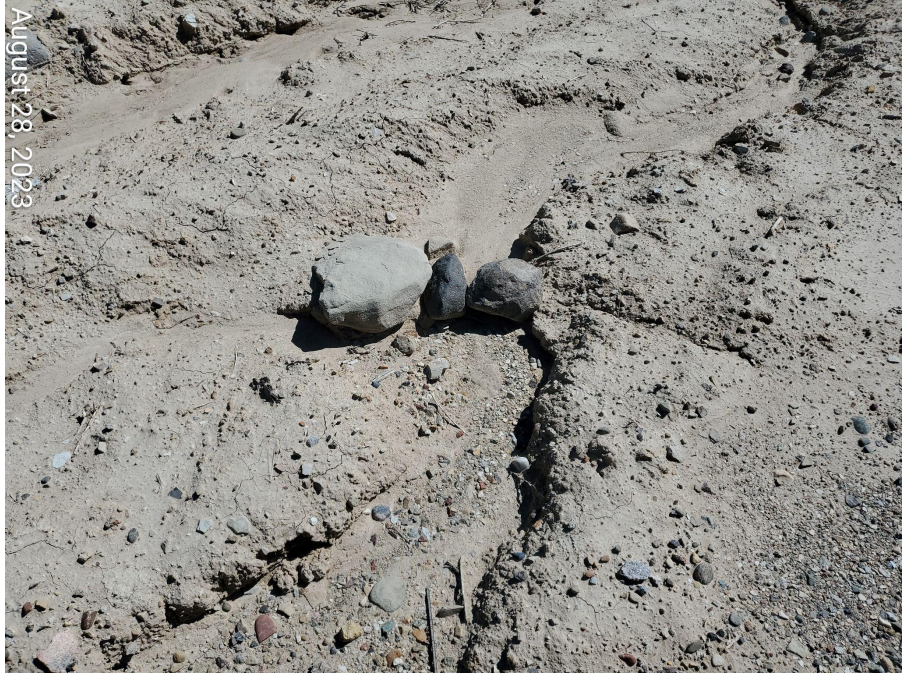
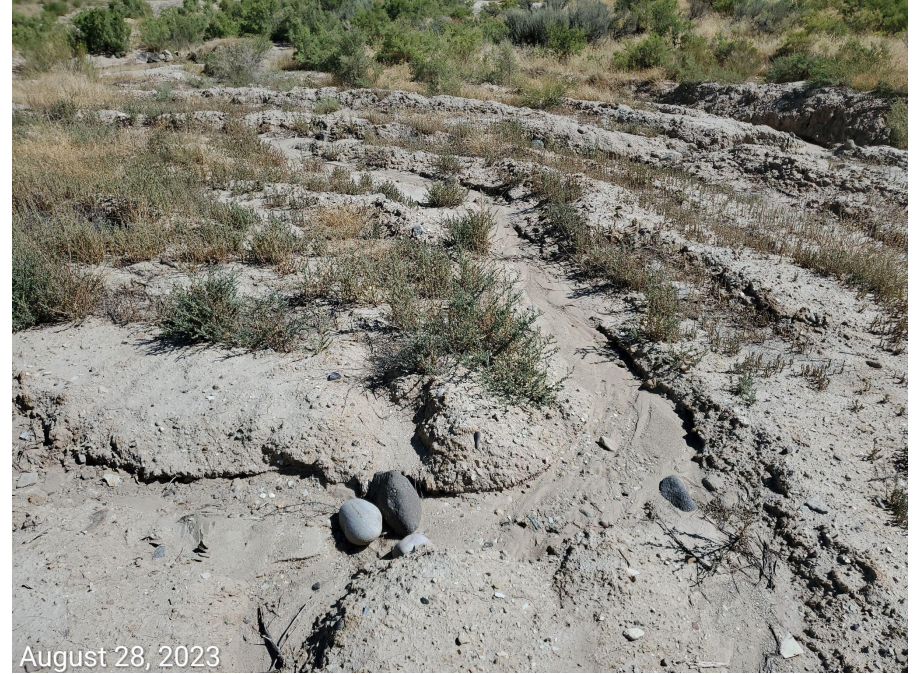
**Photo 4:** Photo shows erosion degradation due to stormwater runoff from the northeast corner of the working pad surface, behind the tank battery. BMPs to properly manage runoff remain inadequate.

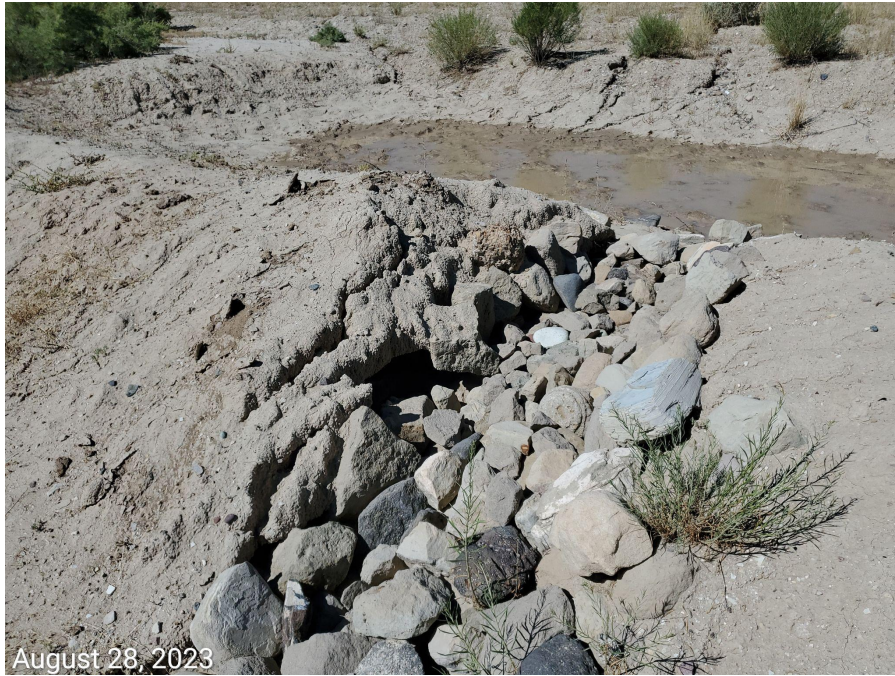
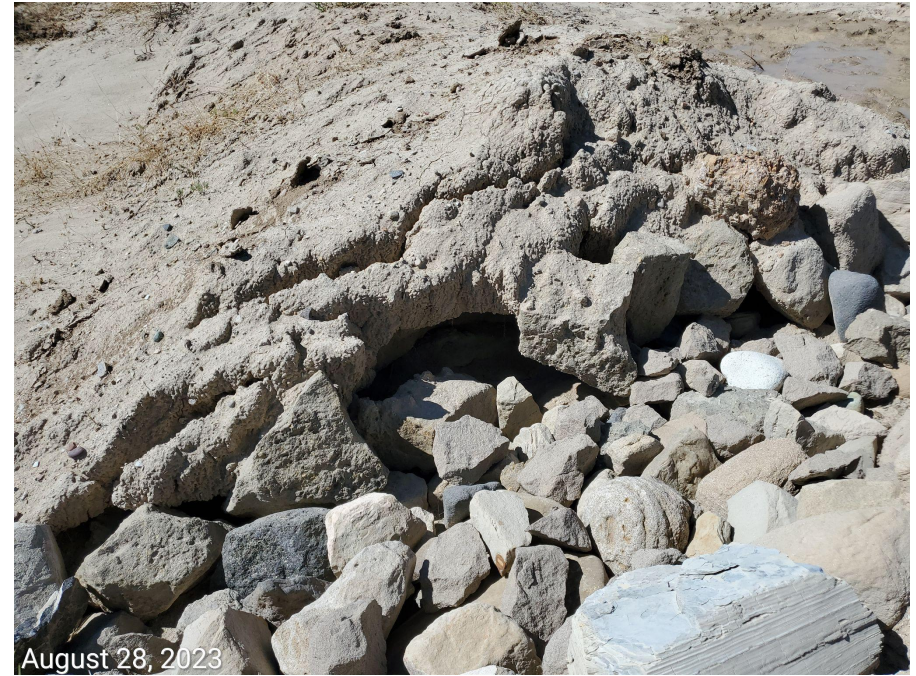
**Photo 5:** Photo taken from the sediment trap on the north east end of the Location. Photo shows outlet has not been installed per good engineering practices; rock armoring has not been installed in conjunction with geotextile lining, resulting in degradation to the control.

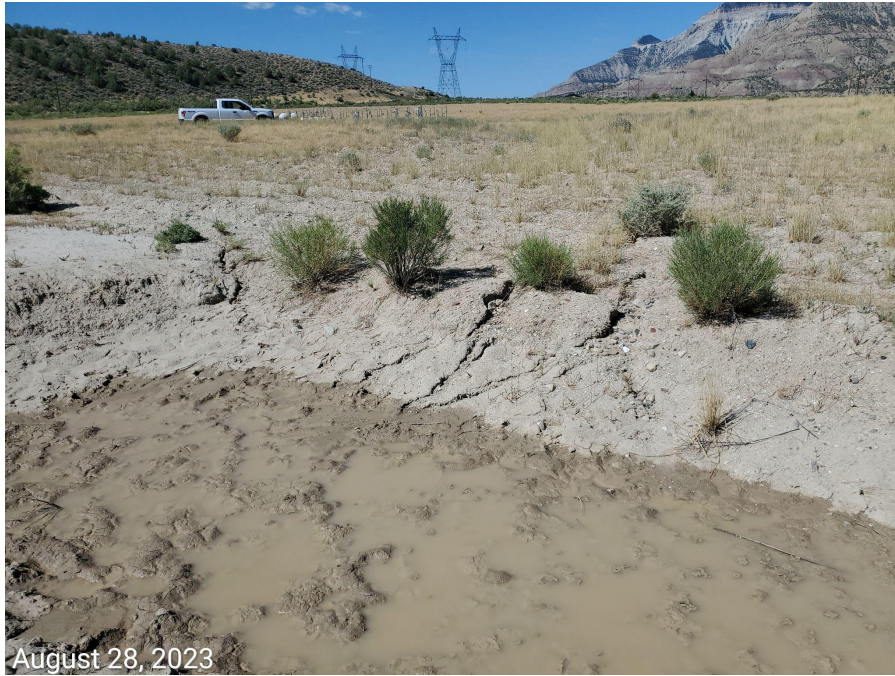
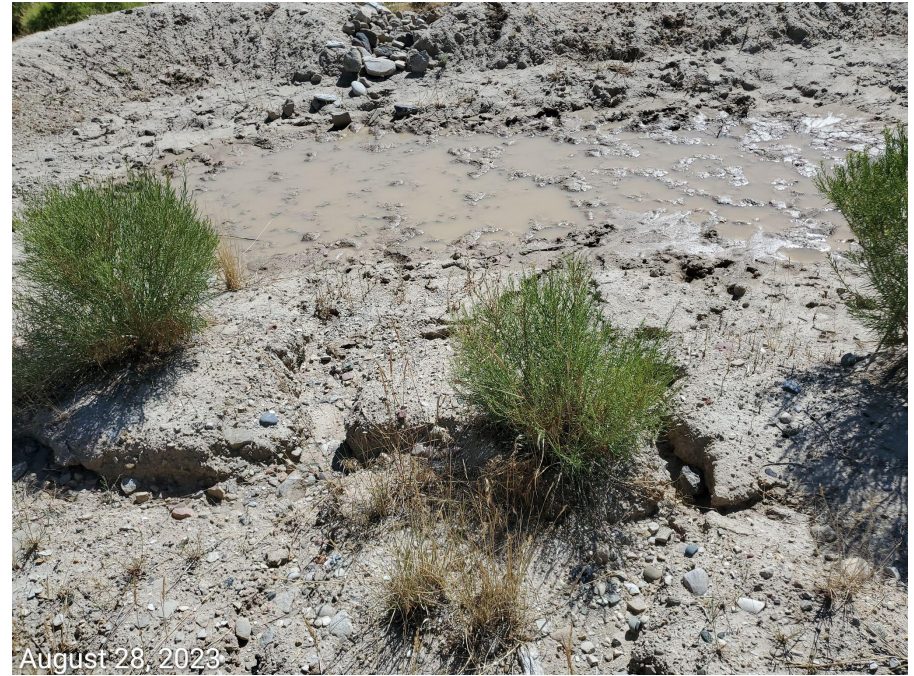
**Photo 6:** Photos shows sediment trap on the north east end of the Location has not been installed with a properly engineered inlet. Stormwater runoff from the pad is resulting in degradation to the control.

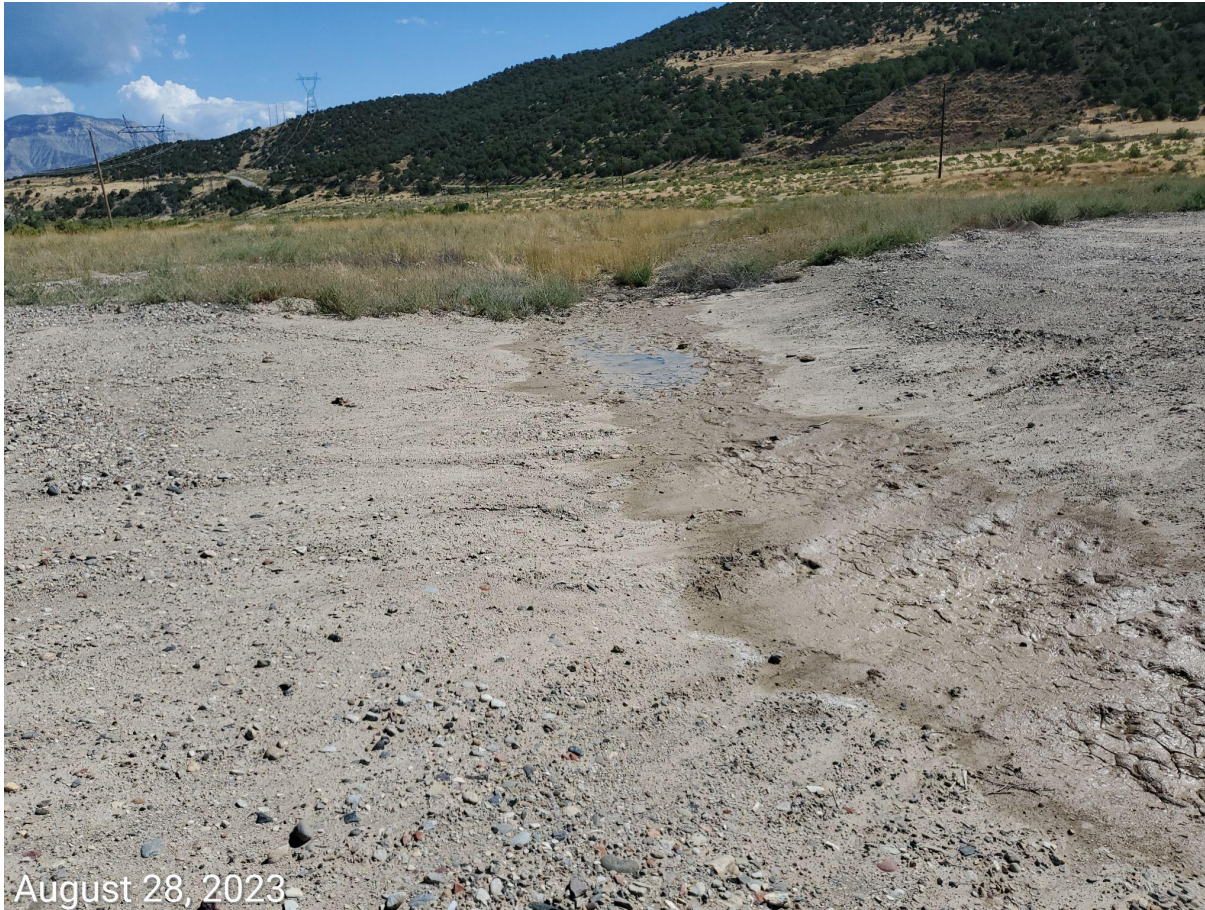
**Photo 7:** Photo shows contoured areas, on the north end of the working pad surface, that discharges stormwater into the interim areas to the north, and into the sediment trap observed within photos 5-6.

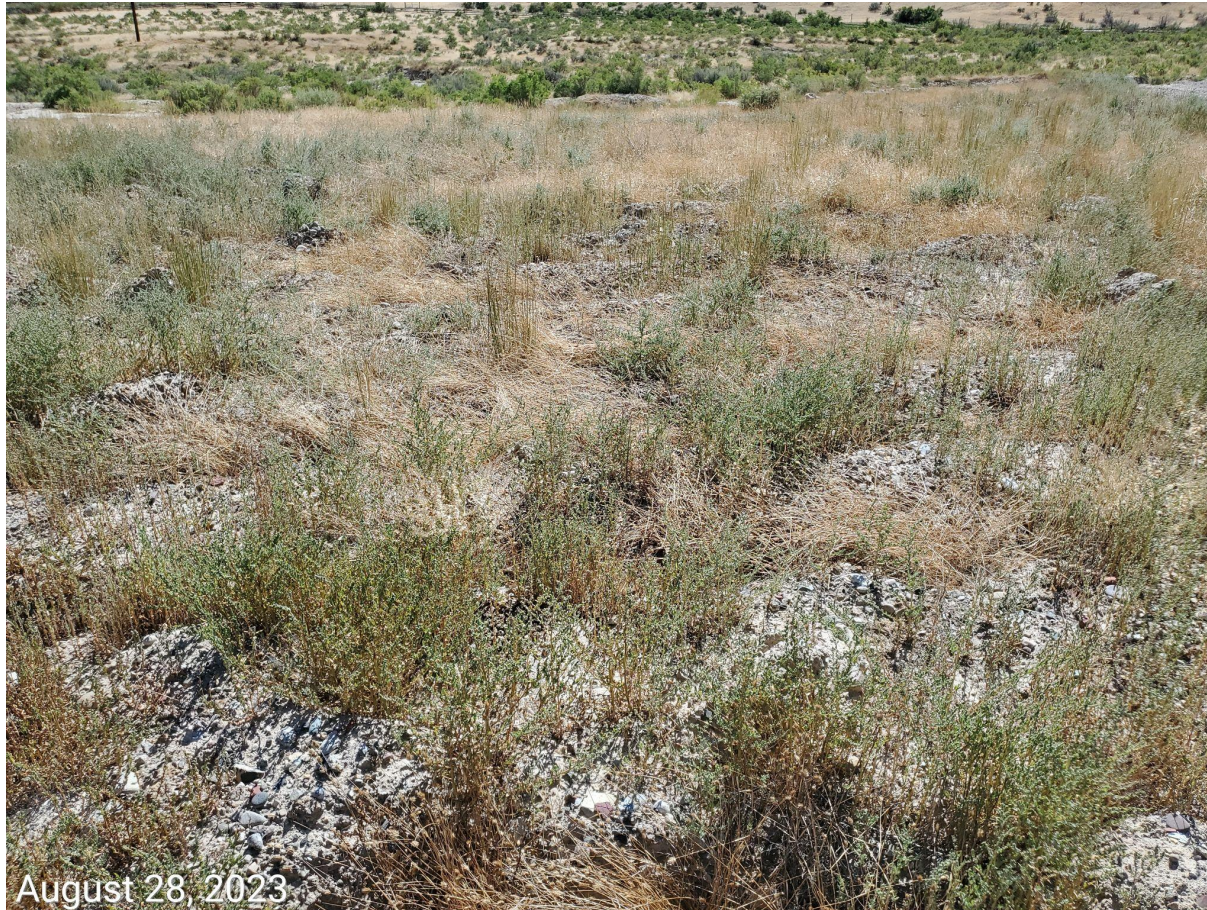
**Photo 8:** Photo taken from the northern interim areas. Vegetation within these areas are predominantly undesirable plant species.

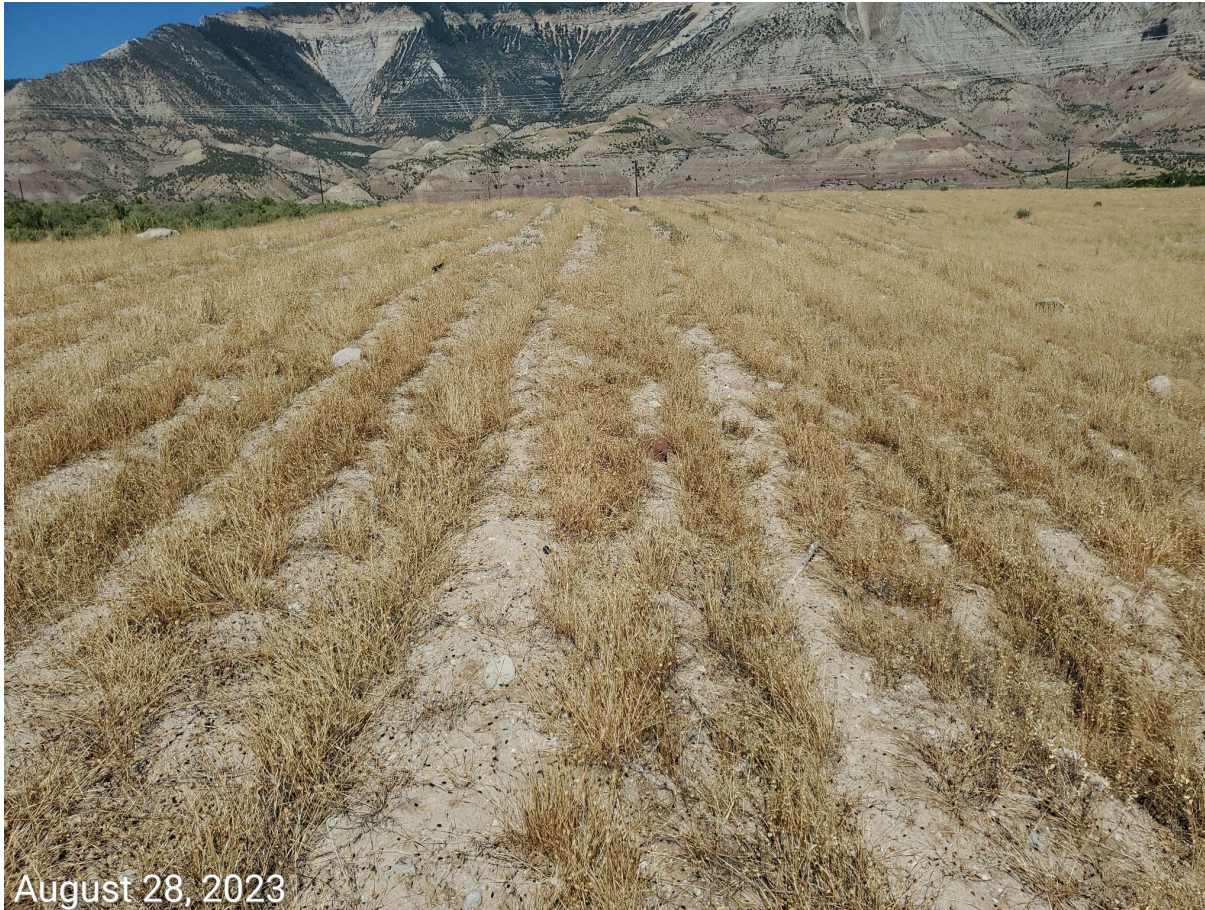
**Photo 9:** Photo taken from the southern/western interim areas. Desirable vegetative establishment is more evident within these areas, though Undesirable Plant Species remain dominant.
