Inspection Photos  
well 081-60020

Inspection  
Date:8/29/2023

All Photos taken  
by C-ecmc staff,  
John Heil

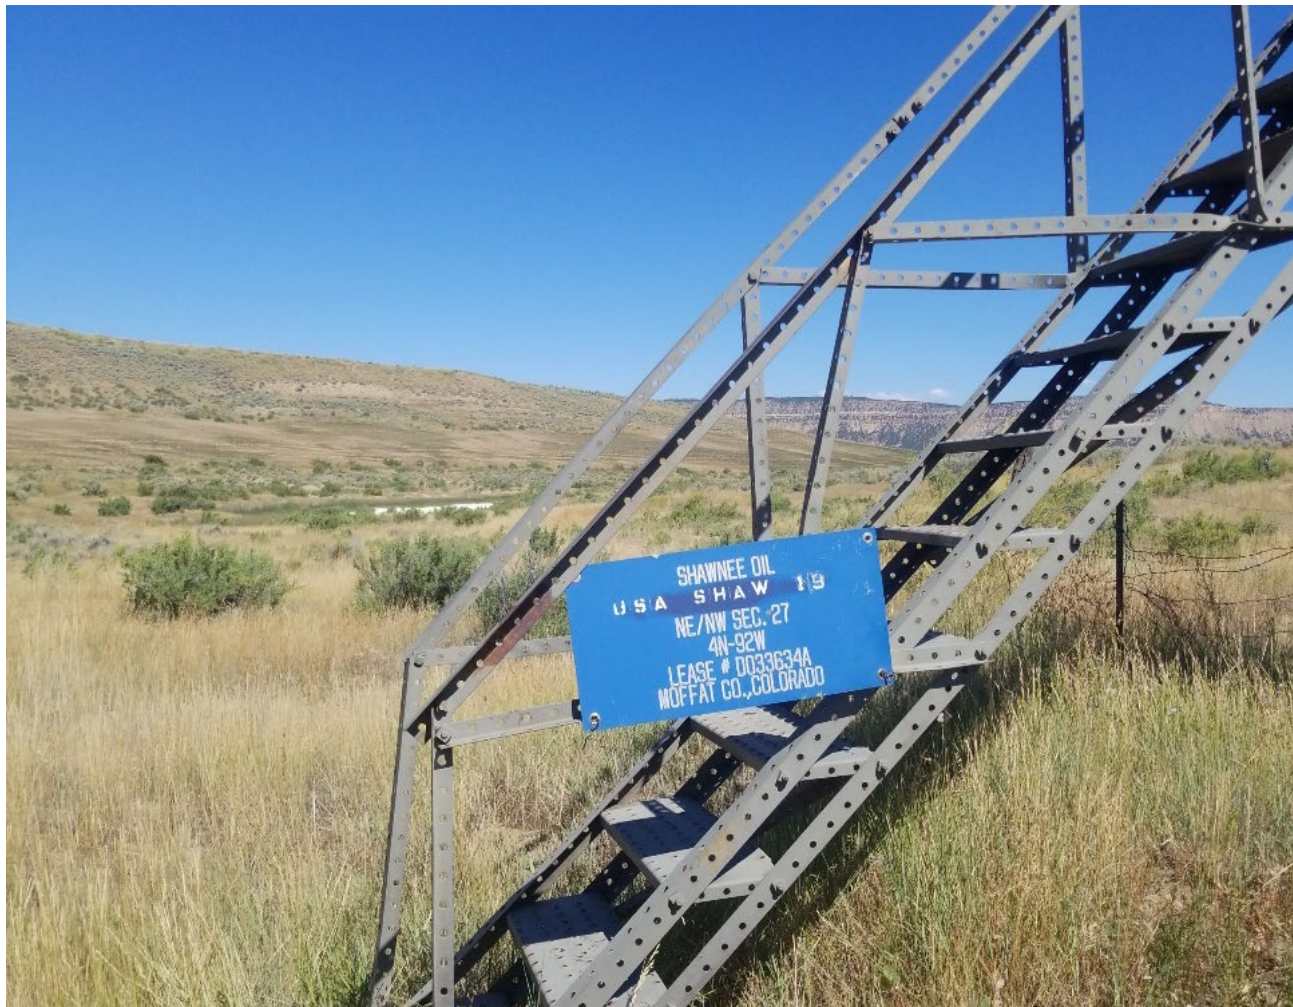
Photo #1 Sign at Single AGT.

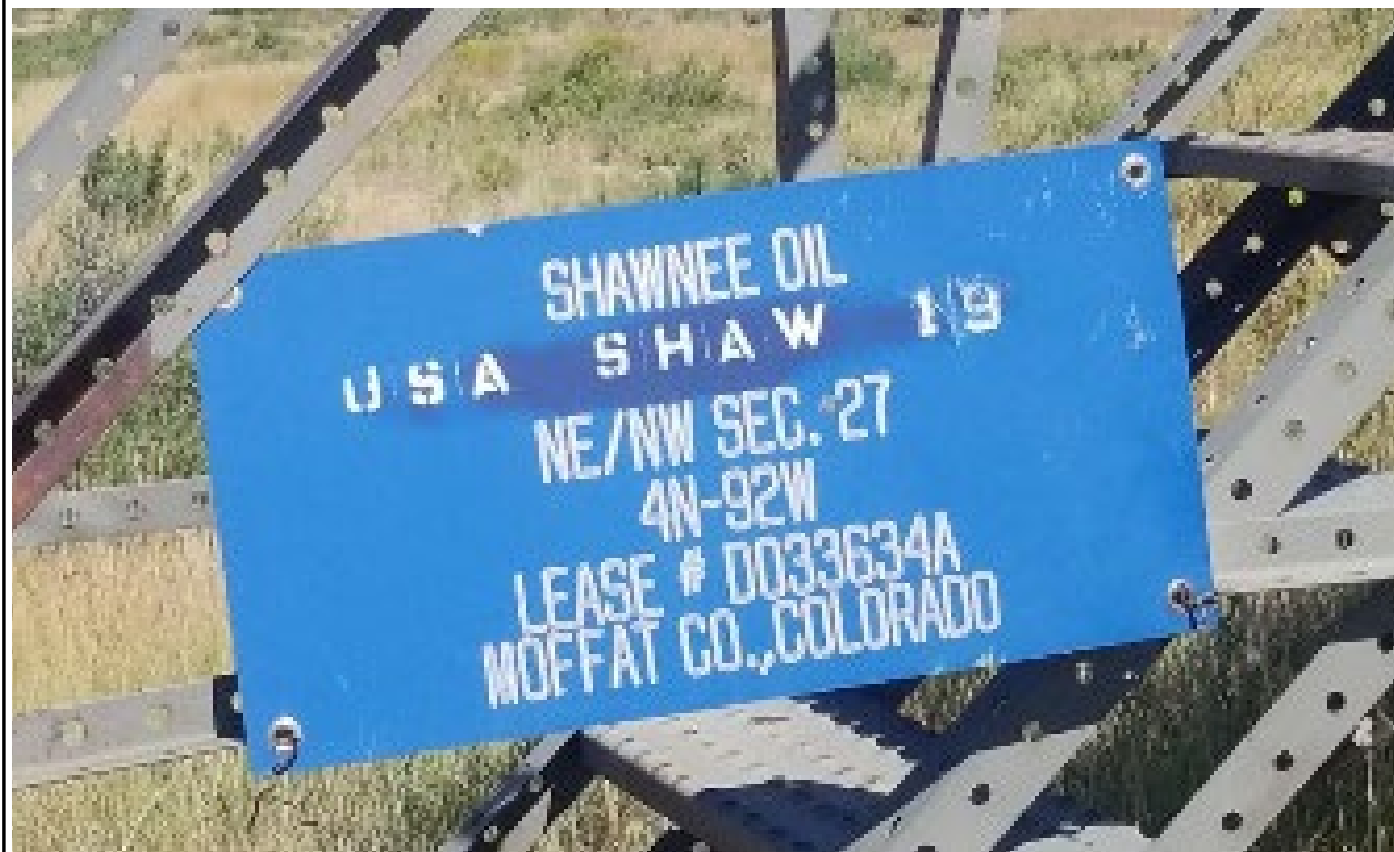
Photo #2 close up of Photo #1.

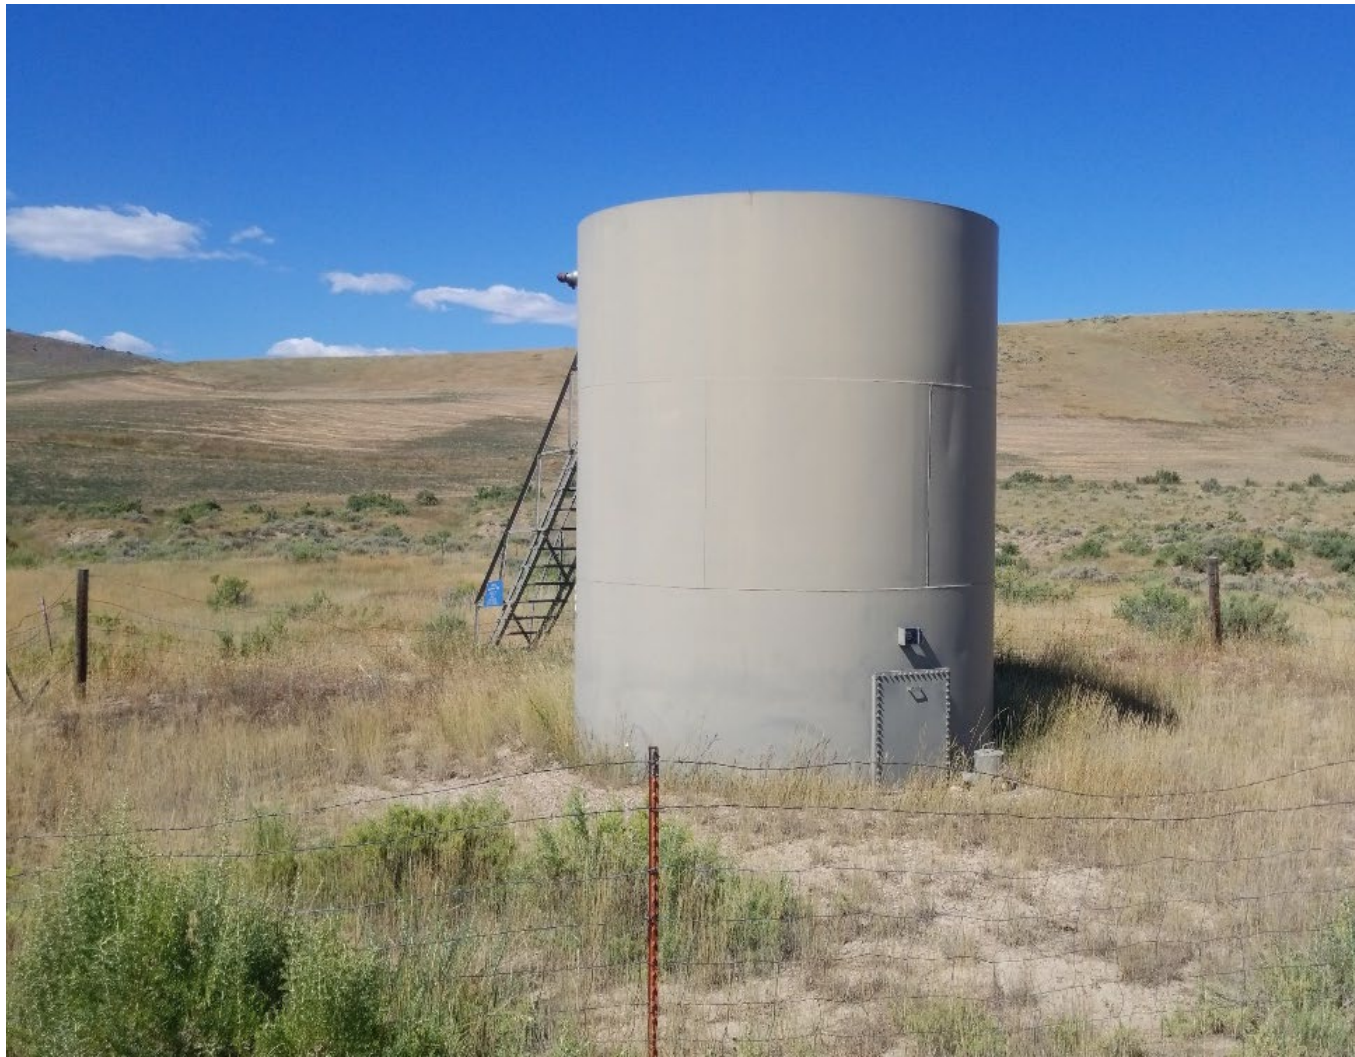
**Photo #3 Tank battery , looking west. Wellhead is out of photo to the cameras left.**

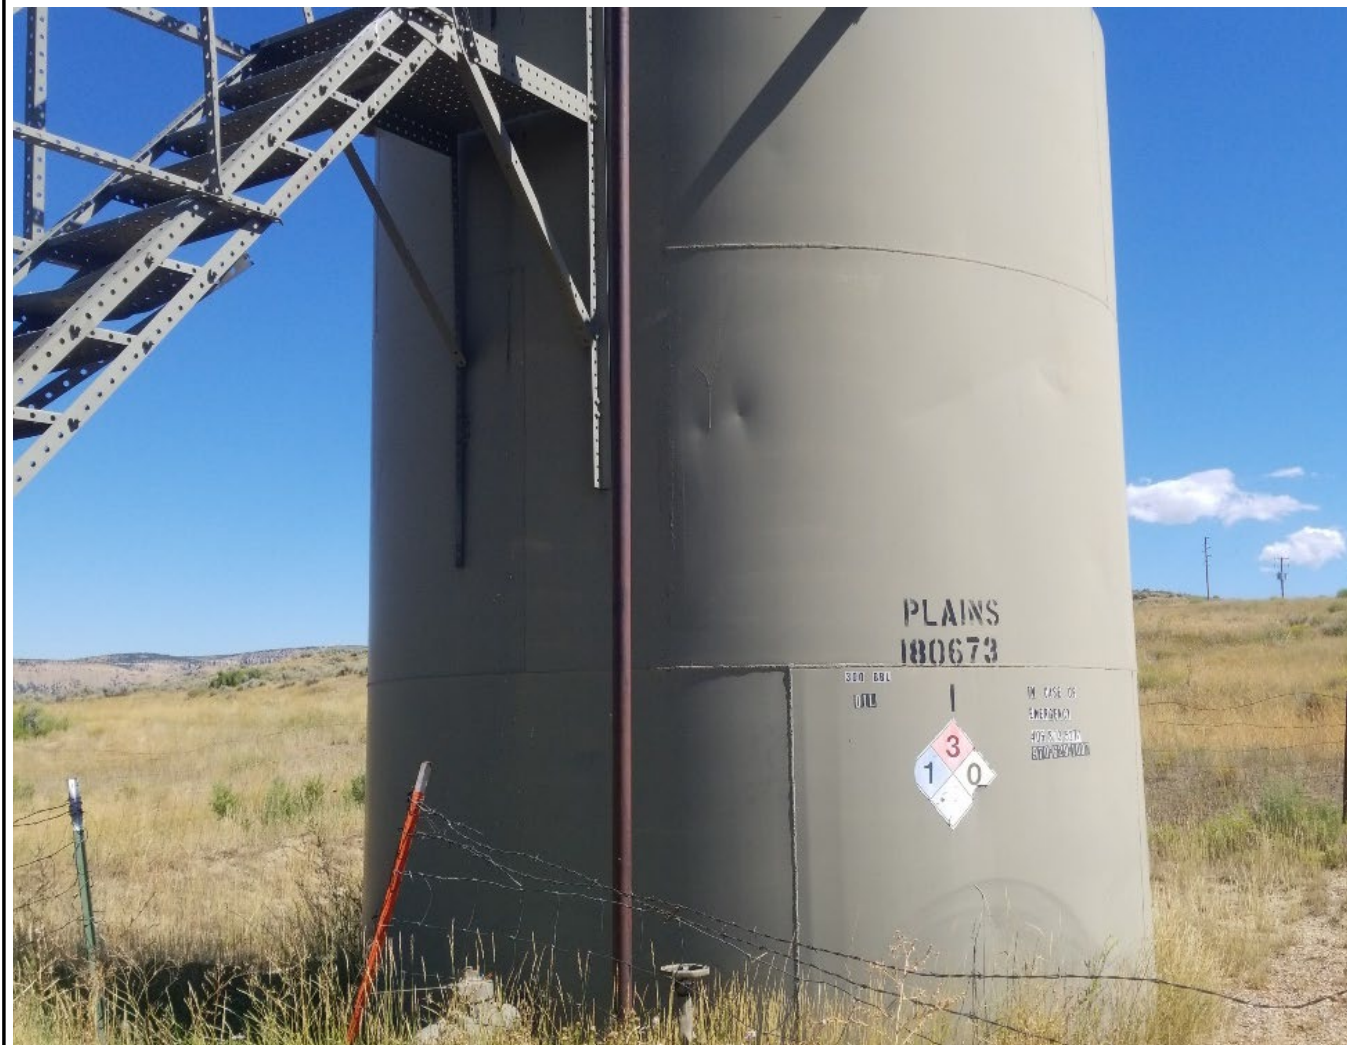
**Photo#4 pacquering on Tank.**

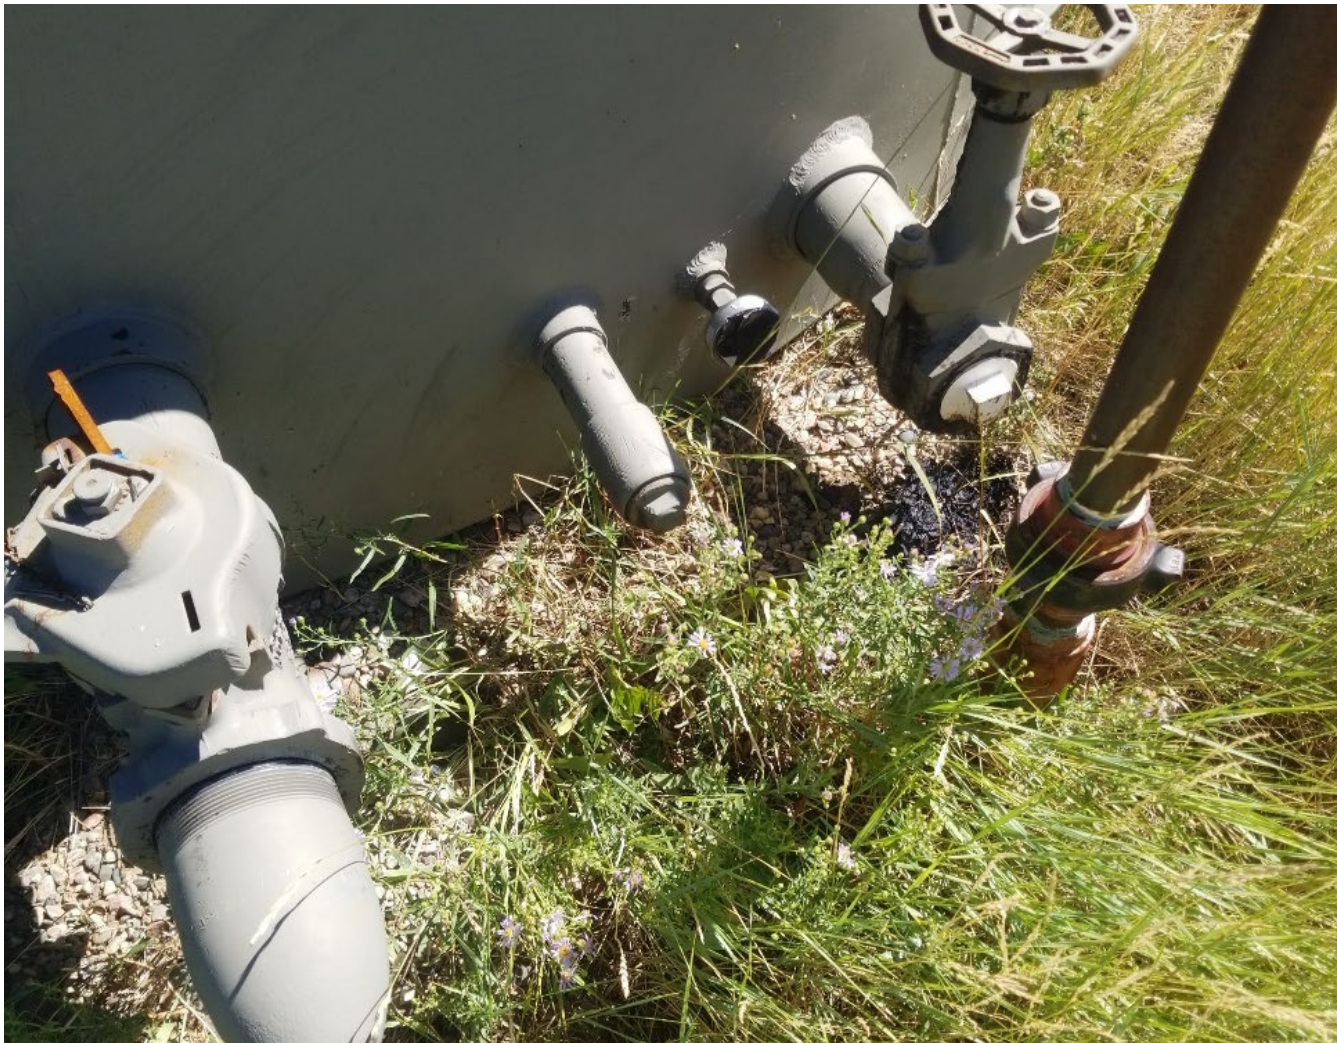
**Photo #5 Back of tank. It appears that the blind plug in tank is PVC and is leaking.**

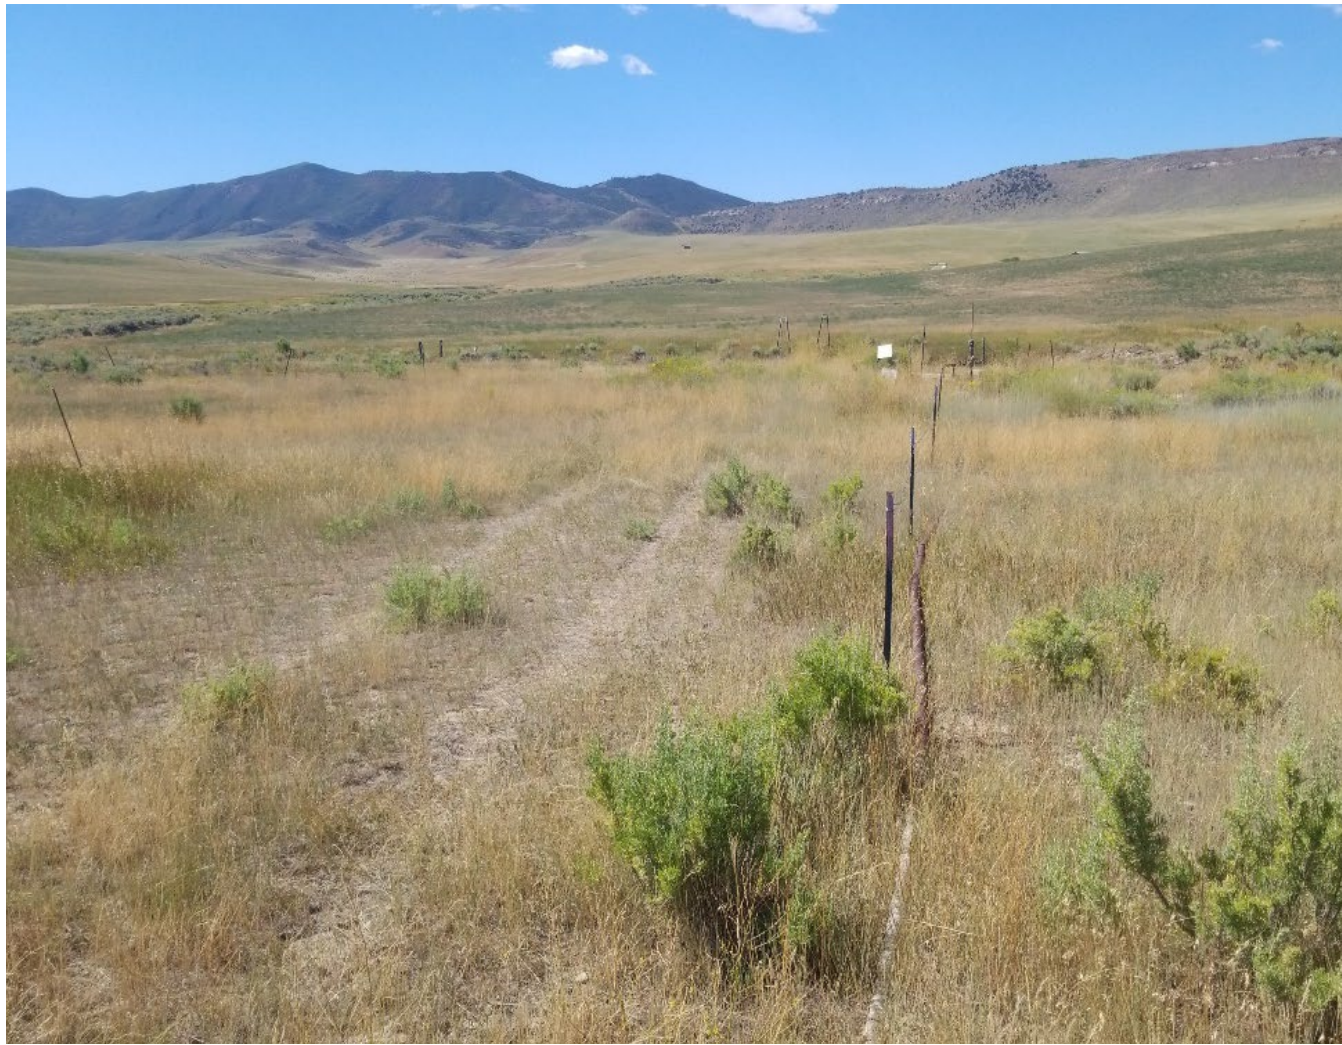
**Photo #6 From Tank to wellhead. Note 1 wire fence along the surface flowline.**

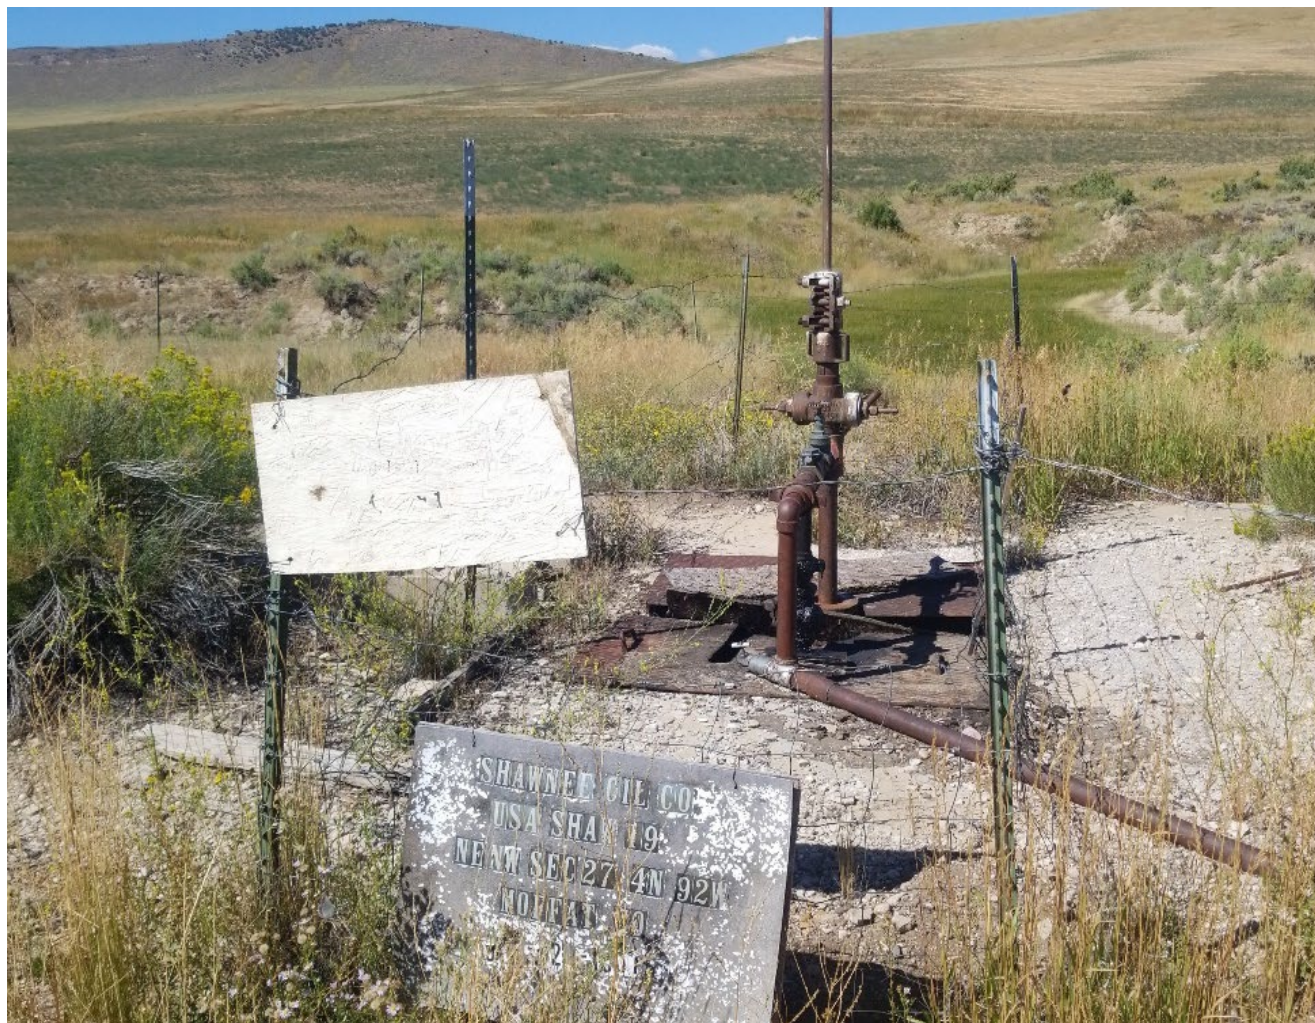
**Photo #7 Wellhead. The well was TA. Appeared that well has a pump string in the hole and no pumping unit. Steel plate over wellhead, cellar was filled with fluid, see later Photo for detail on cellar fluid.**

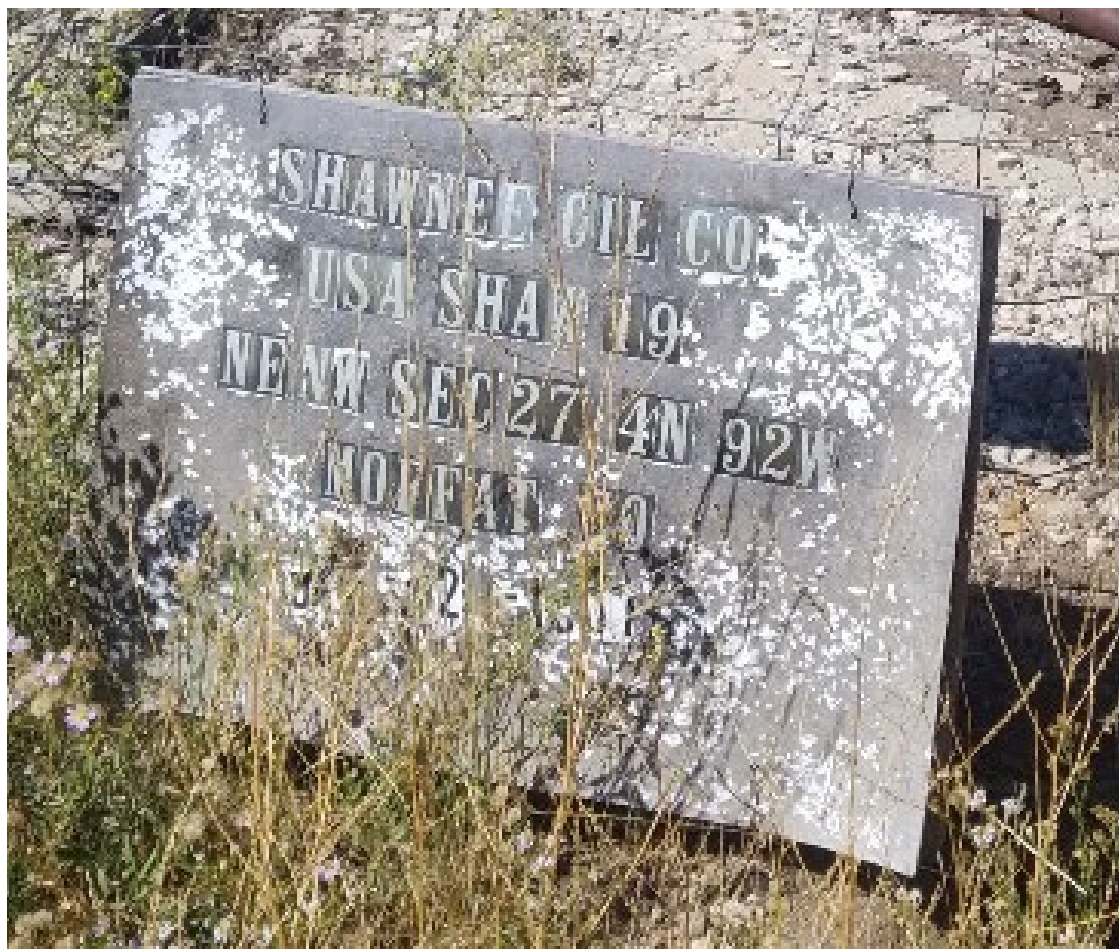
Photo #8 Sign at Wellhead.

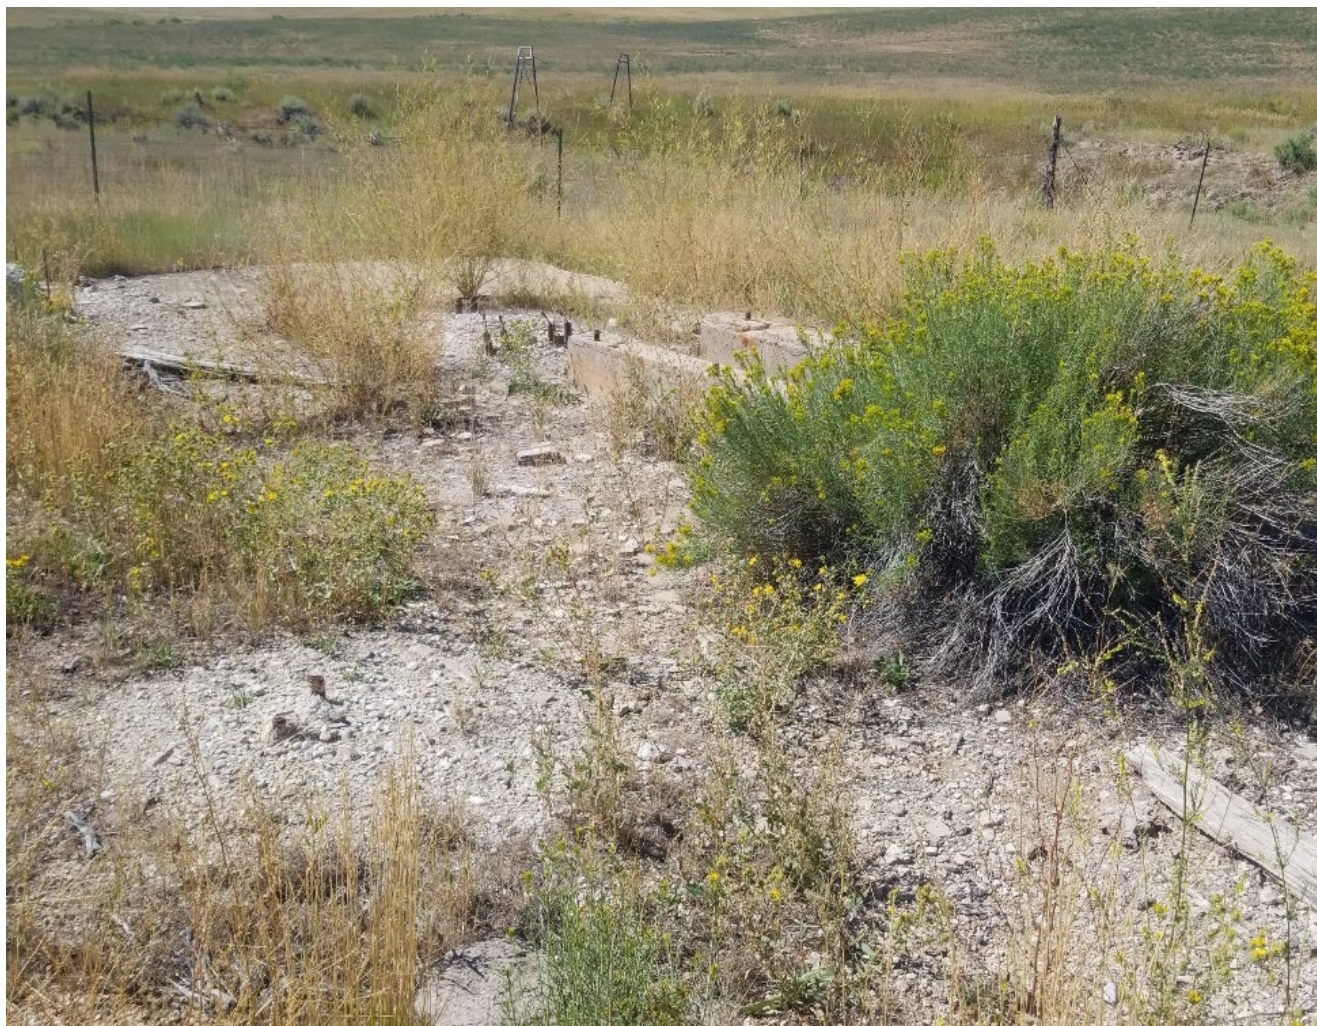
**Photo #9 Old cement pad for pumping unit, south of pad.**

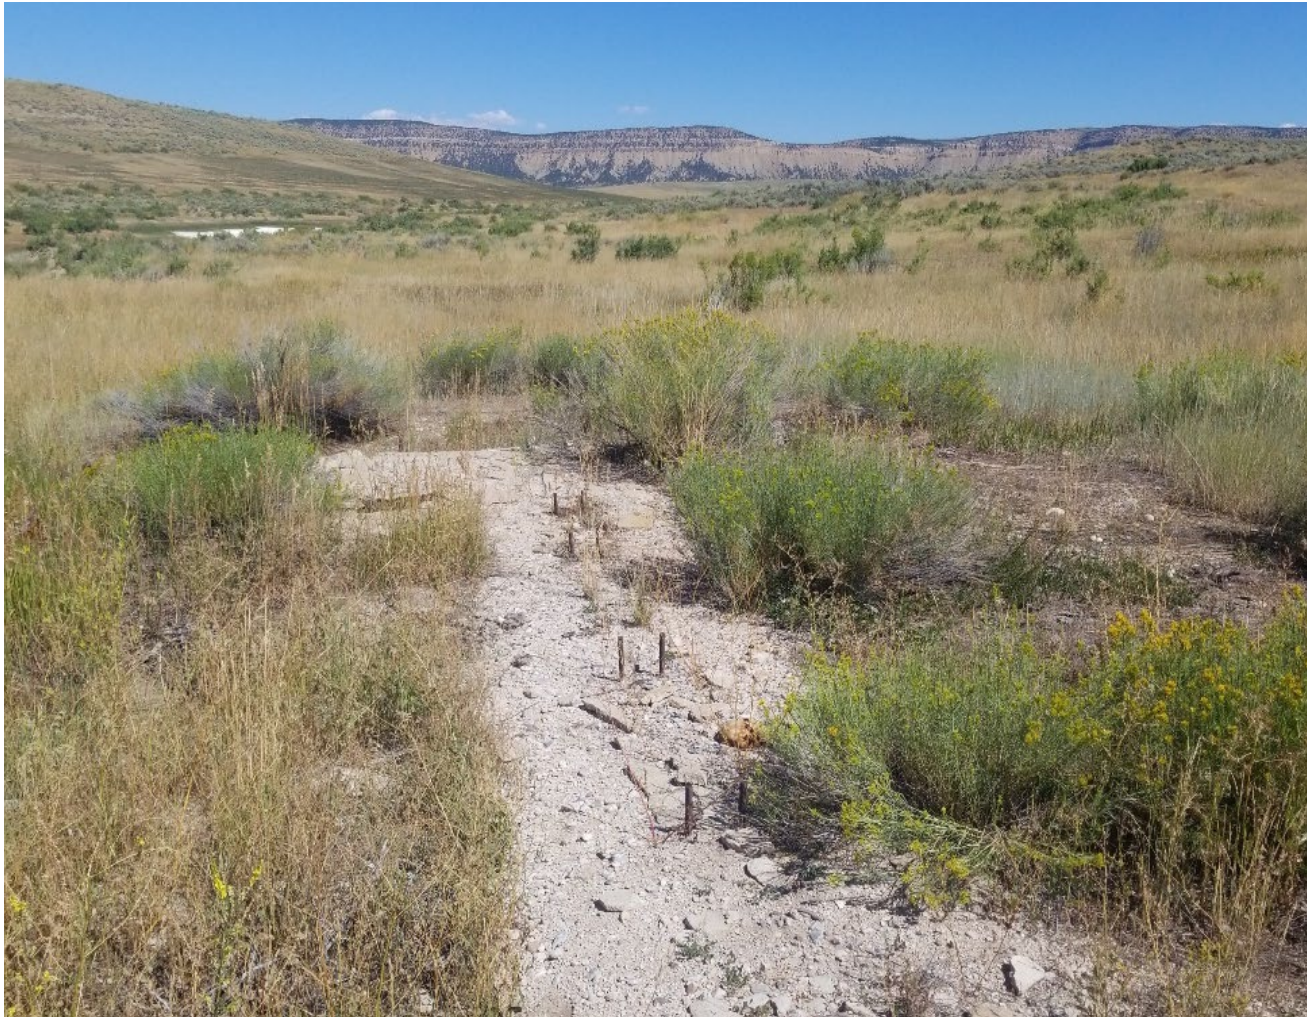
**Photo #11 old concrete pad to north of well**

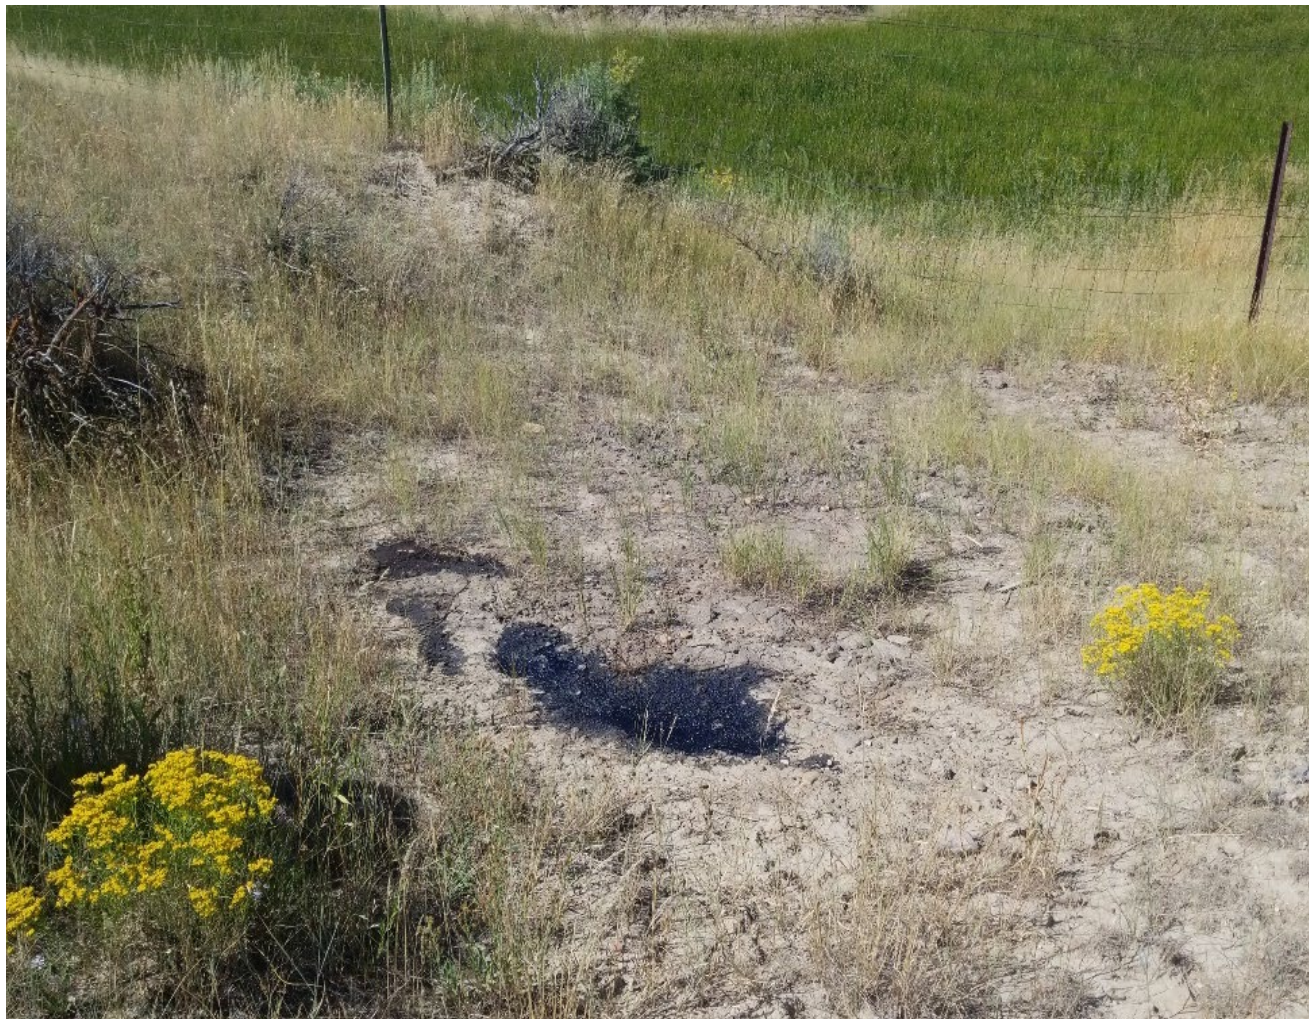
**Photo #12 Oil that was daylighting out of ground below grade of cellar. The source of this oil is unknown, it appears to be seeping out of the ground.**

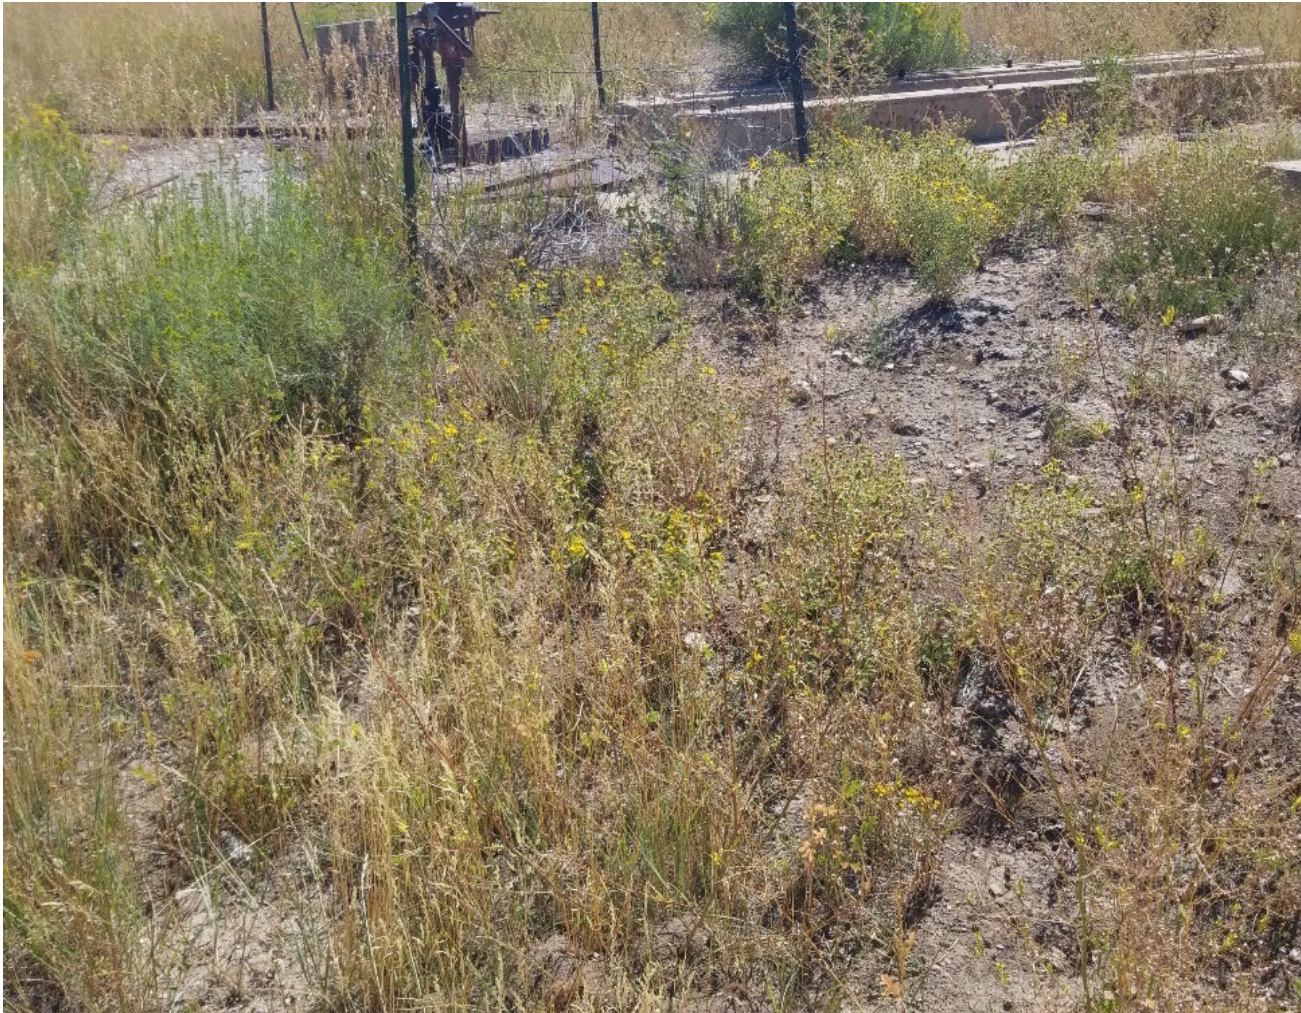
**Photo #13 Camera is standing over the oil seep looking at wellhead.**

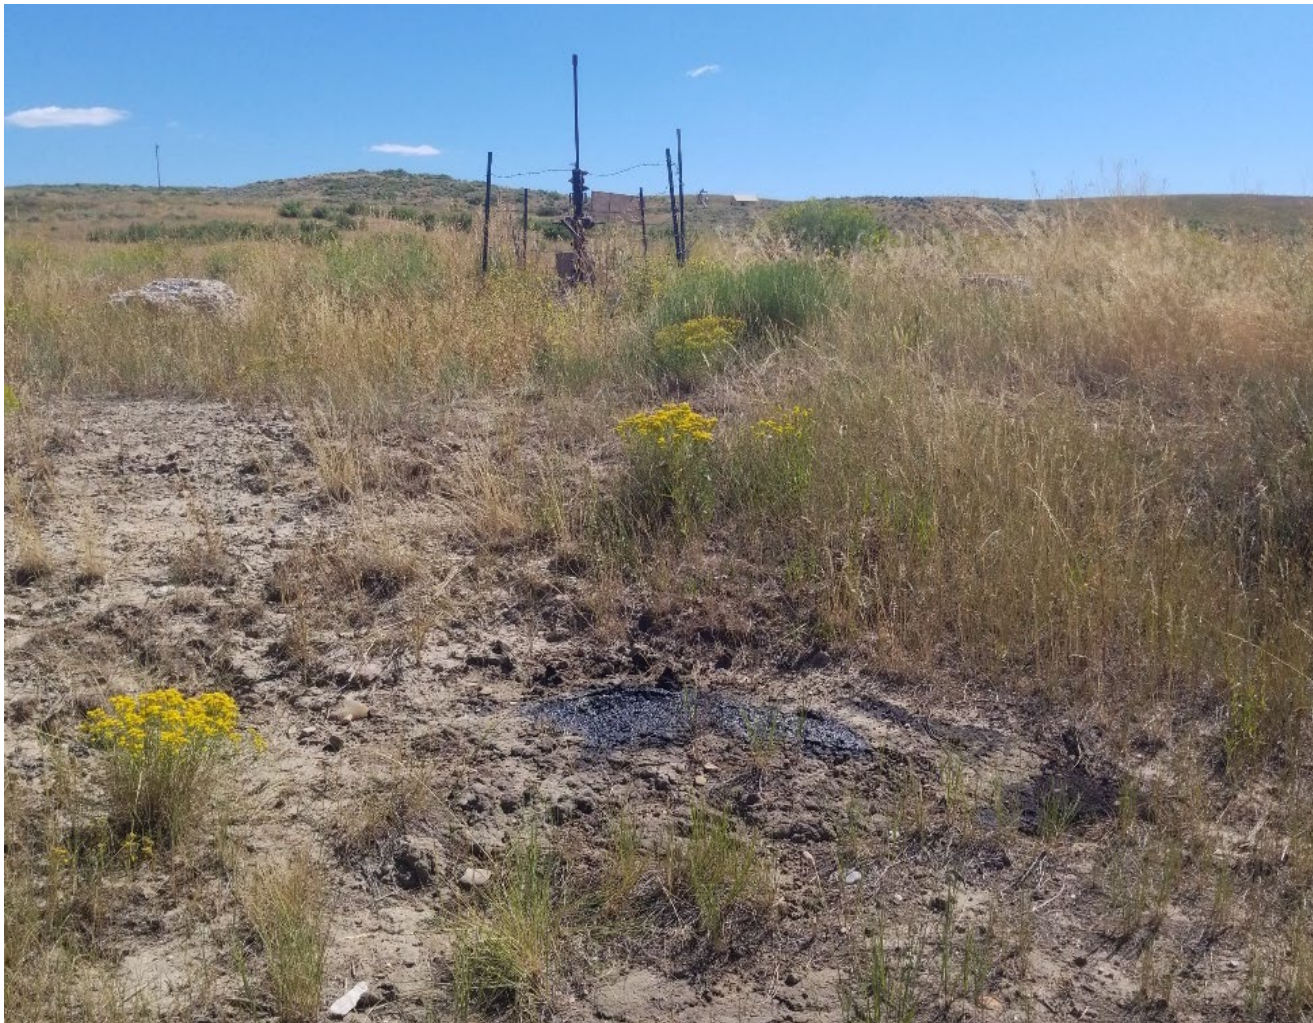
**Photo #14 showing perspective of seep to wellhead. The seep is downgrade to the west. Source of the seep should be investigated and documented on a Form 27 Remediation workplan.**

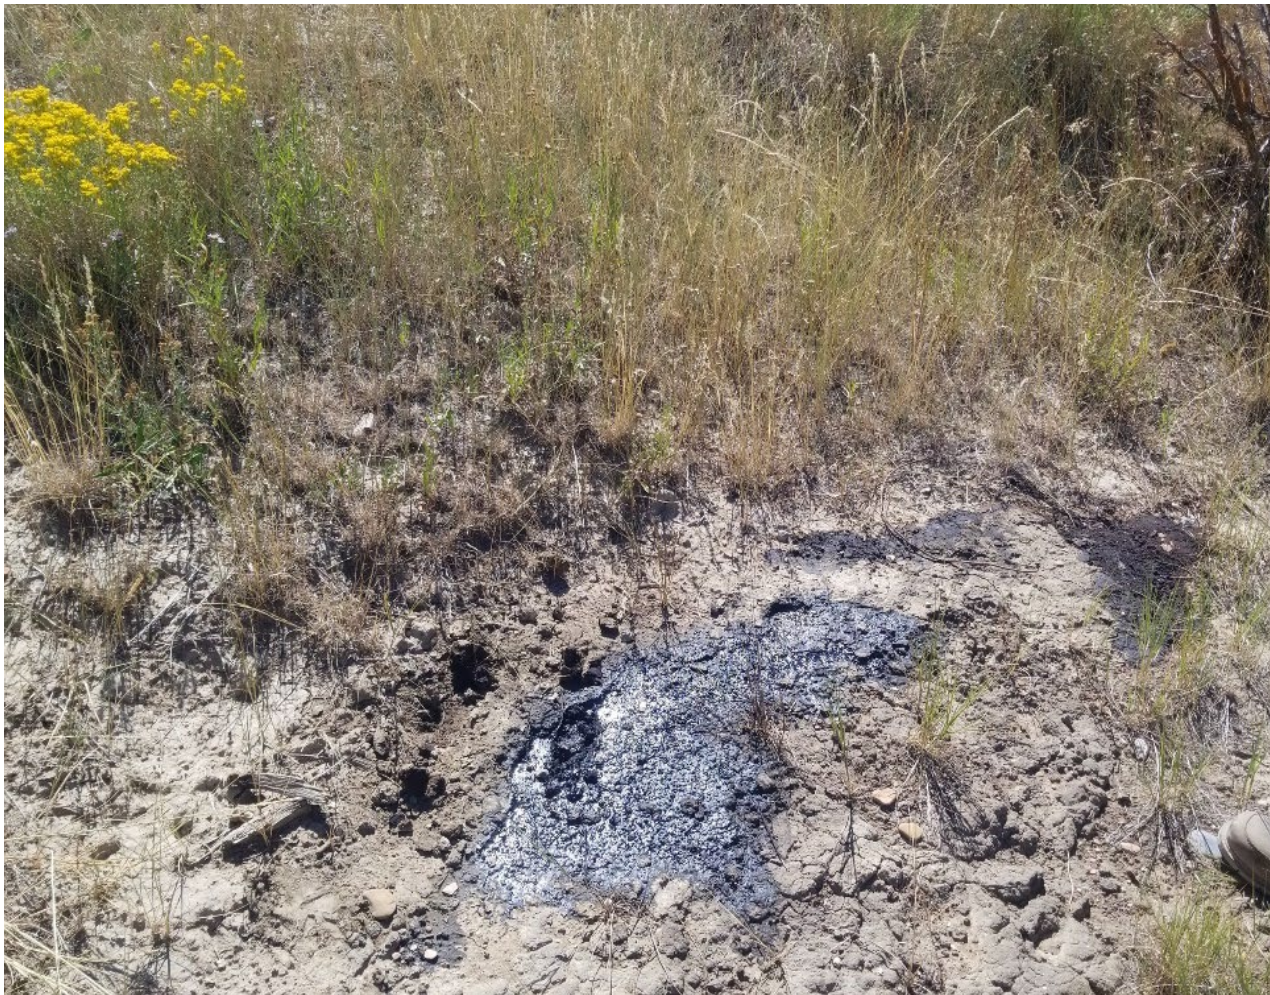
**Photo#15 close up of the seep**

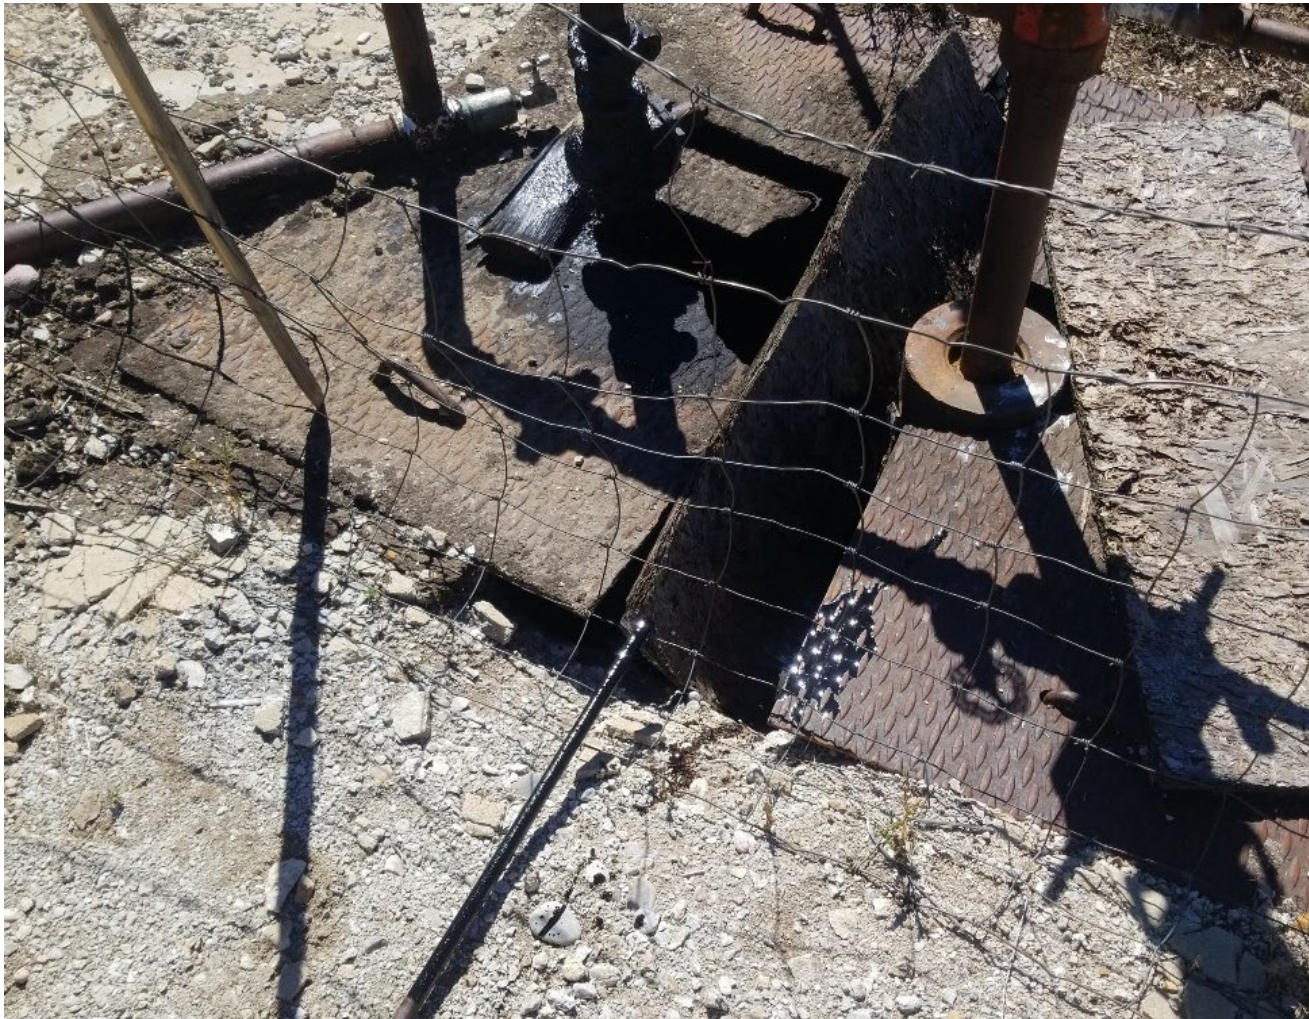
**Photo #16 The seal rod at bottom of photo was dipped into the cellar to gauge the fluid and surface of the bottom of the cellar. The bottom of the cellar felt like gravel and cobbles. The Fluid depth appeared to be ~18". The fluid shall be removed. This cellar has been observed to be full of fluid in previous inspection. The source of the leak that is charging this cellar should be investigated and stopped.**
