Inspection Photos

Location Name: TEP ROCKY MOUNTAIN LLC, UNOCAL-67S96W/1NWSE

Location ID: 324063

Date: 8/22/2023

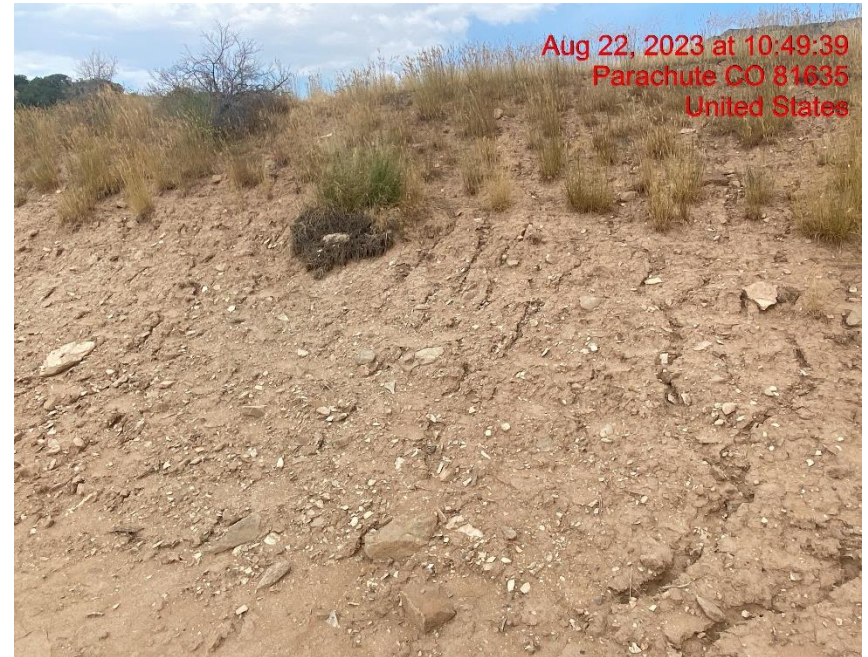
**Insufficient Erosion Control/Rill Erosion Running Onto
Location – Photo #06022**

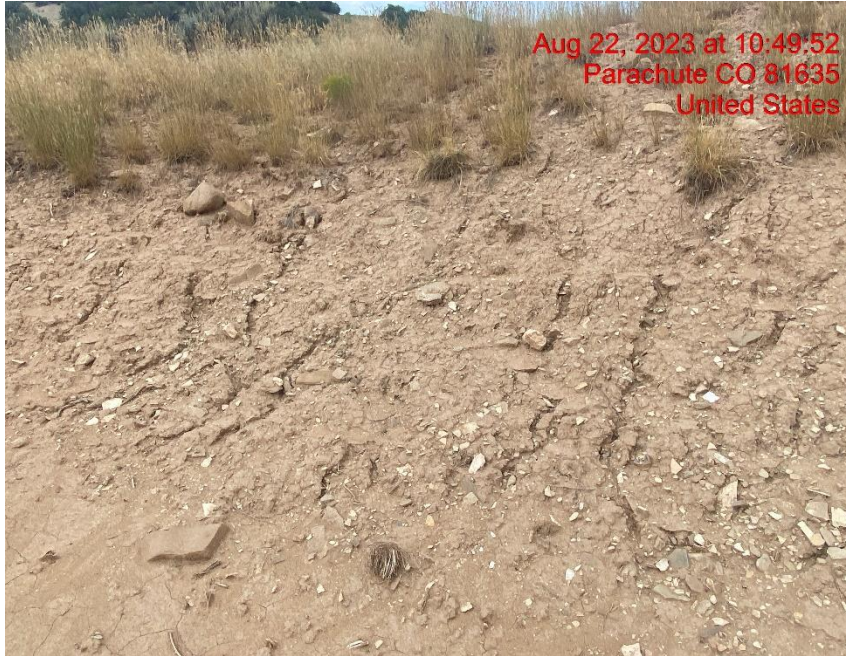
**Insufficient Erosion Control/Rill Erosion Running Onto
Location – Photo #06023**

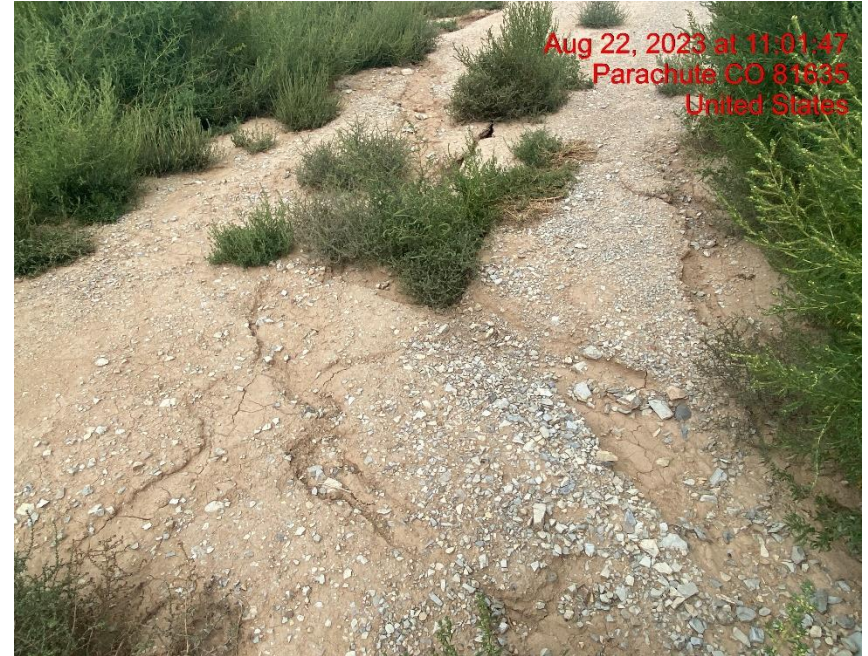
Rill Erosion Cutting Through Access Road – Photo #06025

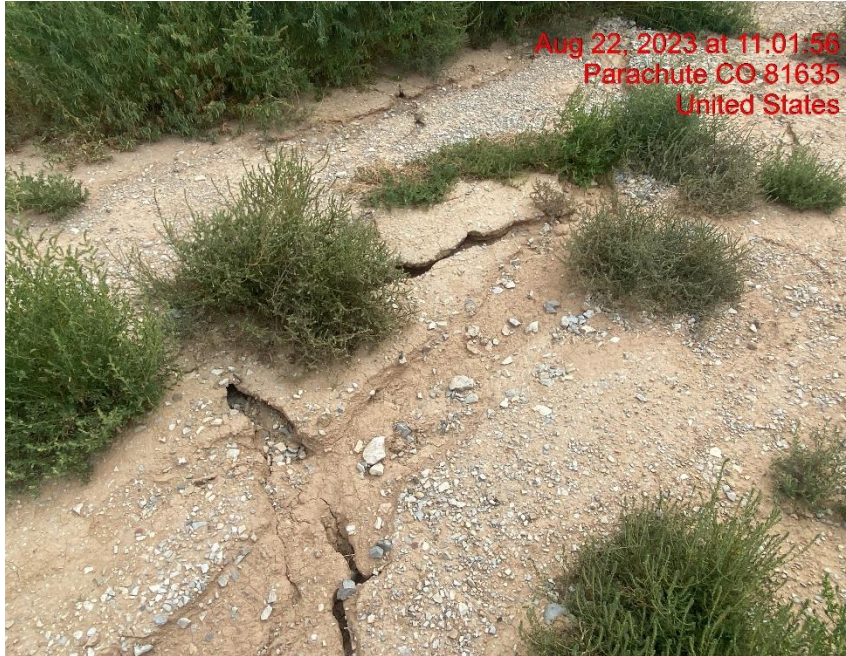
Rill Erosion Cutting Through Access Road – Photo #06026

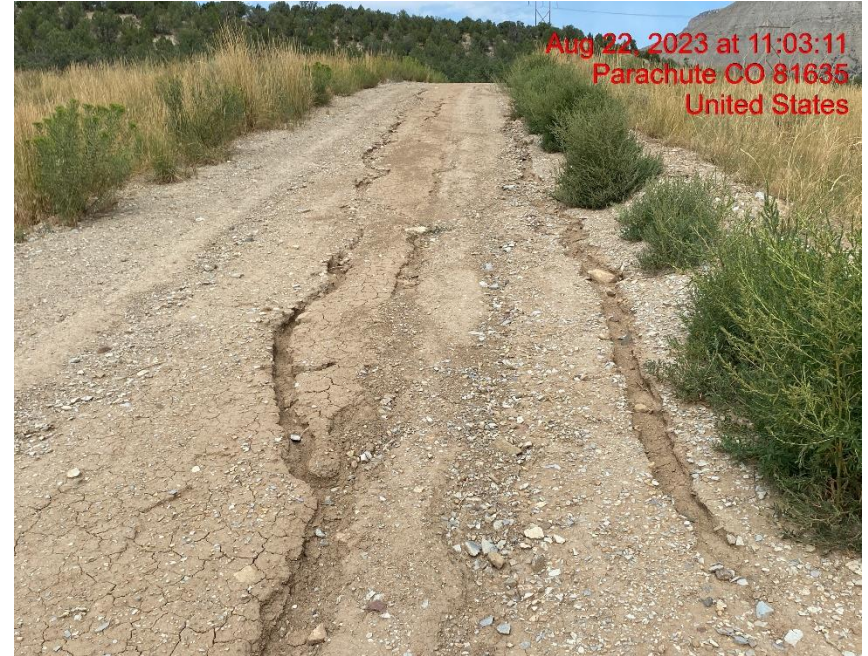
Rill Erosion Cutting Through Access Road – Photo #06027
