Inspection Photos
Location Name: CAERUS PICEANCE LLC D32NEB Pad
Location #: 335301

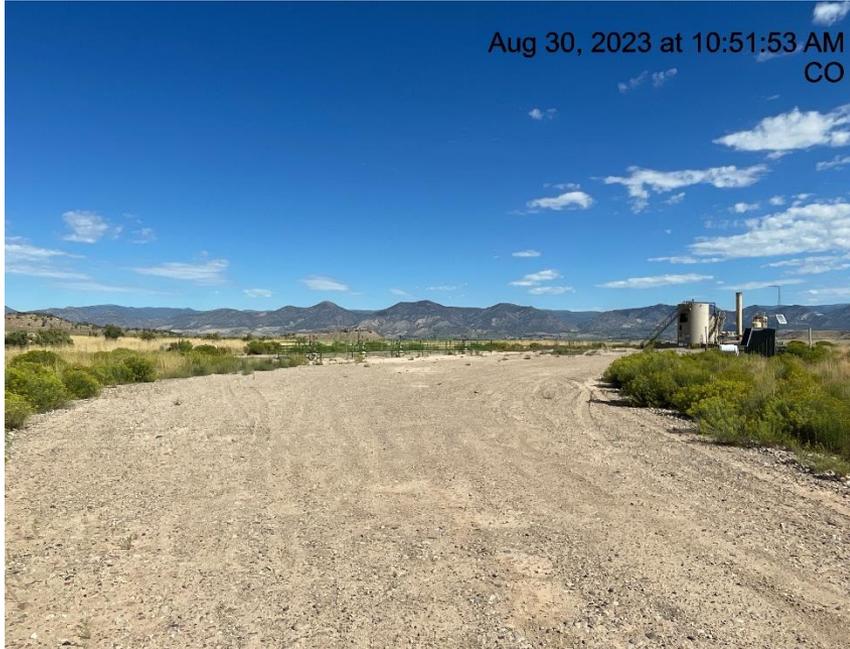
Photo # 7662 From entrance to location

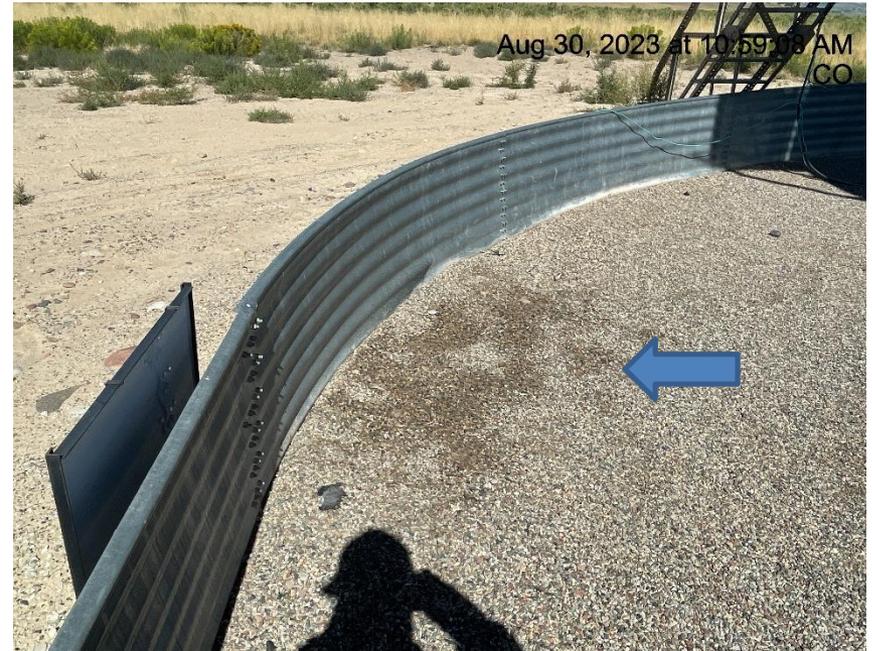
Photo # 7673 Stained gravel in secondary containment

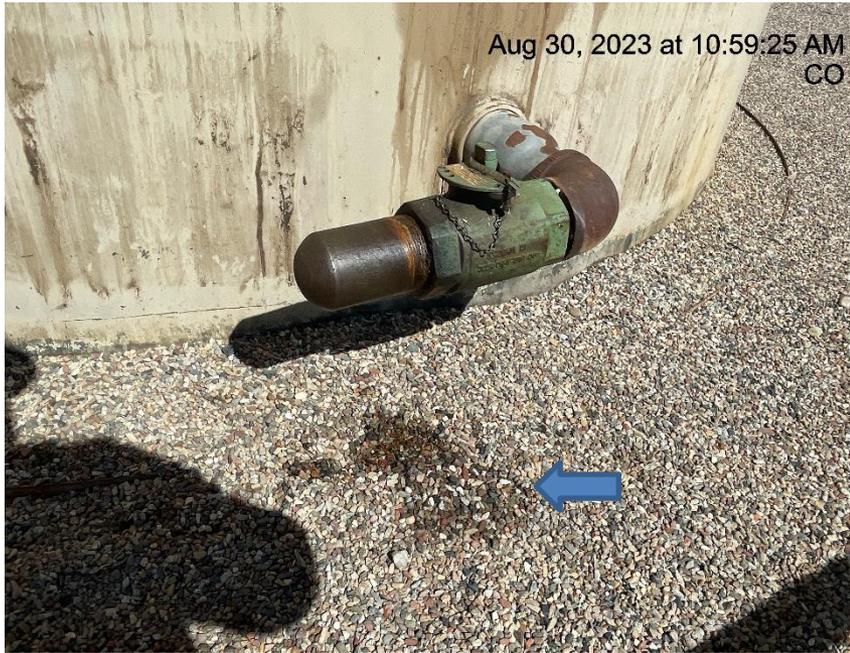
Photo # 7674 Stained gravel in secondary containment

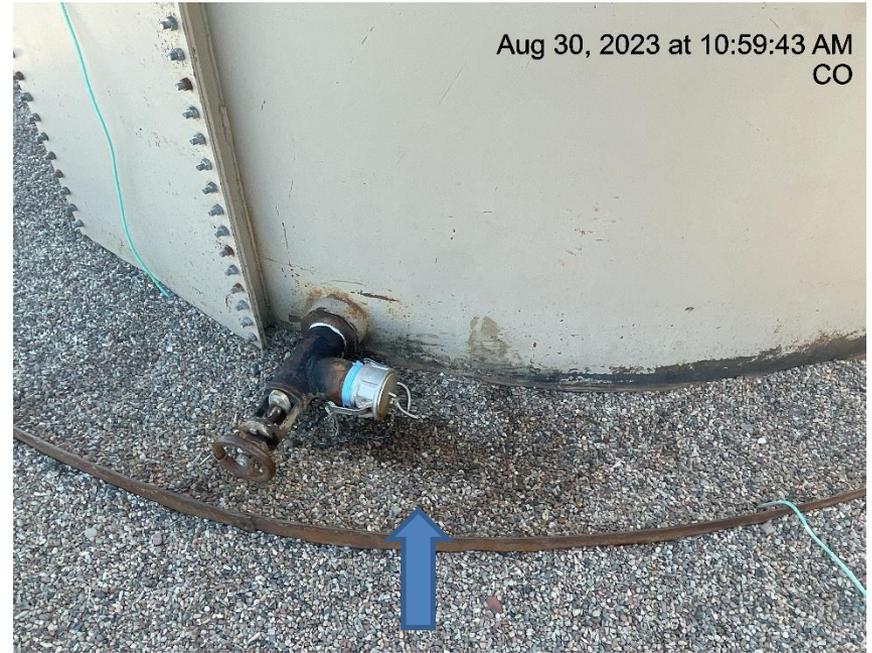
Photo # 7675 Stained gravel in secondary containment

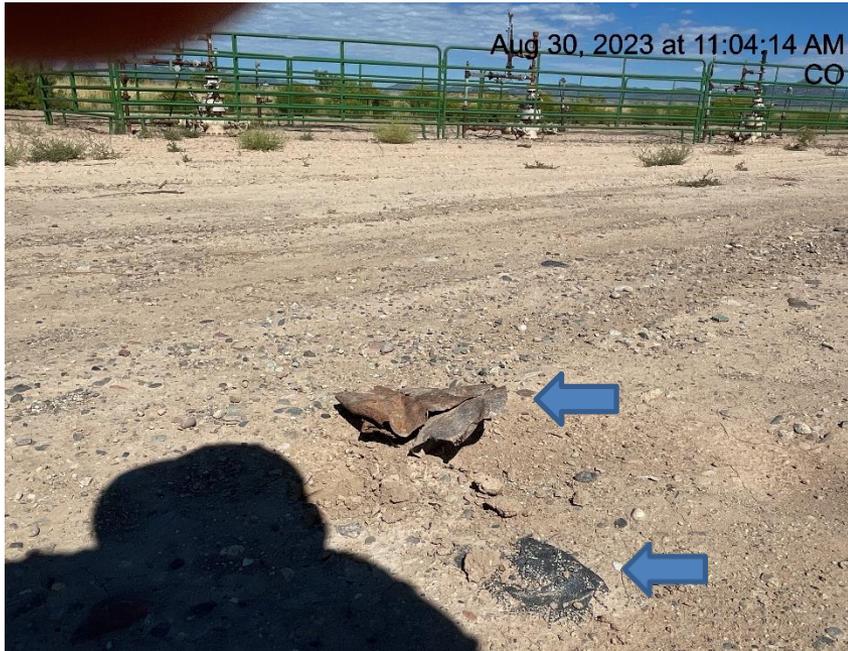
Photo # 7680 Debris
