Inspection Photos

Location Name: CAERUS PICEANCE LLC I27W Pad

Location # 324383

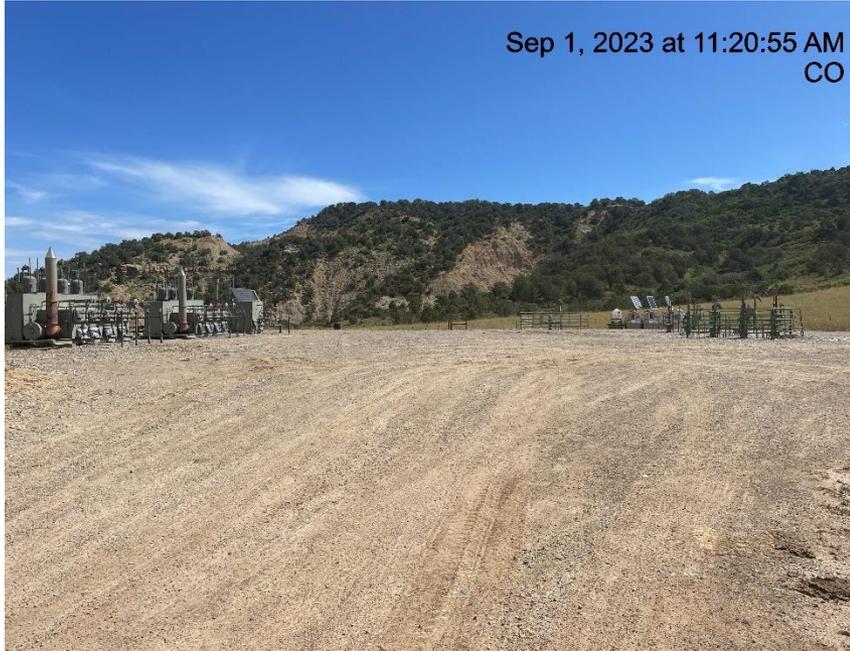
Photo # 8043 From entrance to location

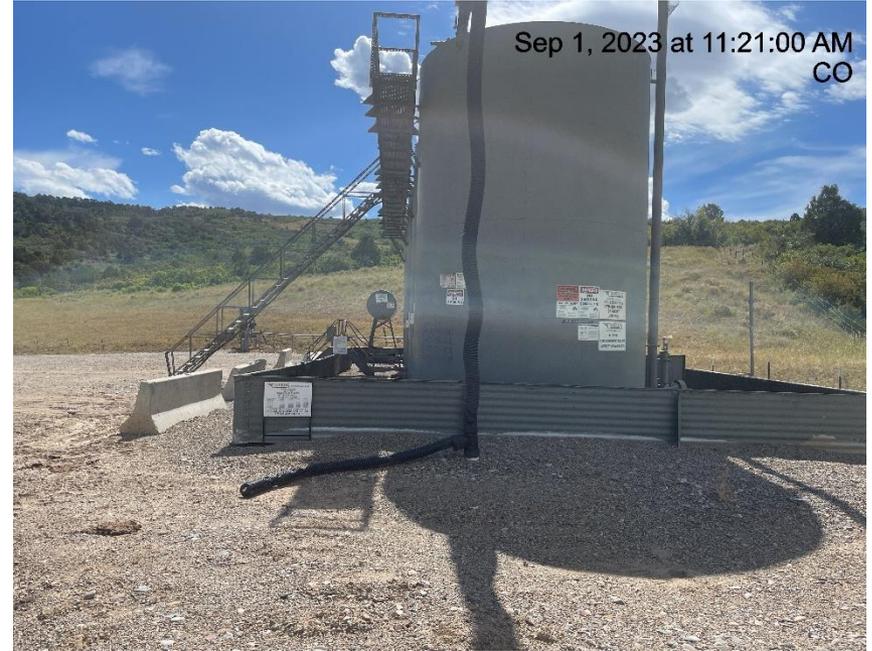
Photo # 8044 From entrance to location

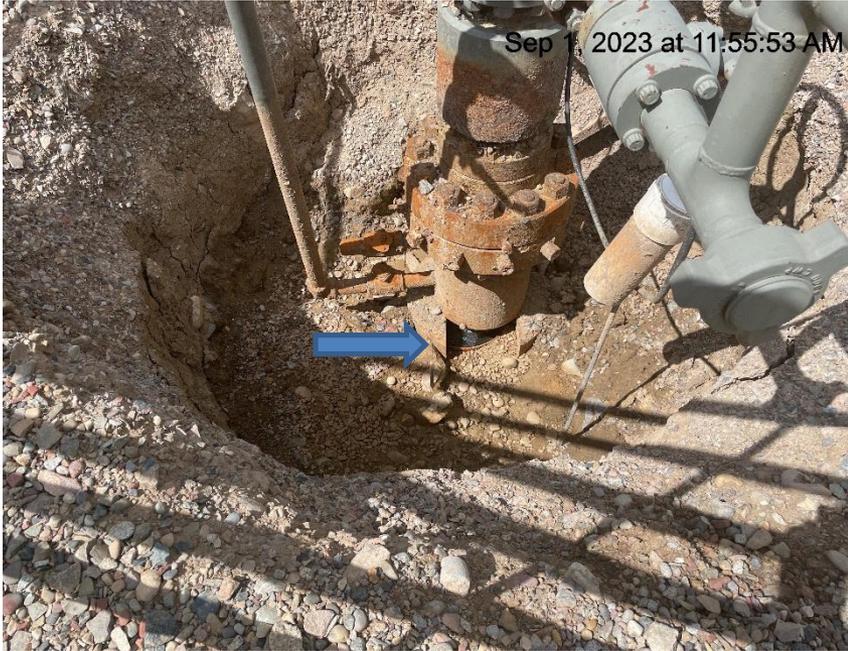
Photo # 8069 MCU 26-4A well, gas is bubbling up from conductor

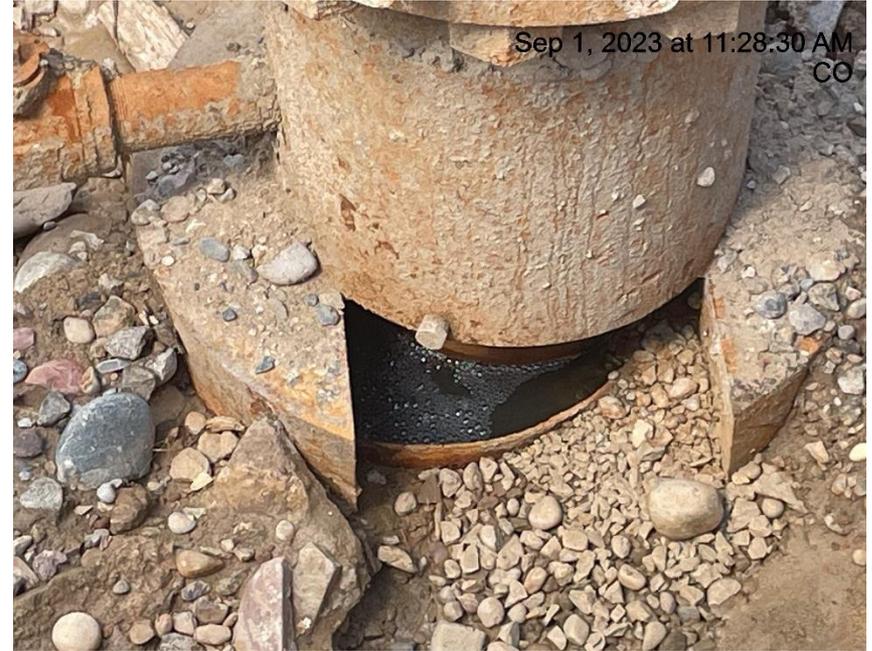
Photo # 8050 MCU 26-4A well, gas is bubbling up from conductor

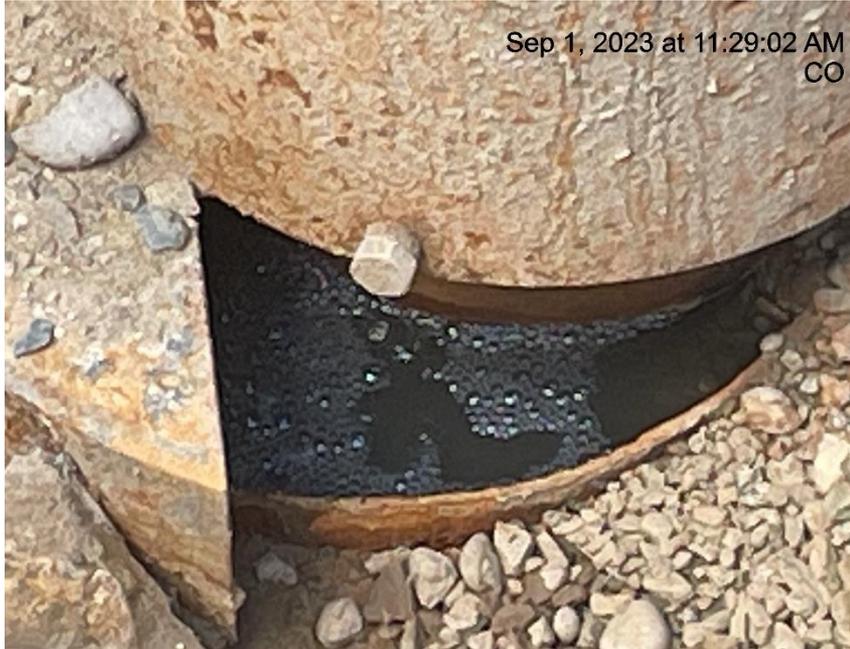
Photo # 8055 MCU 26-4A well, gas is bubbling up from conductor

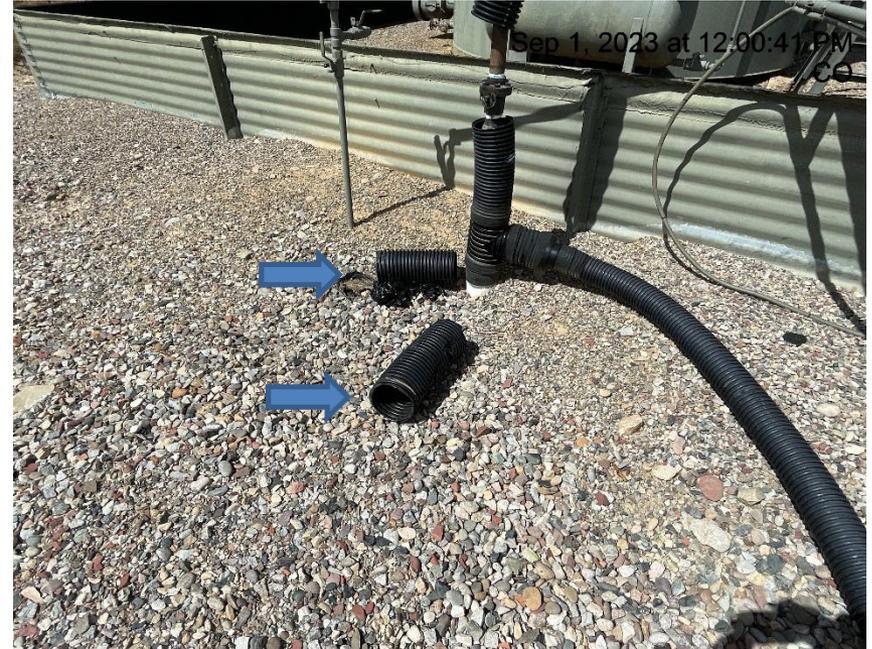
Photo # 8078 Debris

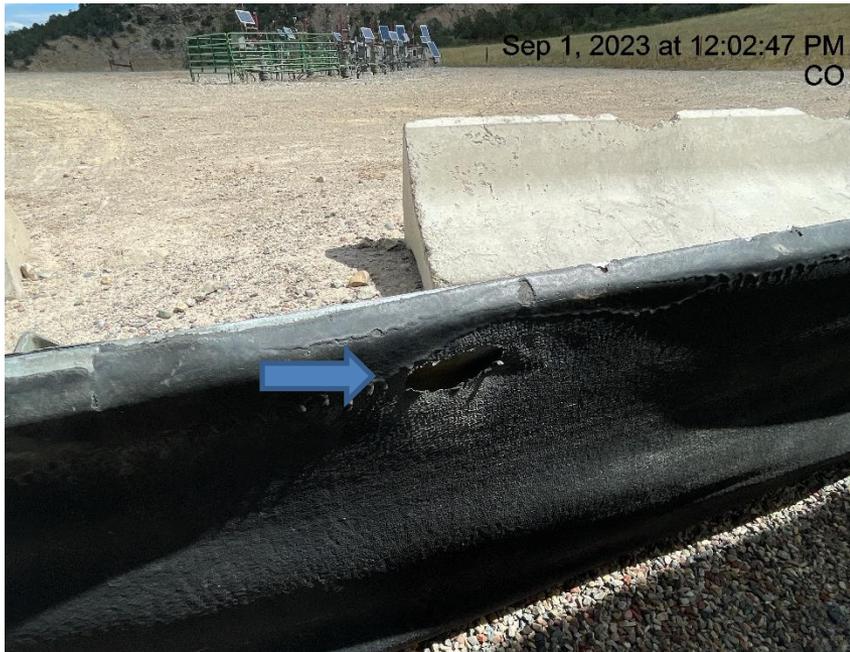
Photo # 8087 Hole in secondary containment liner/liner needs maintenance

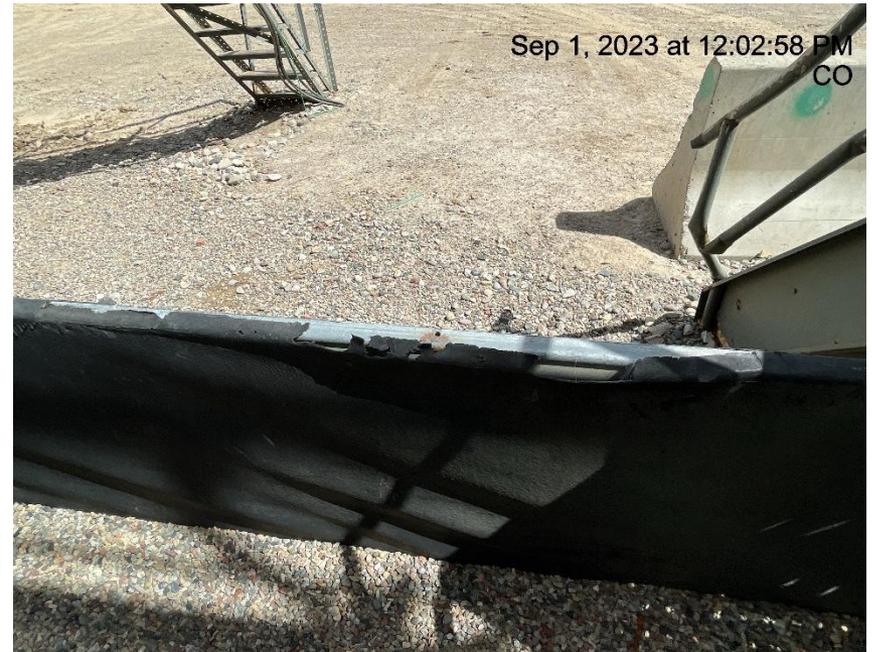
Photo # 8088 Liner needs maintenance

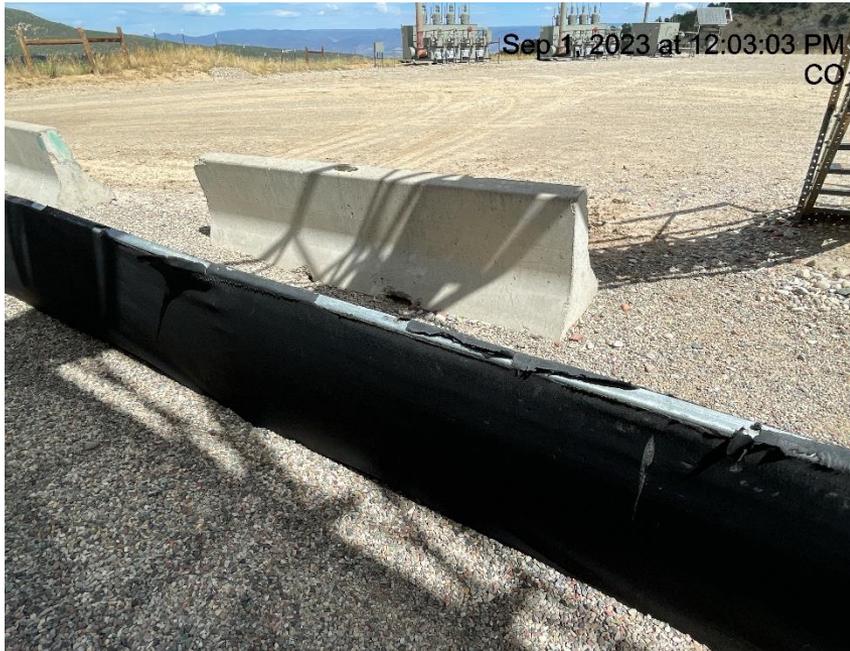
Photo # 8089 Liner needs maintenance

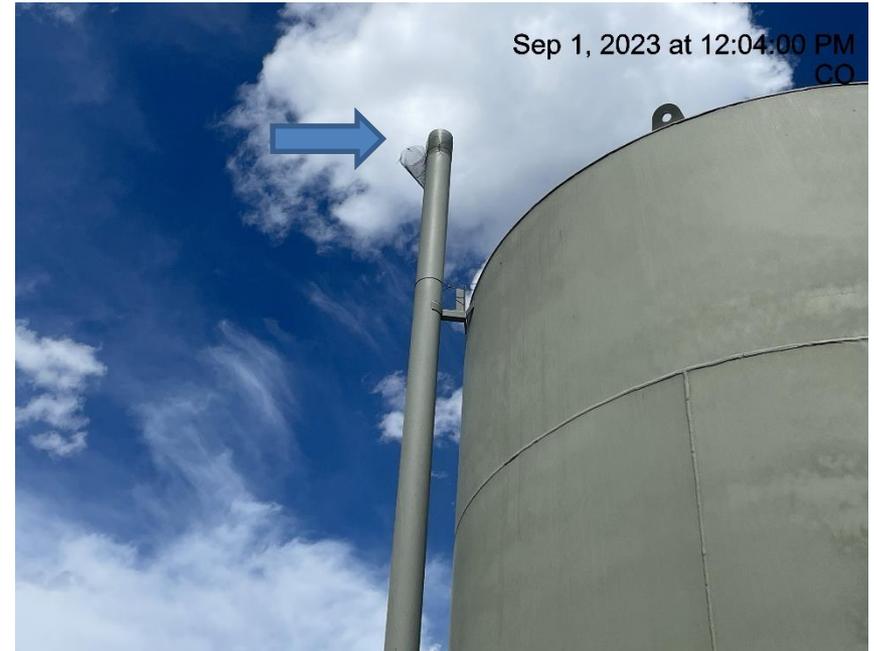
Photo # 8097 Bird protection on 500 bbl heated condensate tank needs maintenance

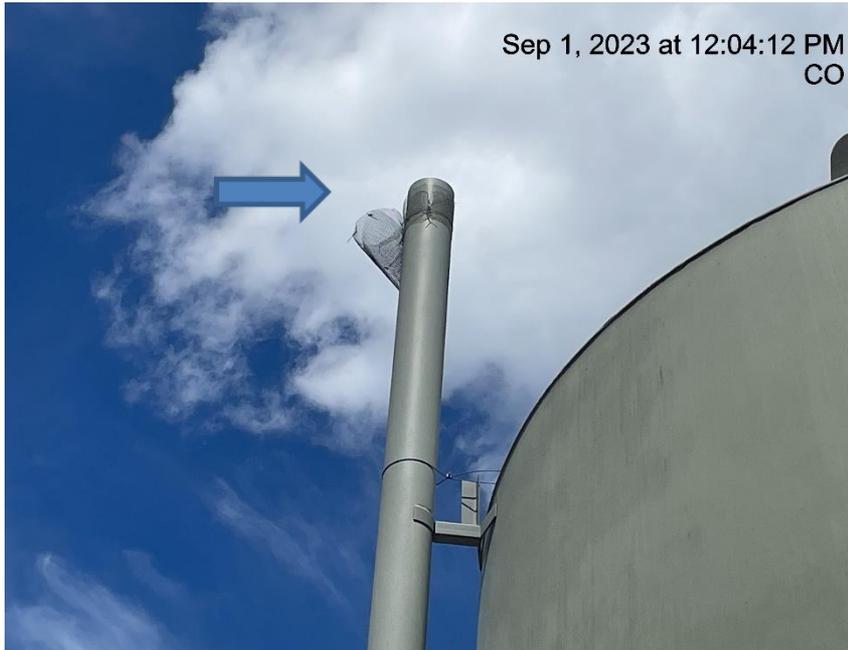
Photo # 8100 Bird protection on 500 bbl heated condensate tank needs maintenance

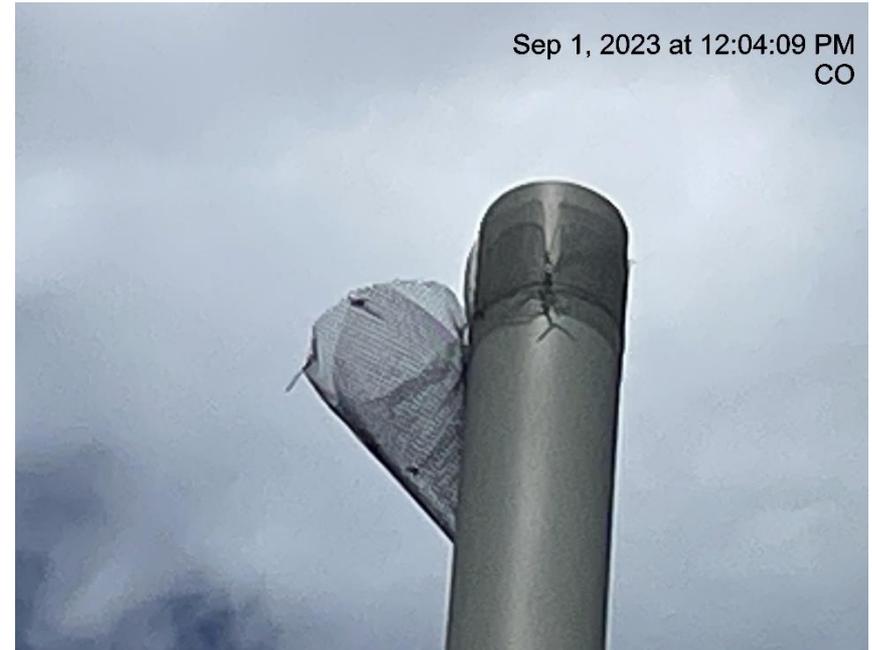
Photo # 8101 Bird protection on 500 bbl heated condensate tank needs maintenance
