**Inspection Photos**  
**Location Name: CAERUS PICEANCE LLC N22W Pad**  
**Location # 324286**

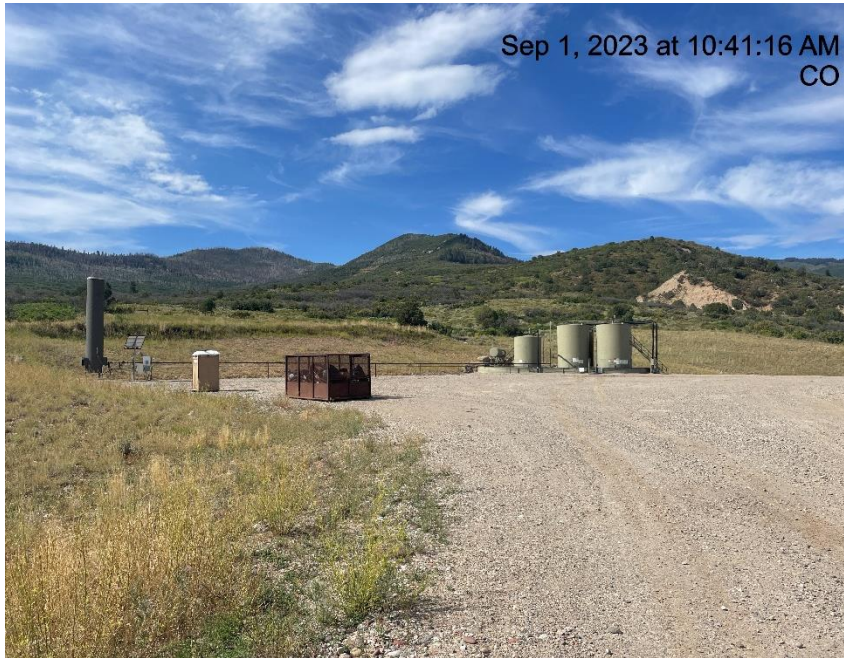
**Photo # 7976 From entrance to location**

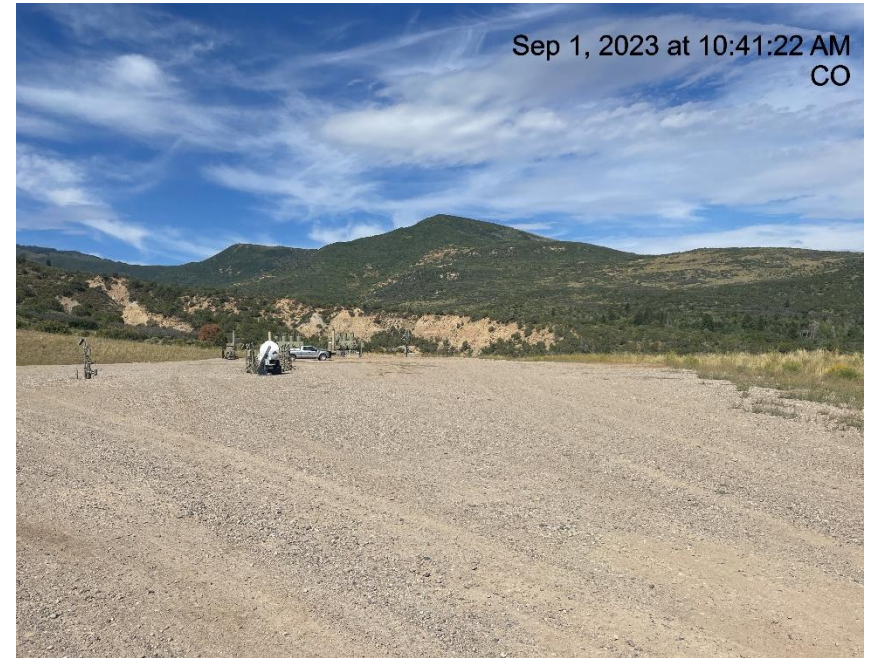
**Photo # 7977 From entrance to location**

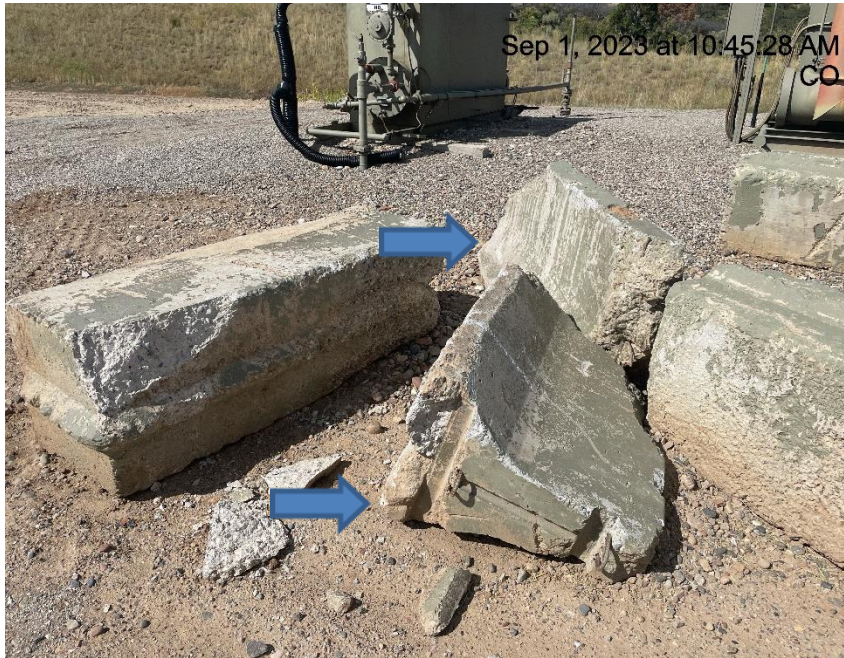
**Photo # 7982 Debris**

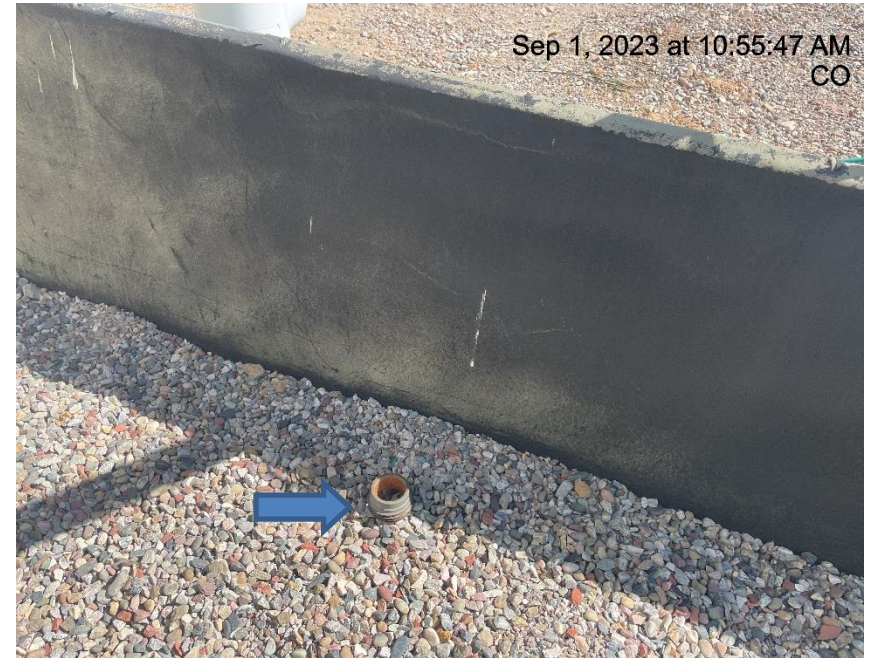
**Photo # 8004 Debris**

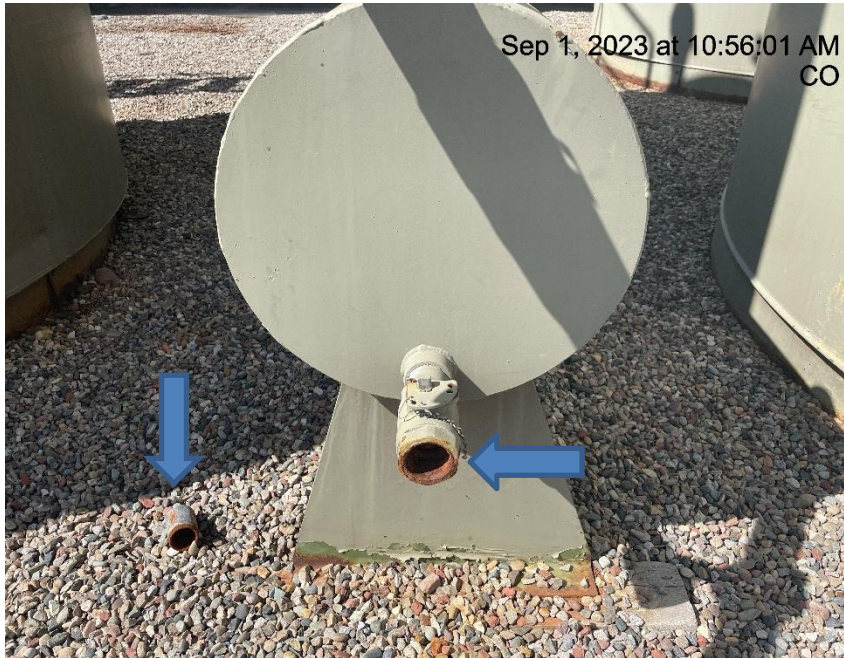
Photo # 8005 Debris & open ended load line

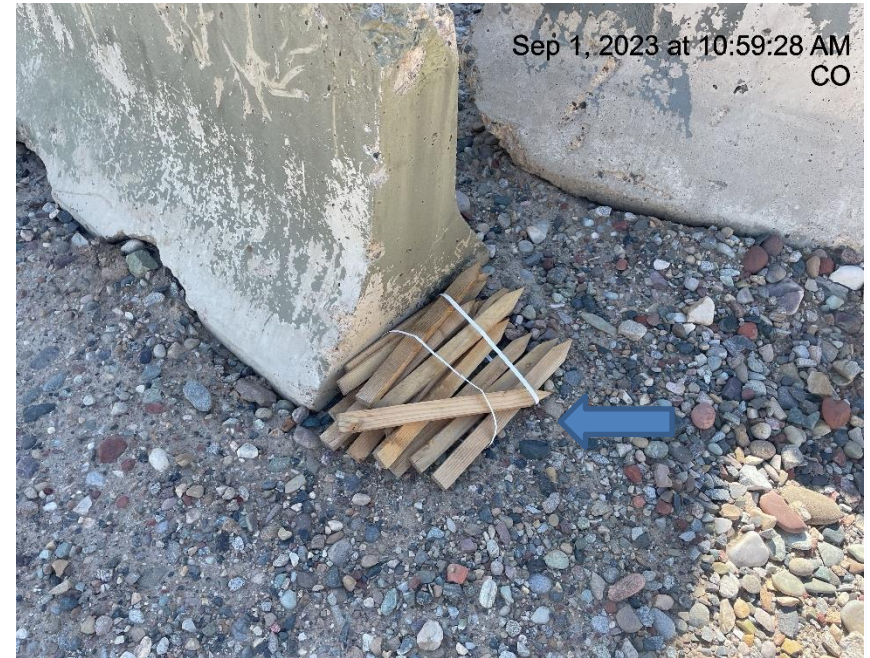
Photo # 8022 Debris

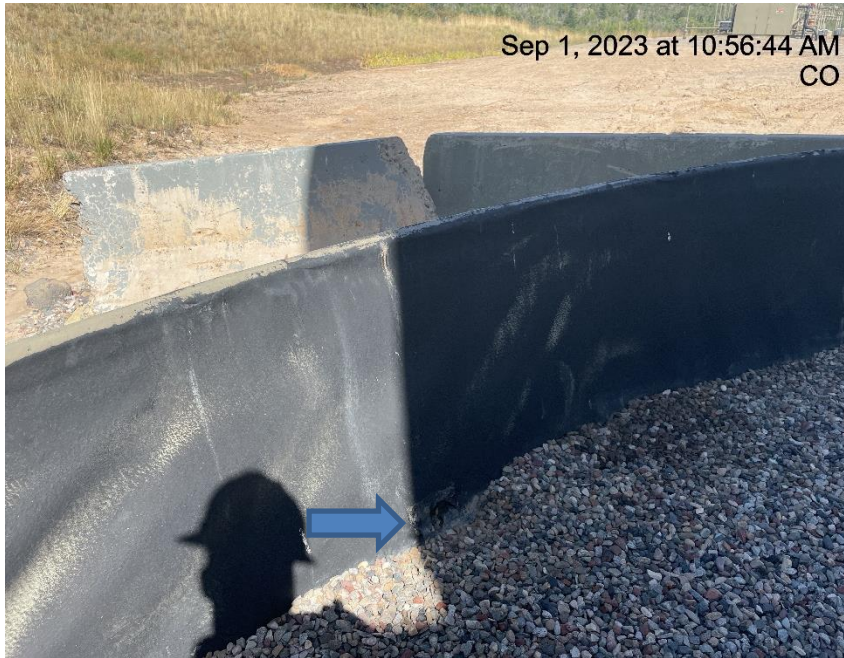
**Photo # 8007 Hole in liner/liner needs maintenance**

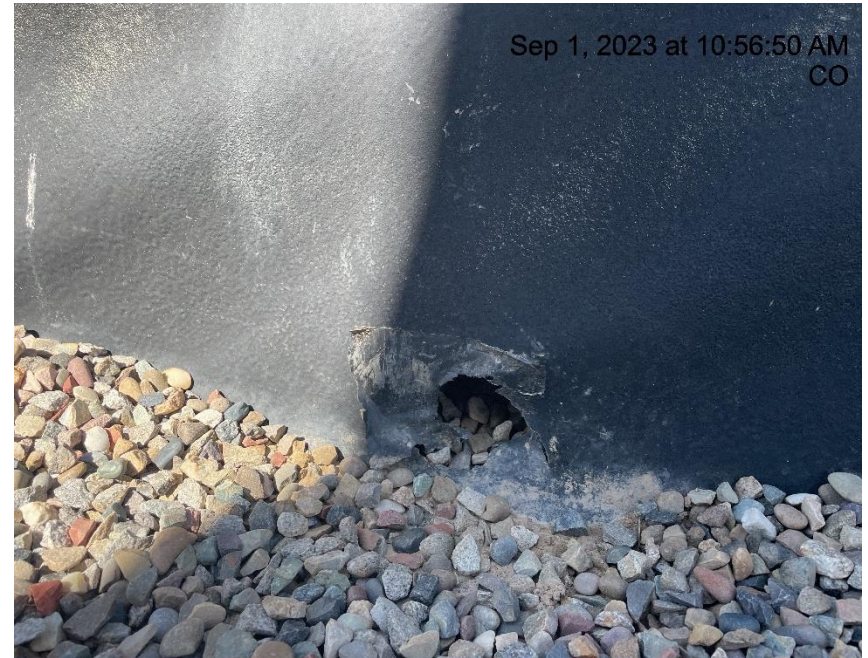
**Photo # 8008 Hole in liner/liner needs maintenance**

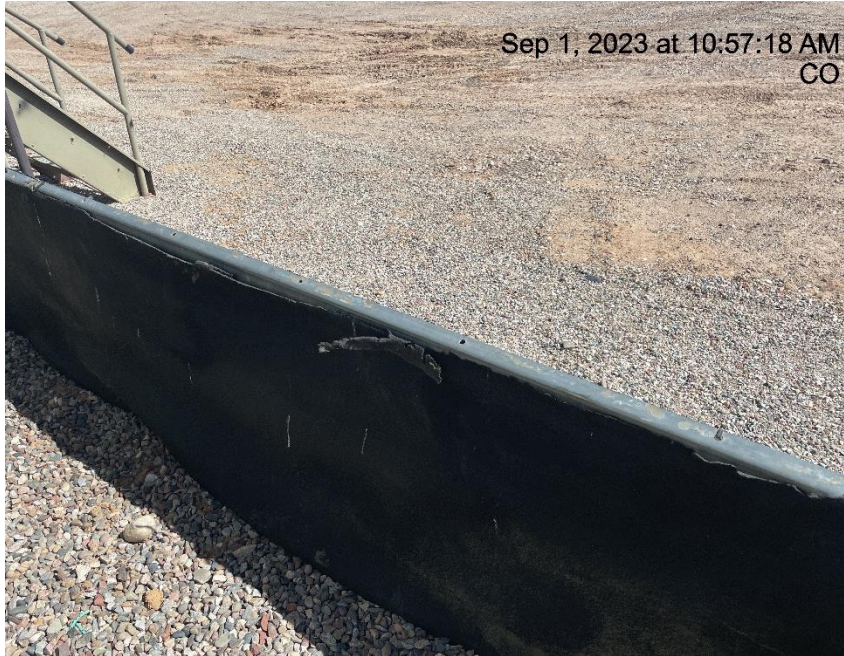
**Photo # 8009 Liner needs maintenance**

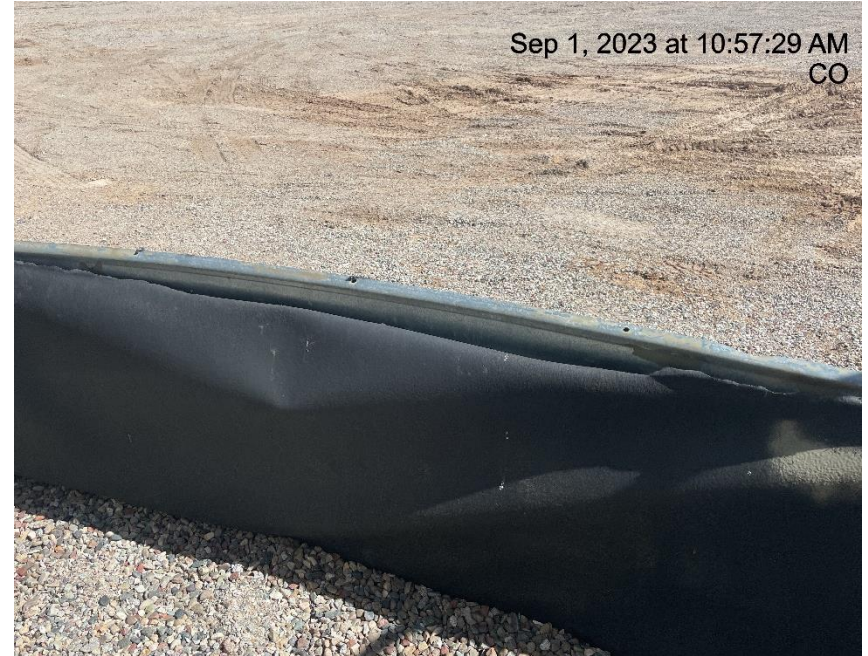
**Photo # 8010 Liner needs maintenance**

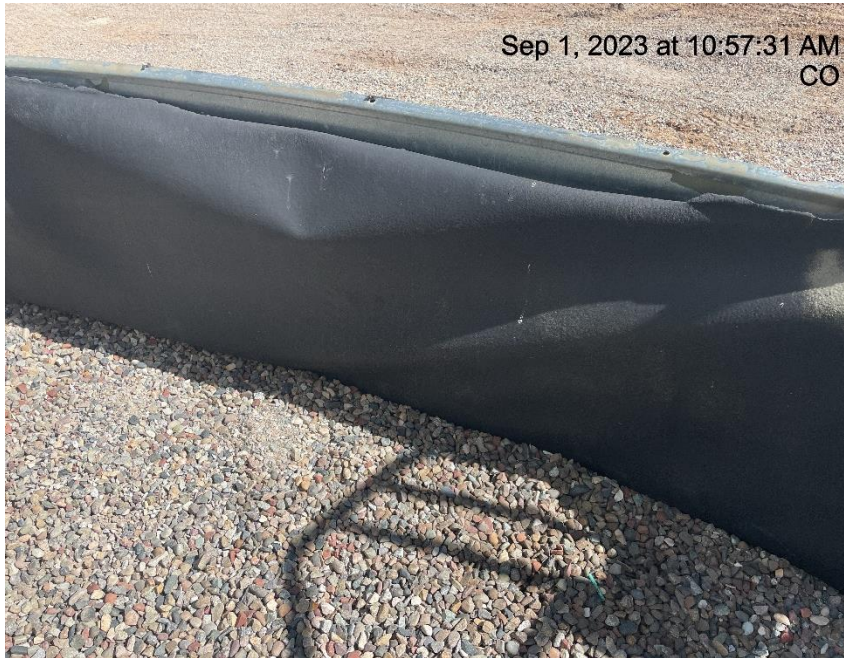
**Photo # 8011 Liner needs maintenance**

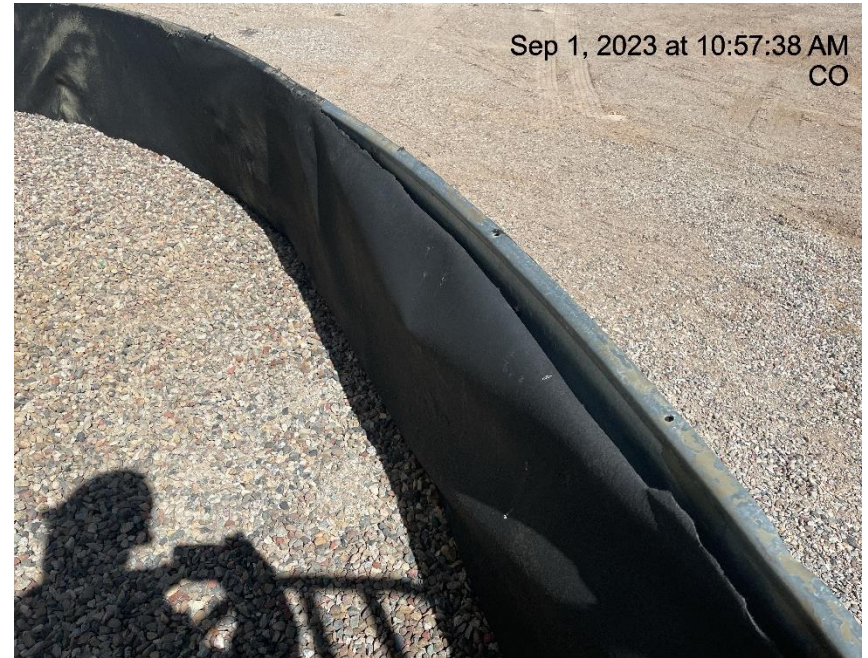
**Photo # 8012 Liner needs maintenance**

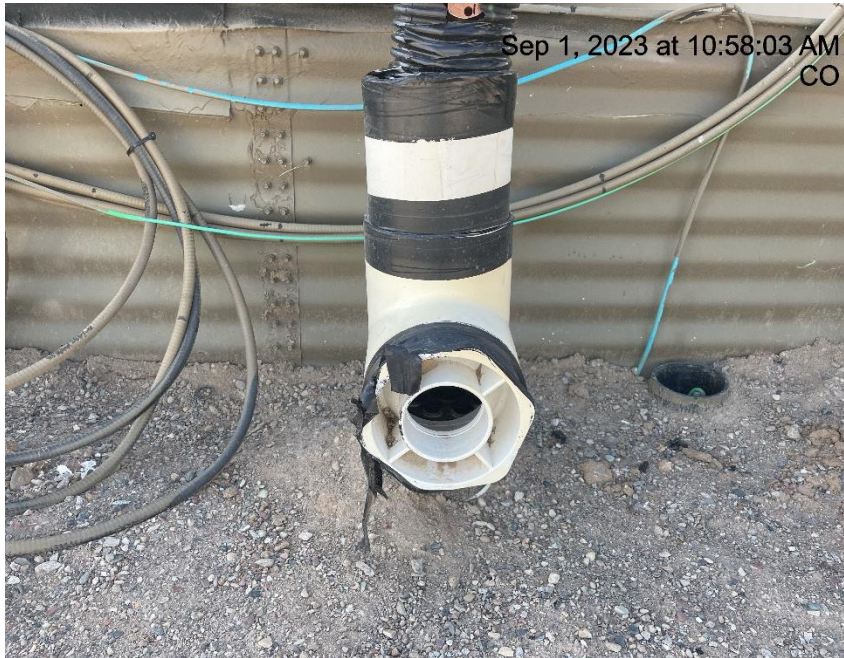
Photo # 8013 Flowline heating insulation open ended

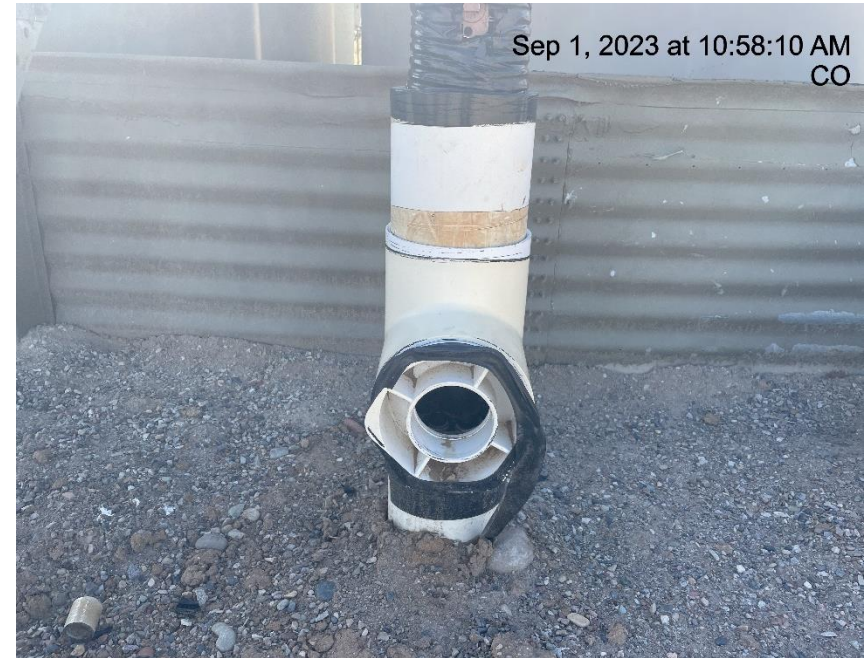
Photo # 8014 Flowline heating insulation open ended

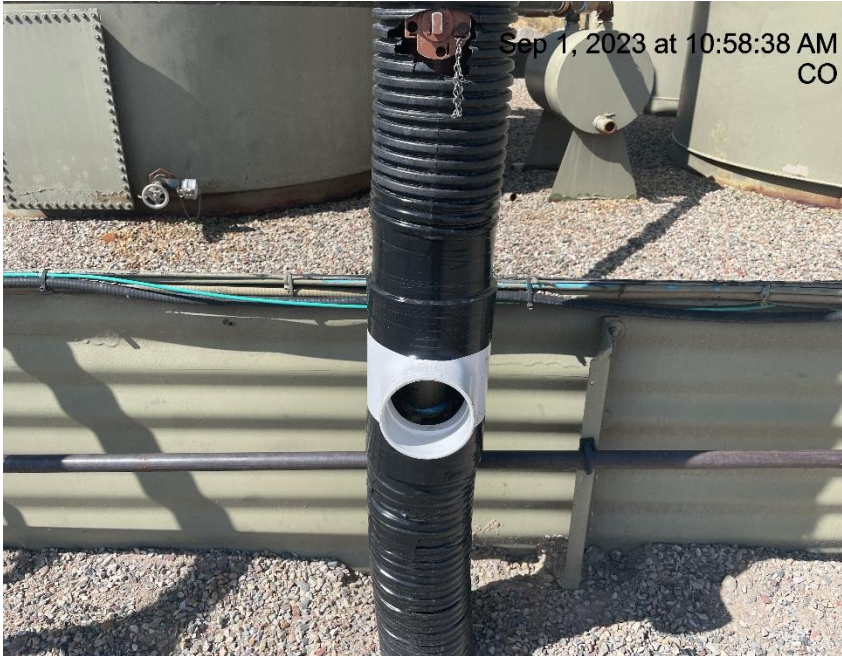
**Photo # 8015 Flowline heating insulation open ended**
