**Storm Water Management and Erosion control**  
**Location Name: CAERUS PICEANCE LLC N22W Pad**  
**Location # 324286**

**Location Overview: Location is within High Priority/Density/Black Bear Habitat areas & in close proximity to NSO Habitat area. Location is approximately 273 yards from West Mamm Creek. Location is within close proximity to Rule 411.b Generalized External Buffer.**  
**Section/Township/Range: 22 7S93W**

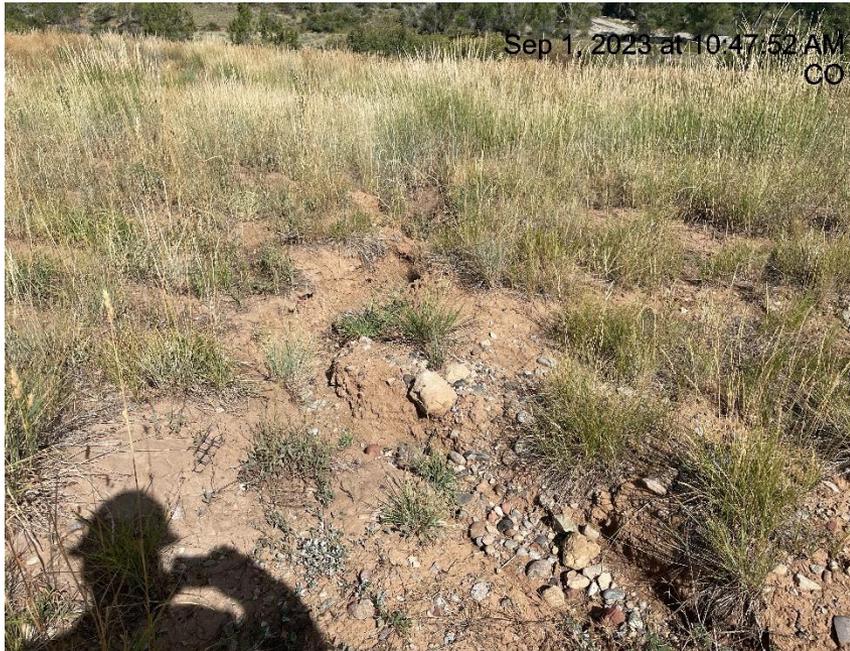
**Photo # 7986 Erosion & transport of sediment/insufficient BMP's (NW corner of location)**

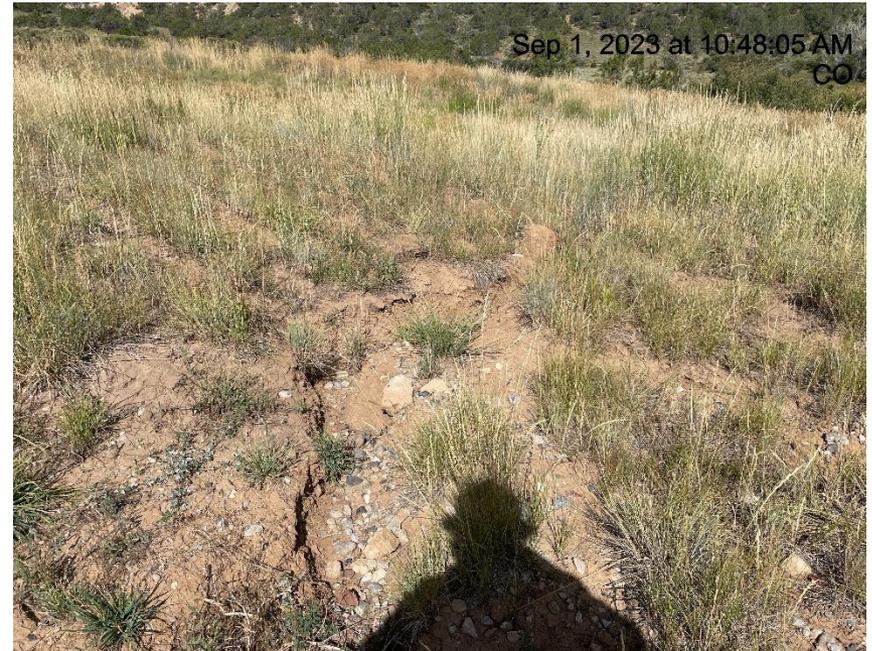
**Photo # 7988 Erosion & transport of sediment/insufficient BMP's (NW corner of location)**

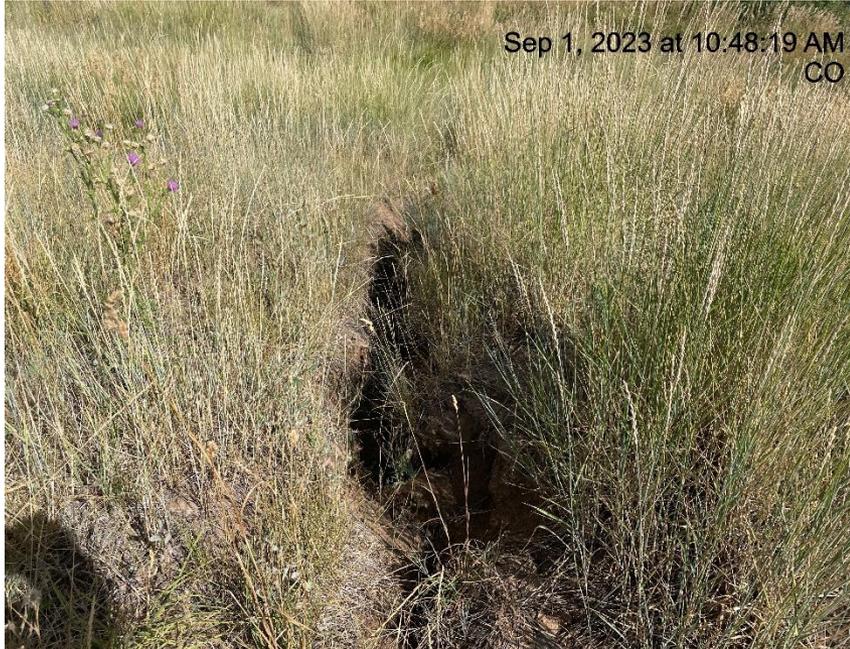
**Photo # 7989 Erosion & transport of sediment/insufficient BMP's (NW corner of location)**

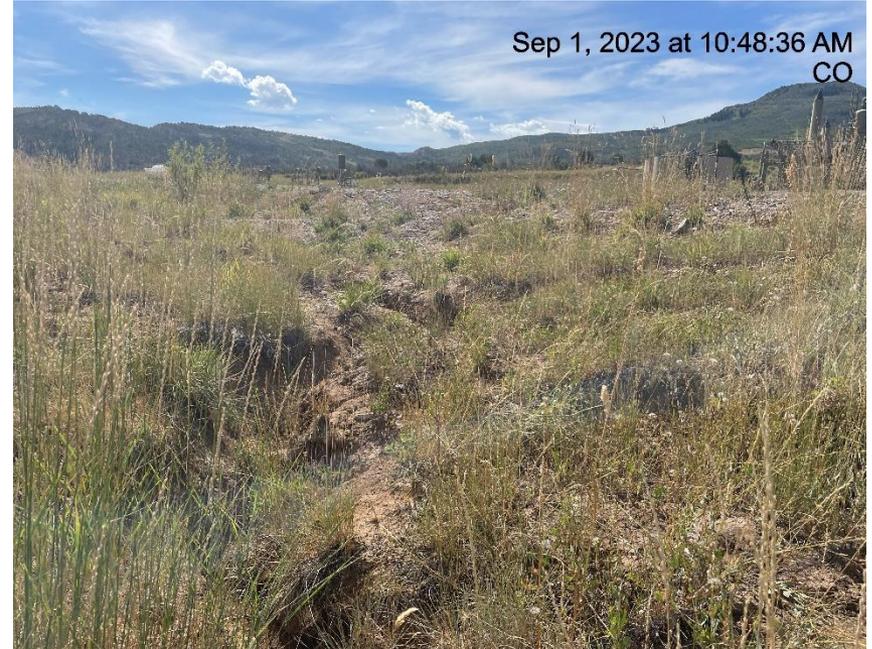
**Photo # 7990 Erosion & transport of sediment/insufficient BMP's (NW corner of location)**

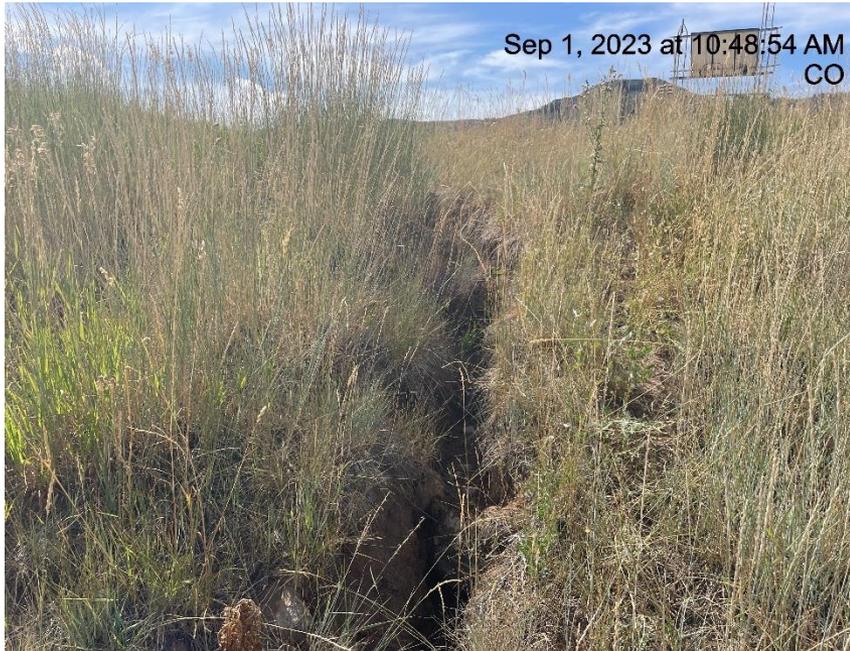
**Photo # 7992 Erosion & transport of sediment/insufficient BMP's (NW corner of location)**

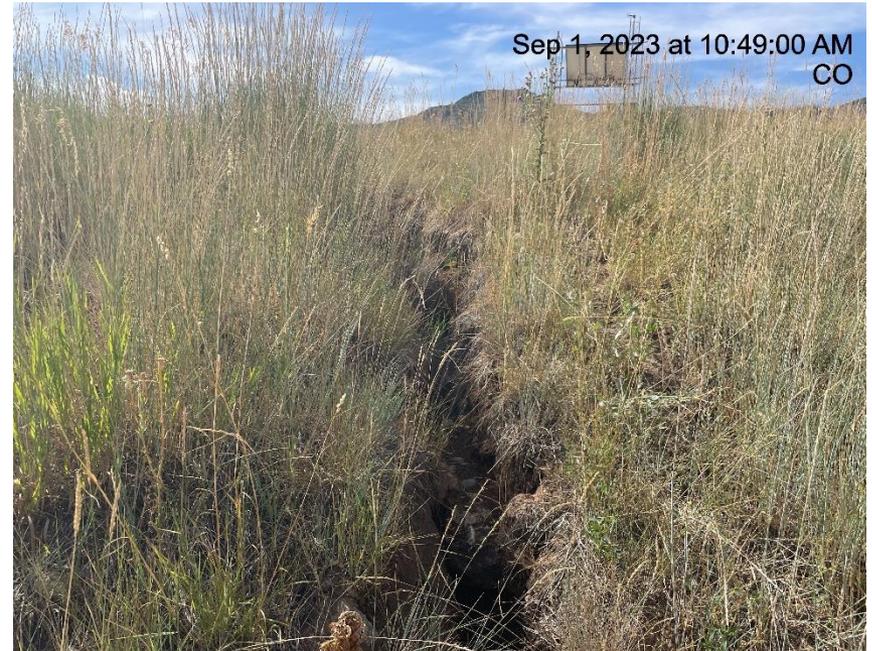
**Photo # 7993 Erosion & transport of sediment/insufficient BMP's (NW corner of location)**

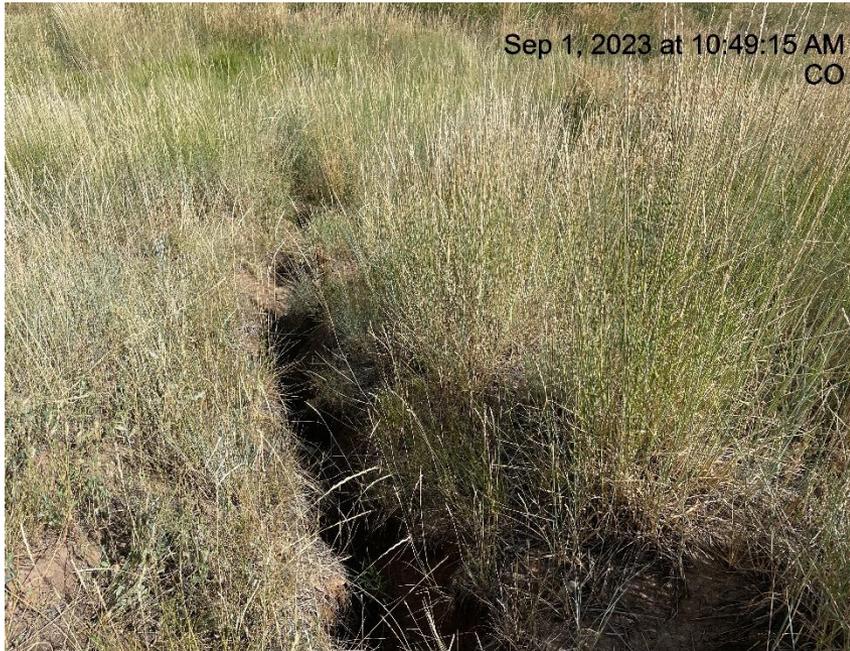
**Photo # 7994 Erosion & transport of sediment/insufficient BMP's (NW corner of location)**

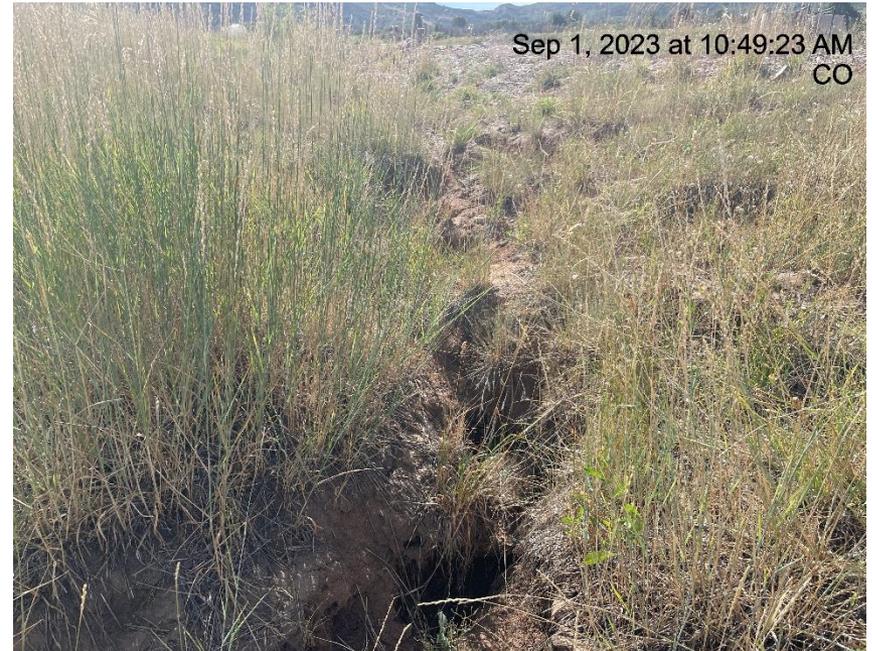
**Photo # 7995 Erosion & transport of sediment/insufficient BMP's (NW corner of location)**

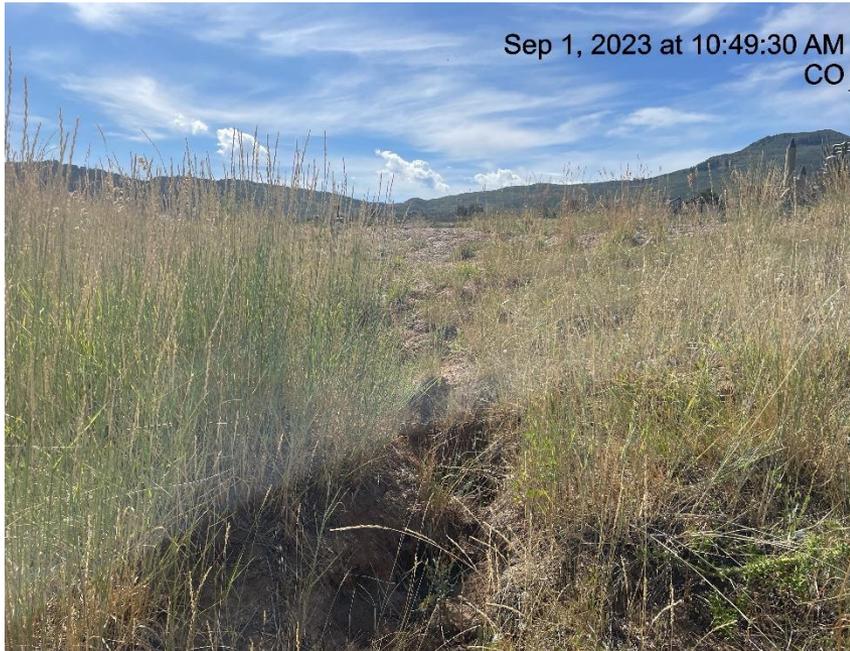
**Photo # 7996 Erosion & transport of sediment/insufficient BMP's (NW corner of location)**

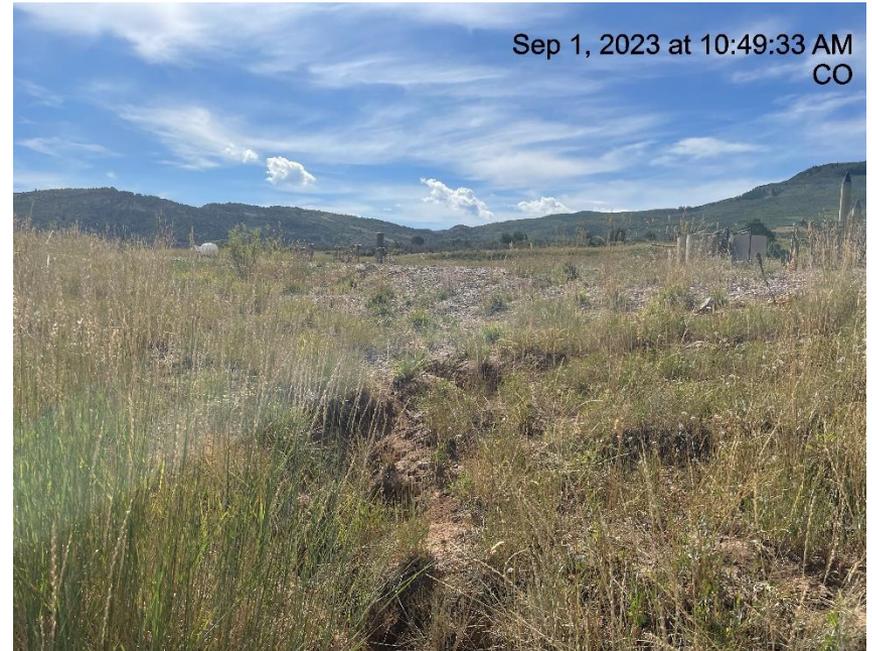
**Photo # 7997 Erosion & transport of sediment/insufficient BMP's (NW corner of location)**
