Inspection Photos
Location Name: CAERUS PICEANCE LLC K22W Pad
Location # 433706

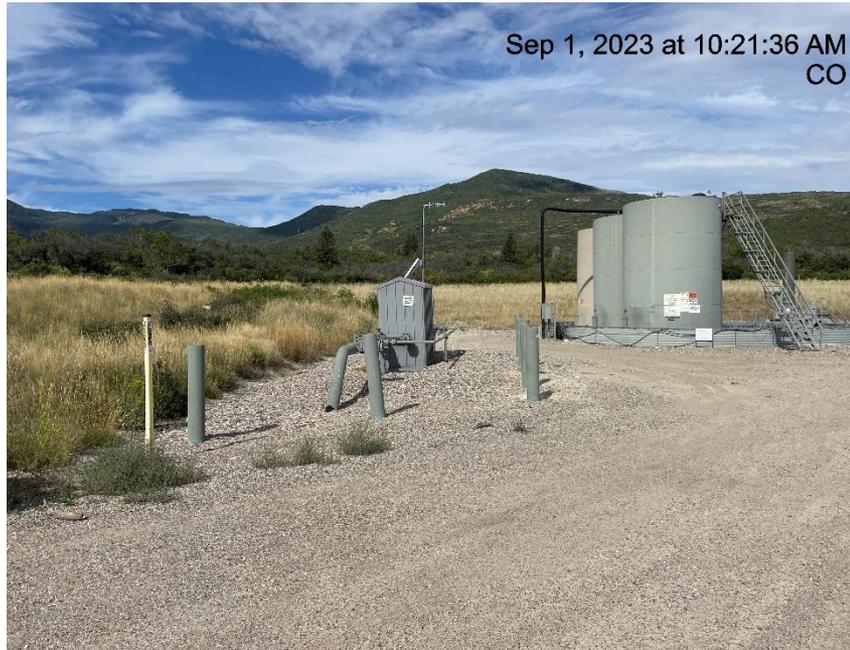
Photo # 7949 From entrance to location

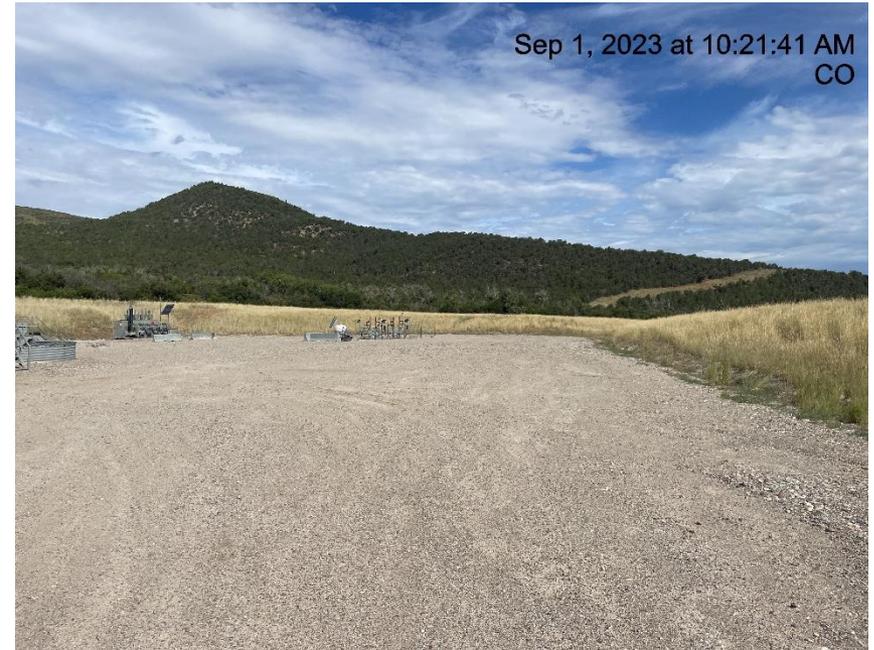
Photo # 7950 From entrance to location

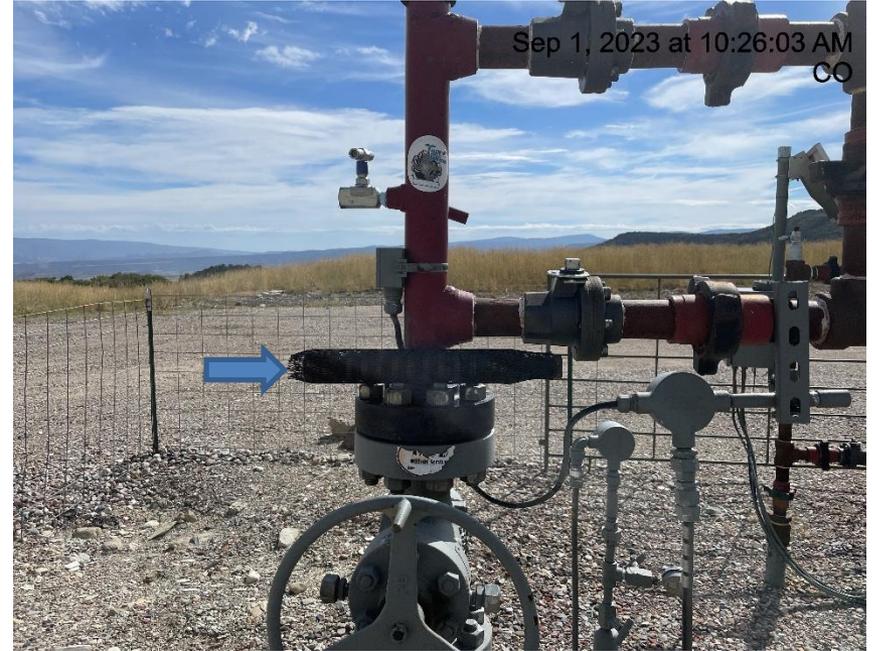
Photo # 7959 Debris

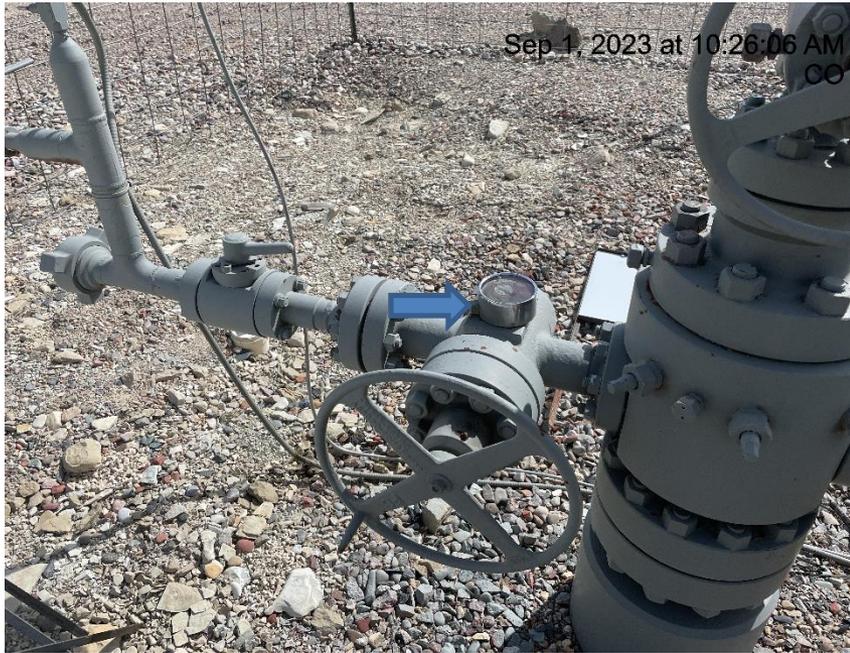
Photo # 7960 Debris

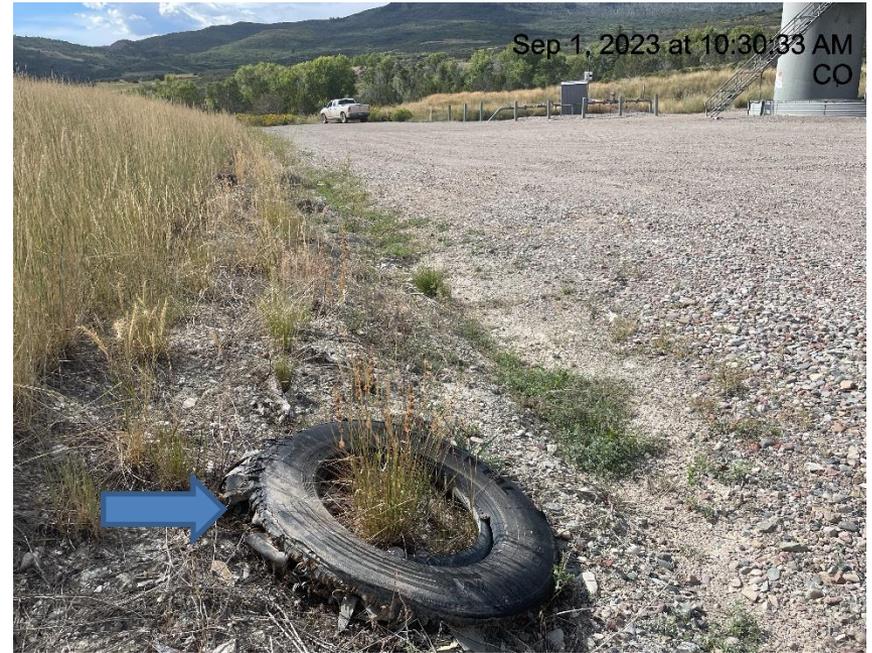
Photo # 7964 Debris

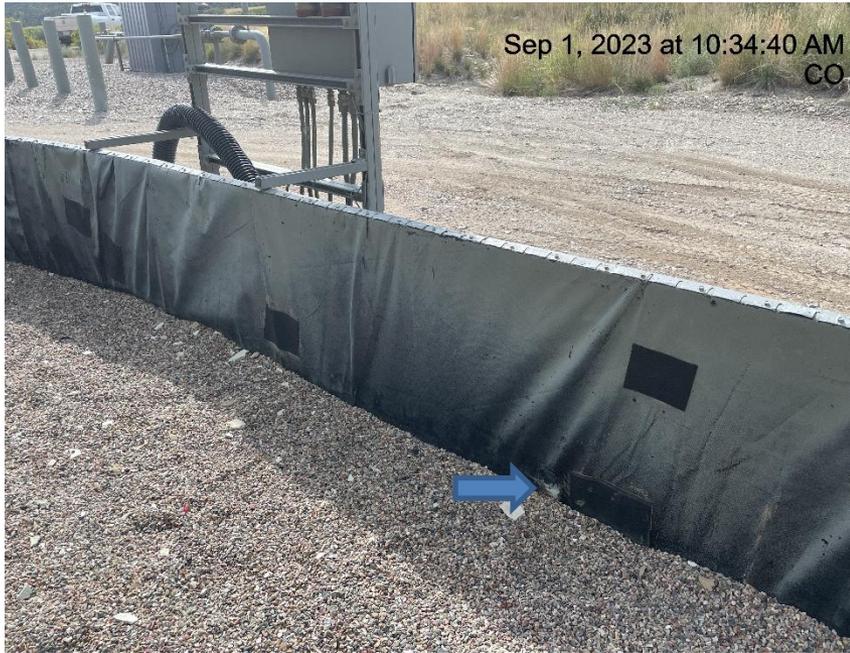
Photo # 7971 Hole in liner/liner needs maintenance

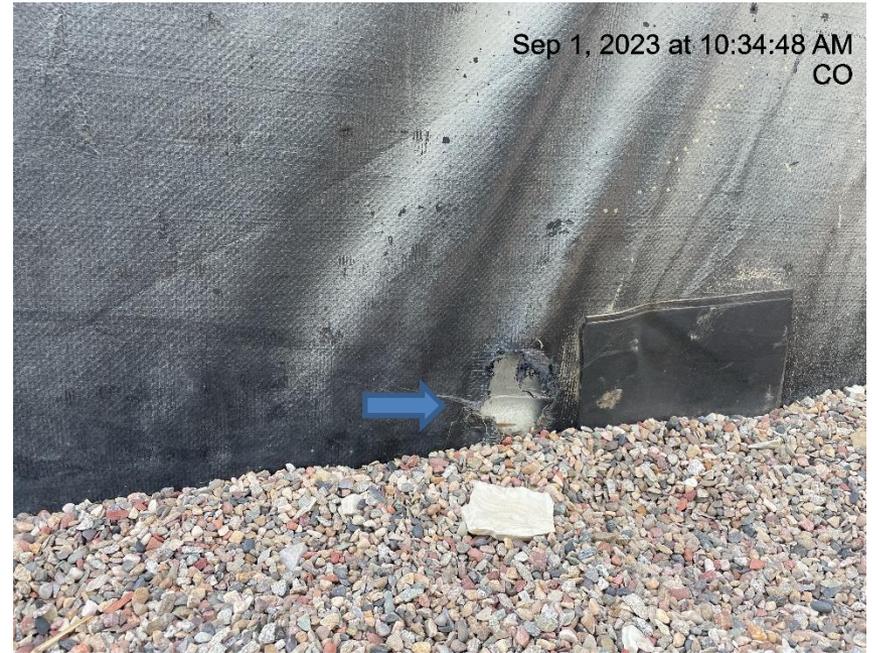
Photo # 7972 Hole in liner/liner needs maintenance
