Inspection Photos
Location Name: Guerrero 13, 14, 23, 33, 35-7
Location ID: 423389

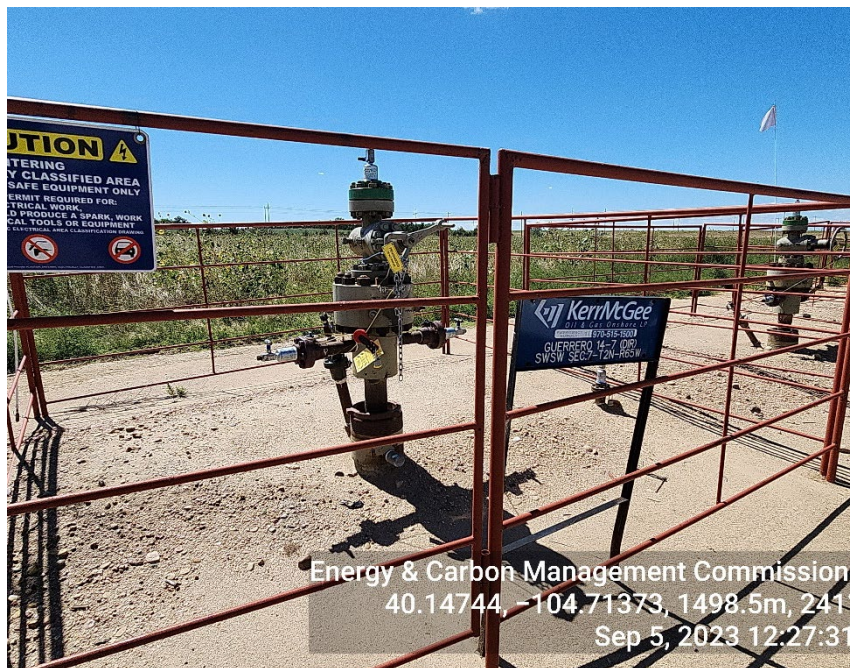
Photo 1: TA Wellhead

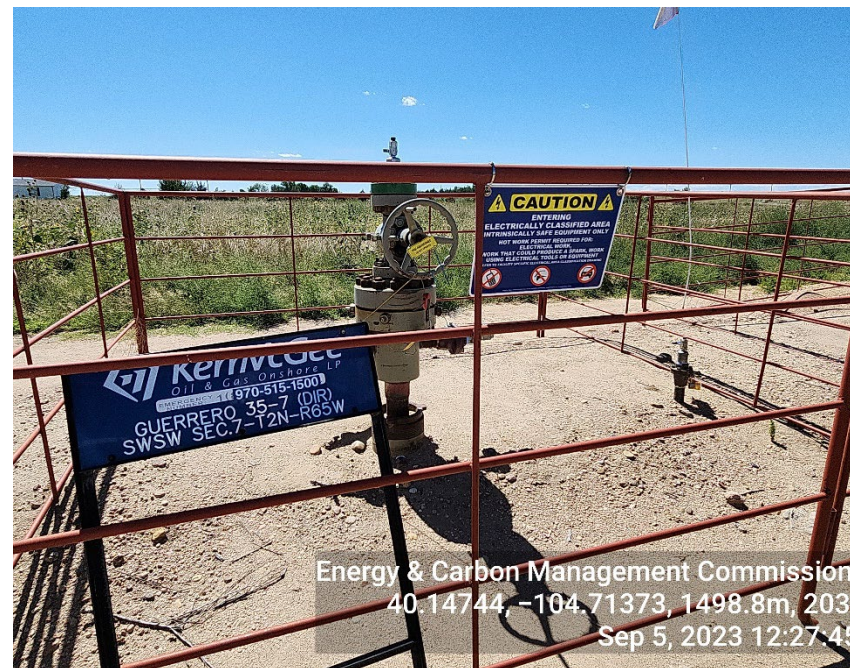
Photo 2: TA Wellhead

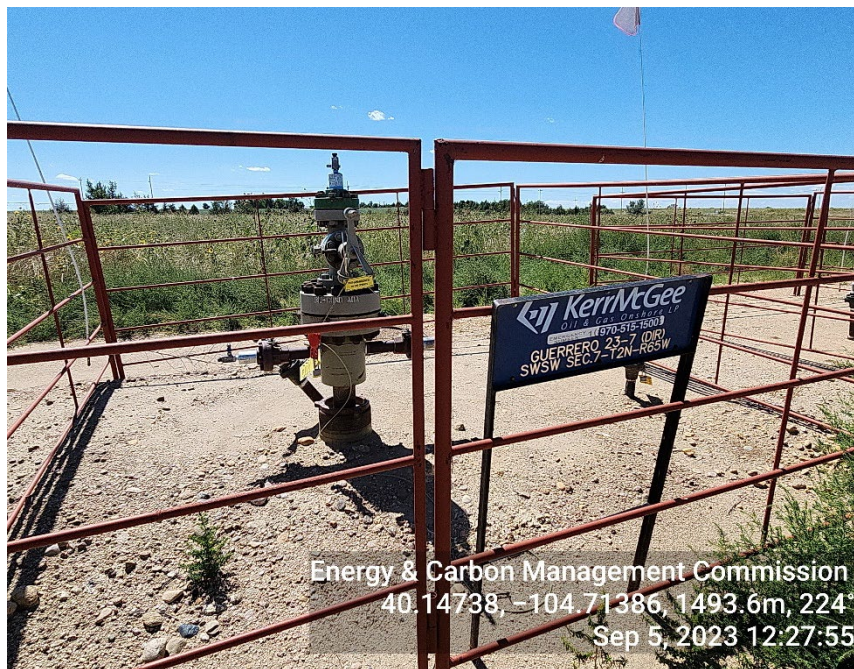
Photo 3: TA Wellhead

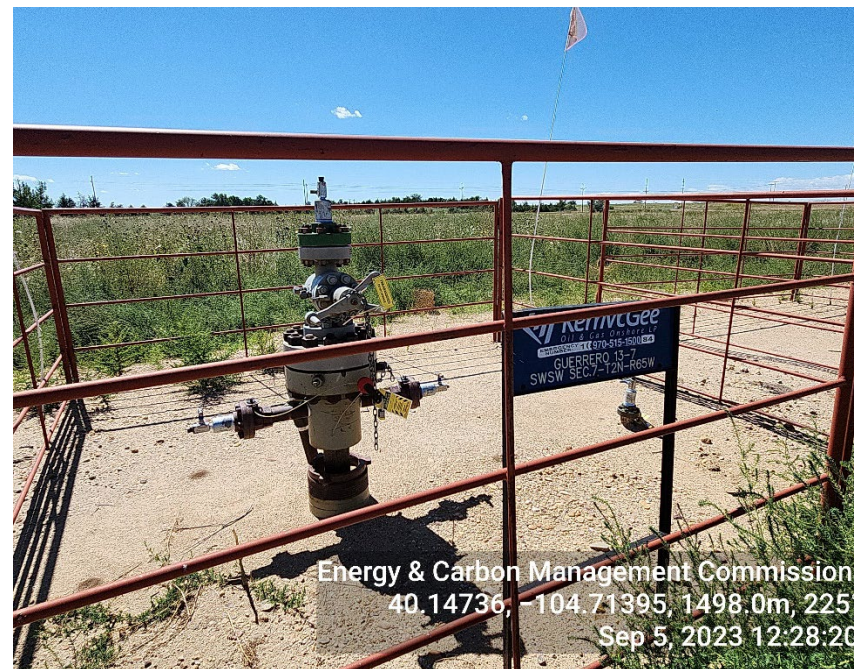
Photo 4: TA Wellhead

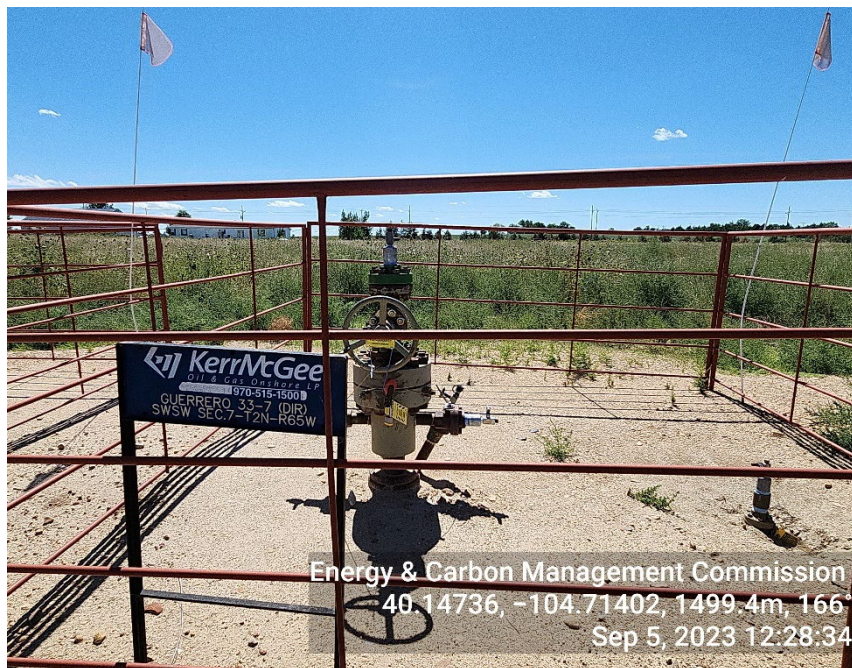
Photo 5: TA Wellhead

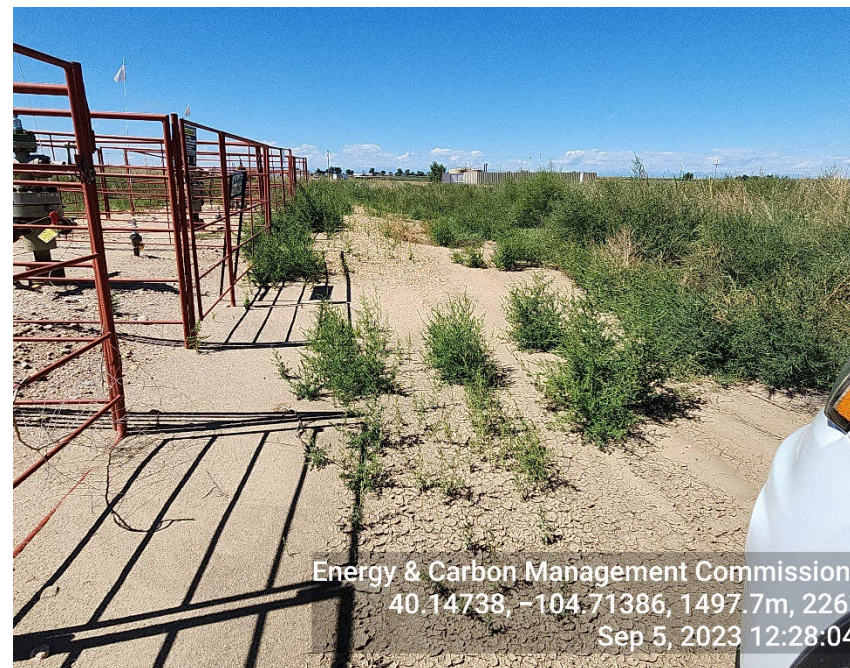
Photo 6: Overgrown vegetation.

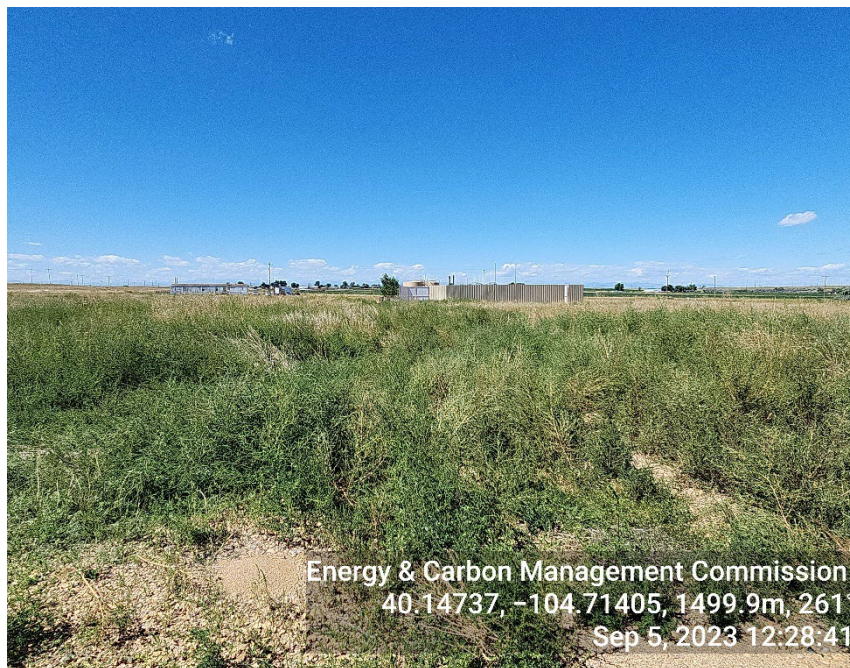
Photo 7: Overgrown vegetation on access road to wellheads.

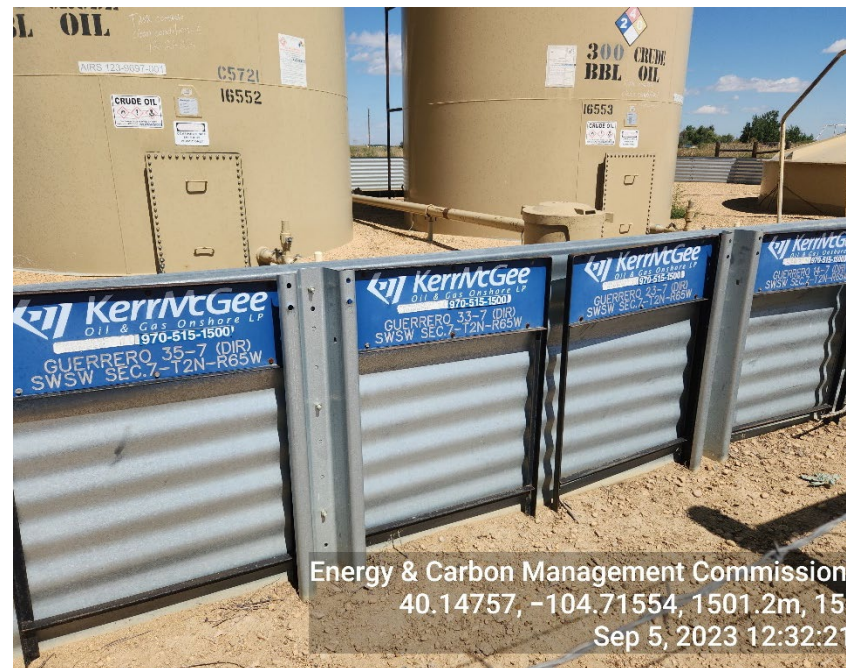
Photo 8: Tank Battery Signs

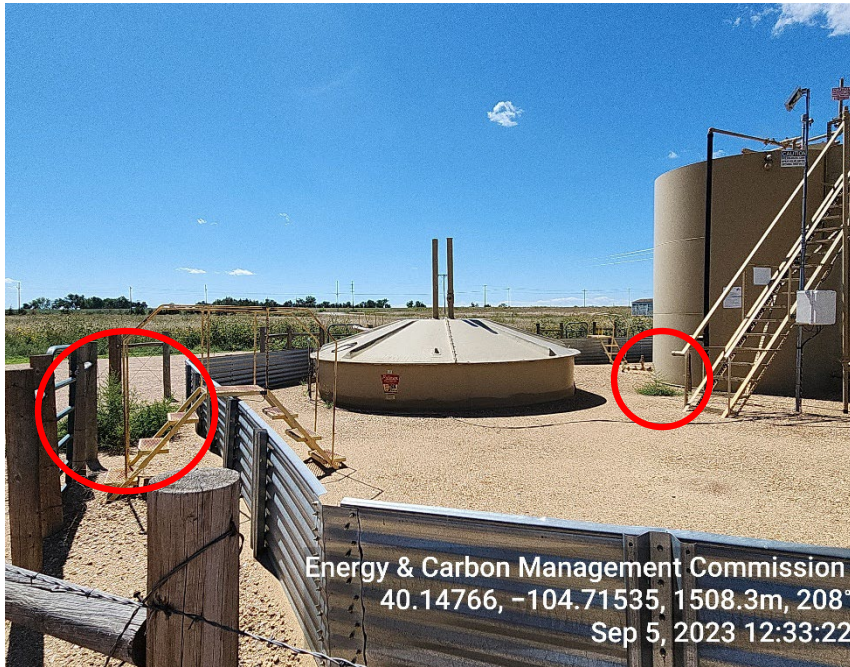
Photo 9: Weeds

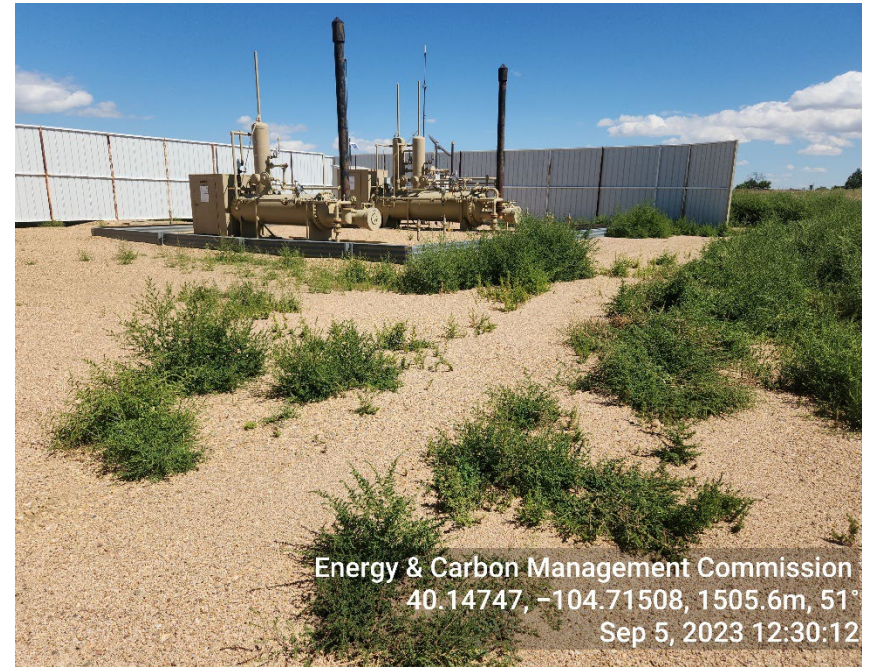
Photo 10: Over grown vegetation.

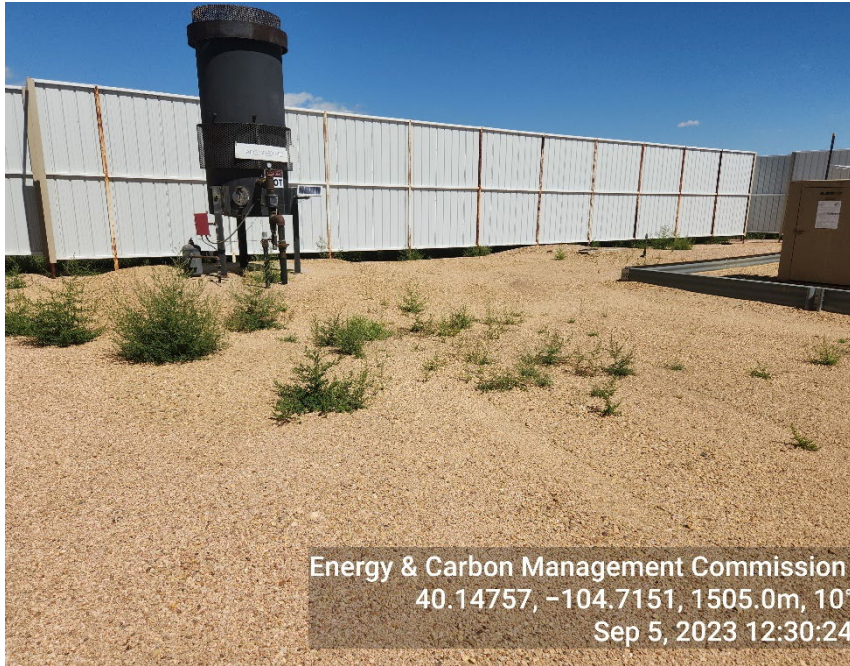
Photo 11: Weeds

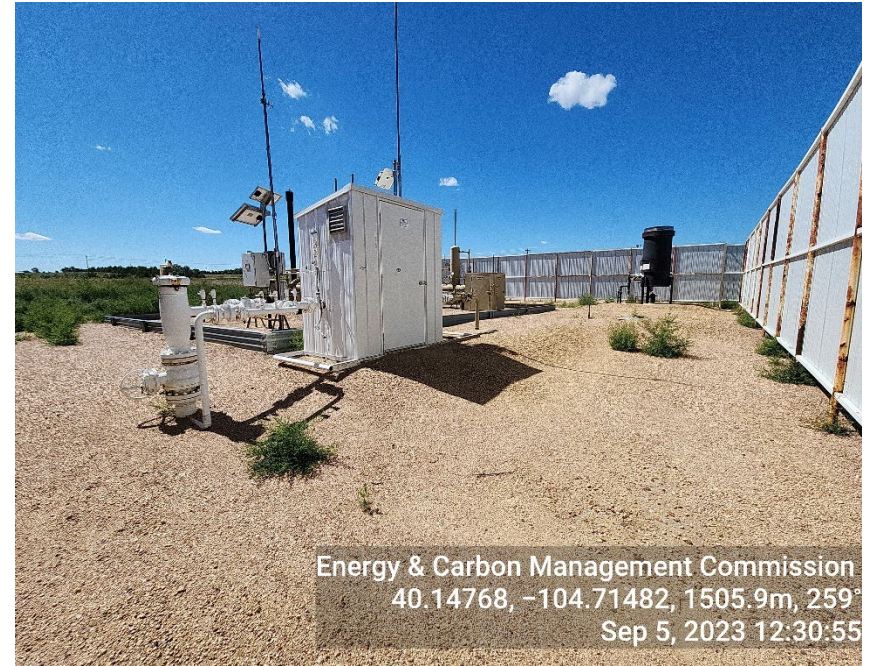
Photo 12: Weeds

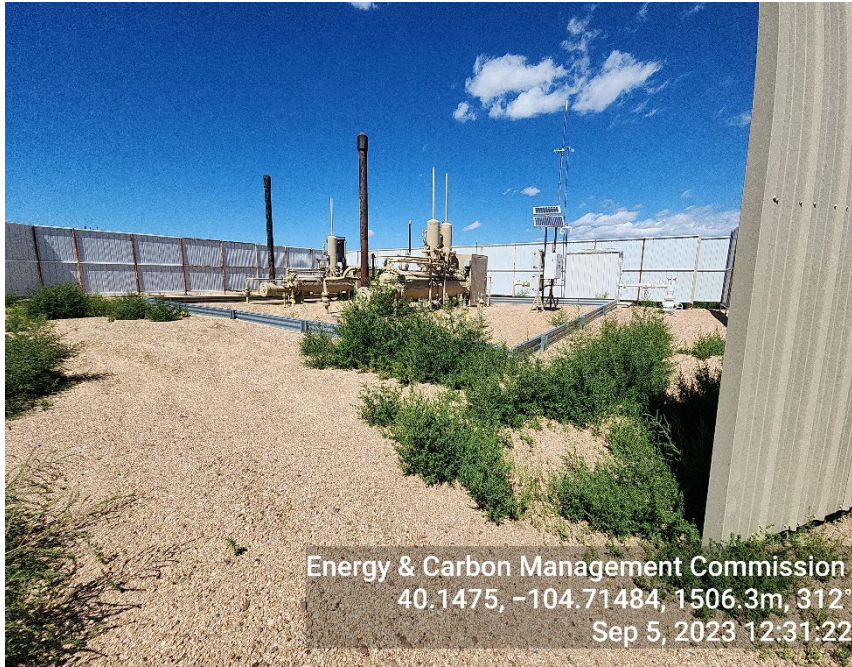
Photo 13: Weeds
