## Inspection Photos

Location Name: TEP ROCKY MOUNTAIN LLC, UNION ENERGY MINING DIV.-66S96W/33SWSE

Location ID: 334868

Date: 8/24/2023

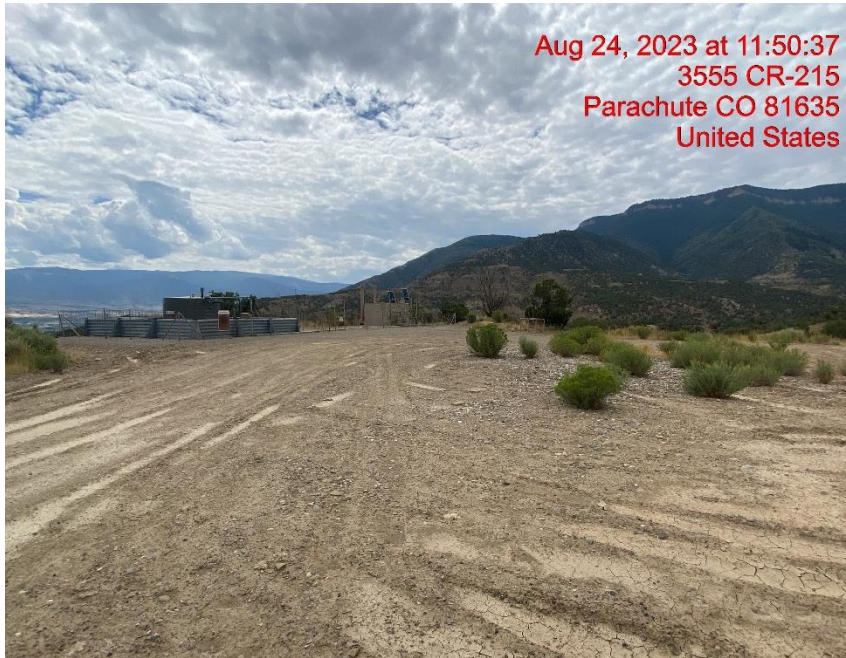
North End of Location – Photo #06148

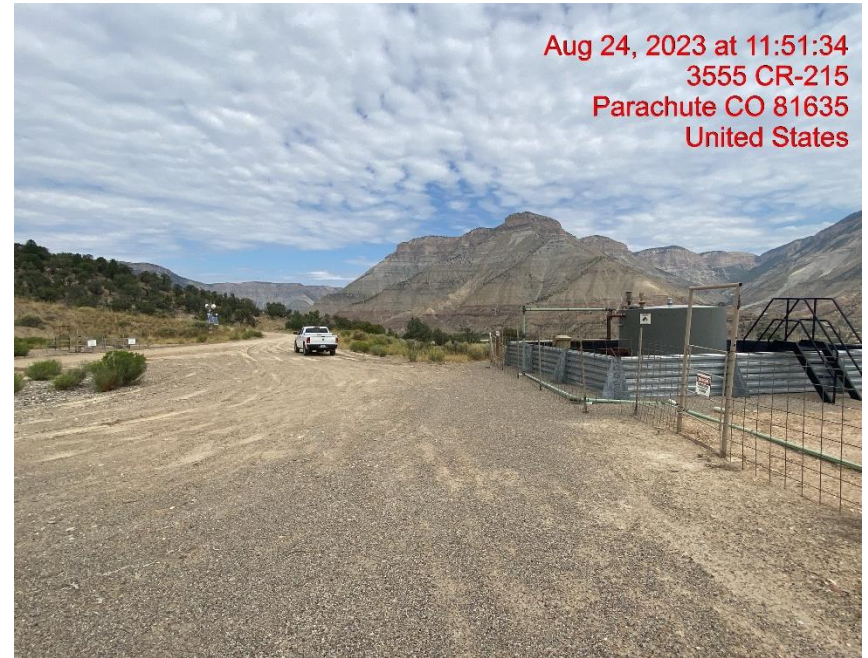
South End of Location – Photo #06150

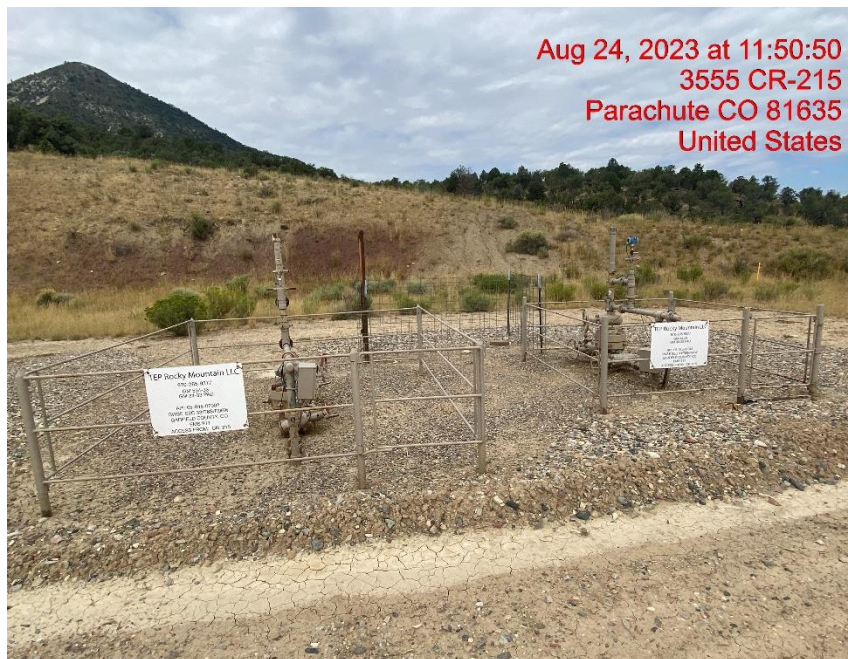
Wellheads – Photo #06149

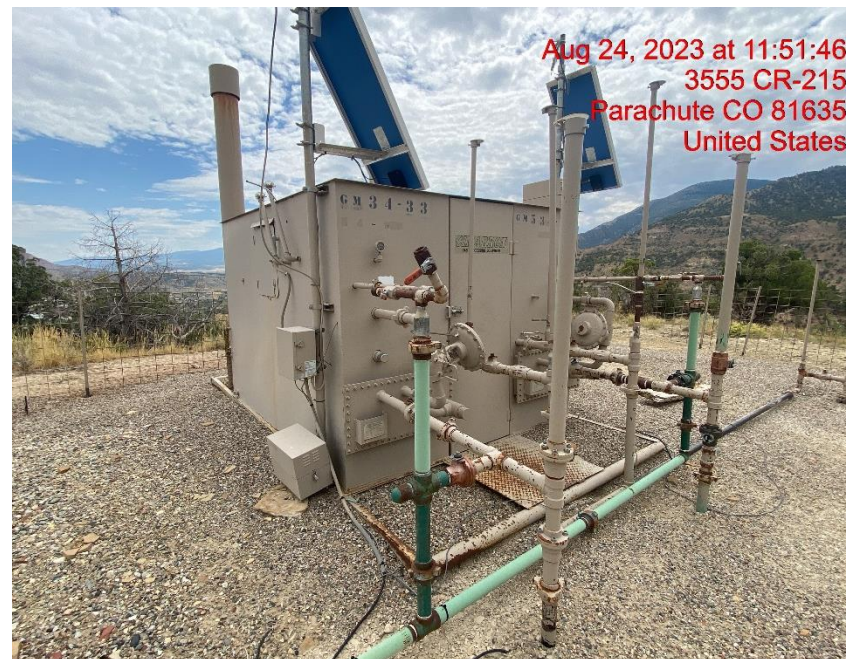
Separators – Photo #06151

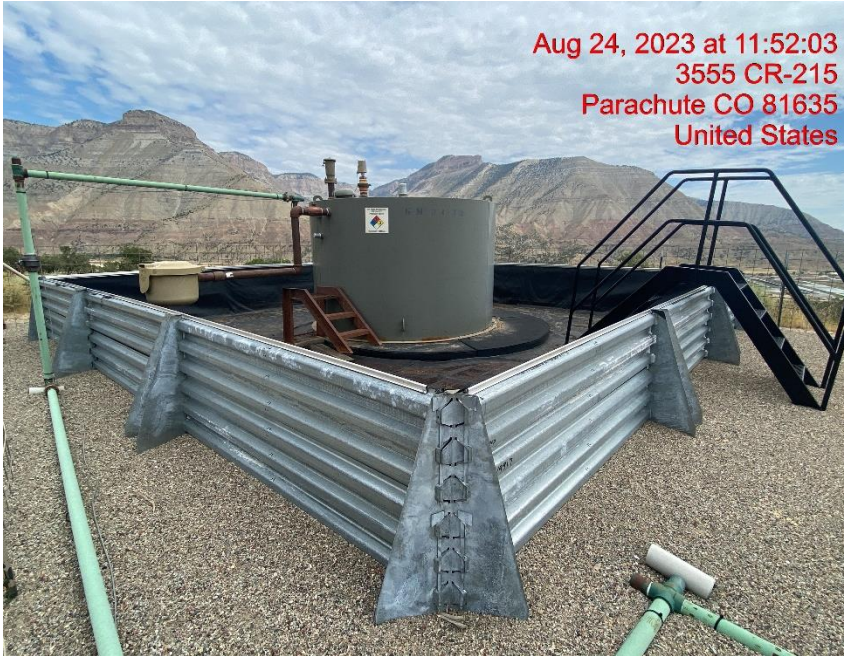
Tank Battery – Photo #06152

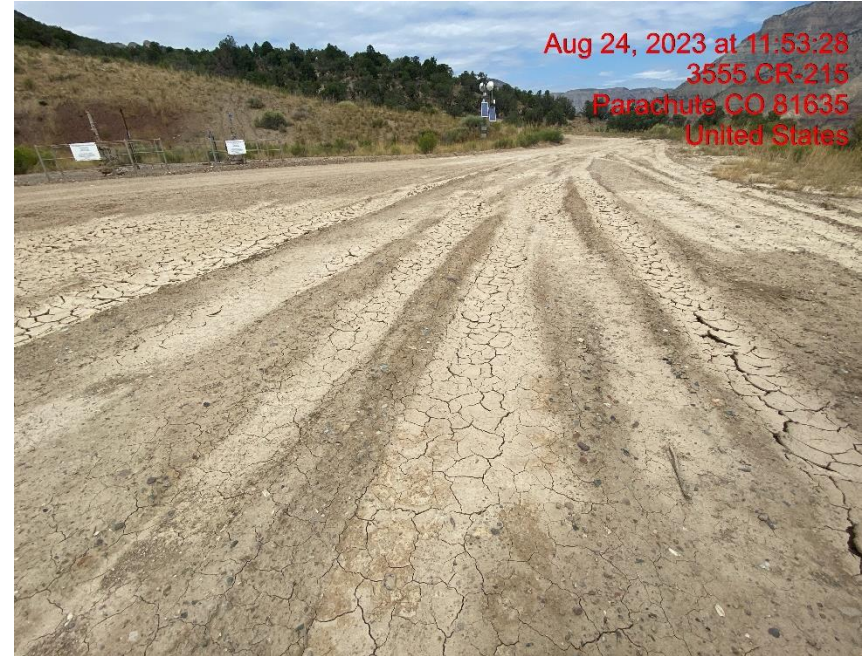
Location Lacks Stabilization – Photo #06155

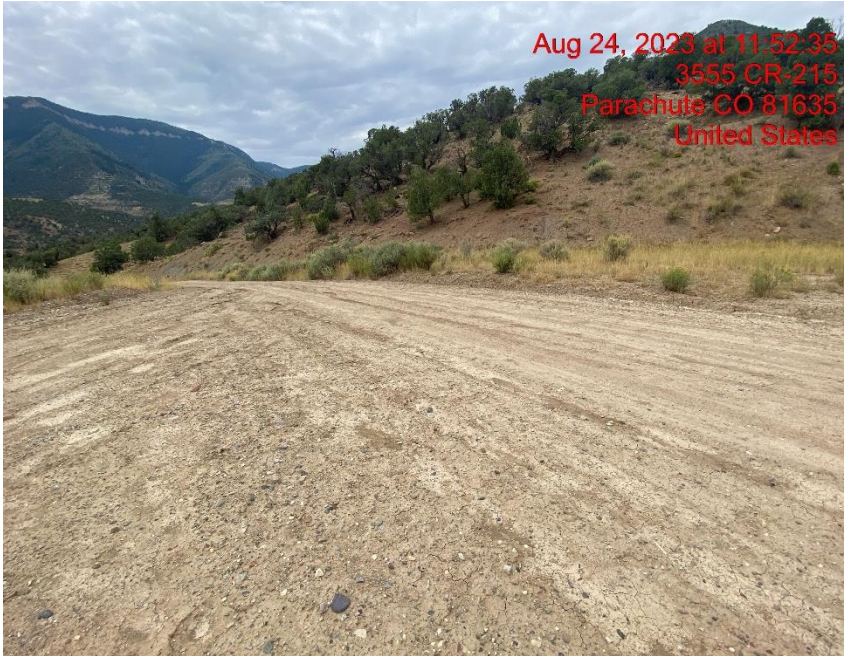
**Insufficient Vehicle Tracking BMPs at Location Entrance/Exit  
– Photo #06153**

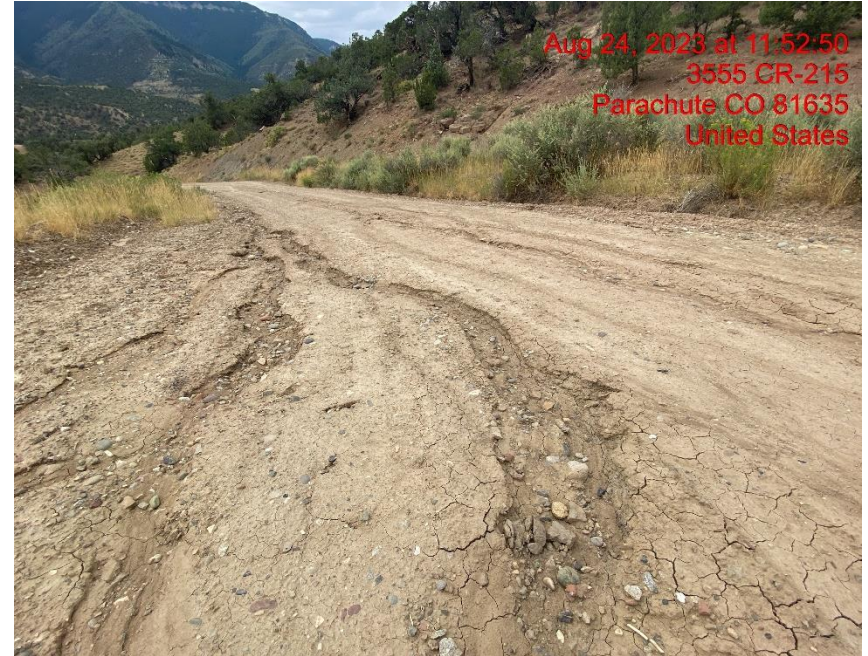
**Insufficient Erosion Control/Rill Erosion on Access Road –  
Photo #06154**
