Operator: CRESTONE PEAK RESOURCES OPERATING LLC

Location Name: BRERETON-61S69W 14SWSE

Loc ID: 321359

Inspection: 705000412

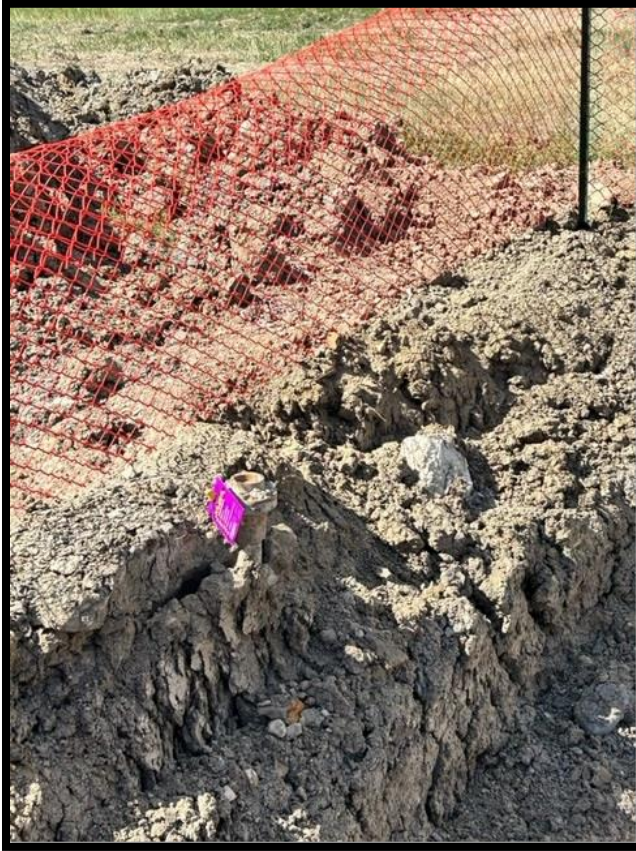
Exhibit A

CA: Well (Brereton 2-14) has been plugged and abandoned. ECMC form 42 notice of start of plugging operations doc #403437490 received on 06/19/2023. ECMC flowline pre-abandonment notice doc #403390984 received on 05/02/2023; flowline AIP work has not been completed at time of inspection. Fenced excavation observed at the PA wellhead. Flowline riser (WH) at PA well observed at south end excavation (No OOSLAT in place); flowline riser at inlet to HHS connected to flowline manifold (No isolation/ OOSLAT). Facility/ battery services additional (SI) wells. Remediation work is in progress. Comply with ECMC Rules 1105.b. & 1105.c.

CA Resolution: Operator has reported and provided photo evidence that appropriate OOSLAT have been installed at the flowline riser (WH) and the flowline riser at the inlet to HHS connected to the flowline manifold to comply with Rules 1105.b. & 1105.c.
