Operator: EXTRACTION OIL & GAS INC
Location Name: BRERETON-61S69W 14SWSE
Loc ID: 321359
Inspection: 705000412

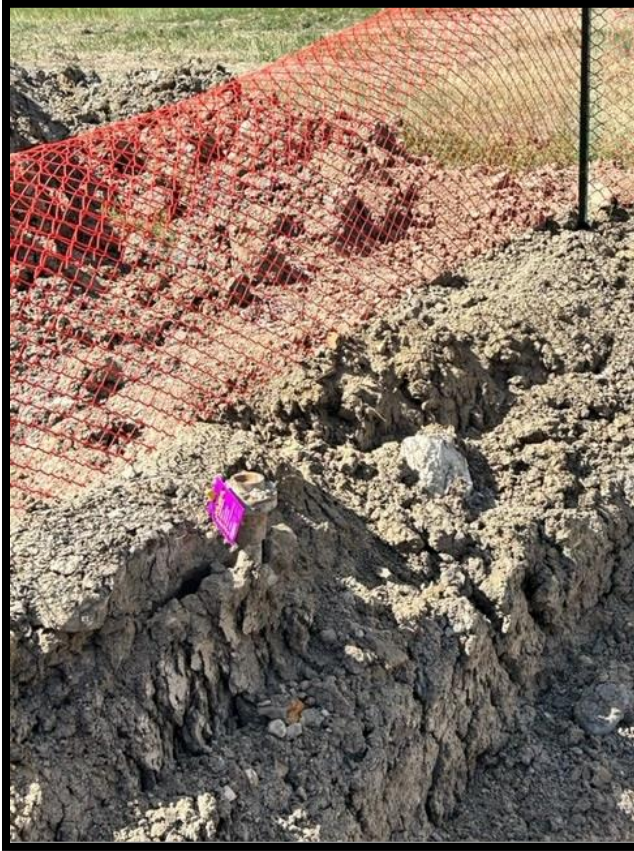
Exhibit A

CA: Well (Brereton 2-14) has been plugged and abandoned. ECMC form 42 notice of start of plugging operations doc #403437490 received on 06/19/2023. ECMC flowline pre-abandonment notice doc #403390984 received on 05/02/2023; flowline AIP work has not been completed at time of inspection. Fenced excavation observed at the PA wellhead. Flowline riser (WH) at PA well observed at south end excavation (No OOSLAT in place); flowline riser at inlet to HHS connected to flowline manifold (No isolation/ OOSLAT). Facility/ battery services additional (SI) wells. Remediation work is in progress. Comply with ECMC Rules 1105.b. & 1105.c.

CA Resolution: Operator has reported and provided photo evidence that appropriate OOSLAT have been installed at the flowline riser (WH) and the flowline riser at the inlet to HHS connected to the flowline manifold to comply with Rules 1105.b. & 1105.c.
