## Inspection Photos

Location Name: TEP ROCKY MOUNTAIN LLC, UNOCAL-66S96W/33NESW

Location ID: 324117

Date: 8/24/2023

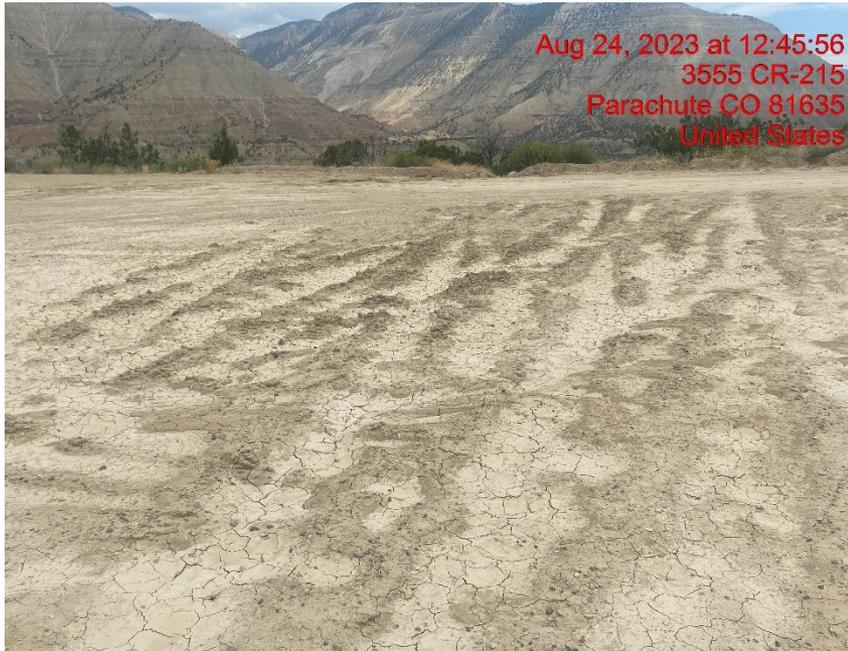
**Location Lacks Stabilization – Photo #06187**

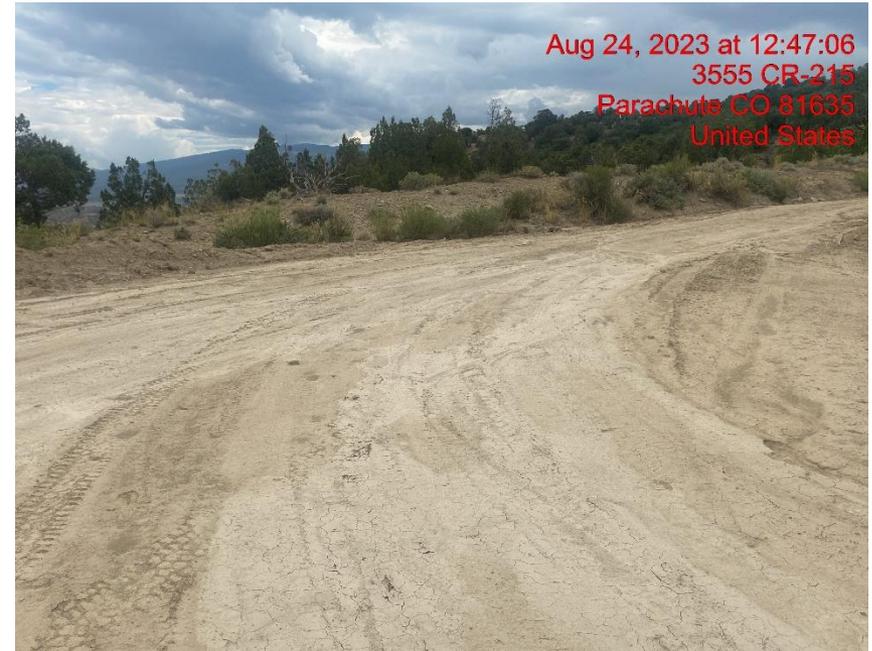
**Insufficient Vehicle Tracking BMPs at Location Entrance/Exit  
– Photo #06190**

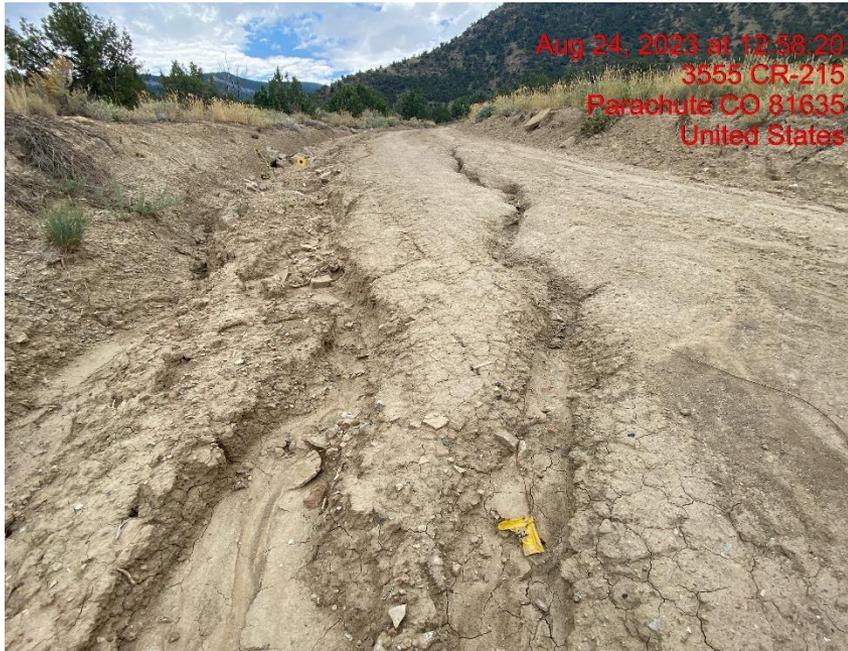
Insufficient Erosion Controls/Rill Erosion on Access Road –  
Photo #06191

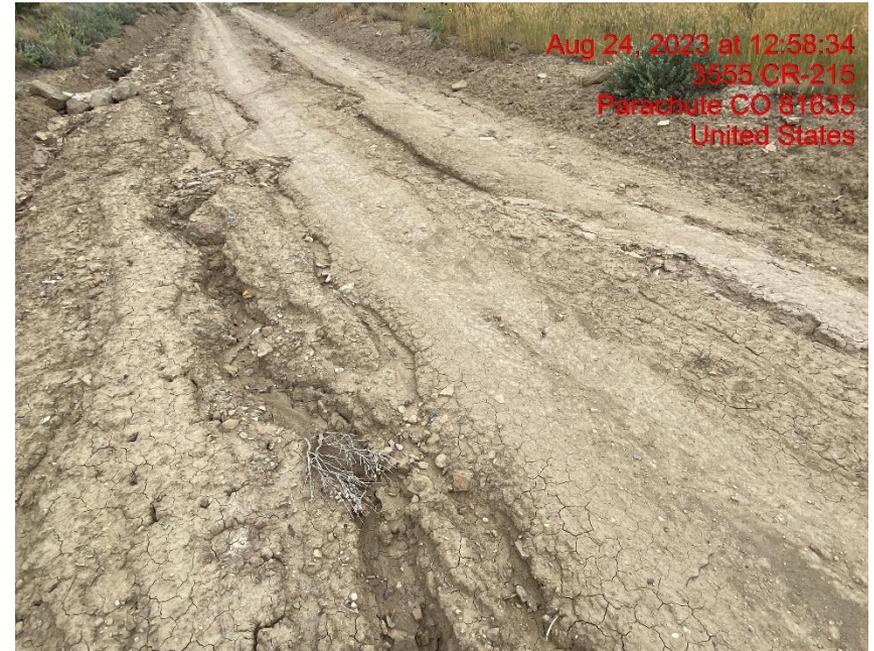
Insufficient Erosion Controls/Rill Erosion on Access Road –  
Photo #06192
