## Inspection Photos

Location Name: TEP Rocky Mountain LLC CLOUGH RWF 22-14 Pad

Location # 335853

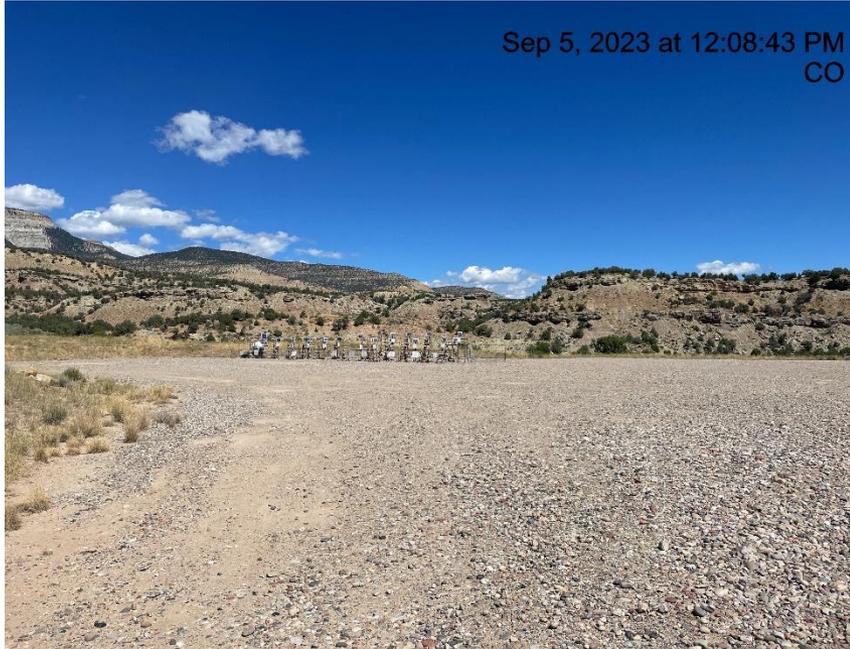
Photo # 8220 From entrance to location

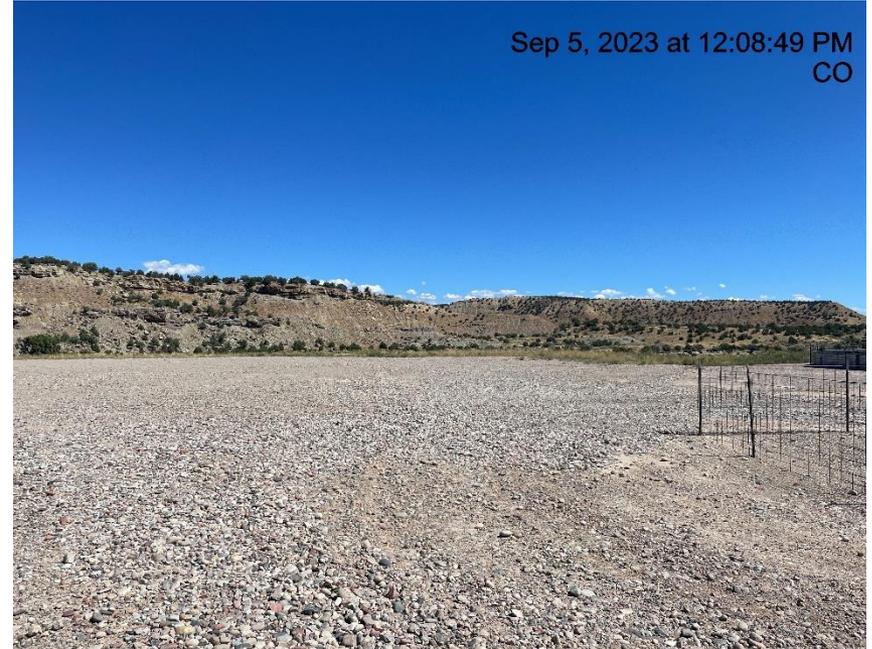
Photo # 8221 From entrance to location

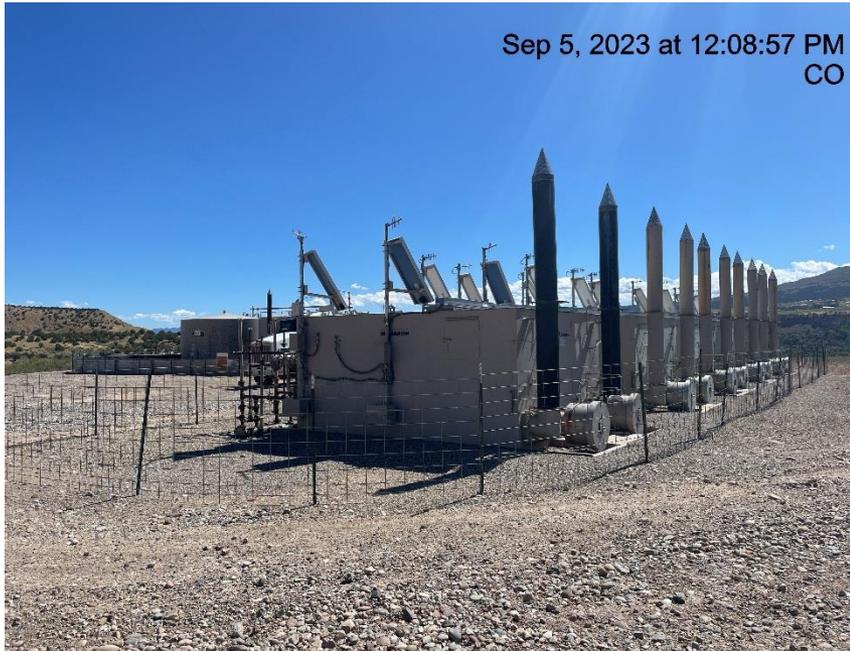
Photo # 8222 From entrance to location

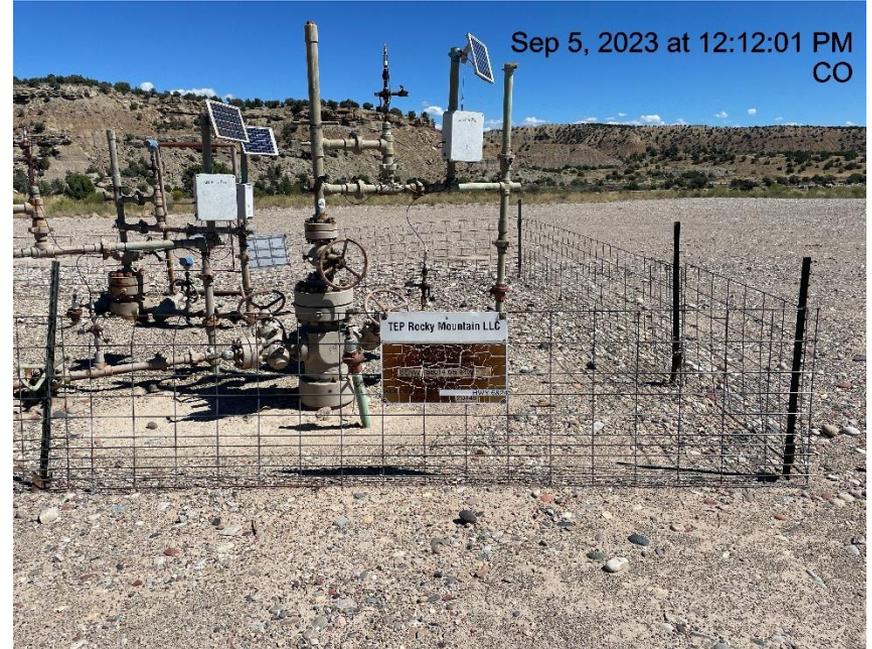
Photo # 8227 RWF 413-14 wellhead sign illegible

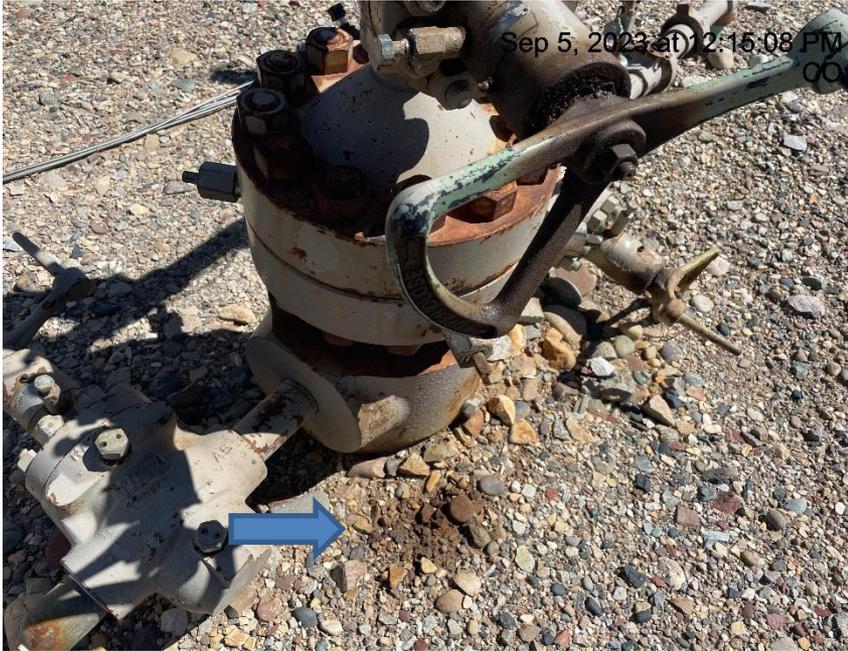
Photo # 8230 Stained soils & gravel near wellheads

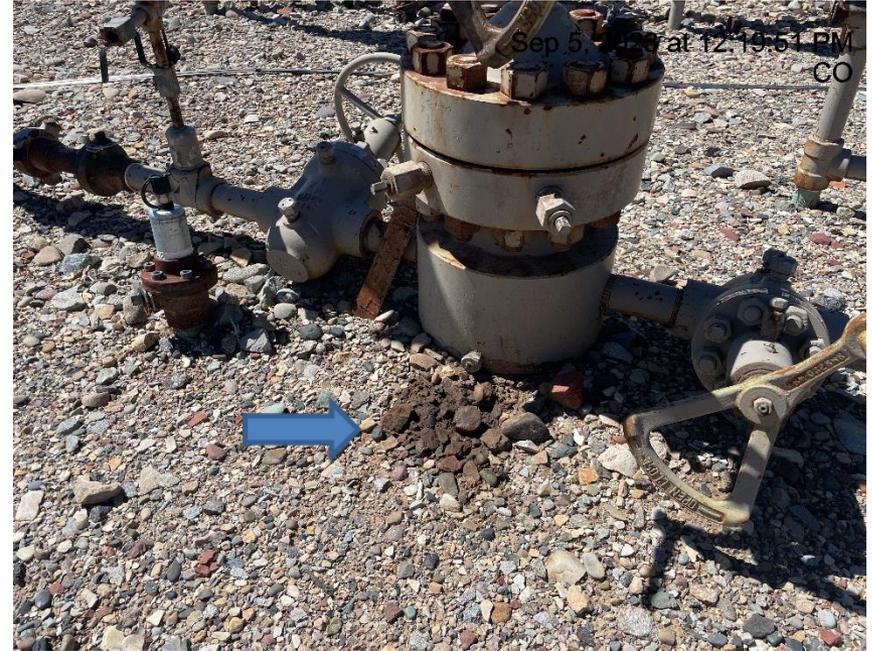
Photo # 8241 Stained soils & gravel near wellheads

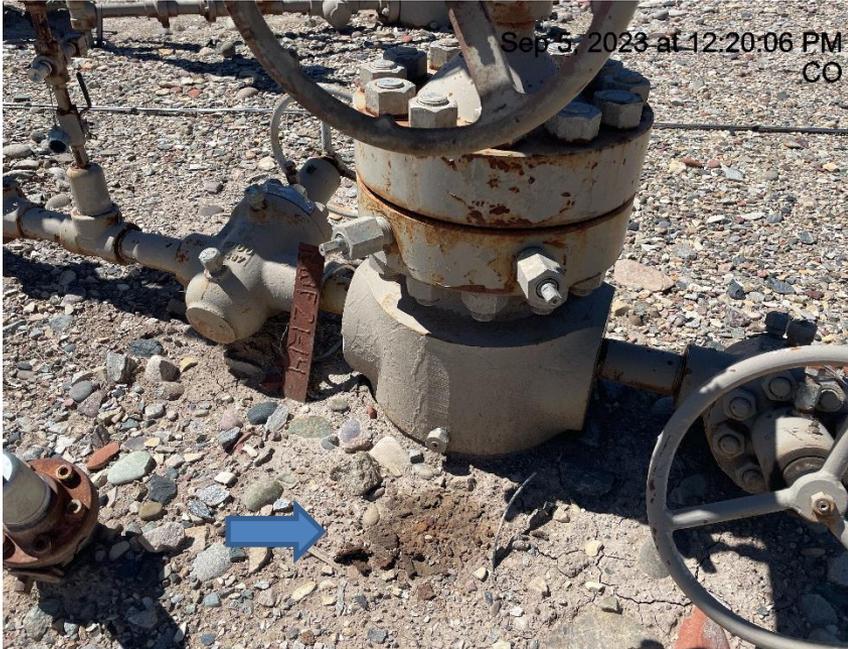
Photo # 8243 Stained soils & gravel near wellheads

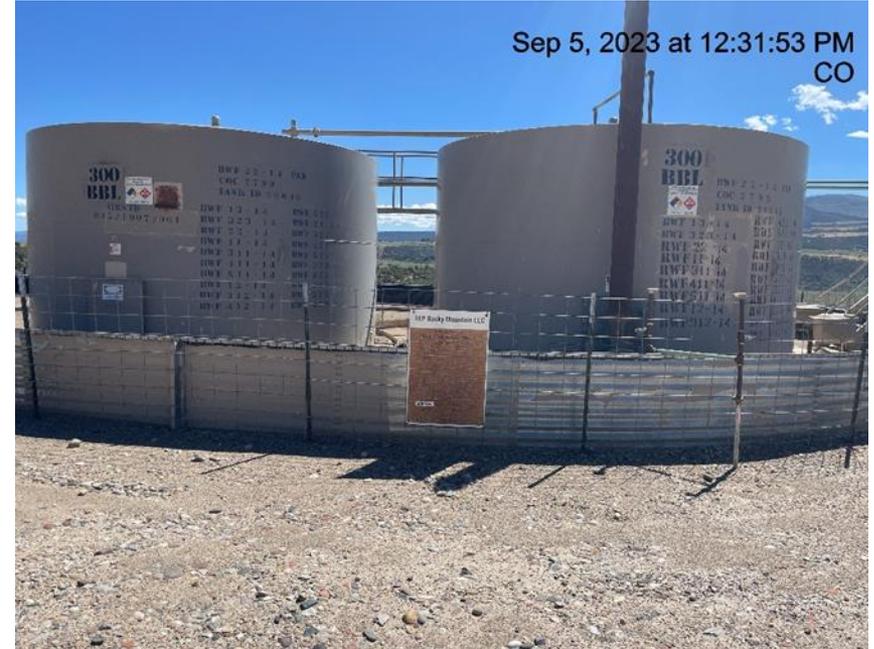
Photo # 8213 Battery sign weathered & illegible
