Inspection Photos

API: 099-06063

Operator: RENEGADE OIL & GAS COMPANY

Inspection Date: 9/6/2023

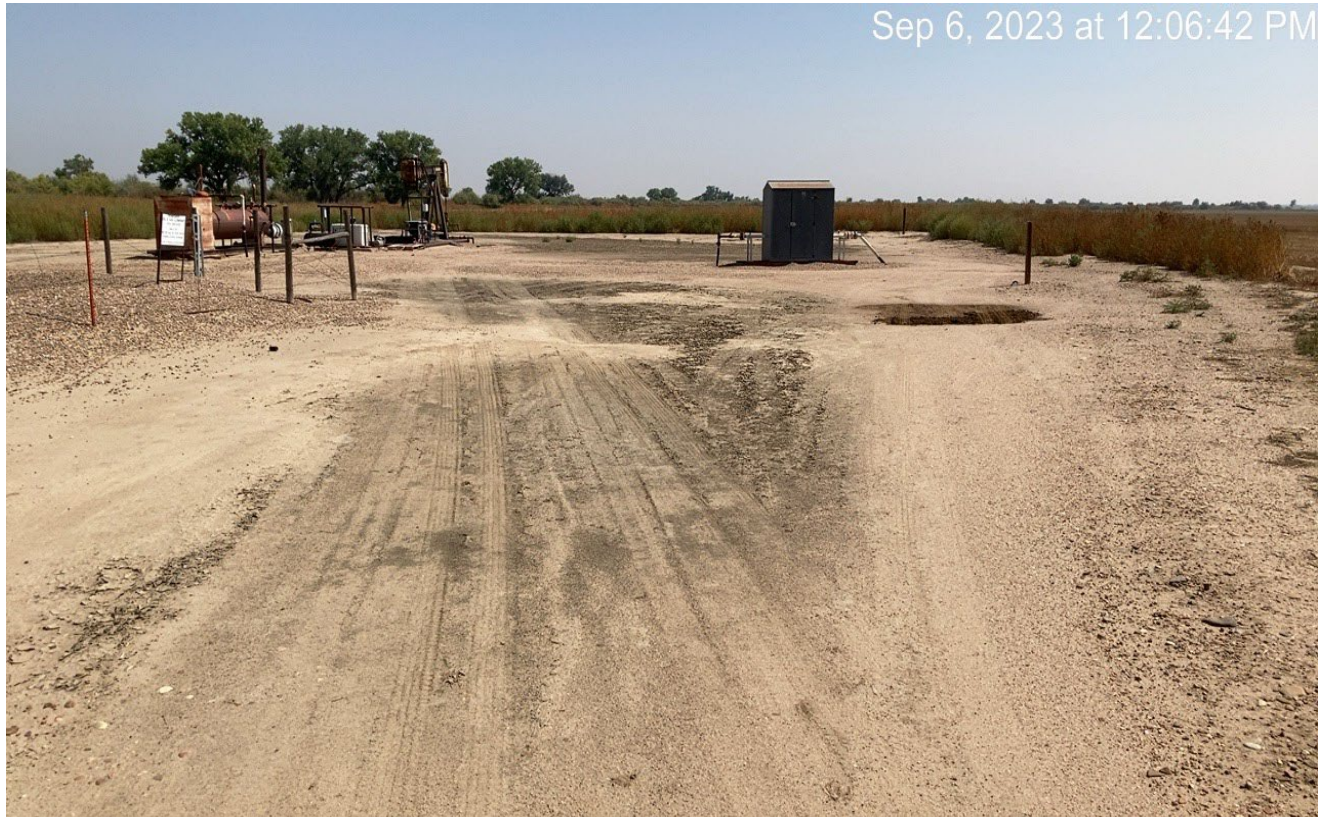
Photo 1. Facing northeast toward the wellsite.

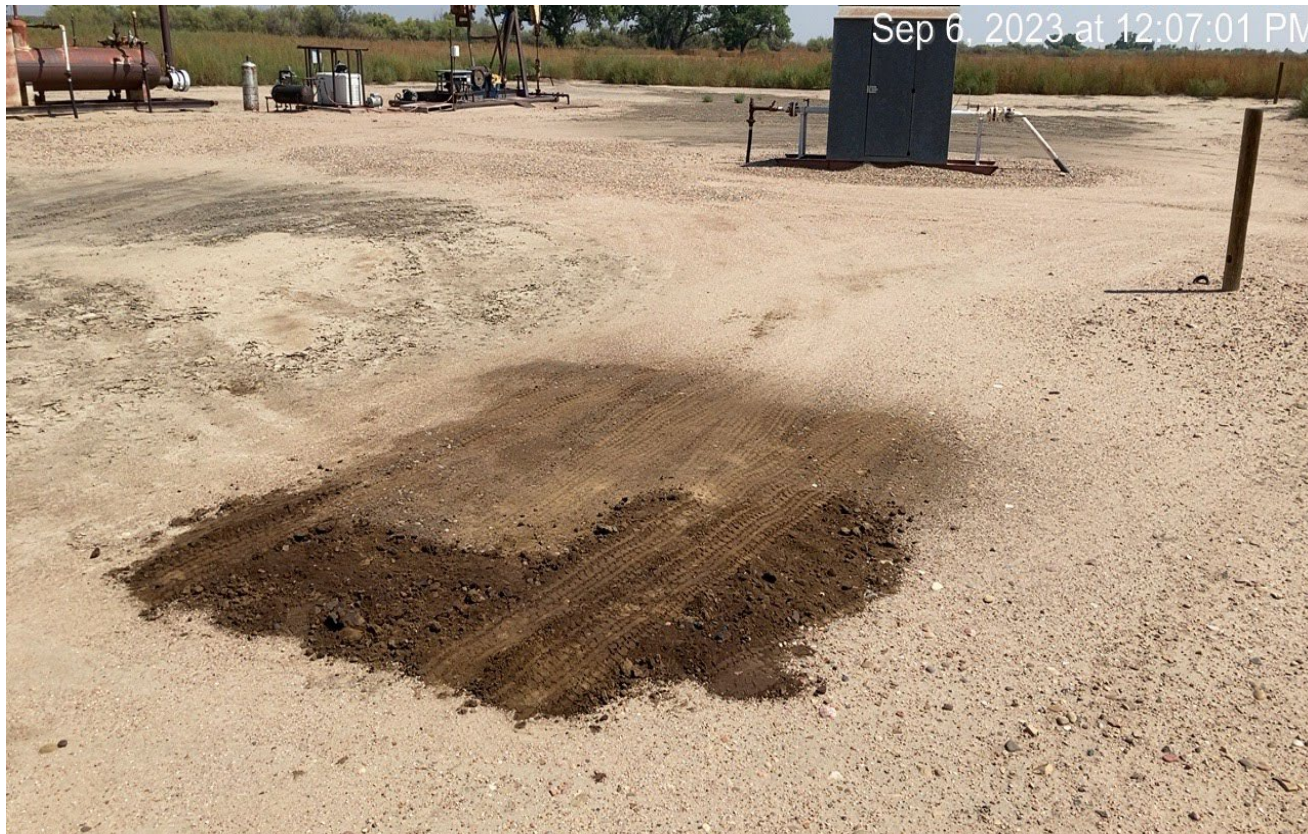
Photo 2. There is oily soils that have been dumped on the ground which appears to have been dug up at the tank battery. This has caused additional contamination. E&P waste was not properly disposed.

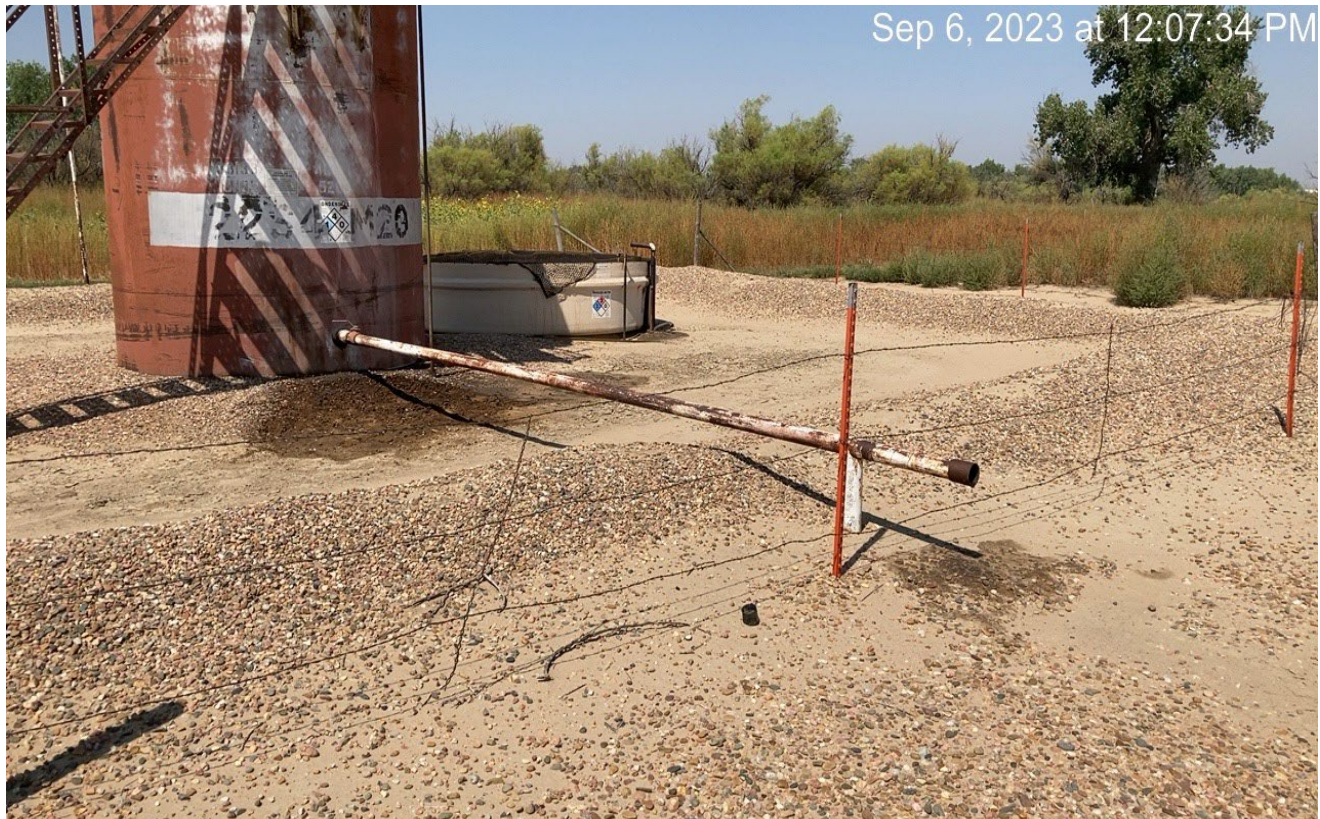
Photo 3. Facing toward the tank battery. There is oil stained soil at the pipe outlet and at the base of the tanks.

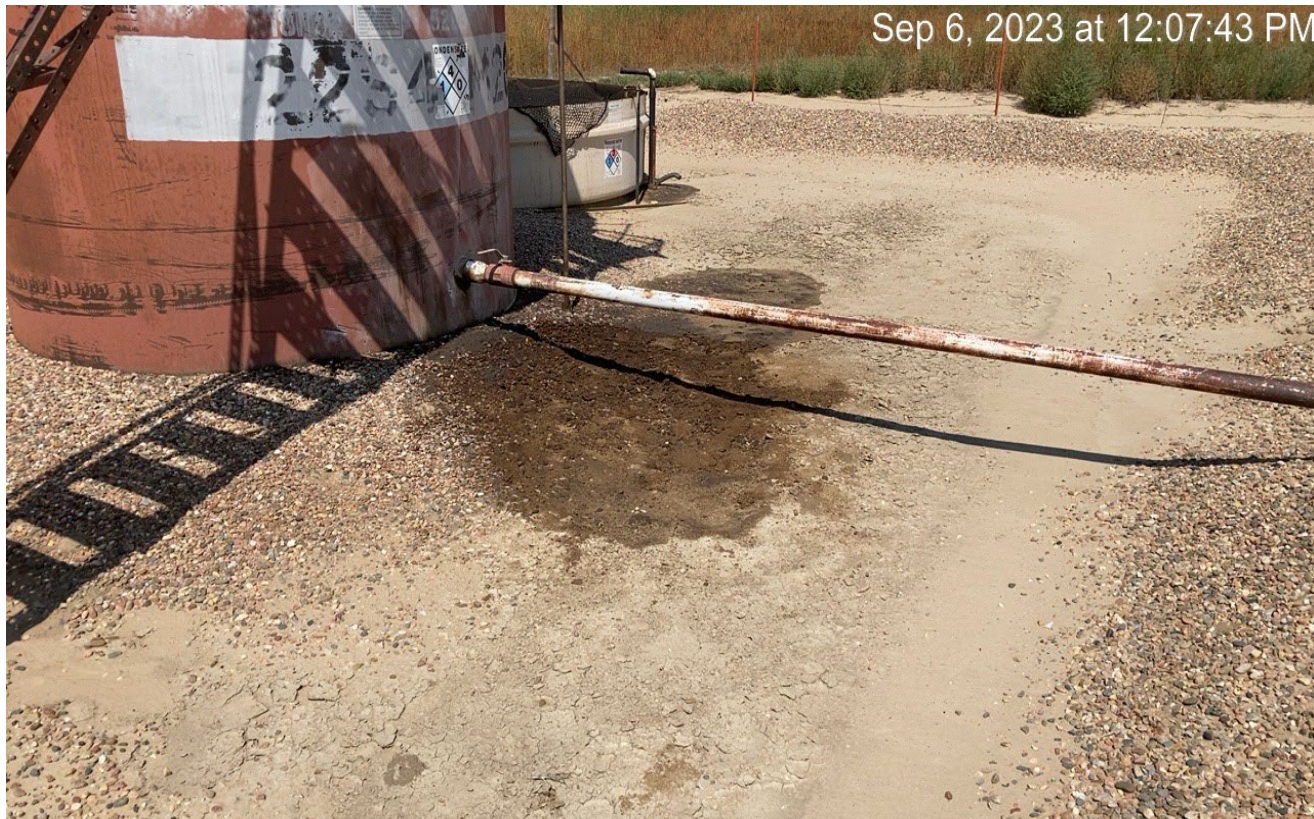
Photo 4. The oil stained soils have been dug up with a shovel oily soils still remain and need to be fully excavated and properly disposed. Previous corrective action was not completed.

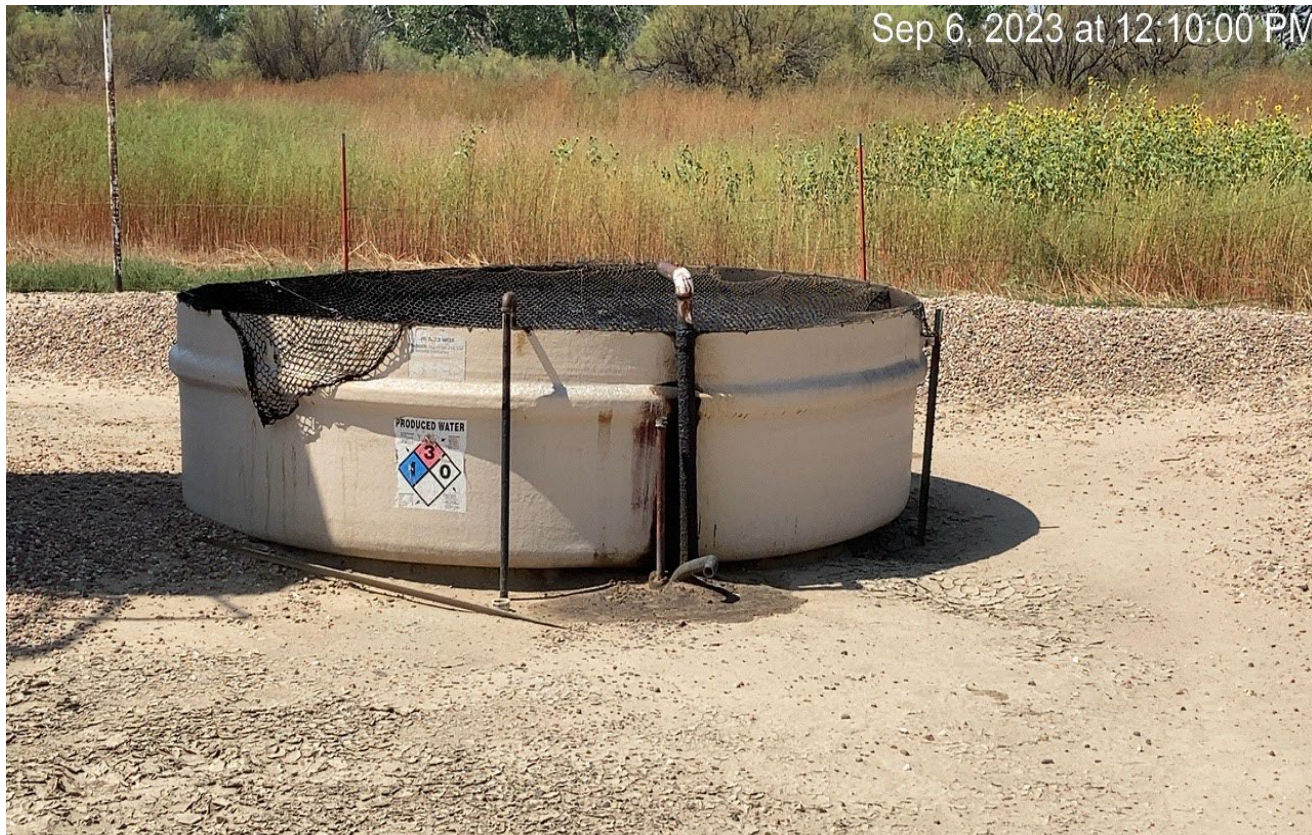
Photo 5. There is oil staining that overtopped the open top tank. There is oil inside the tank and the tank is mislabeled as produced water. Previous corrective action was not completed.

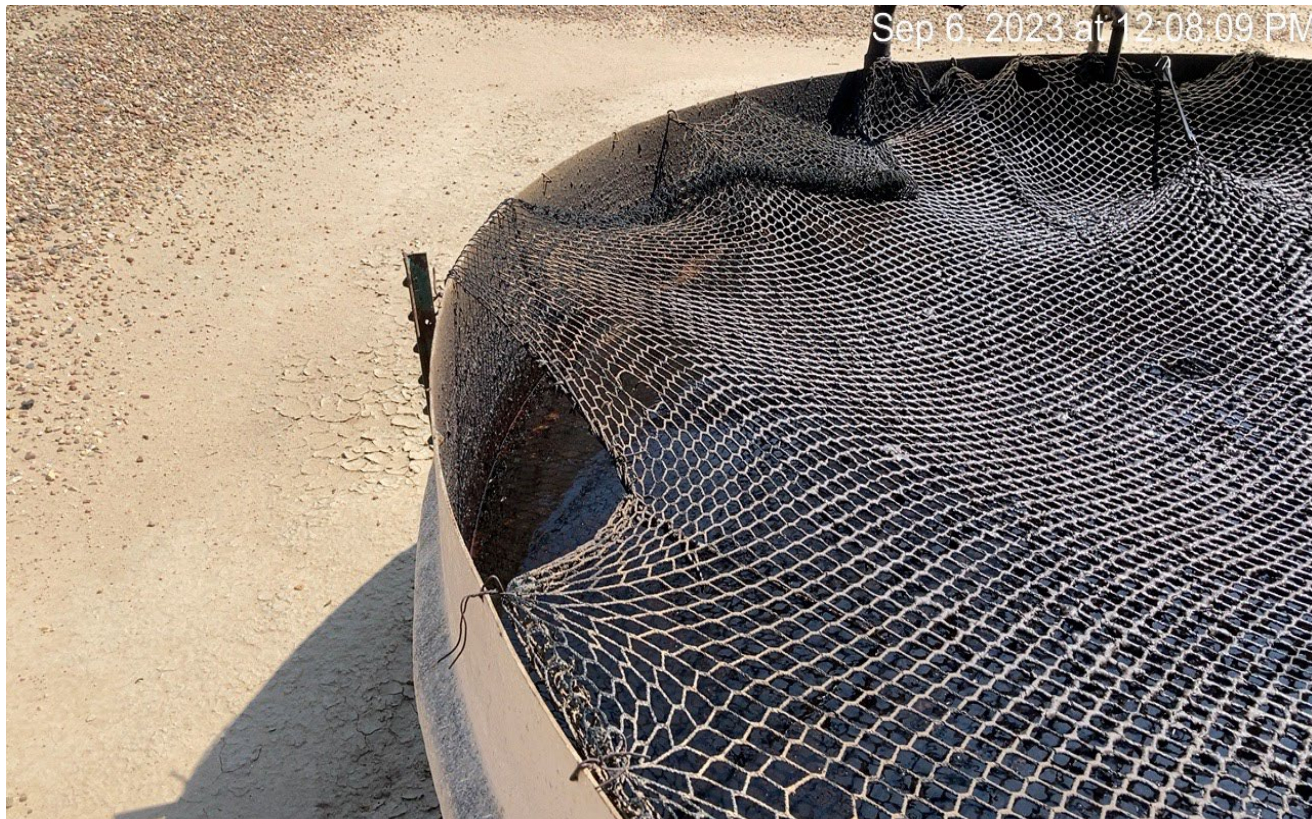
Photo 6. The netting on the open top tank is still insufficient to prevent wildlife entry. Previous corrective action was not completed.

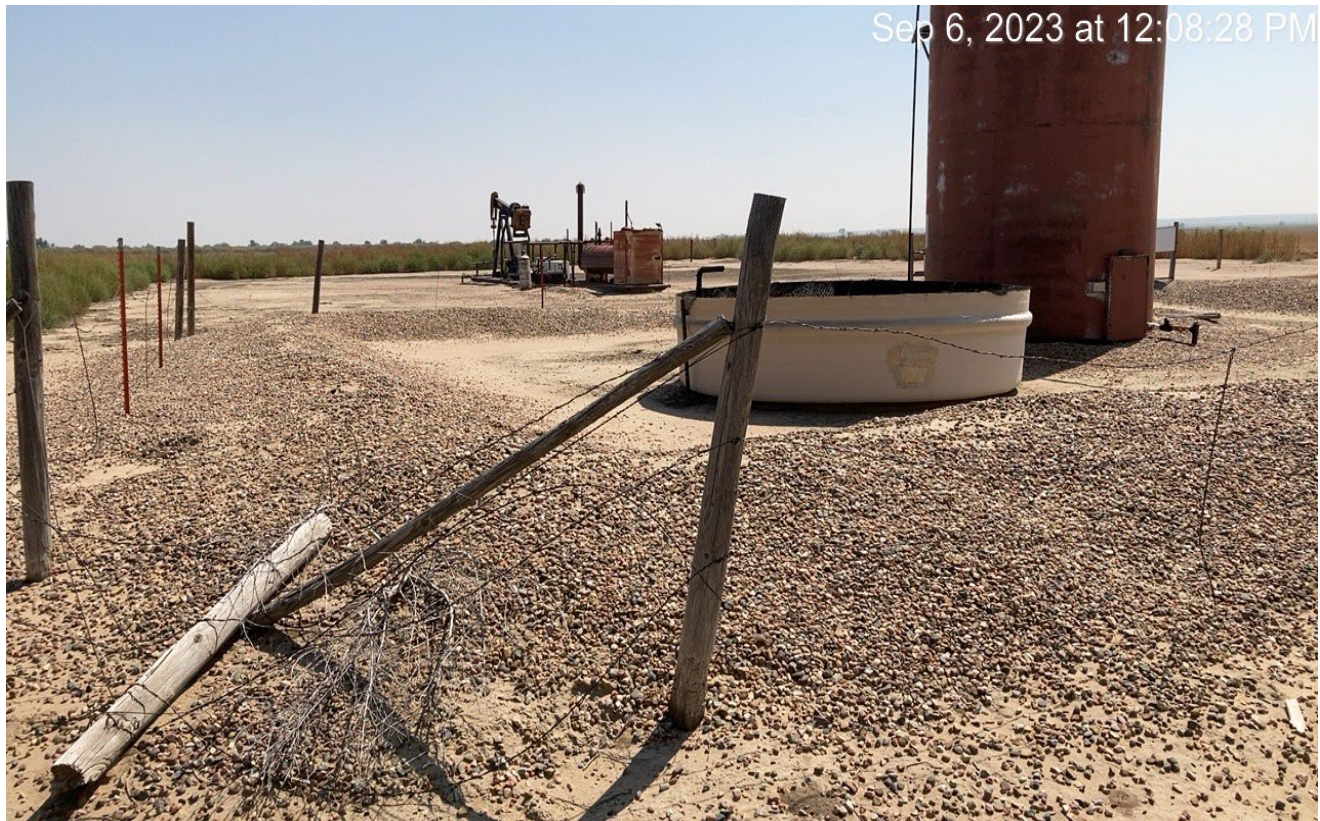
Photo 7. The fence at the northwest corner of the tank battery is in disrepair..

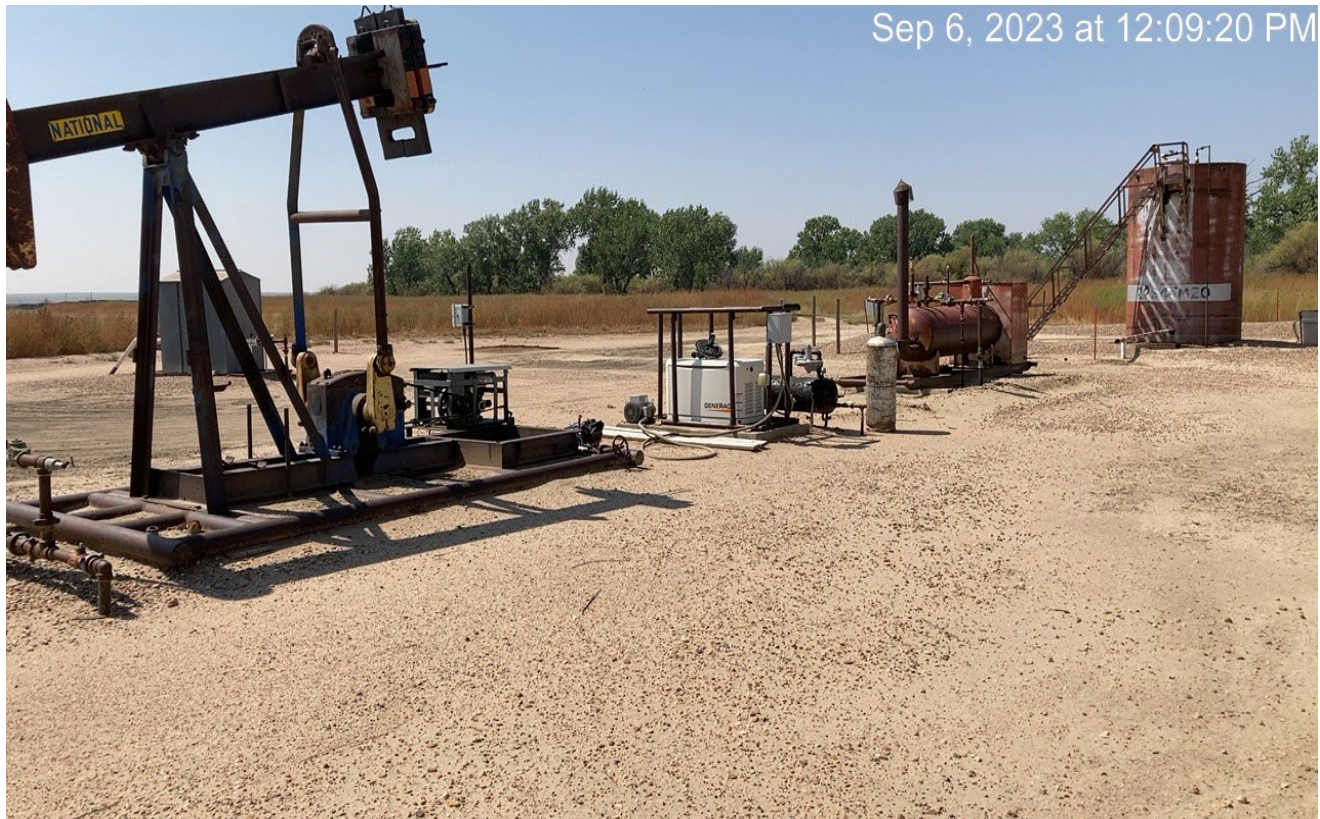
Photo 8. Facing southwest toward the wellsite.
