Inspection Photos

API: 099-06909

Operator: RENEGADE OIL & GAS COMPANY

Inspection Date: 9/6/2023

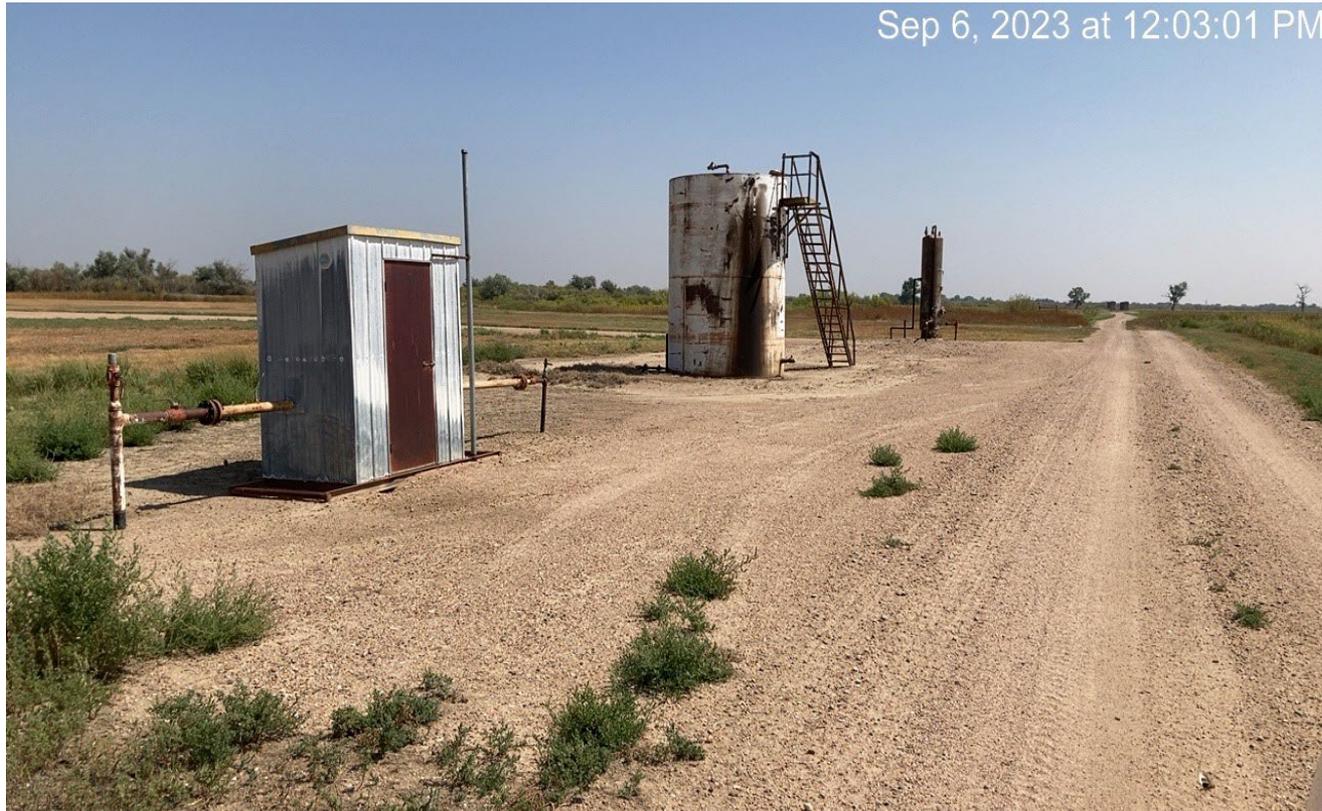
Photo 1. Facing northeast toward the offsite tank battery there is no sign posted at the tank battery which is off site from the well. Previous corrective action was not completed.

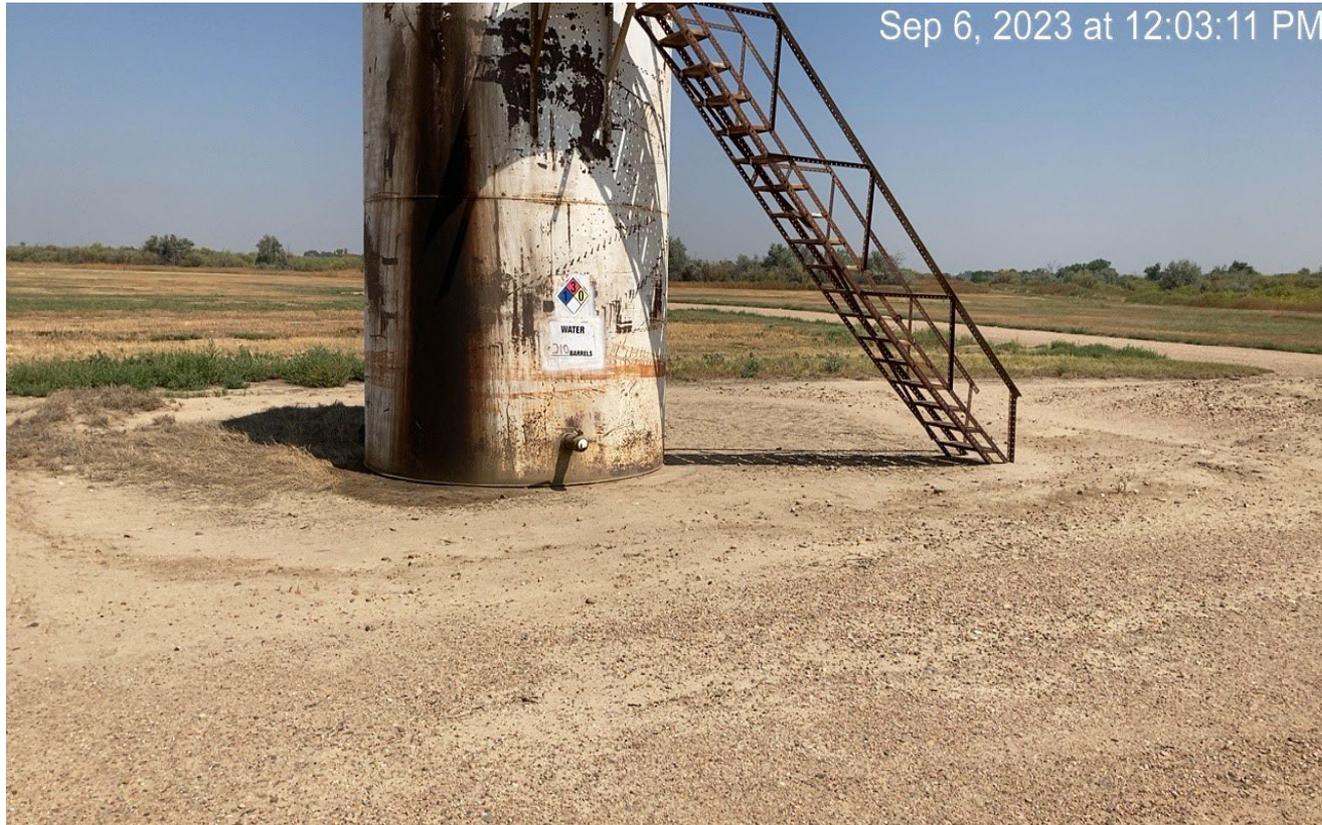
Photo 2. Facing toward the tank which is labeled as water. It appears crude oil has leaked out from the top. Additionally there is no secondary containment around the tank. Previous corrective action was not completed.

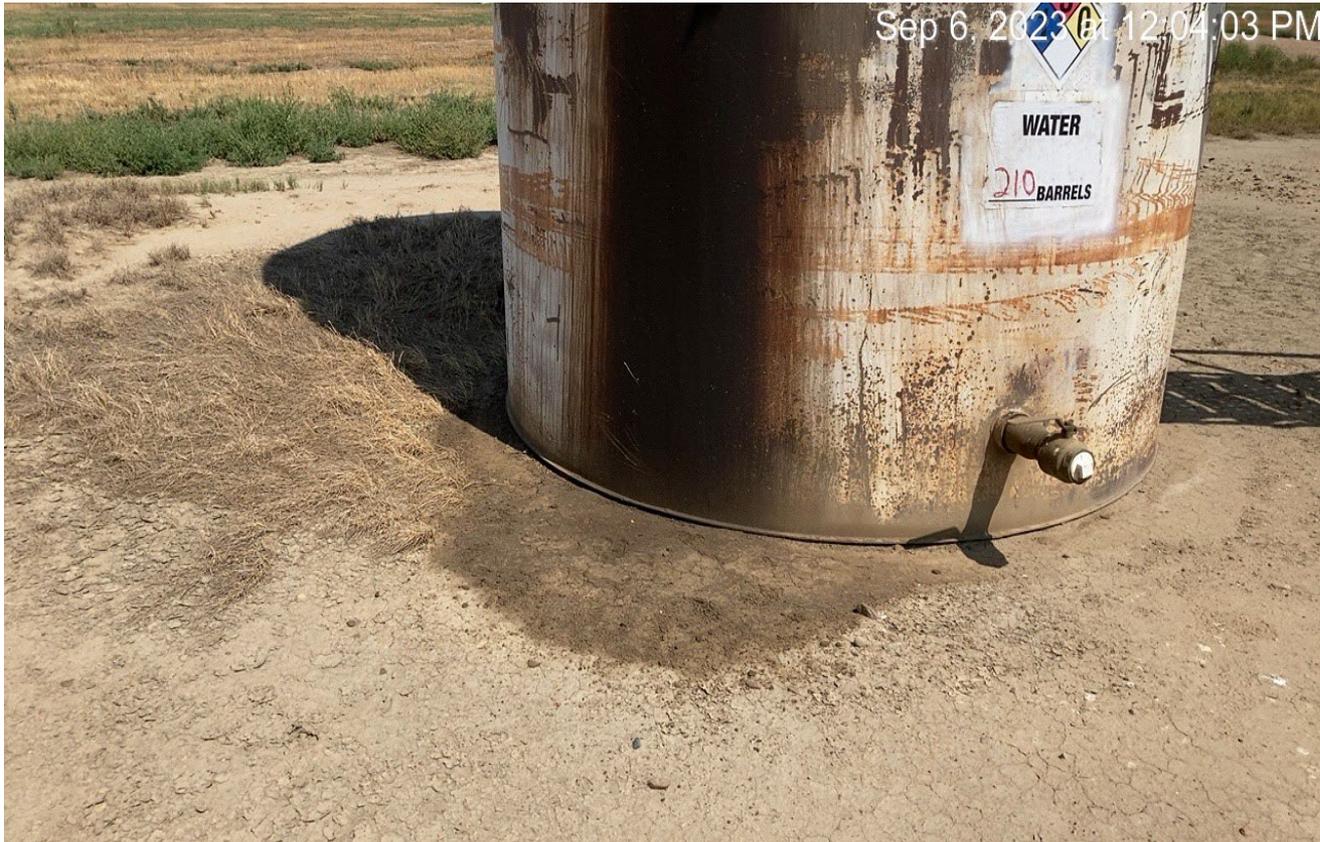
Photo 3. Facing toward the tank battery. There is oil stained soil at the pipe outlet and at the base of the tanks. Previous corrective action was not completed.

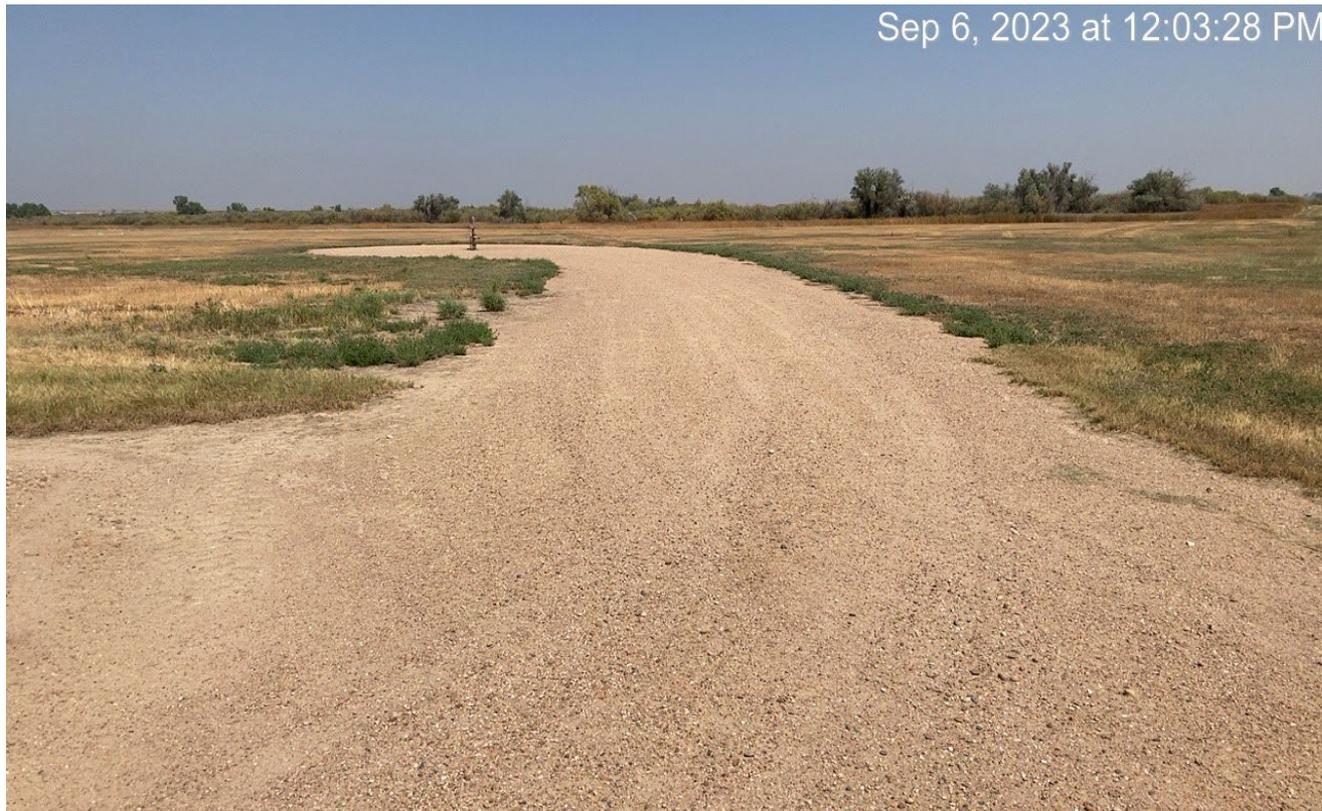
Photo 4. There is well sign posted at the wellhead. The well is a distance away from the tank battery and an addition sign should be posted at the tank battery.
