Inspection Photos

API: 099-06059

Operator: RENEGADE OIL & GAS COMPANY

Inspection Date: 9/6/2023

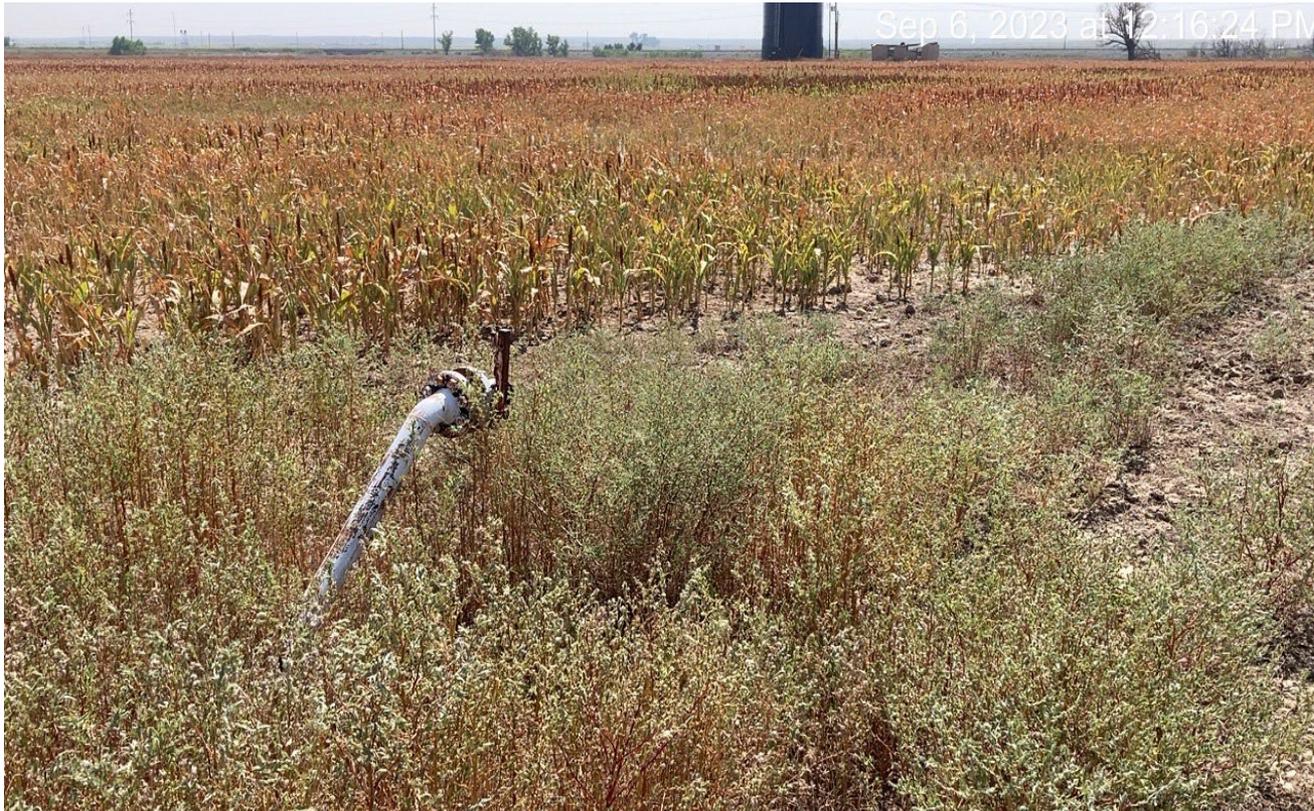
Photo 1. Facing southeast at the abandoned wellsite. There is an abandoned pipe riser that still remains and must be removed. Pipe riser is interfering with crop production.

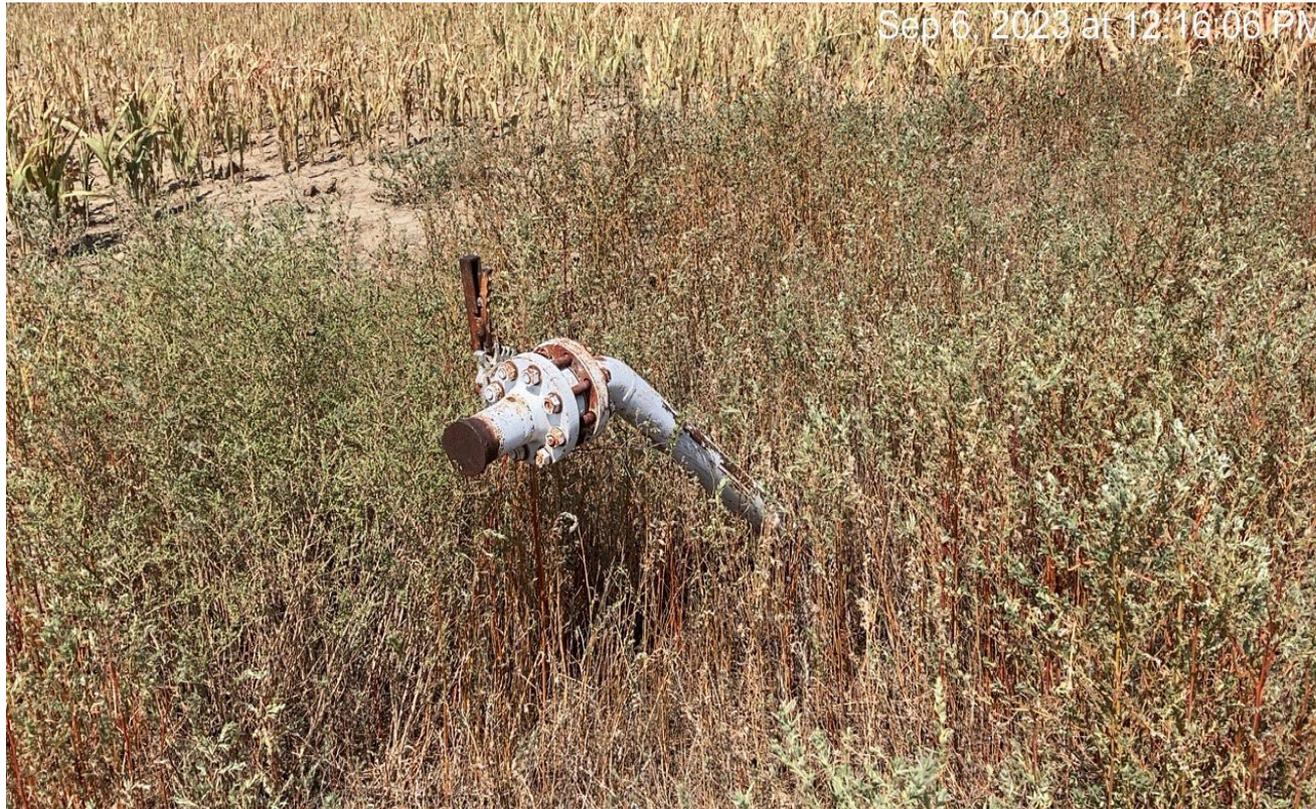
Photo 2. Abandoned capped pipe riser needs to be removed.
